Subject: Vapor Mitigation System Documentation and Maintenance Plan
Pilgrim Cleaners, 7475 Mineral Point Road #600, Madison, Wisconsin
BRRS #02-13-551995

Post Mitigation Report

Project: Pilgrim Cleaners, High Point Shopping Center

VAPOR MITIGATION SYSTEM MAINTENANCE PLAN
Pilgrim Cleaners, 7475 Mineral Point Road #600, Madison, Wisconsin

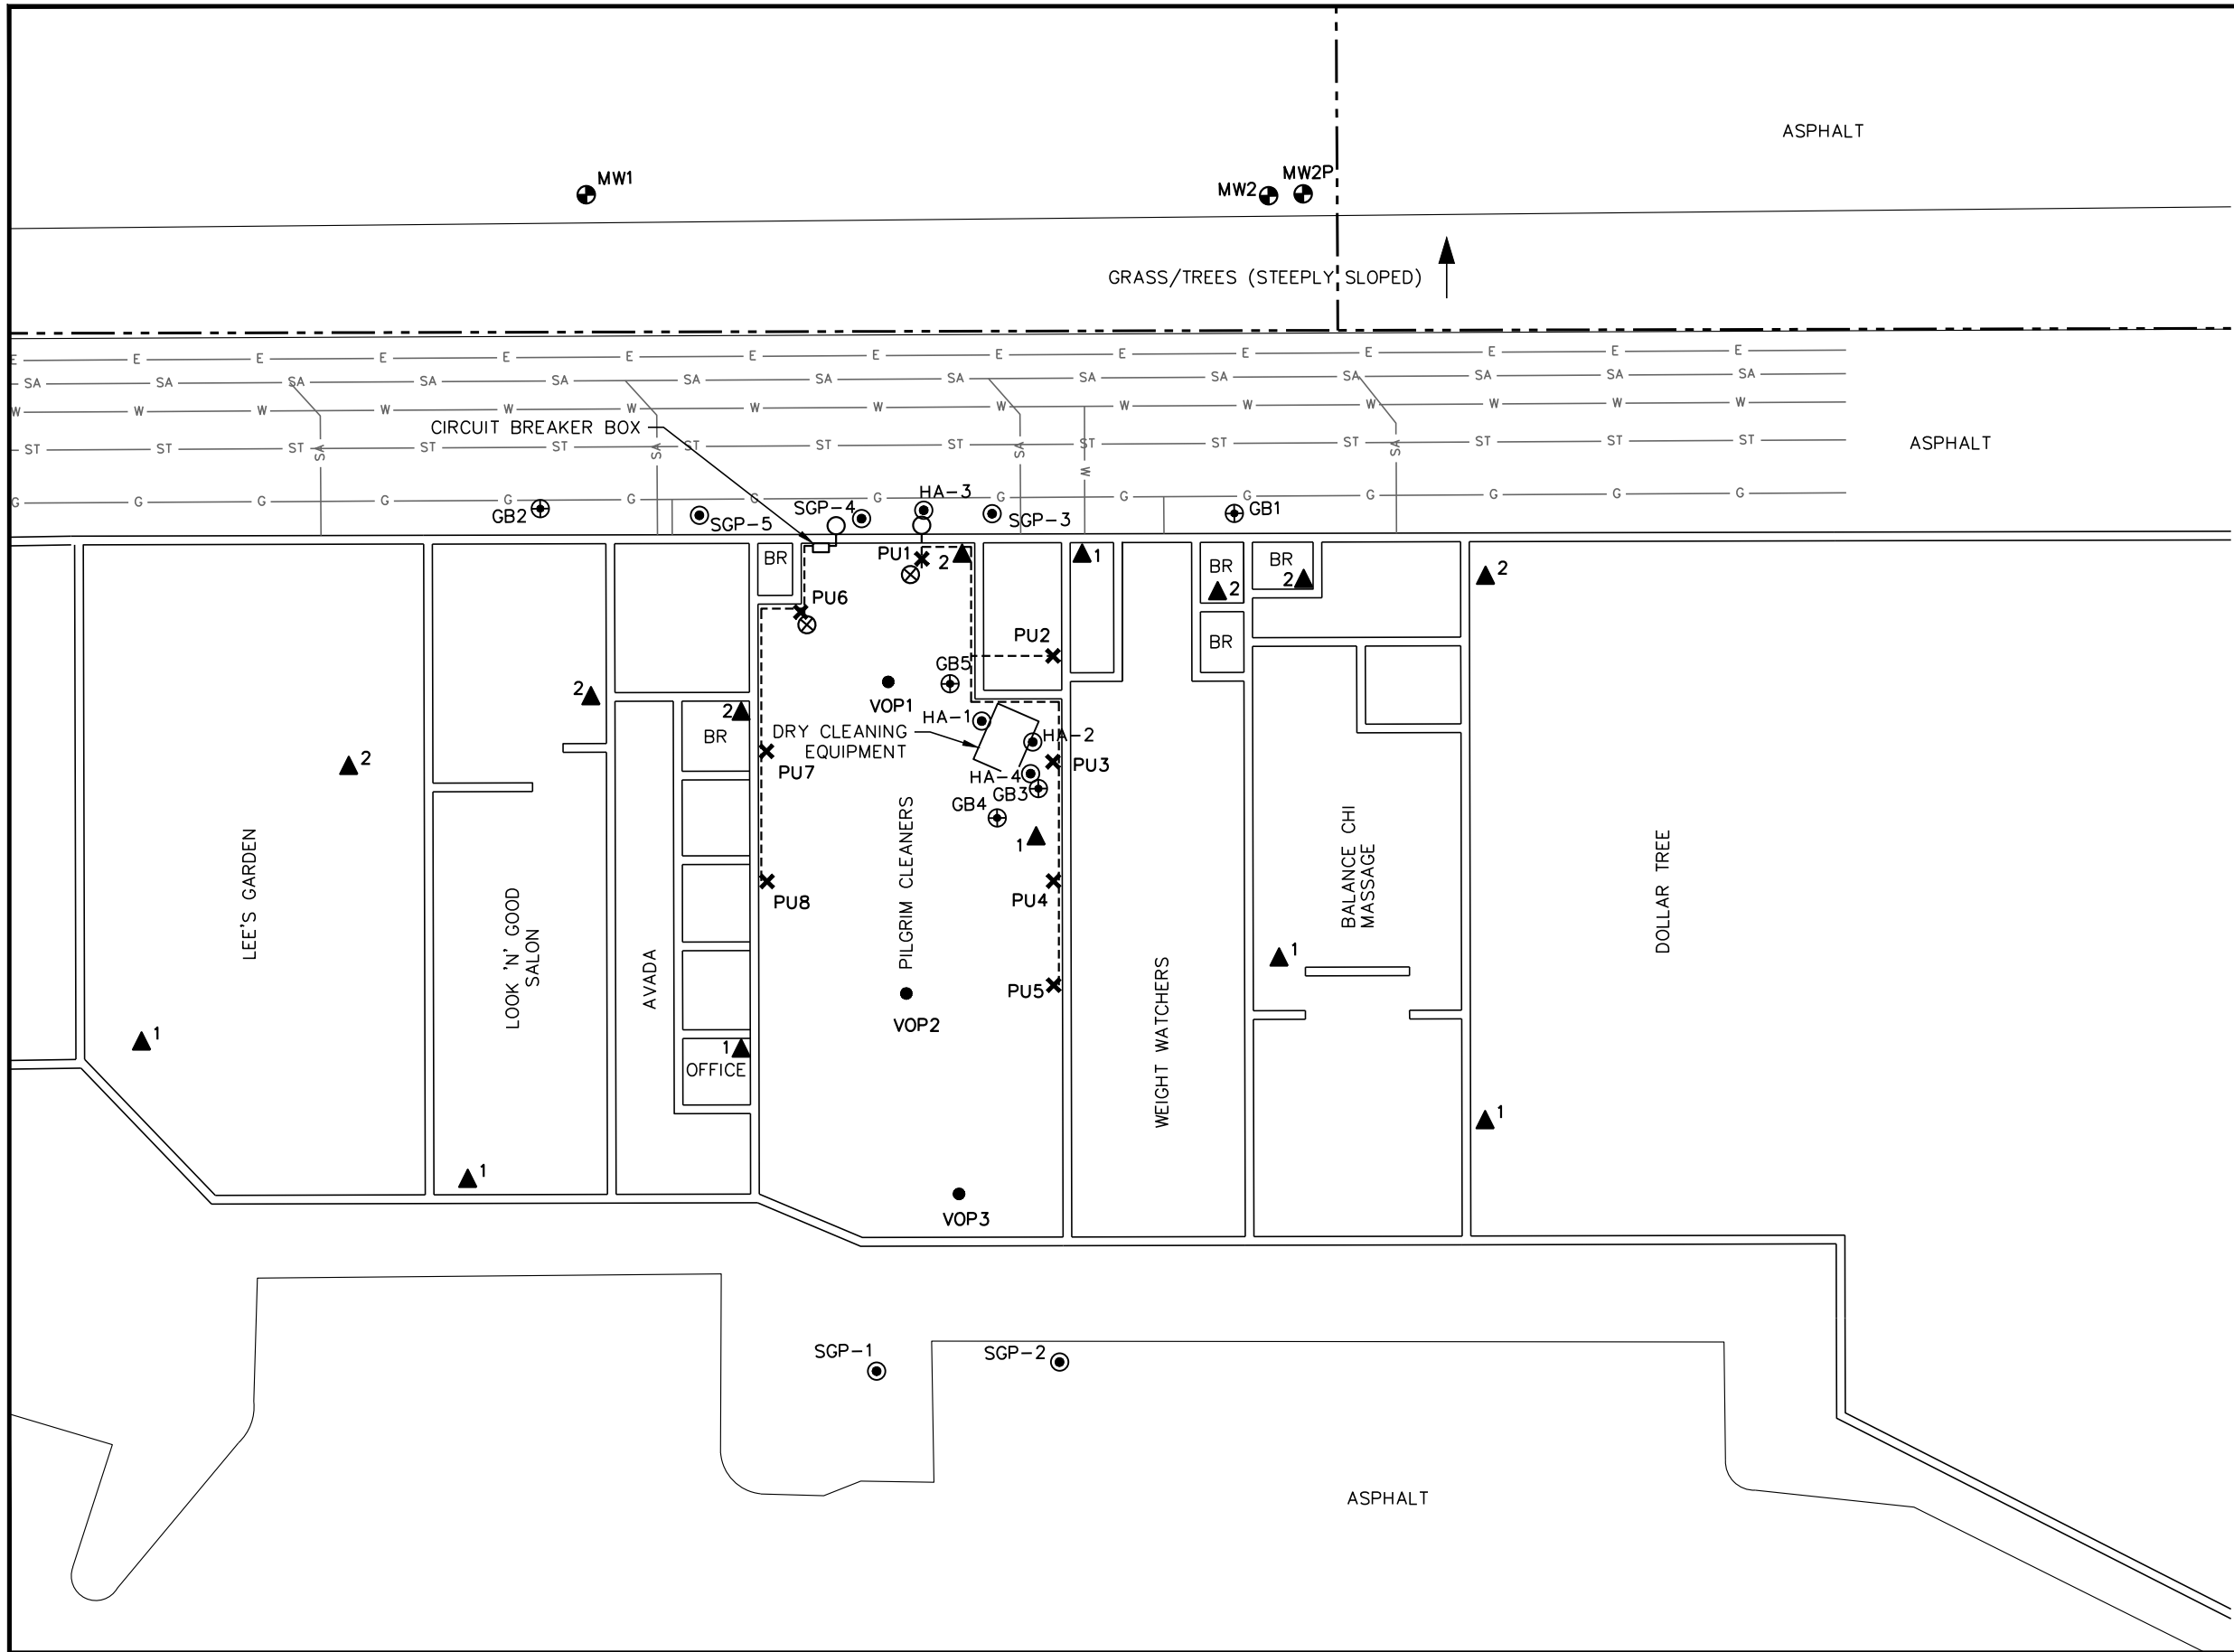
Figure 1
Detailed Site Plan

The VMS was constructed with eight vacuum pick up points at locations shown on **Figure 1**. Each pick up point was constructed with 3-inch diameter schedule 40 PVC pipe set in the sub-slab material. The PVC pipes were sealed into the floor to prevent leakage. Pick up points 1 through 5 were plumbed to 3-inch diameter PVC header pipe which runs along the south side of the dry cleaner unit. Pick up points 6 through 8 were plumbed to a separate 3-inch diameter header pipe which runs along the northern side of the dry cleaner unit. The header pipes extend through the east wall of the building. The gap between the header pipes and building wall was sealed.

Each fan is equipped with an on/off switch for servicing and a manometer to monitor fan operation. Power to the fans can also be controlled by a breaker in a circuit break box located at the east side of the unit as shown on **Figure 1**.

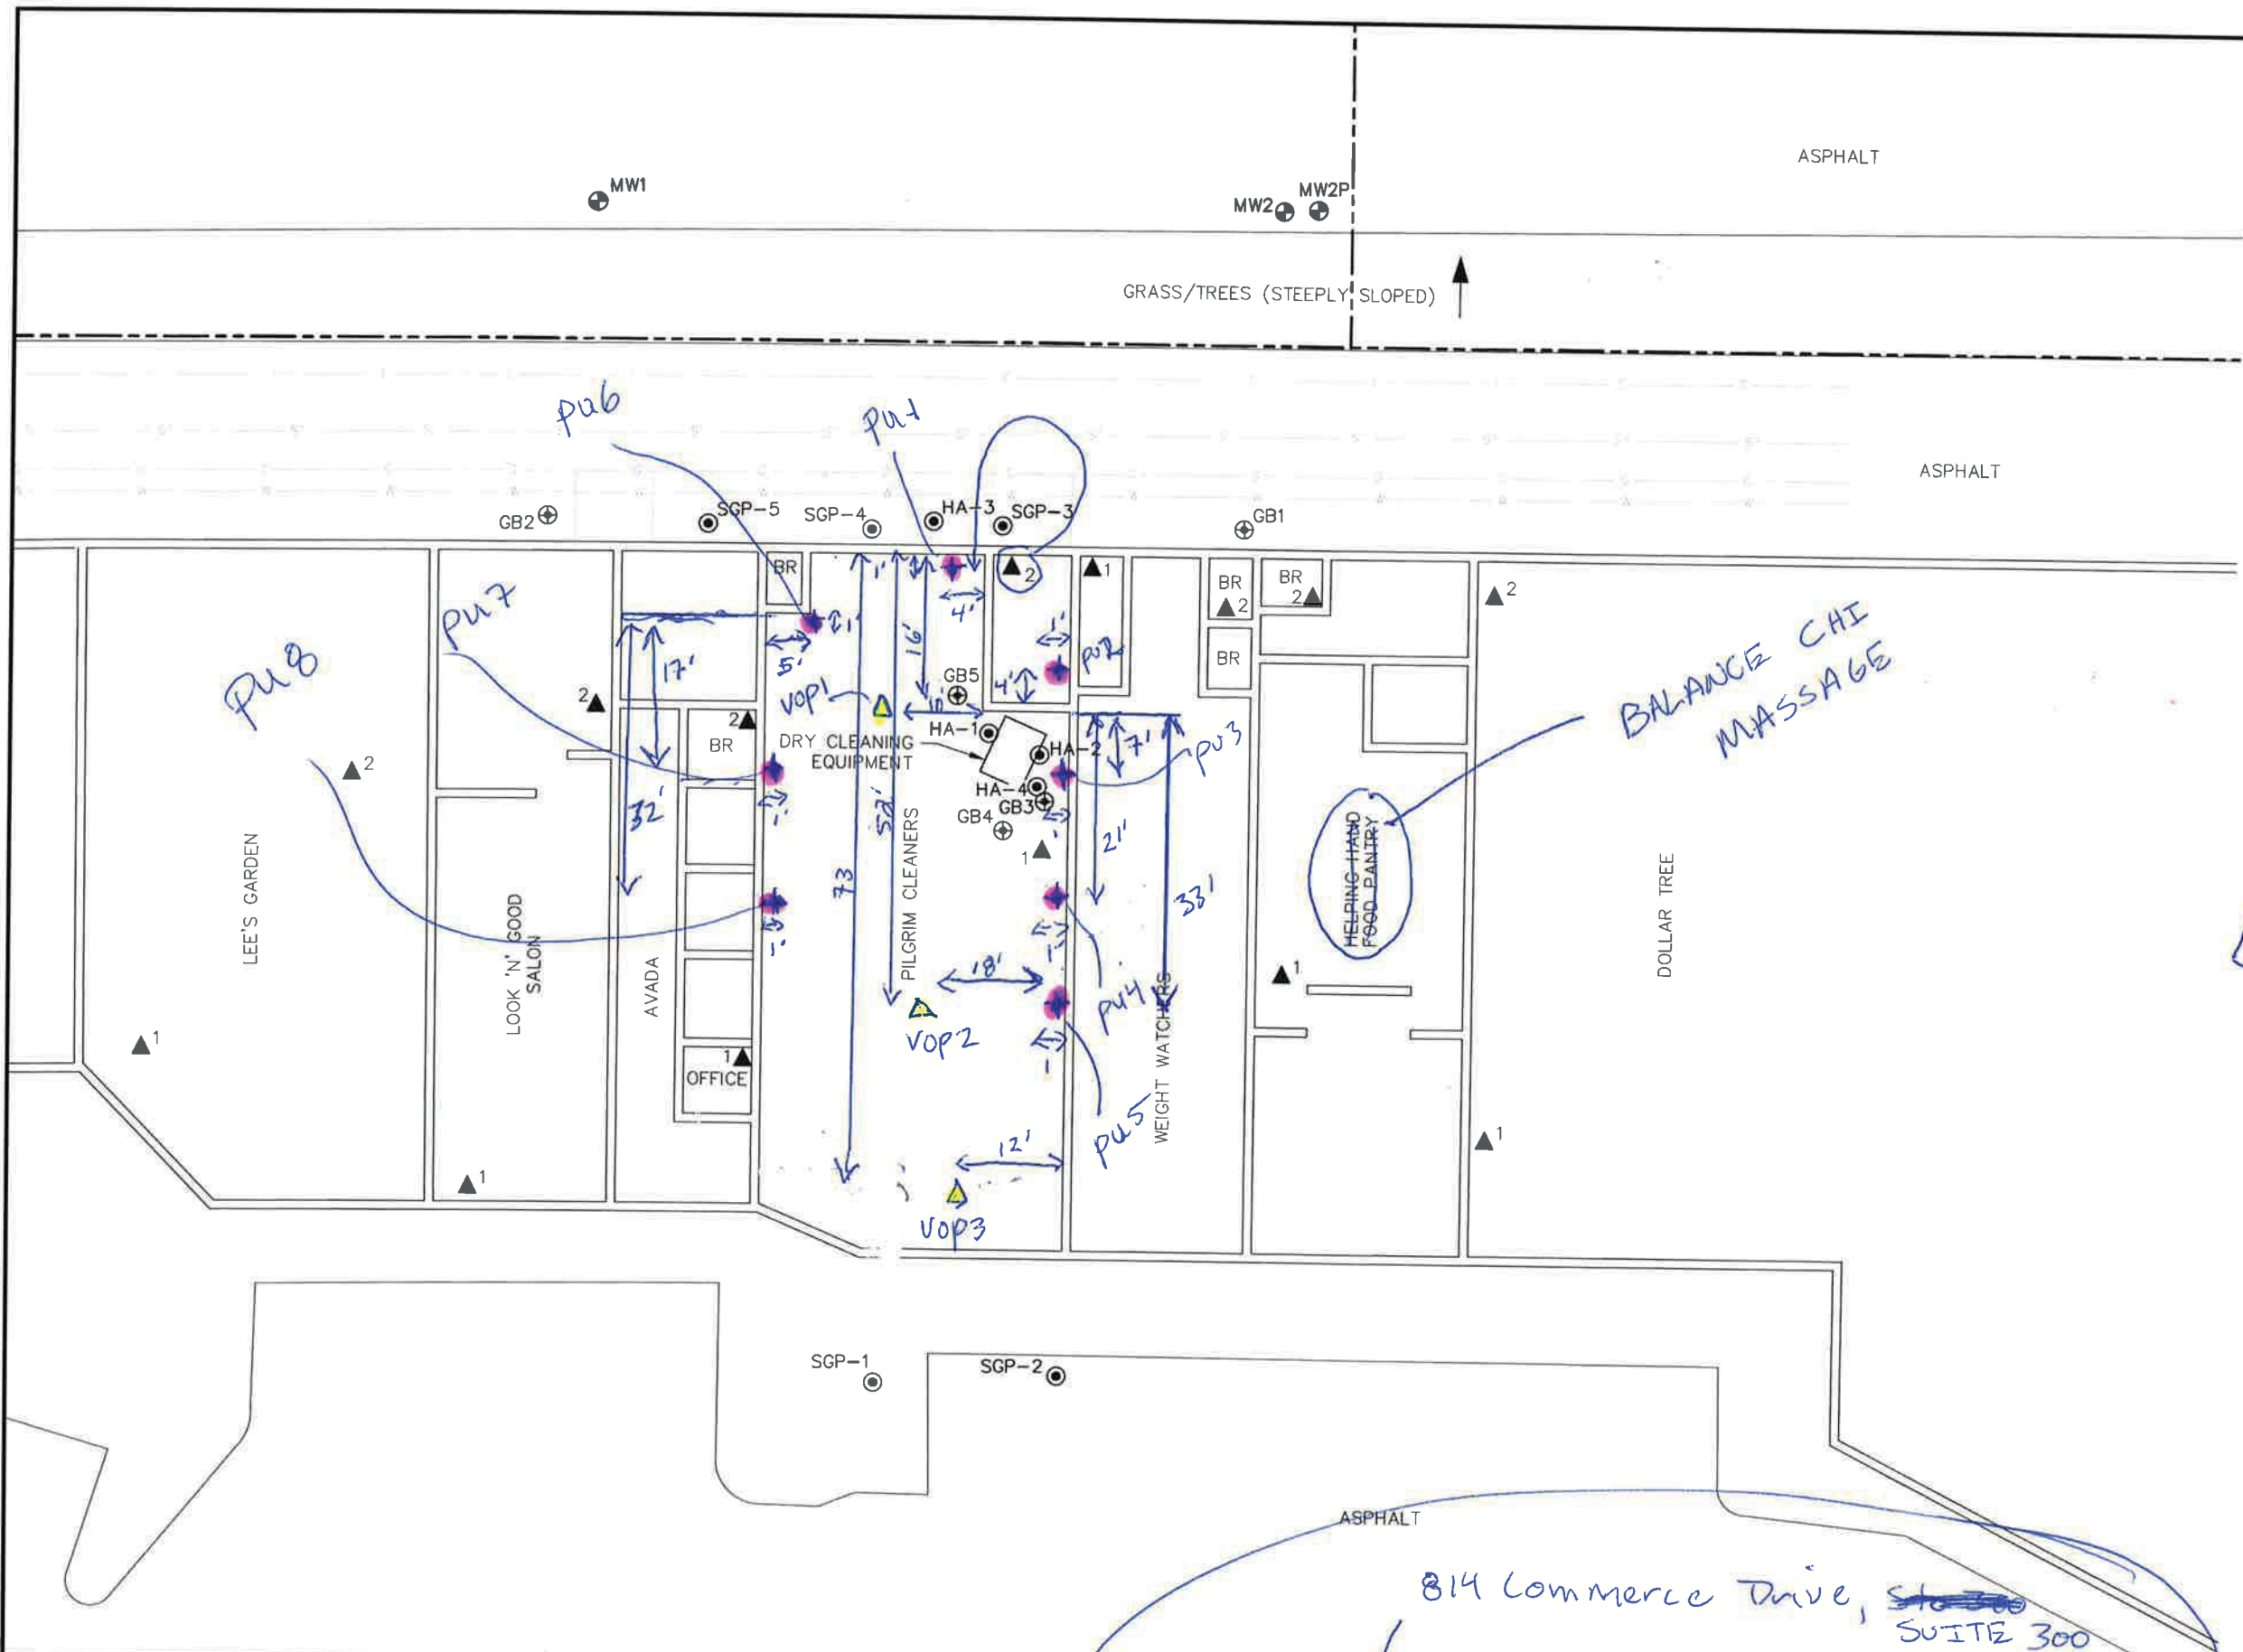
Three sub-slab vacuum observation points were installed by SCS (VOP-1, VOP-2, and VOP-3). These were used to take depressurization readings. (See drawing for approximate locations.)

VOP-1 Read minus - 0.148 inches WC. Is located about 16 feet from the back wall (east wall) and 12 feet north of the boiler room wall.

VOP-2 Read minus -0.034 inches WC. Is located about 52 feet from the back wall (east wall) and 18 feet from the south wall.

VOP-3 Read minus -0.013. Located a few feet from the front of the building (the east side) near the counter. Is located about 73 feet from the back wall (east wall) and 12 feet off the south wall.

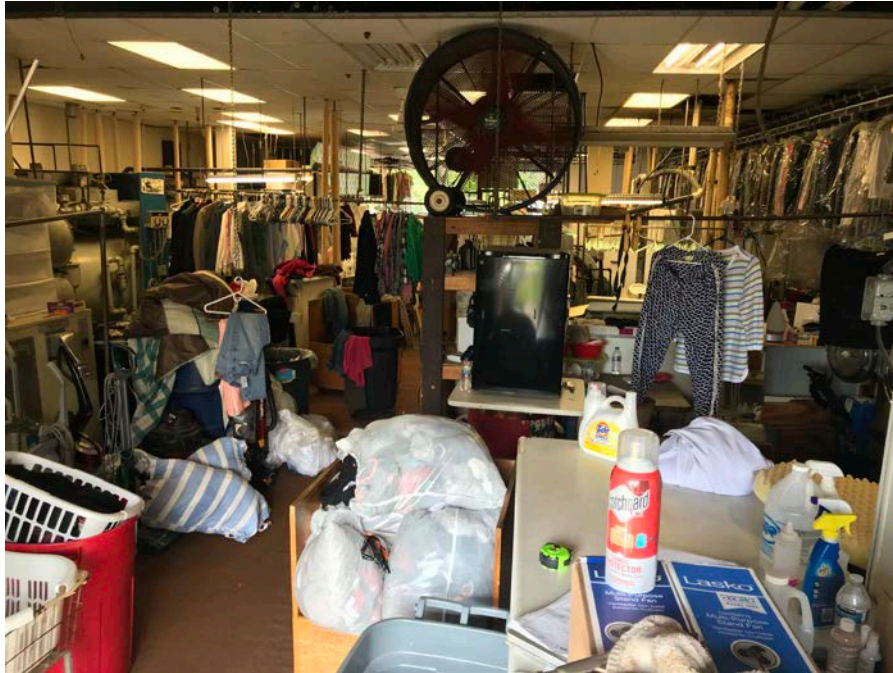
Photo 1: Looking west from east end of Pilgrim Cleaners unit.

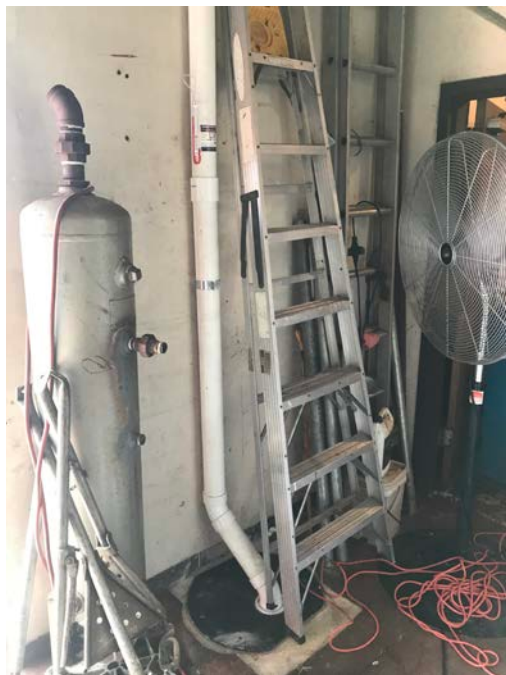
Pickup 1 is located against the back wall on the eastern end on the south side near the boiler room. This pickup point was excavated to 40 inches of depth. The dry cleaner operator reported that the sewer lateral in this area had been dug up and replaced twice so it's likely that the fill was primarily a fine builder's sand. The sewer lateral was not encountered during pickup point construction.

A manometer was installed on the riser pipe of PU 1. After startup the manometer read 3.5 inches of water column. Based on the fan curve the fan is moving approximately 18 cfm based on the fan curve.

Photo 2: Pick Up Point 1 with manometer at southeast corner of unit.

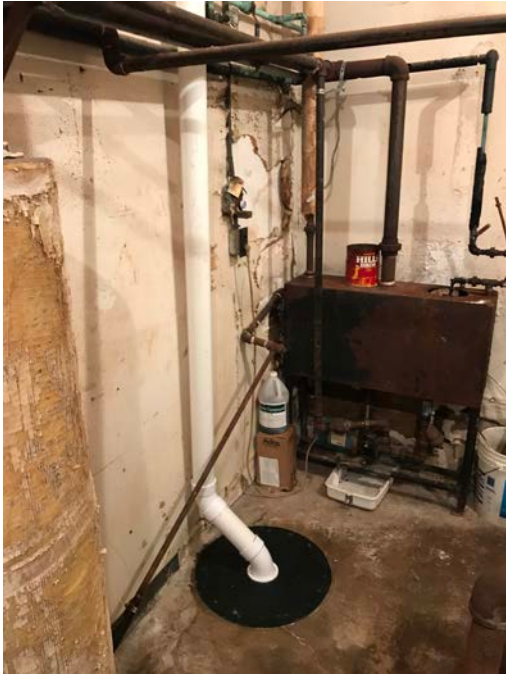
Pickup 2 is located in the boiler room. This pickup was excavated to 24 inches where two PVC pipes running east and west were discovered. The dry cleaner operator reported that the pipes received water from the boiler and discharged to storm sewers, with one pipe running out the back of the building and the other out the front of the building. The pipes were not damaged during the pickup point installation and appeared to be in good condition.

Photo 3: Pick Up Point 2
in boiler room.

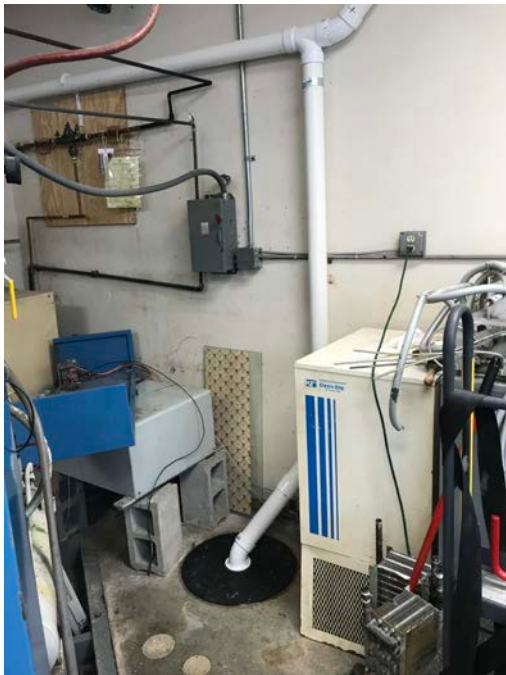
Pickup 3 is located on the south wall west of the boiler room. This pickup was excavated to approximately 18 inches.

Photo 4: Pick Up Point 3
on south wall of unit.

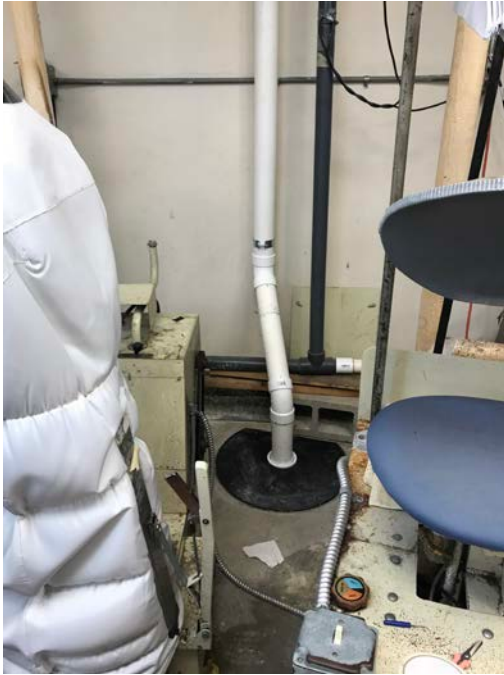
Pickup 4 is located on the south wall west of pickup 3. This pickup was excavated to approximately 16 inches on one side. A large rock blocked half the hole at about one foot deep.

Photo 5: Pick Up Point 4
on south wall of unit.

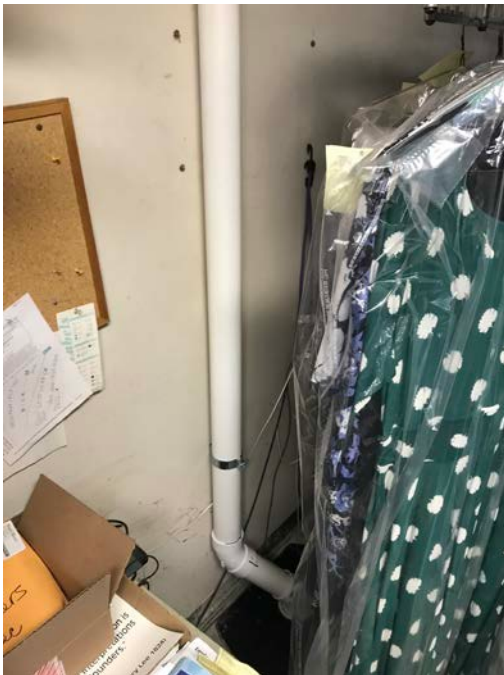
Pickup 5 is located on the south wall west of pickup 4. This pickup was excavated to approximately 12 inches before large rocks prevented further excavation.

Photo 6: Pick Up Point 5
on south wall of unit.

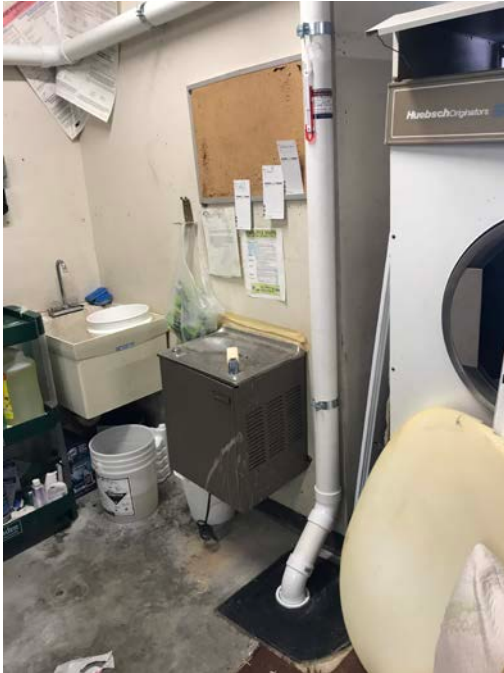
Pickup 6 is located near the water cooler just outside the bathroom. This pickup was excavated to approximately 16 inches deep. Packed rock and rubble prevented further excavation.

A manometer was installed on the riser pipe of PU 6. After startup the manometer read 3.7 inches of water column. Based on the fan curve the fan is moving approximately 12 cfm based on the fan curve.

Photo 7: Pick Up Point 6 with manometer on north wall of unit.

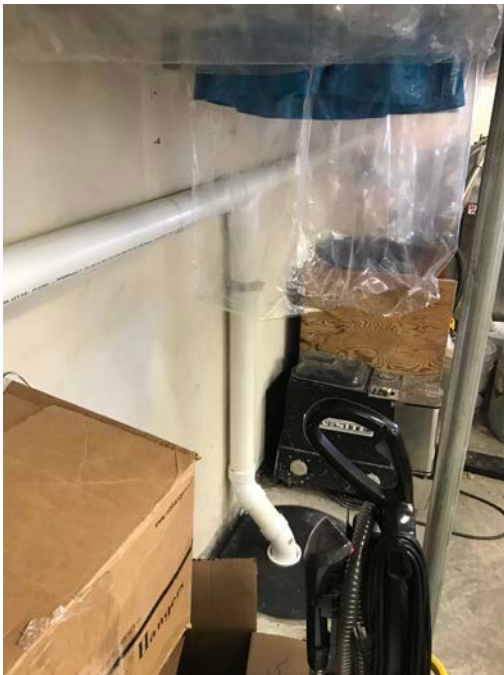
Pickup 7 is located about 15 feet west of pickup 6 along the north wall. This pickup was excavated to about 24 inches deep. Packed rock and rubble prevented further excavation.

Photo 8: Pick Up Point 7 on north wall of unit.

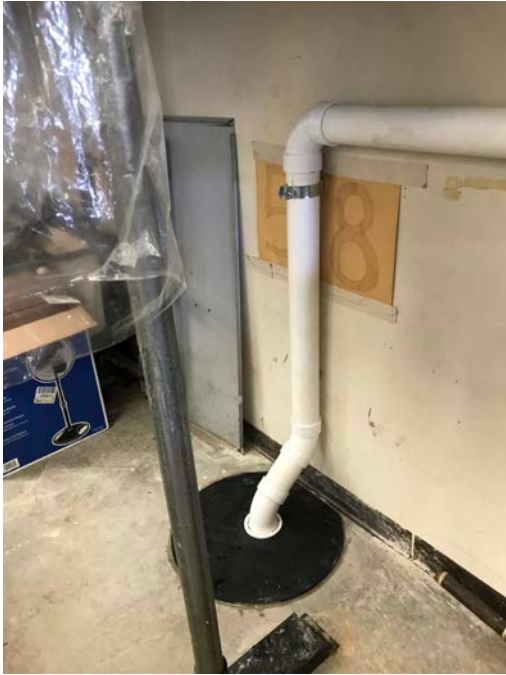
Pickup 8 is located about 15 feet west of pickup 7 along the north wall. This pickup was excavated to about 14 inches deep. Packed rock and rubble prevented further excavation.

Photo 9: Pick up Point 8 on north wall of unit.

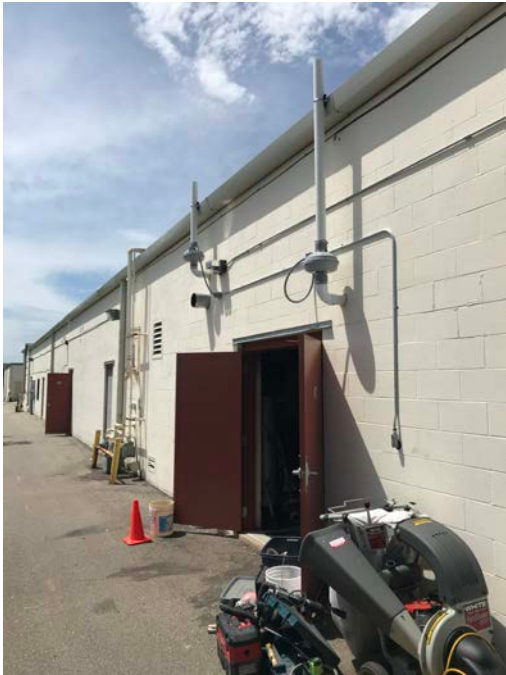
pickup points to allow condensation to drain. The fans were installed outside the building on the east side (the alley). The fans were mounted on an upturned elbow. Final discharge was run vertically to a foot above eave height.

The fans are specially designed & fabricated for use in mitigation systems. The fans installed are both AMG Eagle; 160 watts, 1.37 amps max., 3150 rpm, capable of pulling 4.0 inches of W.C.

Photo 10: Blowers on east exterior wall of unit.
