**SUBJECT: NOTICE OF NONCOMPLIANCE**  
Continuing Obligations Associated with Lee's Cleaners  
1727 South Main Street, Rice Lake, Wisconsin  
WDNR BRRTS #02-03-552055  
FID #603010540  
Barron County Parcel #276500667000

**NOTICE OF NONCOMPLIANCE**

**MAINTENANCE PLAN**

**D.3 Maintenance Plan Photographs**  
BRRTS# 02-03-552055

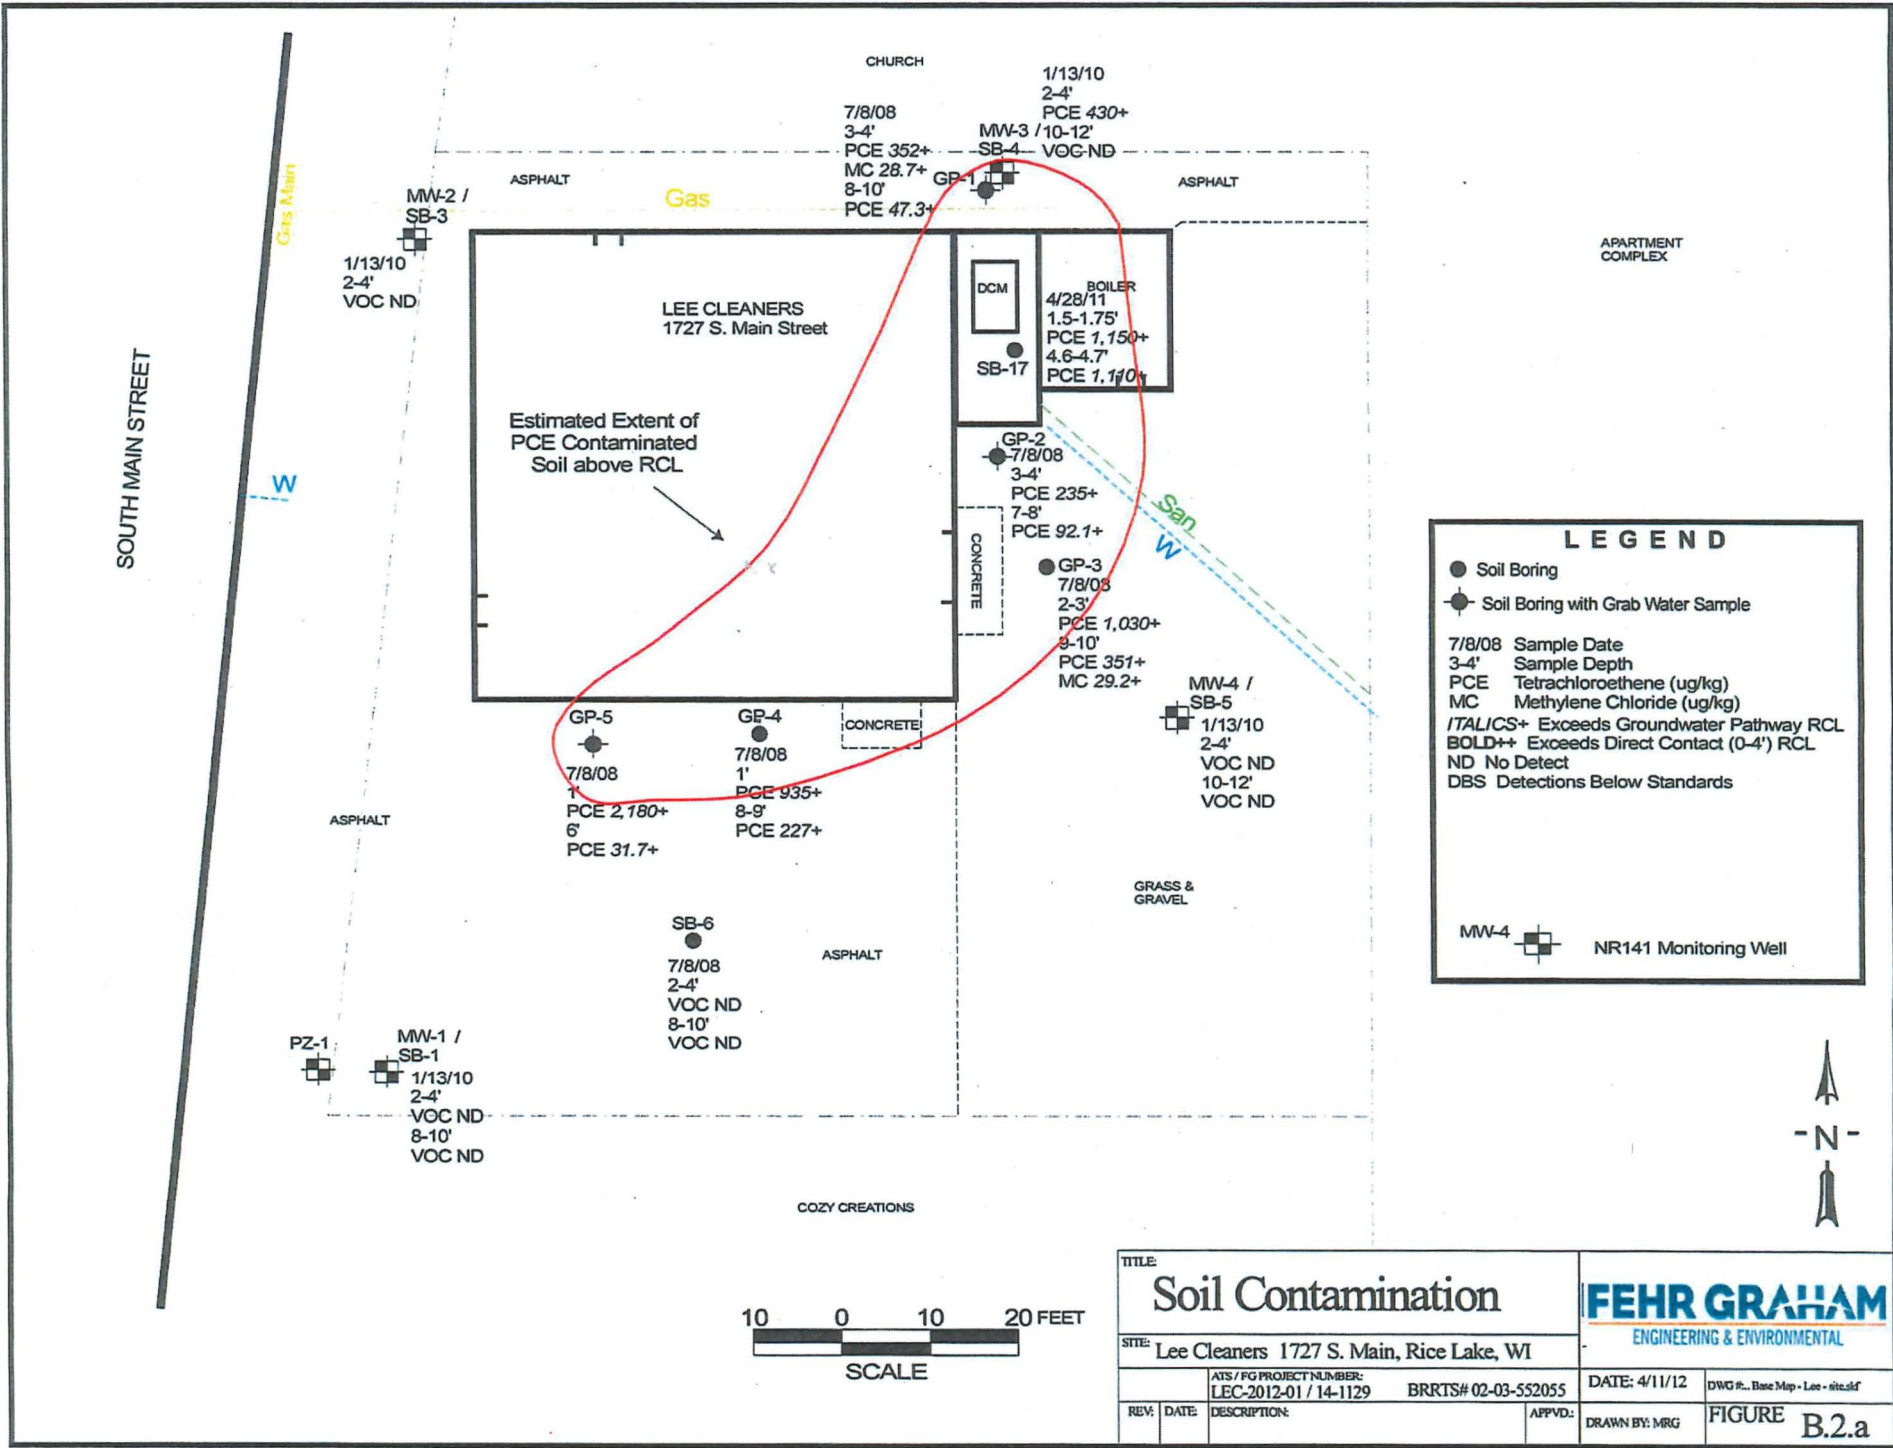
Soil contamination containing Tetrachloroethene (PCE) is present beneath the concrete slab floor of the building, beneath the asphalt/concrete pavement surrounding the building and beneath the grass cover that is directly east of the building at levels above the groundwater pathway RCL (Figure B.2.a).

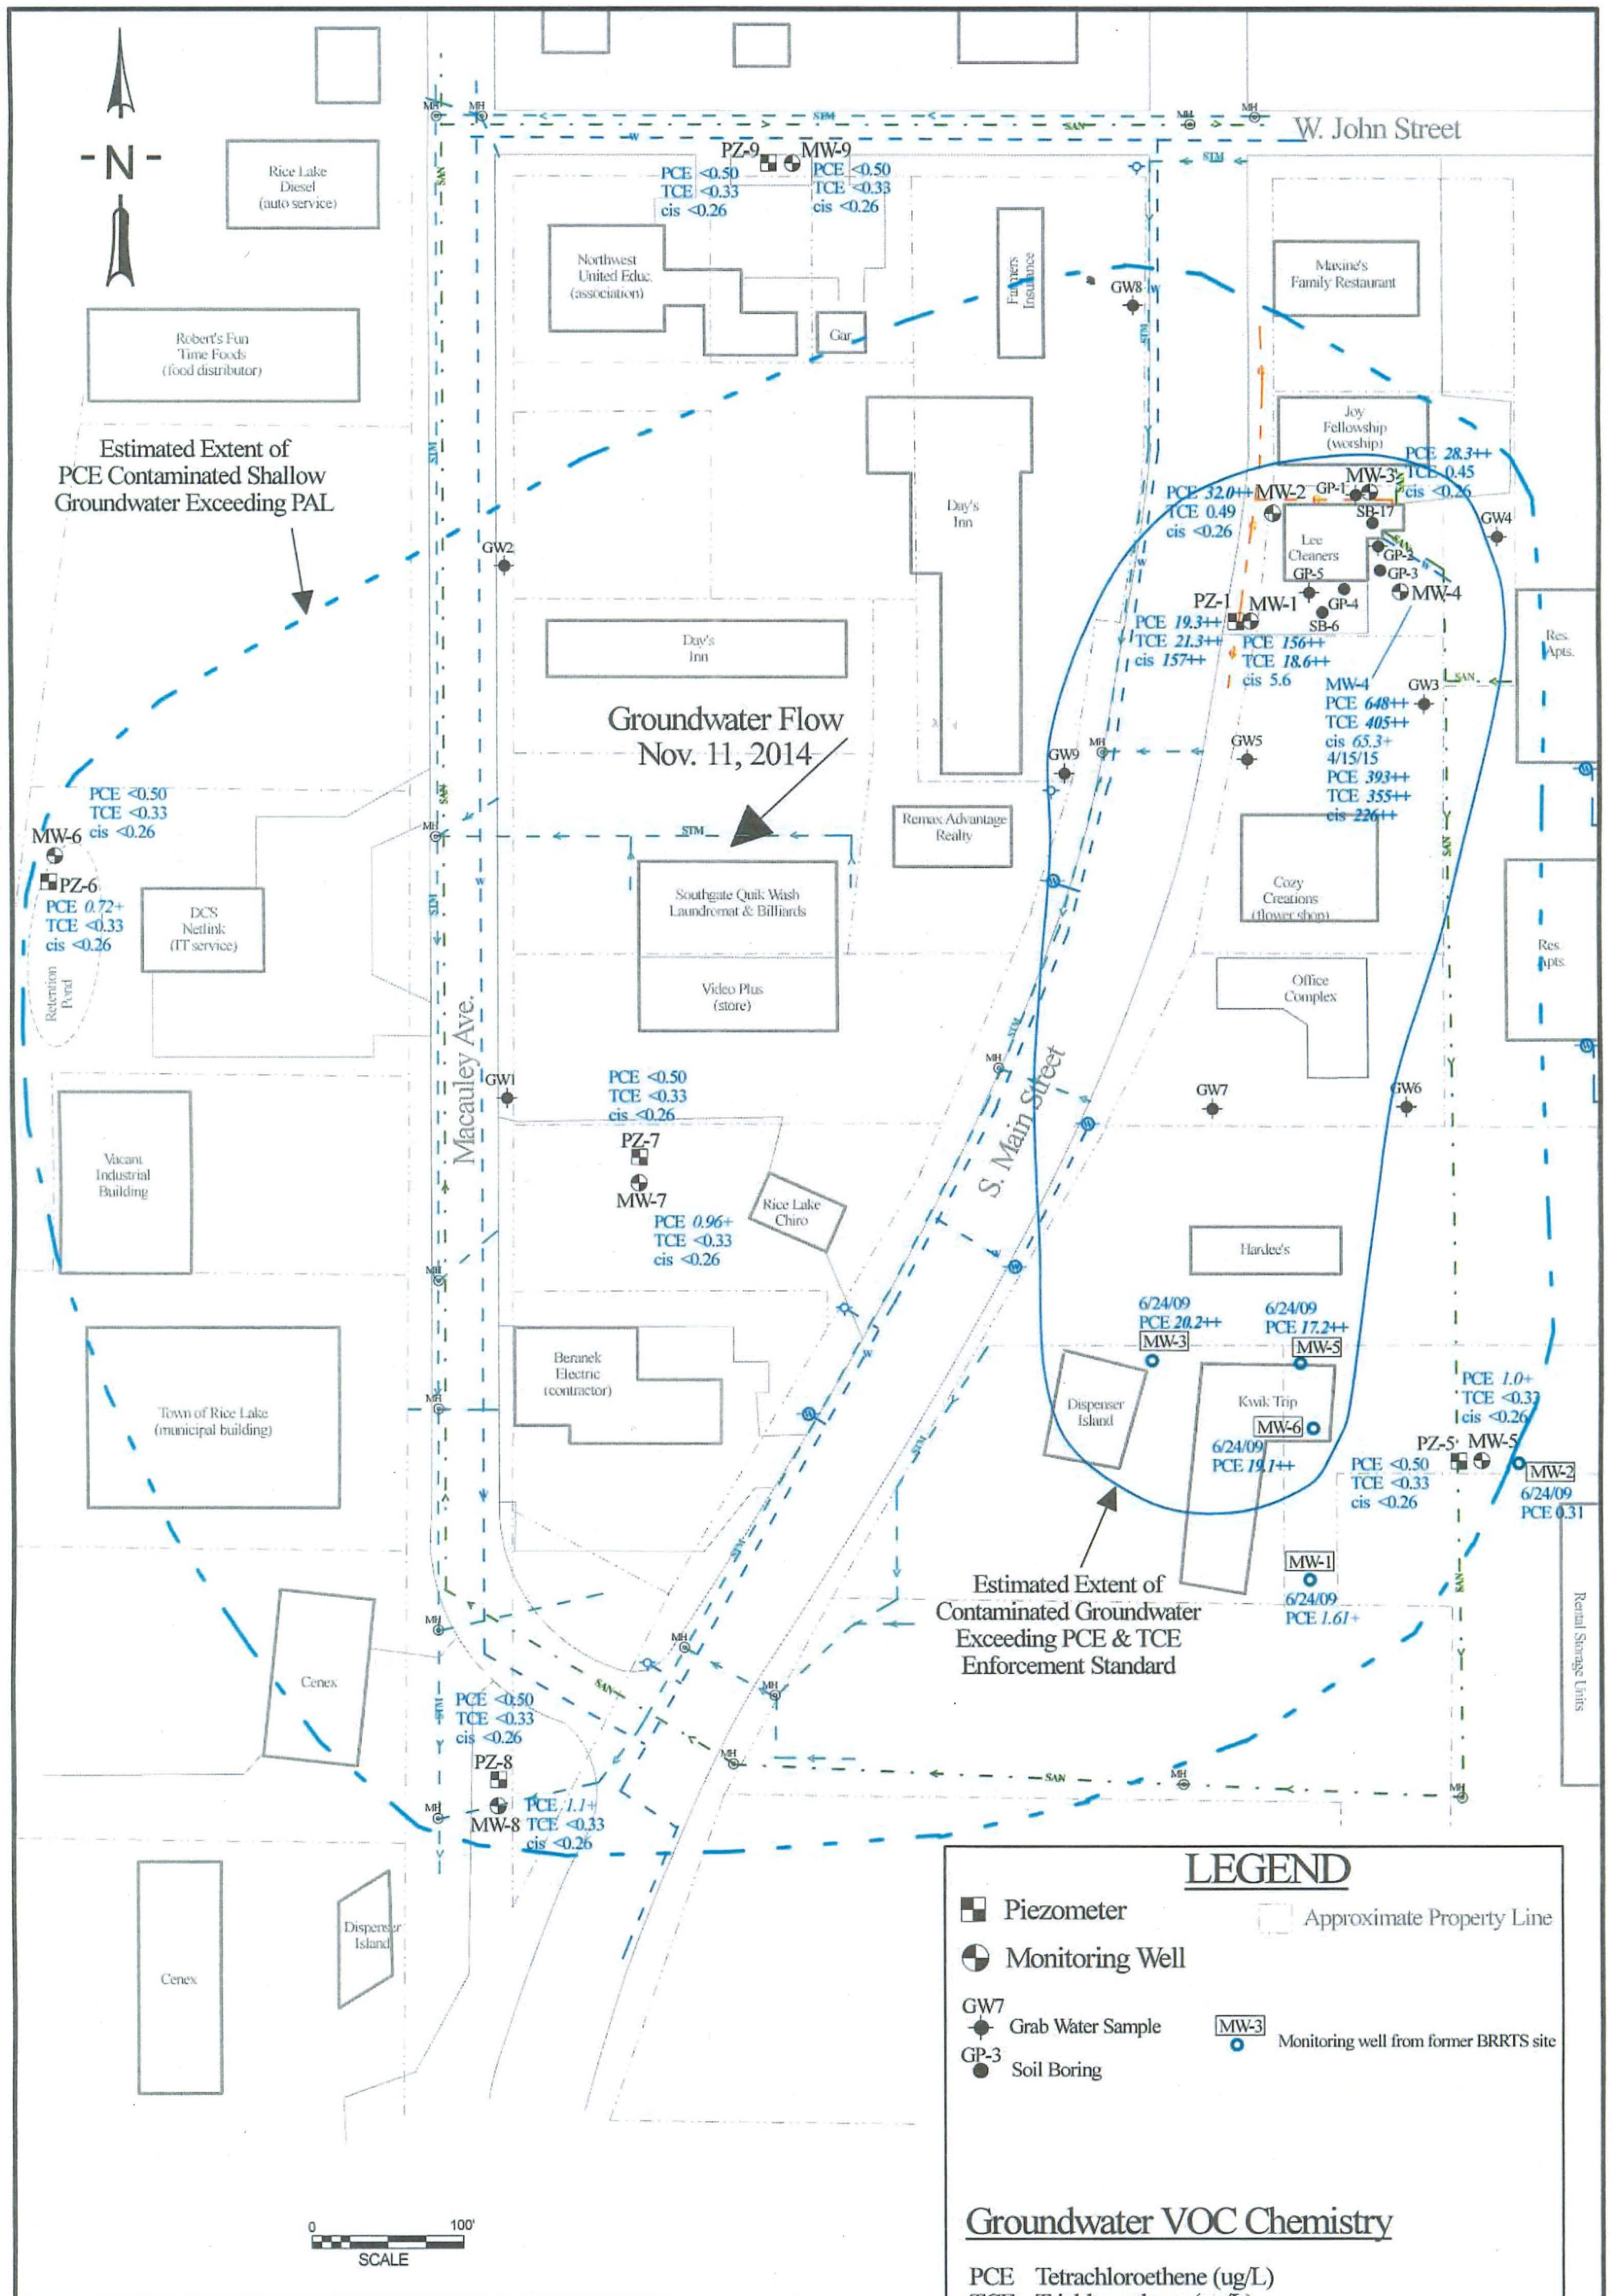
Groundwater contamination containing PCE, trichloroethene (TCE), cis-1,2 Dichloroethene (DCE) and vinyl chloride (VC) is present above the NR140 Enforcement Standard (Figure B.3.b) at the Property.

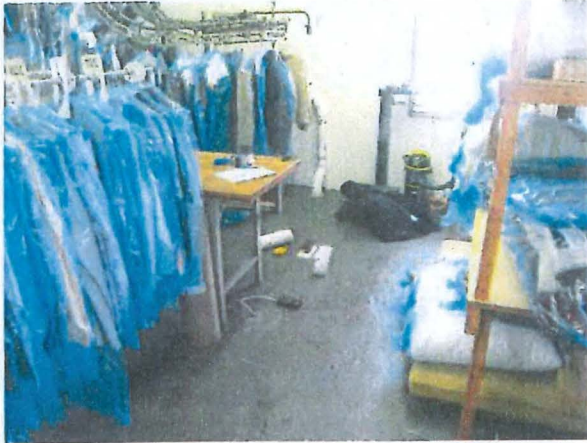
South vapor mitigation system inside Lee's Cleaners building, one floor penetration.

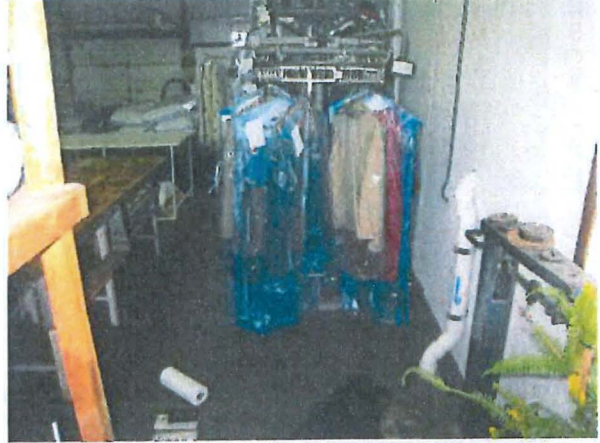
South vapor mitigation system inside Lee's Cleaners building, one floor penetration.

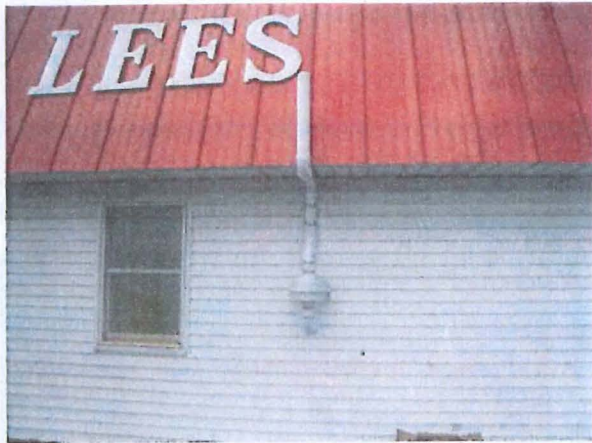
South fan outside Lee's Cleaners building. Looking north.

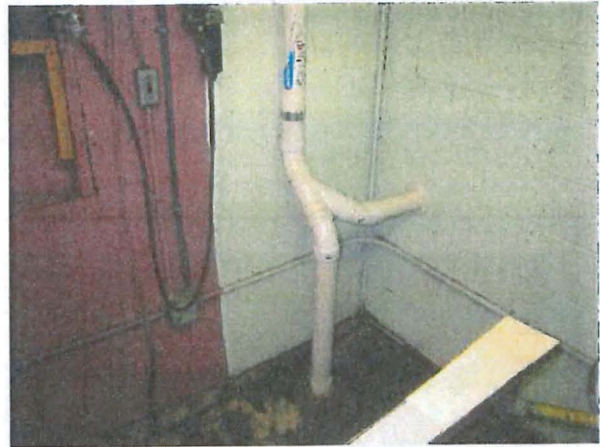
North vapor mitigation system inside Lee's Cleaners building, two floor penetrations.

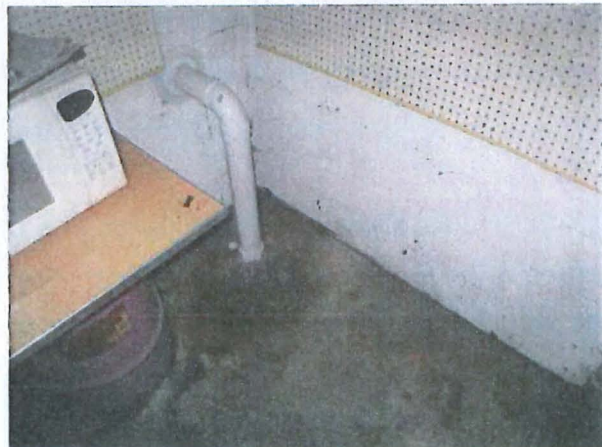
North vapor mitigation system inside Lee's Cleaners building, two floor penetrations.

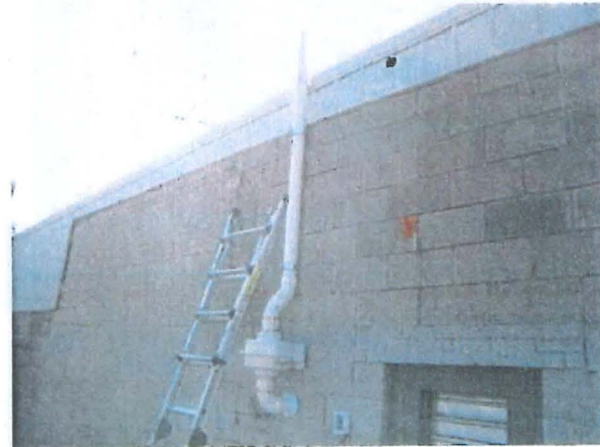
North fan outside Lee's Cleaners building. Looking southeast.
