**From:** Donald Johnson <donaldjohnson715@msn.com>  
**Sent:** Thursday, February 4, 2021 9:01 AM  
**To:** Flietner, Barbara J - DNR; Saari, Christopher A - DNR  
**Cc:** Deborah Wickham-Keller  
**Subject:** Lee's Dry Cleaners vapor mitigation  
**Attachments:** Power Switch\_North System\_Lees Cleaners.pdf; Power Switch\_South System\_Lees Cleaners.pdf; Subslab Inspection\_North System\_Lees Cleaners.pdf; Subslab Inspection\_South System\_Lees Cleaners.pdf; Utube\_North System\_Lees Cleaners.pdf; Utube\_South System\_Lees Cleaners.pdf

**Subslab Depressurization System Inspection Log NORTH SYSTEM**

Site Name Lees Cleaners  
 Address 1727 S. Main Street  
 Rice Lake, WI  
 BRRTS# 02-03-552055

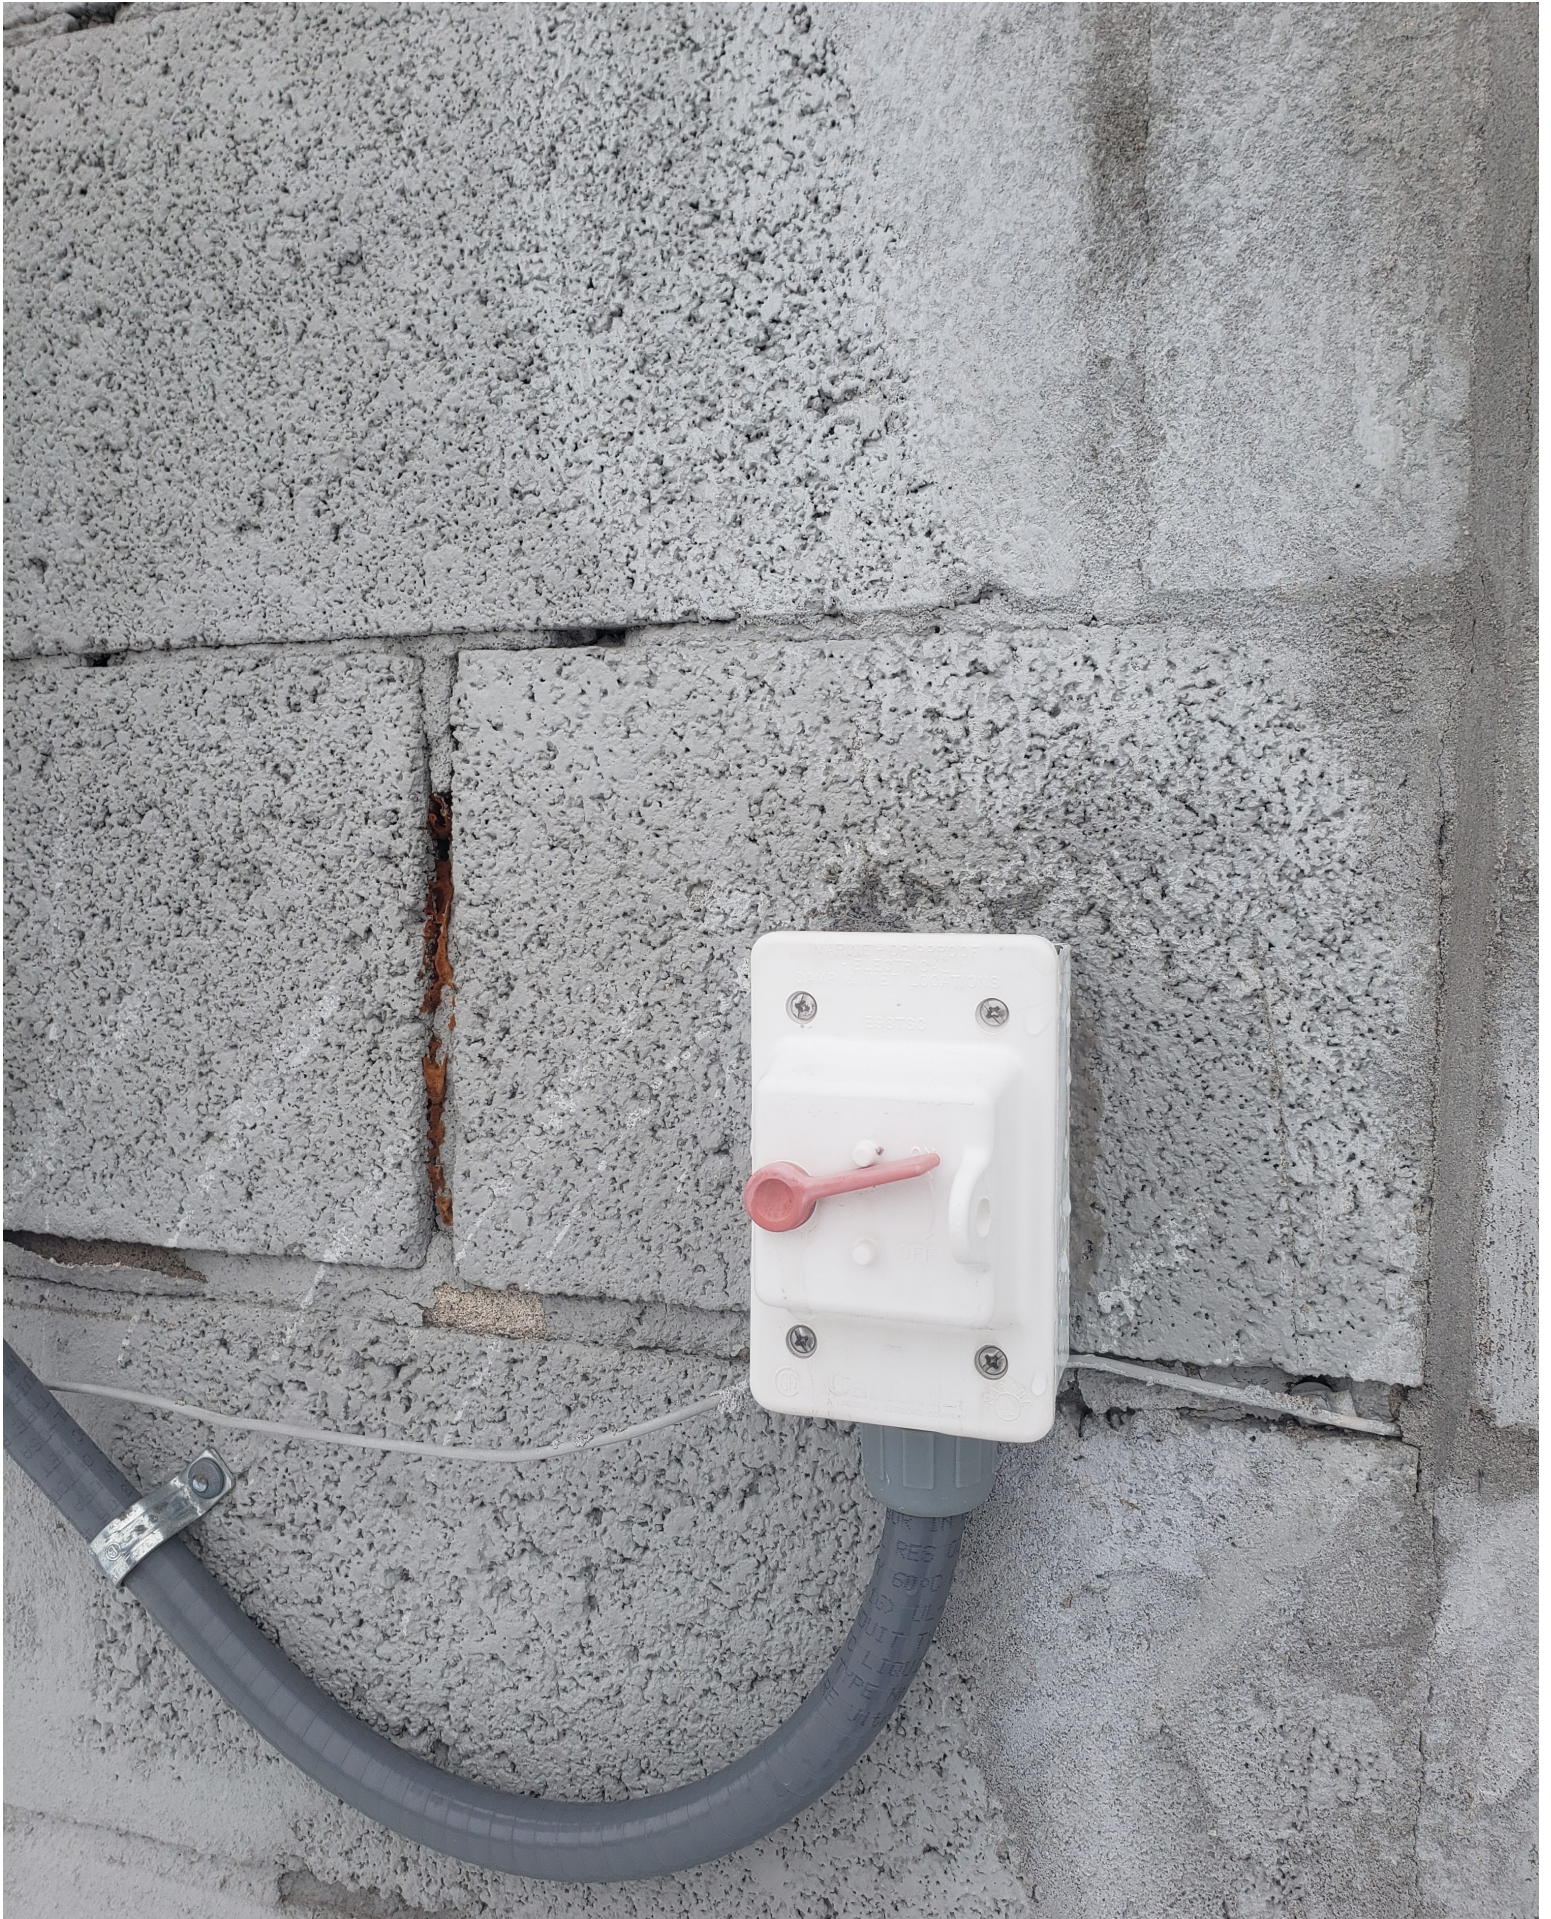
Date	Time	Location	Reading (inches H2O )	Method	Comments
11/17/2014	1:00 PM	North Wall	1.8"	U-Tube	
1/24/2020	4:00 PM	North Wall	1.2"	U-Tube	
2/27/2020	3:00 PM	North Wall	1.1"	U-Tube	
3/25/2020	10: AM	North Wall	1.2"	U-Tube	
4/20/2020	11: AM	North Wall	2.1"	U-Tube	
5/24/2020	3:00 pm	North Wall	1.2"	U-Tube	
6/20/2020	4:30 PM	North Wall	1.2"	U-Tube	
7/28/2020	11:33 AM	North Wall	1.2"	U-Tube	
9/11/2020	9:02 AM	North Wall	1.1"	U-Tube	
9/30/2020	5:11 PM	North Wall	1.2"	U-Tube	
11/7/20	12:11 PM	North Wall	1.2"	U-Tube	
12/4/20	1:01: PM	North Wall	1.1"	U-Tube	
1/15/21	12:32 PM	North Wall	1.3"	U-Tube	
		North Wall			
		North Wall			
		North Wall			
		North Wall			
		North Wall			
		North Wall			
		North Wall

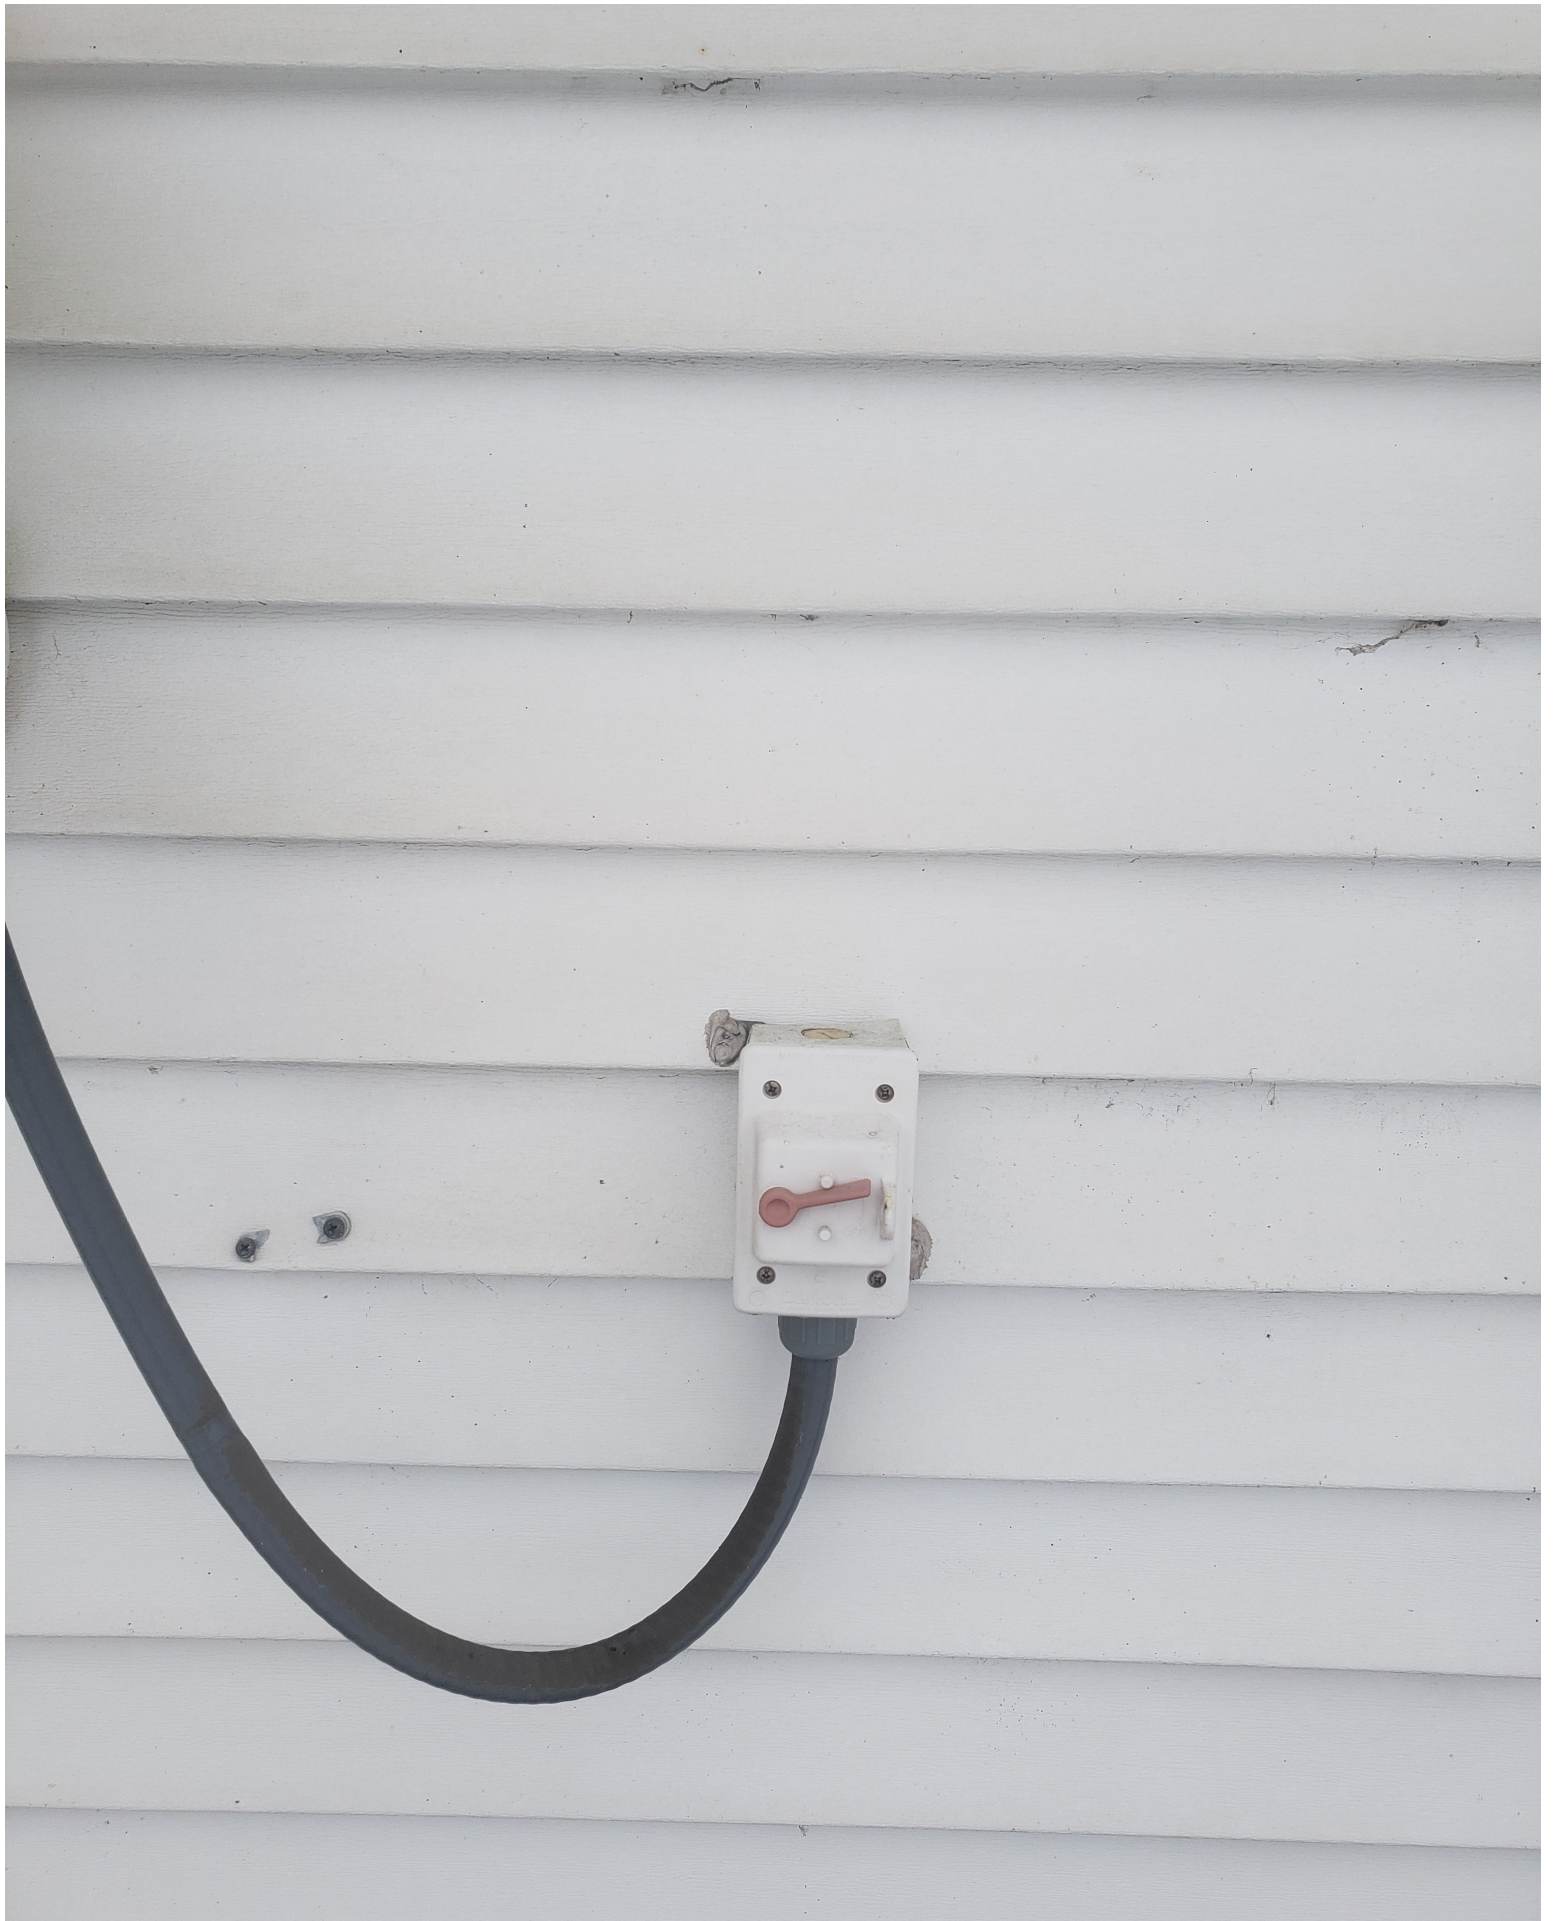
**Subslab Depressurization System Inspection Log SOUTH SYSTEM**

Date	Time	Location	Reading (inches H2O )	Method	Comments
11/17/2014	8:00 AM	South Wall	3.6"	U-Tube	
1/24/2020	4:00 PM	South Wall	2.7"	U-Tube	
2/27/2020	3:00 PM	South Wall	2.7"	U-Tube	
3/25/2020	10:00 AM	South Wall	2.6"	U-Tube	
4/20/2020	11:00 AM	South Wall	2.7"	U-Tube	
5/24/2020	3:00 PM	South Wall	2.6"	U-Tube	
6/20/2020	4:30 PM	South Wall	2.6"	U-Tube	
7/28/2020	11:36 AM	South Wall	2.6"	U-Tube	
9/1/20	9:01 AM	South Wall	2.6"	U-Tube	
9/30/20	5:11 PM	South Wall	2.7"	U-Tube	
11/7/20	12:70 PM	South Wall	2.7"	U-Tube	
12/4/20	1:00 PM	South Wall	2.7"	U-Tube	
1/15/21	12:31 PM	South Wall	2.8"	U-Tube	
		South Wall			
		South Wall			
		South Wall			
		South Wall			
		South Wall			
		South Wall			
		South Wall

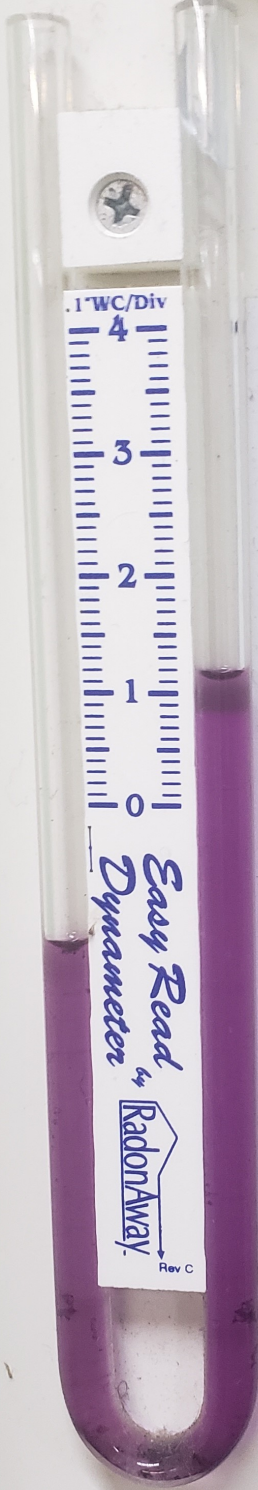
**RAD SPEC**  
OF W  
**866-55**  
1072 Rock Lake  
This device does not measure radon  
**← Vacuum**  
Please call for more information  
 Active  
 Passive  
EPA recommended  
Install Date \_\_\_\_\_  
Initial Pressure \_\_\_\_\_  
Installed By \_\_\_\_\_
