REMEDIAL ACTION REPORT

**Millennium Tiles LLC
550 East Centralia Street
Elkhorn, WI**

Report Date: September 7, 2007

NSEC Project: 07M02

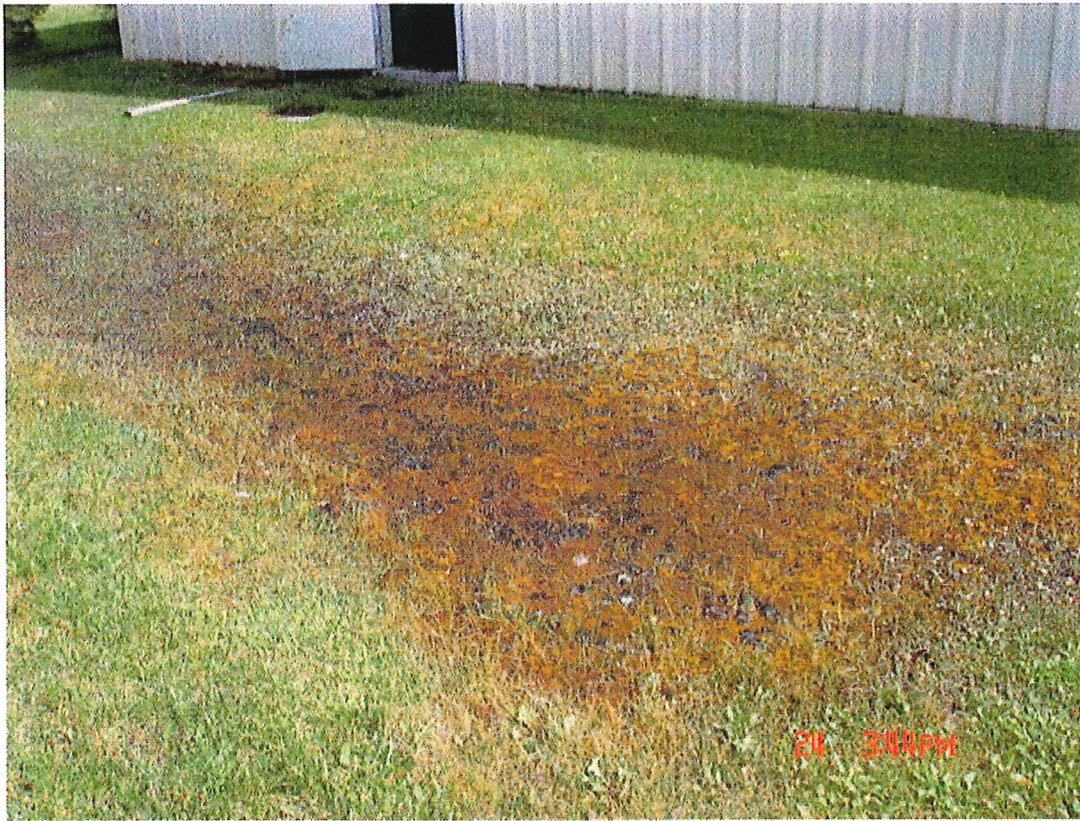
Chromic & Sulfuric acid spill contained by swale

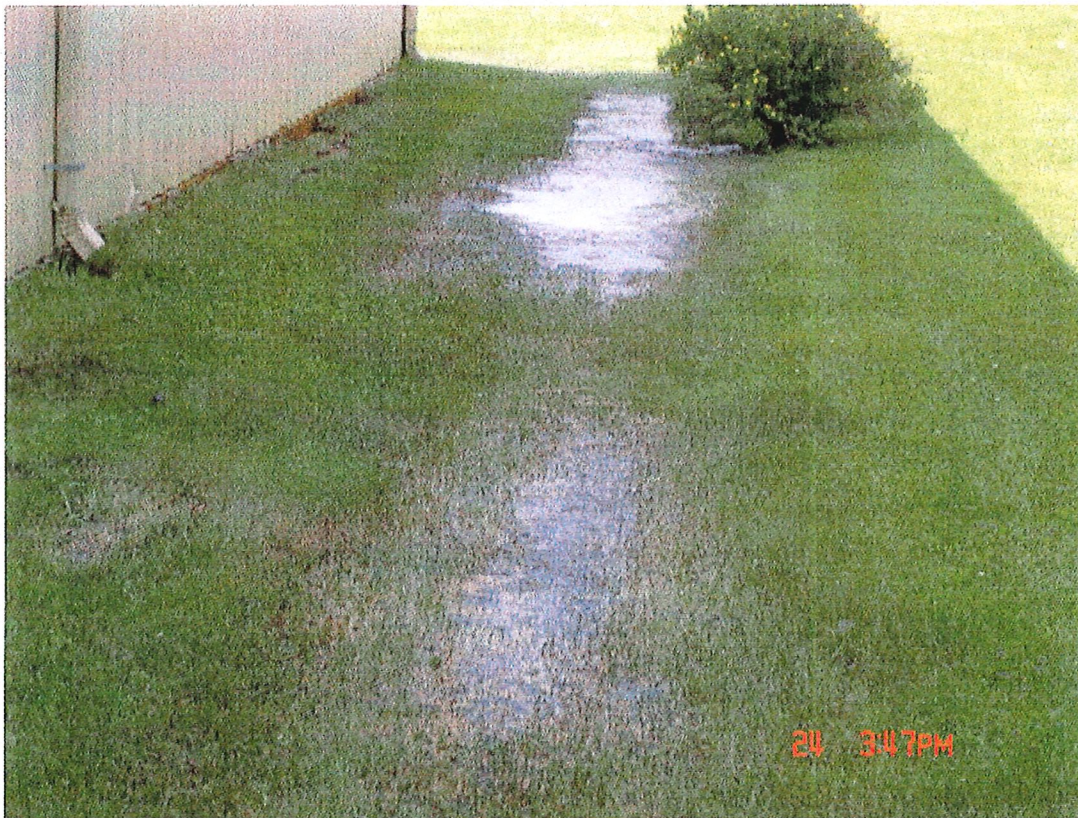
Looking north on east side of building

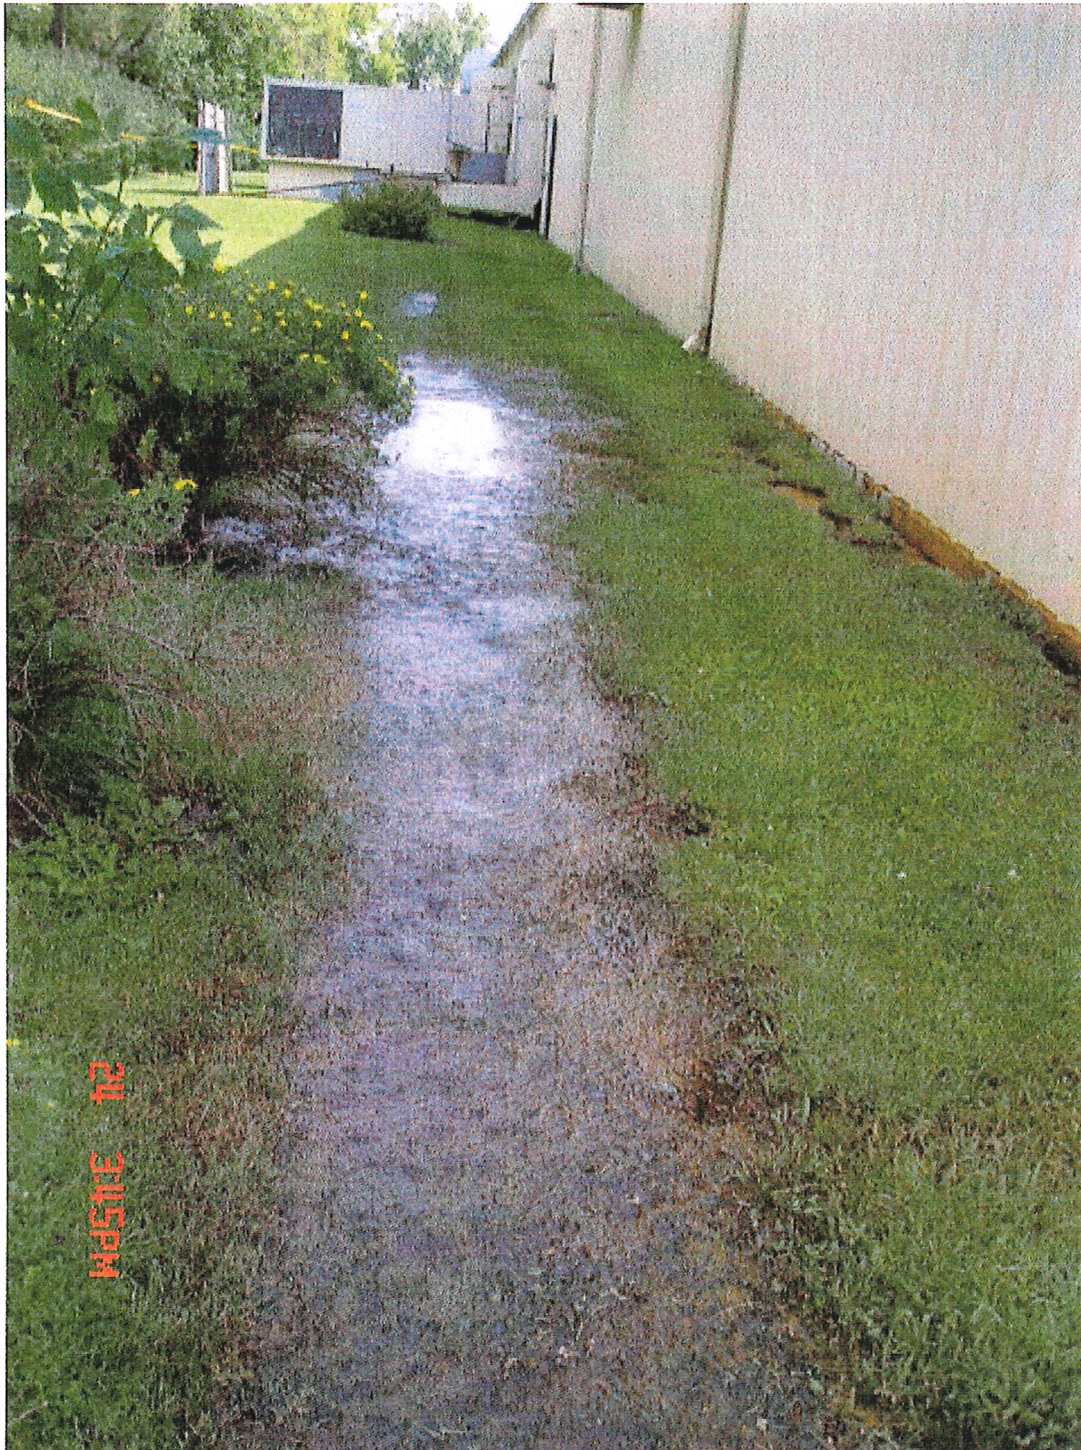
Looking south on east side of building

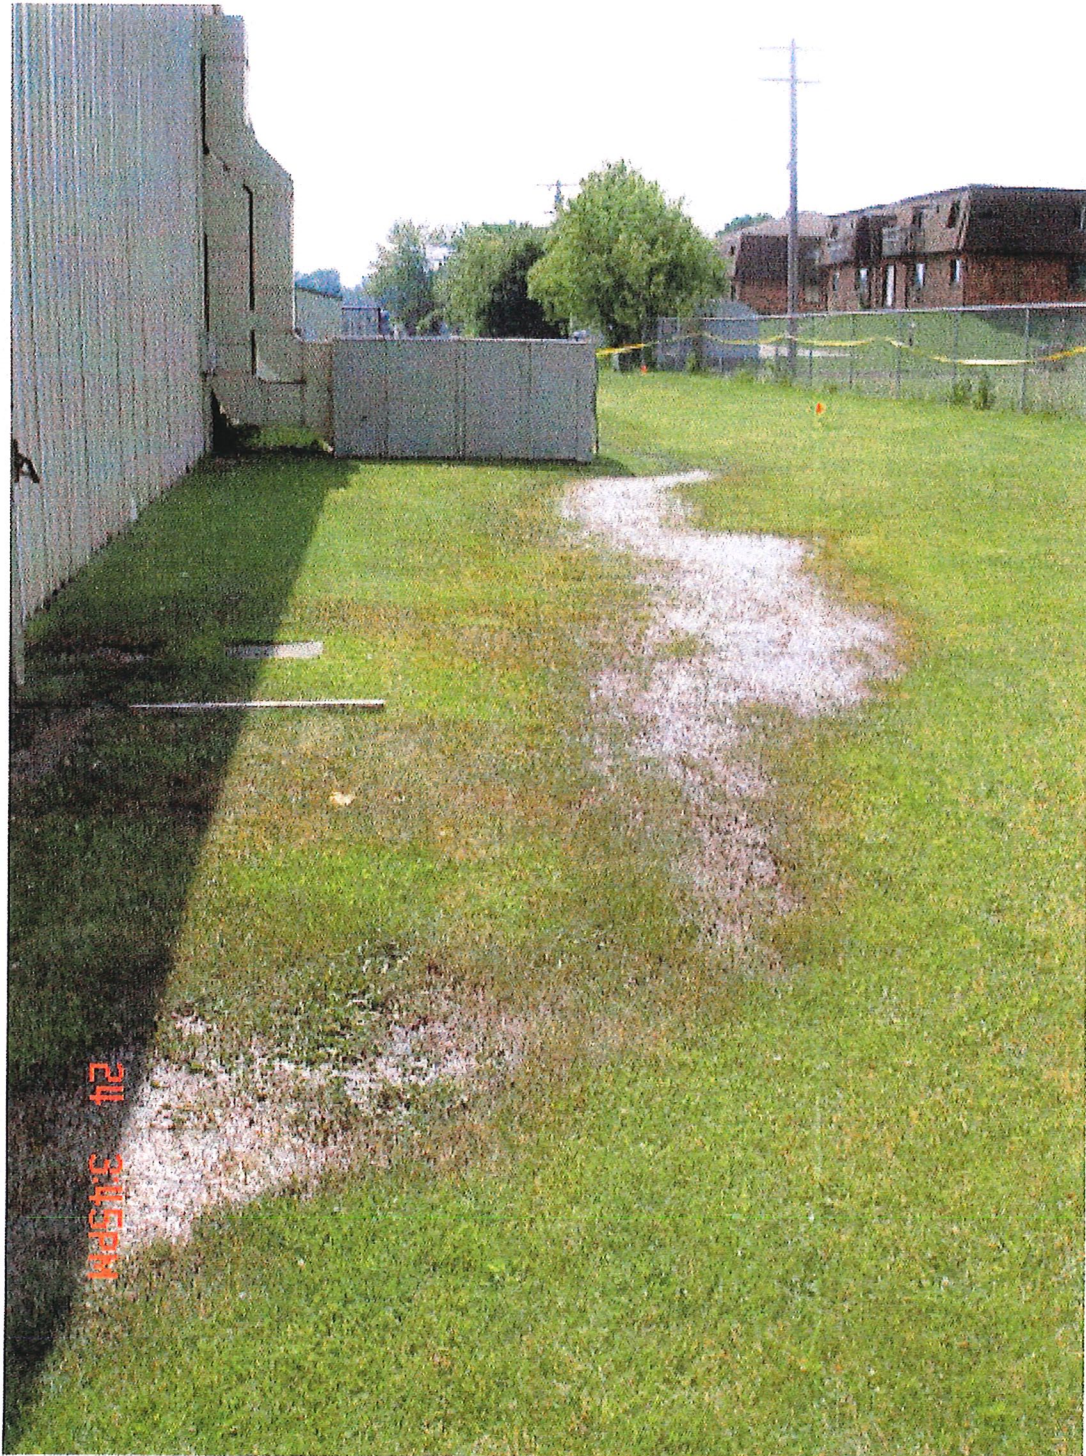
Looking west on north side of building

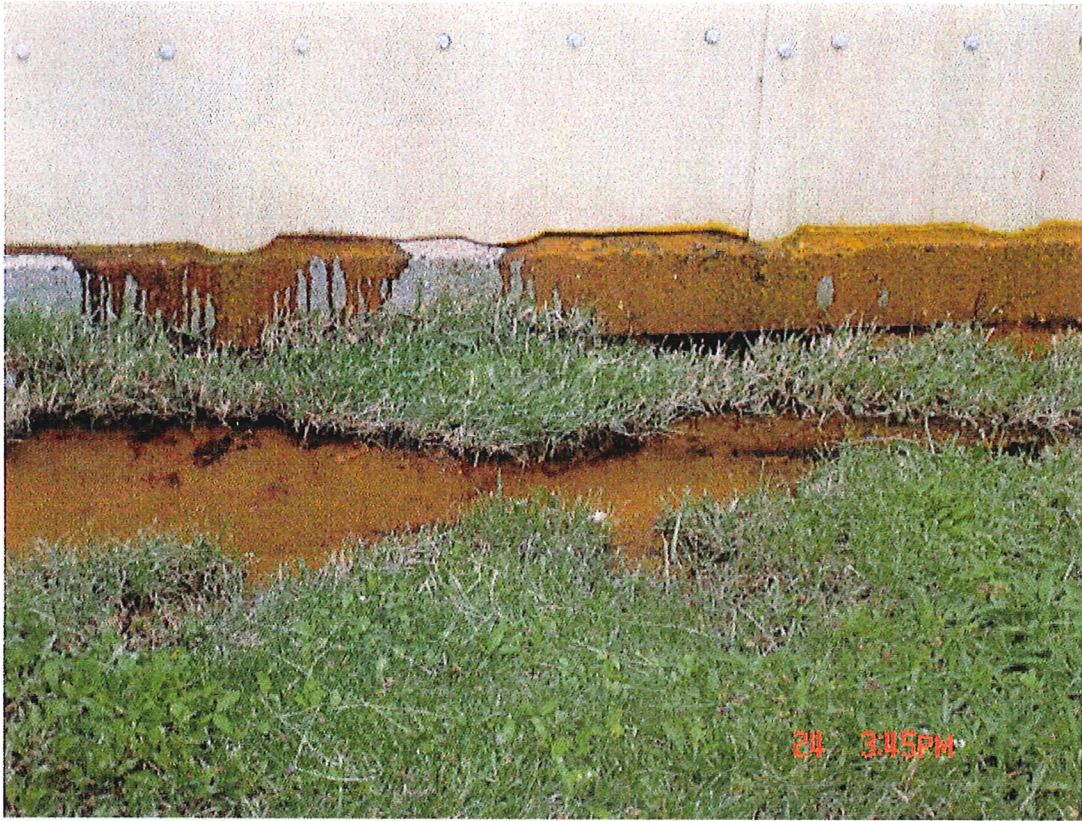
Acid seeping under building wall and onto grass

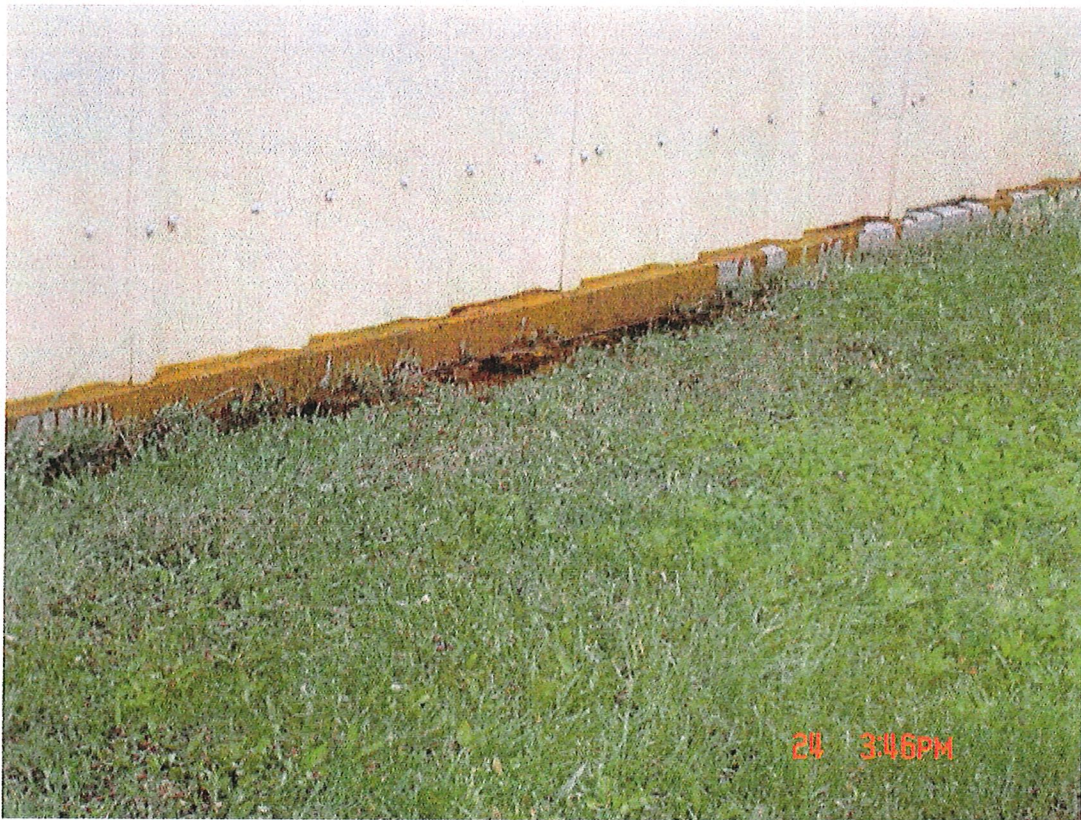
Spilled liquid seeped onto grass and flowed to swale

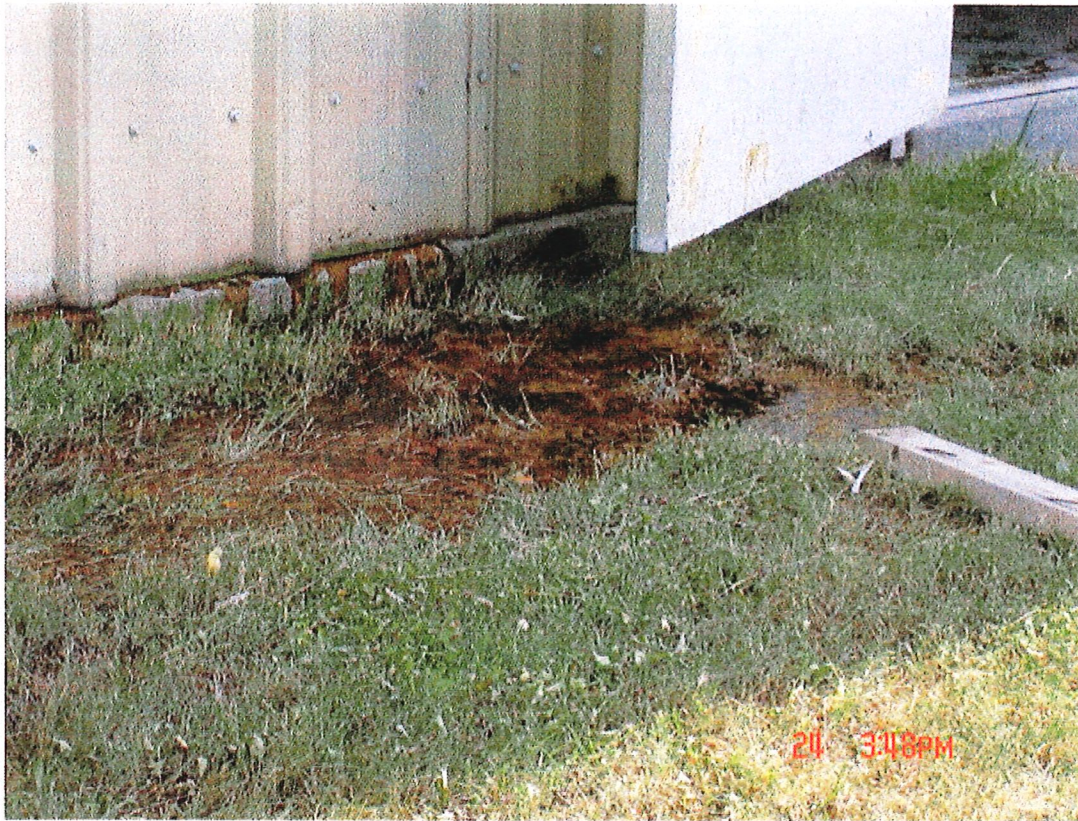
Spilled liquid pooled up near door

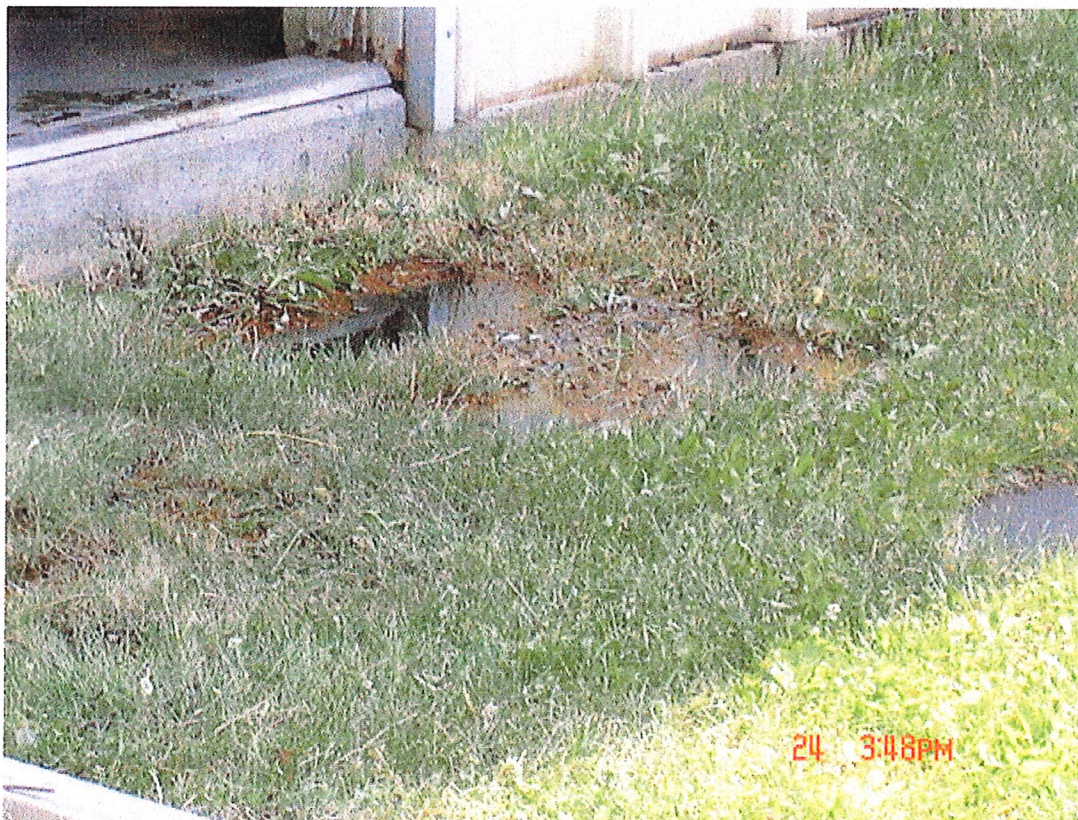
More pooled liquid

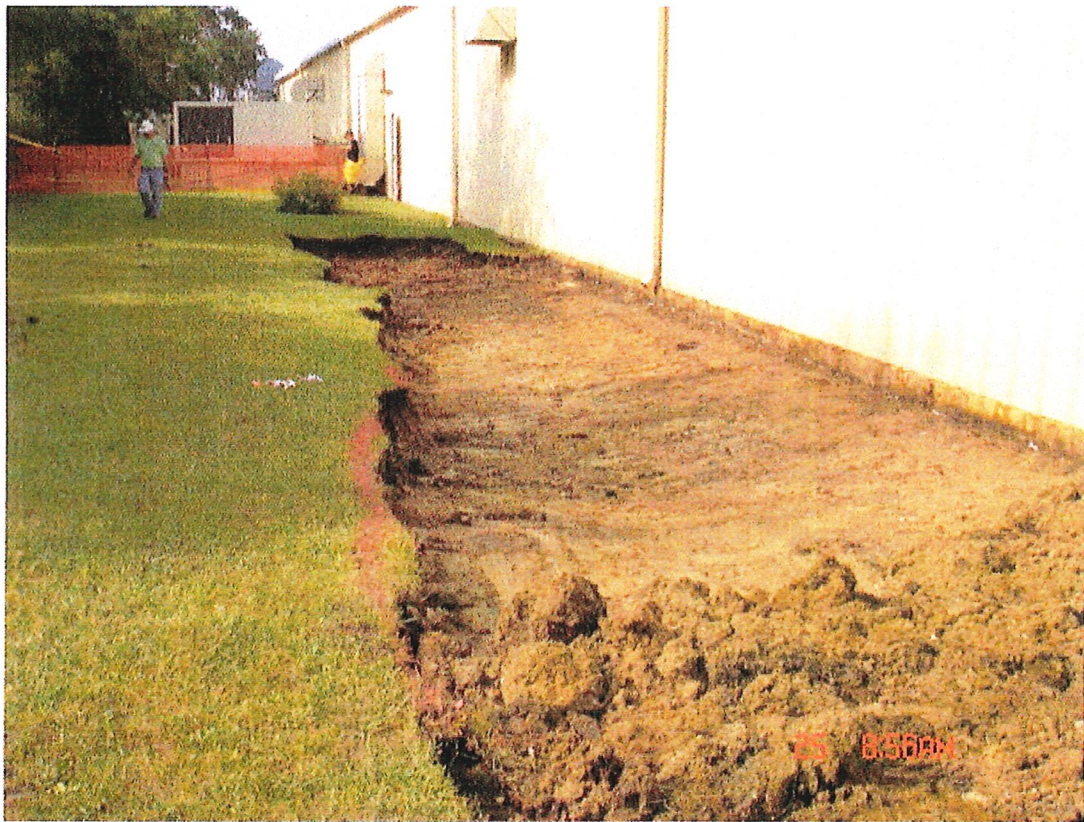
Area excavated on east side of building

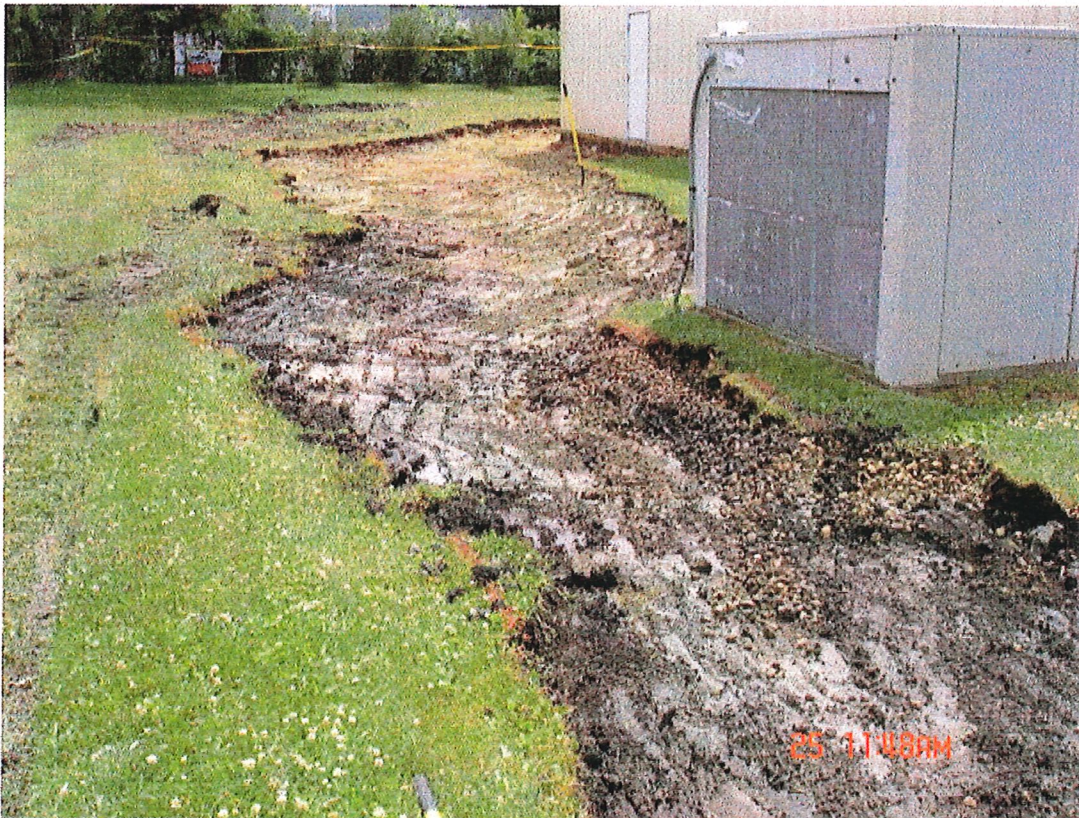
Excavation coming around northeast corner of building

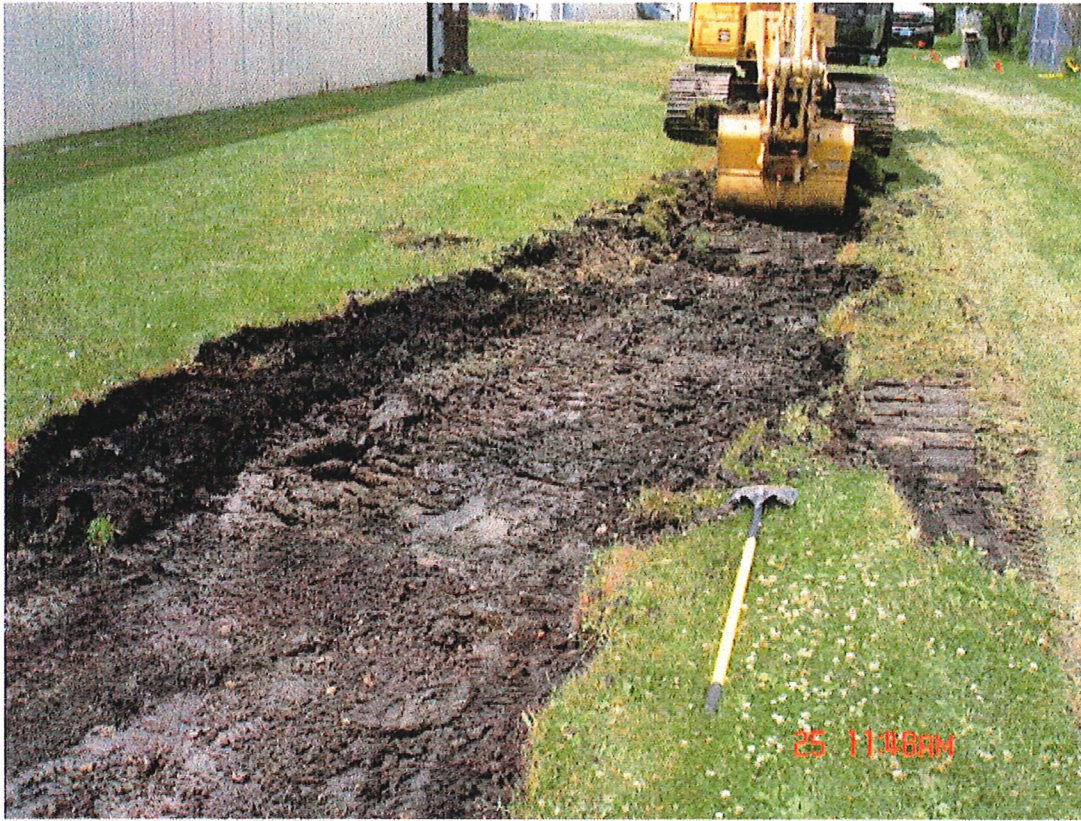
End of first excavation on north side

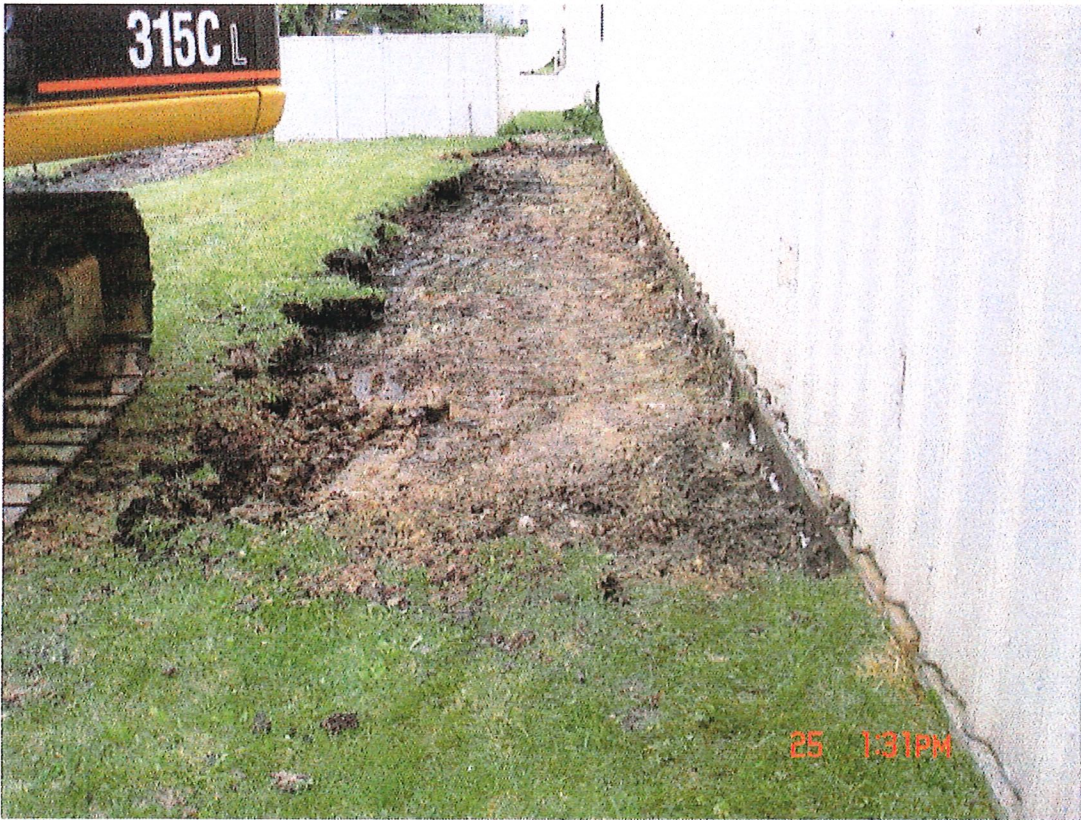
Second excavation on north side adjacent to building

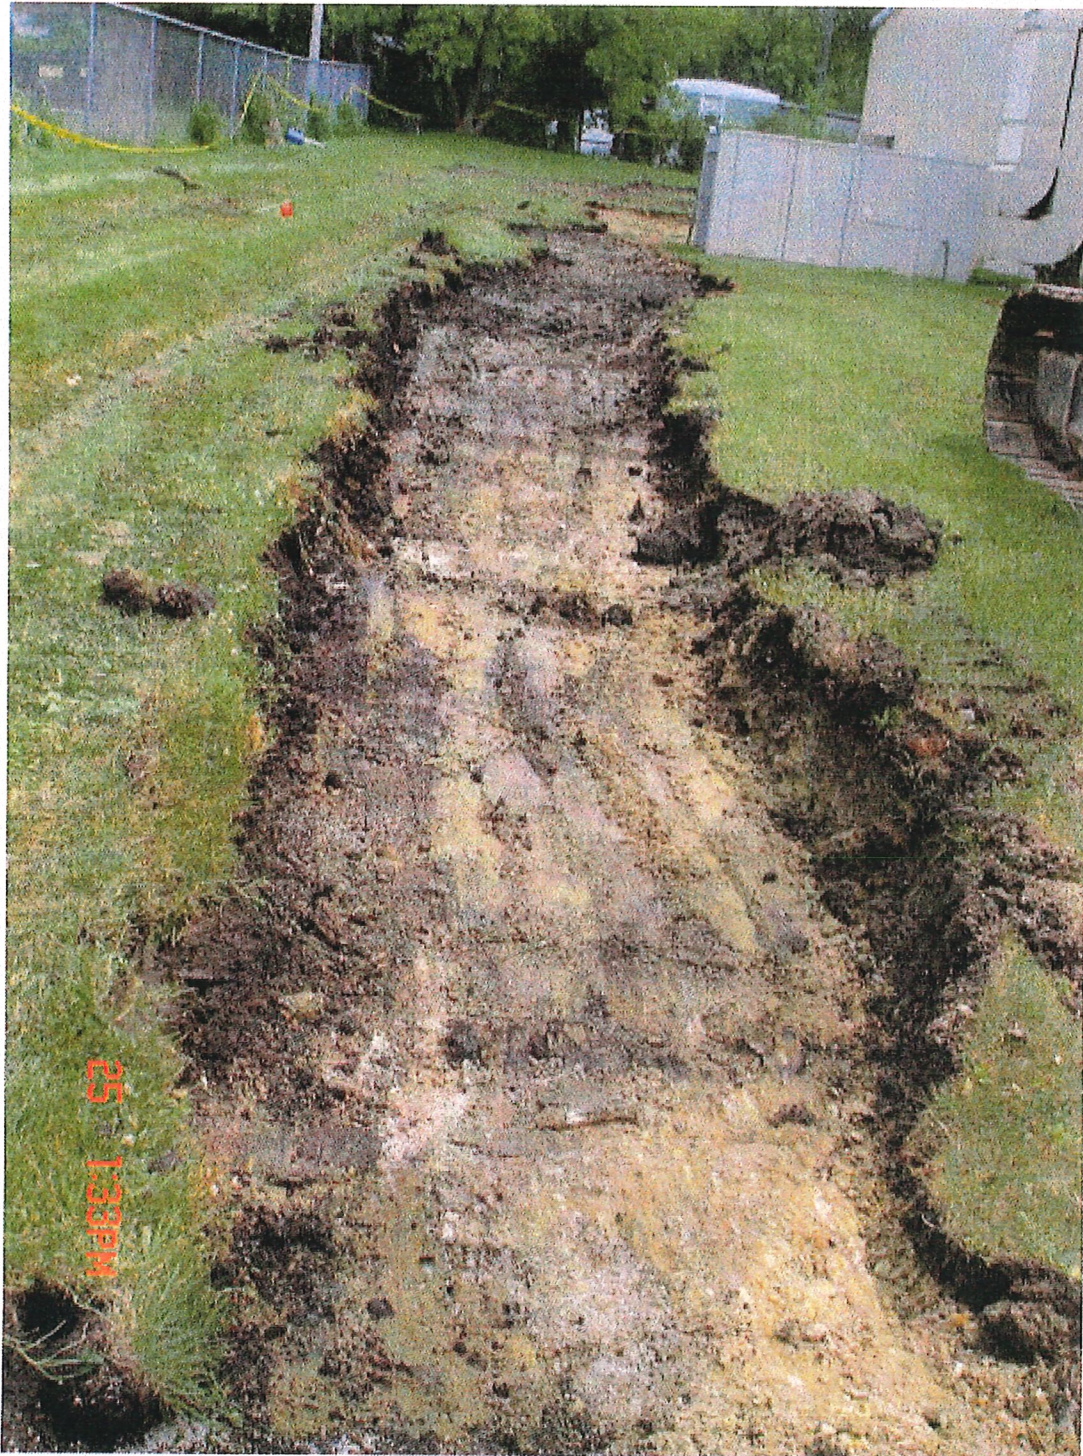
Looking east at excavation on north side of building
