February 11, 2020
Revised March 24, 2020

ReadyEarth
Consulting, Inc.

RE: Reconsideration Letter and Additional Comments Regarding Site Investigation Addendum for the Block System Cleaners Facility Located at 2017 Winnebago Street in Madison, Wisconsin – BRRTS No. 02-13-552132; ReadyEarth Project no. 11-0604

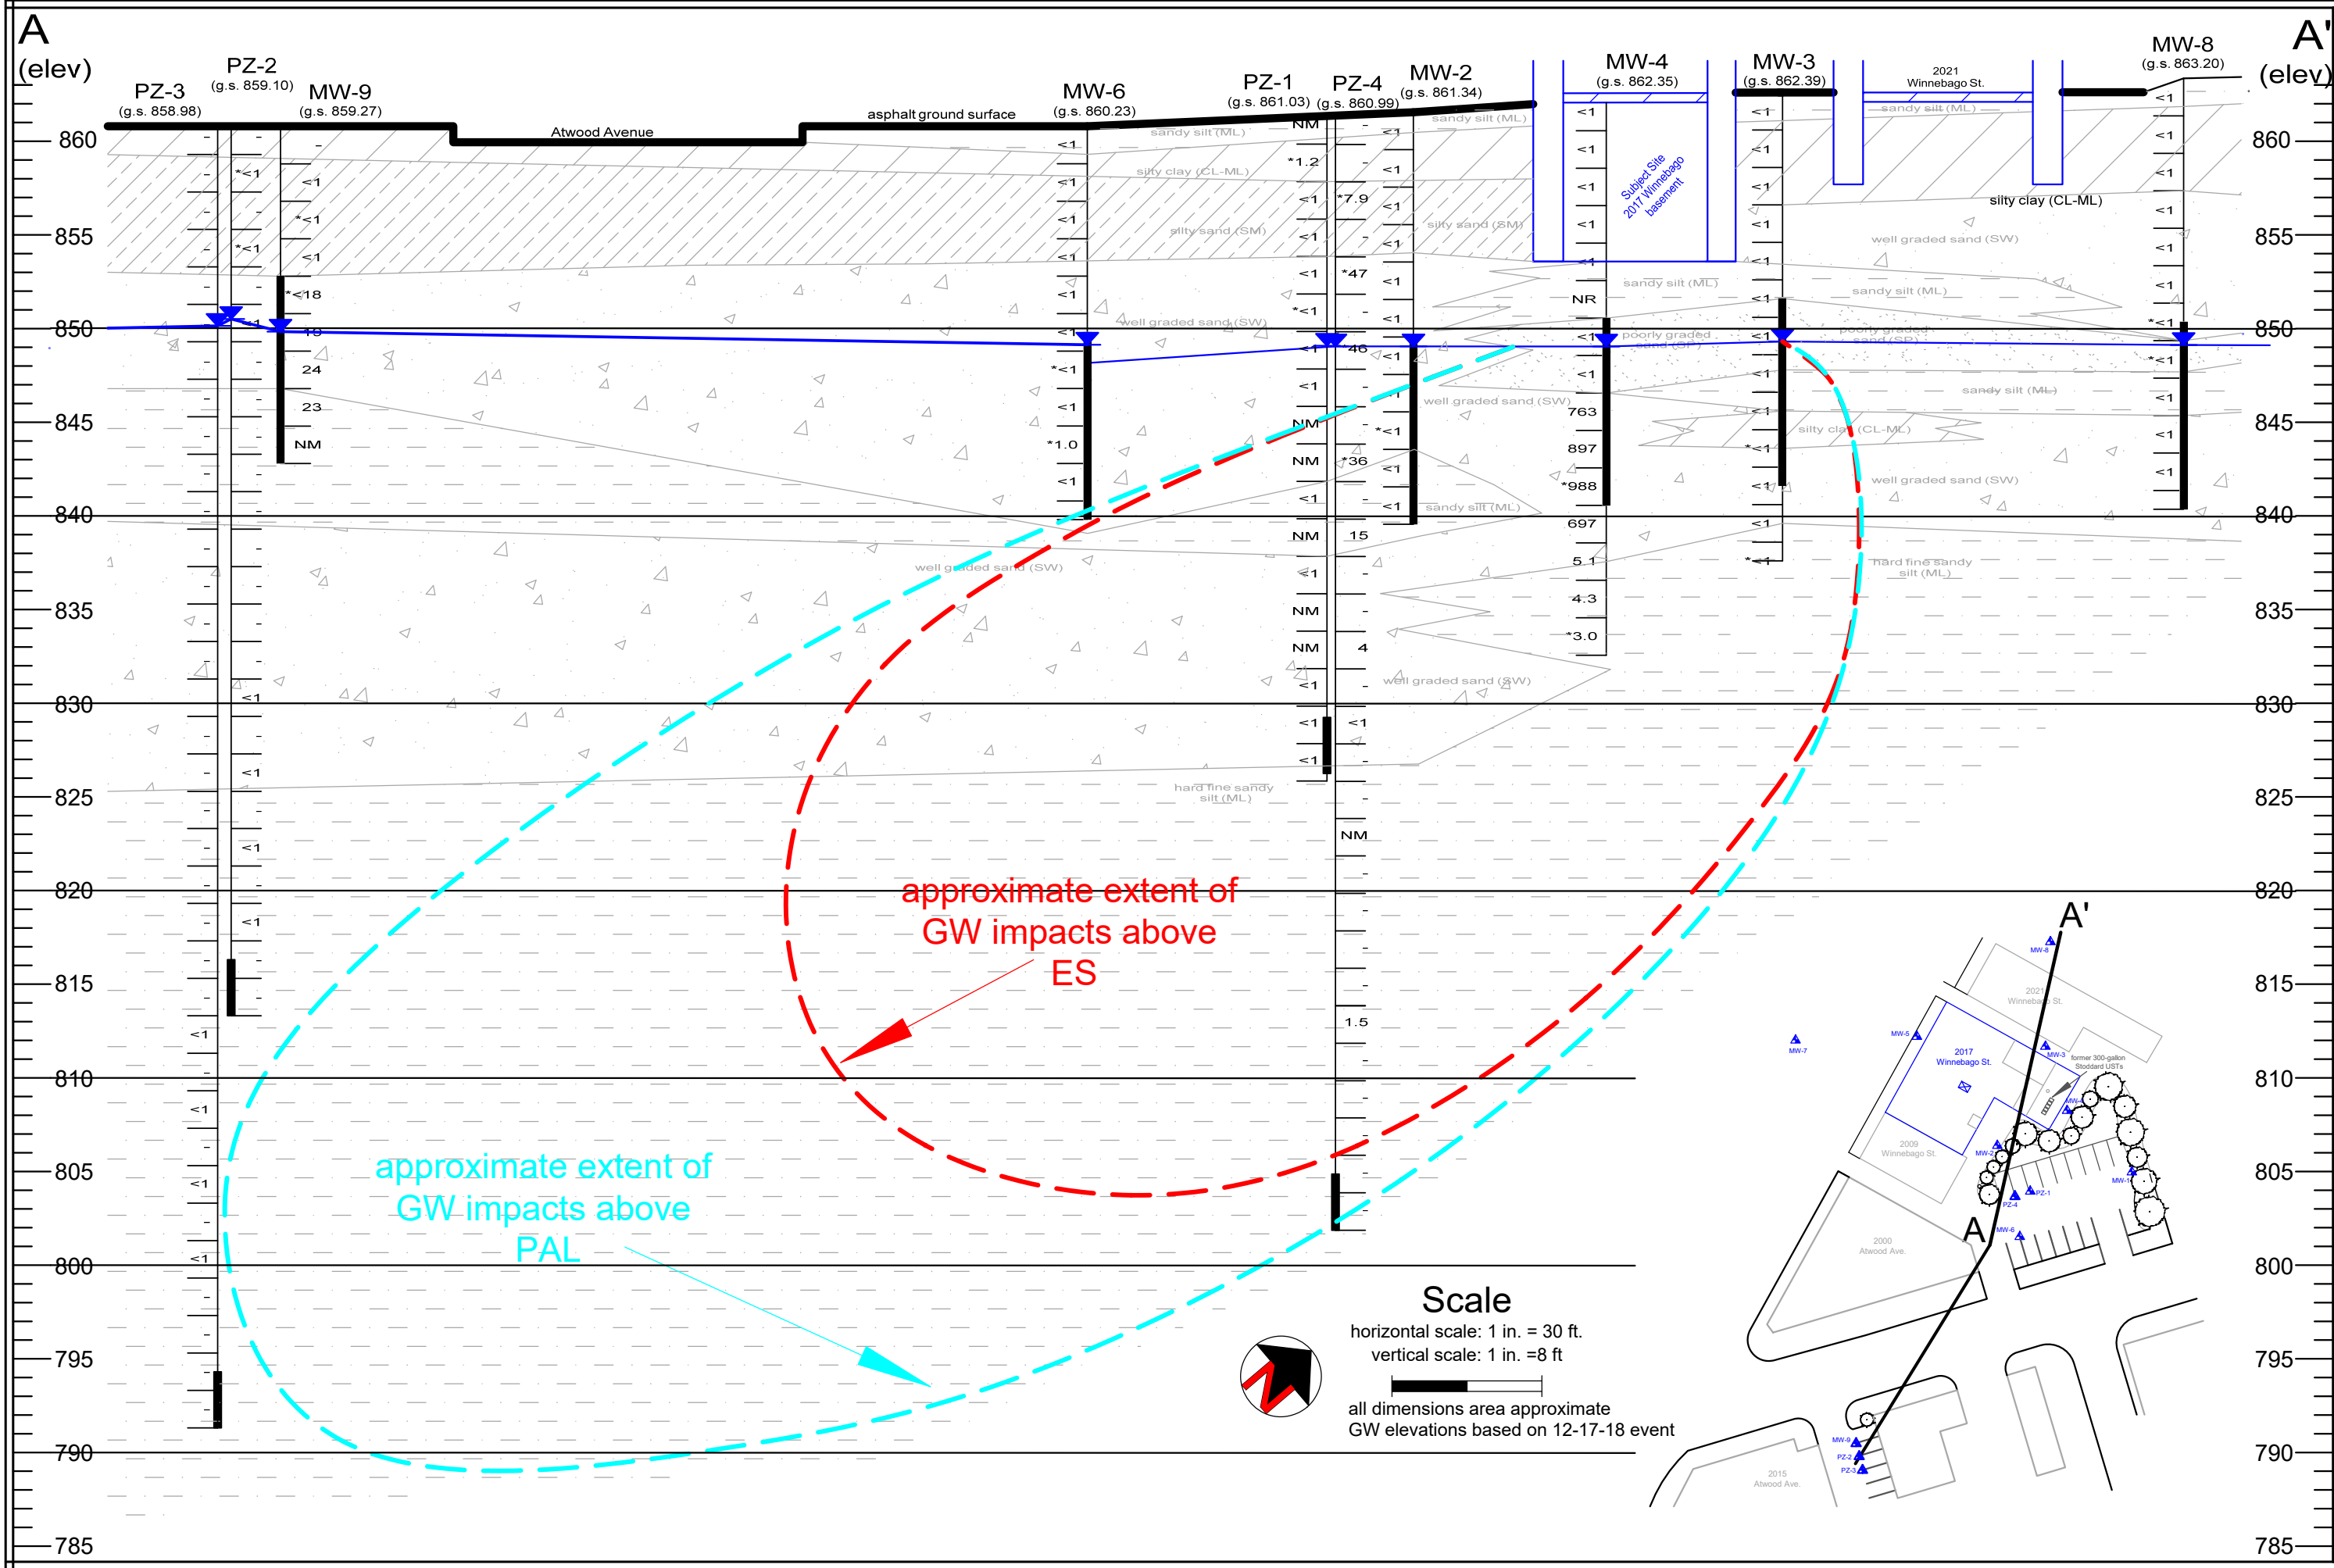
B.3.a Geologic Cross-Section Figure A-A'

Please refer to figure B.3.a cross-section diagram included in Attachment A. Based on soil descriptions presented on the cross-section diagram, the DNR has questioned whether a preferential pathway exists at depth for plume migration, and whether the piezometers are situated to properly evaluate the plume extent.

1. The two soil types in question are labeled on the cross-section diagram as a “well-graded sand” and a “hard fine sandy silt”. The descriptions on the actual boring logs (included in Attachment A) are as follows:

The two units are a silty sand and a sandy silt. Both units include similar components and are quite similar. However, the units are slightly different and are thus graphically represented differently on the cross-section. Due to their similarity, it is likely that the soil transitioned from one description to the other as opposed to breaking sharply. For sure, the units appeared substantially similar in the field insofar that there was no obvious reason to change the approved scope of work. The term well-graded signifies that there is a wide range of particle sizes and relatively lower porosity compared to poorly-graded sand. To be clear, the sand was not beach sand, was not loose and granular (it was more like concrete as opposed to table salt), and did not visually represent a preferential pathway.

4. The plume extent depicted on the cross-section map is a reasonable representation:
- The angle of the plume is established by the shallow wells MW-4 and MW-6, which are along the centerline of the plume: impacts are present at the top of the water table at MW-4 (based on PID readings and soil lab results at the soil/water interface); the low concentrations at MW-6 indicate only the very bottom of that well is engaged with the plume.

- The degree of the concentrations in the other piezometers as compared to PZ-1, and the relationships of the concentrations in those piezometers to the enforcement standard (ES) and PAL indicate that PZ-1 is centrally-located in the plume and that the other piezometers are peripherally-located in the plume. The corroboration of the shallow and deep wells suggests the cross-section is a good model for the plume.

- A reasonable plume cannot be drawn that would incorporate preferential flow above PZ-2 (certainly not exceeding an ES - i.e. the plume cannot extend beyond PZ-2 without being detected at PZ-2). That plume would be an unnatural contortion that wraps back and then drops vertically 25 feet so that it is only slightly detected and at a lower concentration at PZ-2 than at PZ-3.

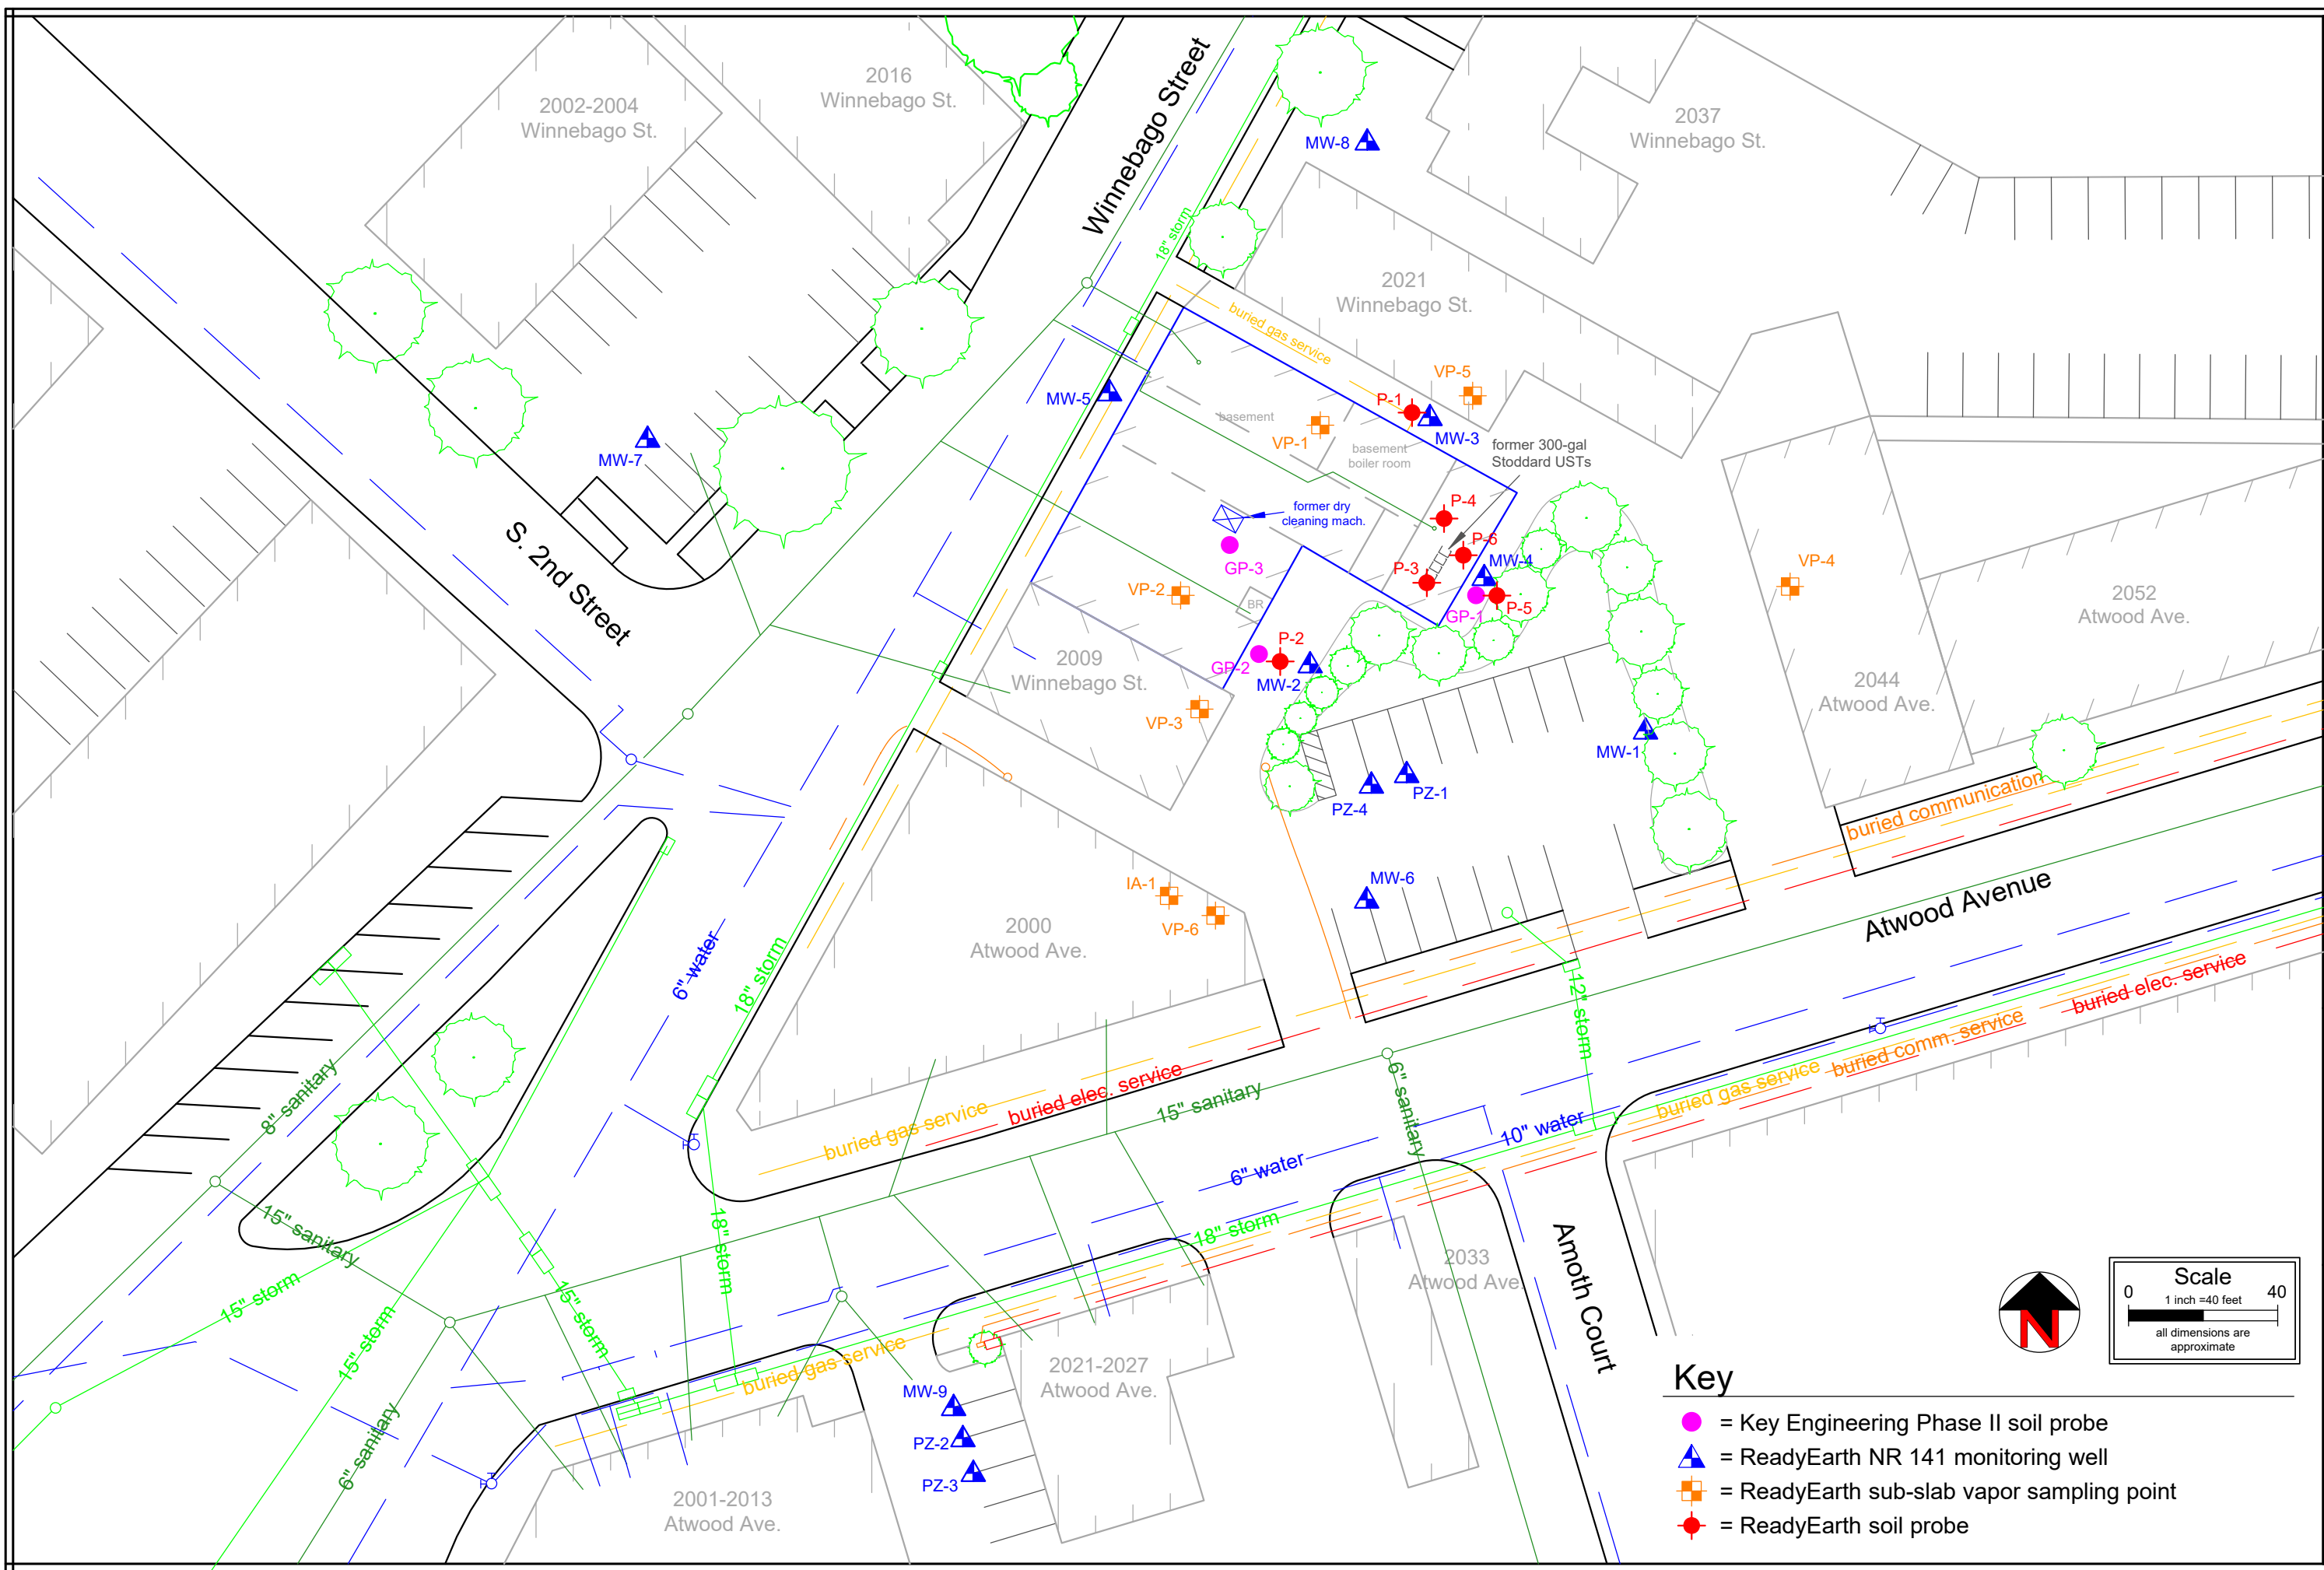
B.1.b Detailed Site Map
 Block System Cleaners
 2017 Winnebago Street
 Madison, Wisconsin

- The buried utilities are indicated on the figure B.1.b.1 Detailed Site Map included in Attachment B. The locations of these utilities have been determined from maps obtained from the City of Madison Engineering Department and/or have been determined through a utility locate.

- The utilities are not affecting the former source area or affecting plume migration. The only utilities along the flow line are those in Atwood Avenue. Those utilities would need to be buried approximately 30 feet bgs in order to intersect the plume.

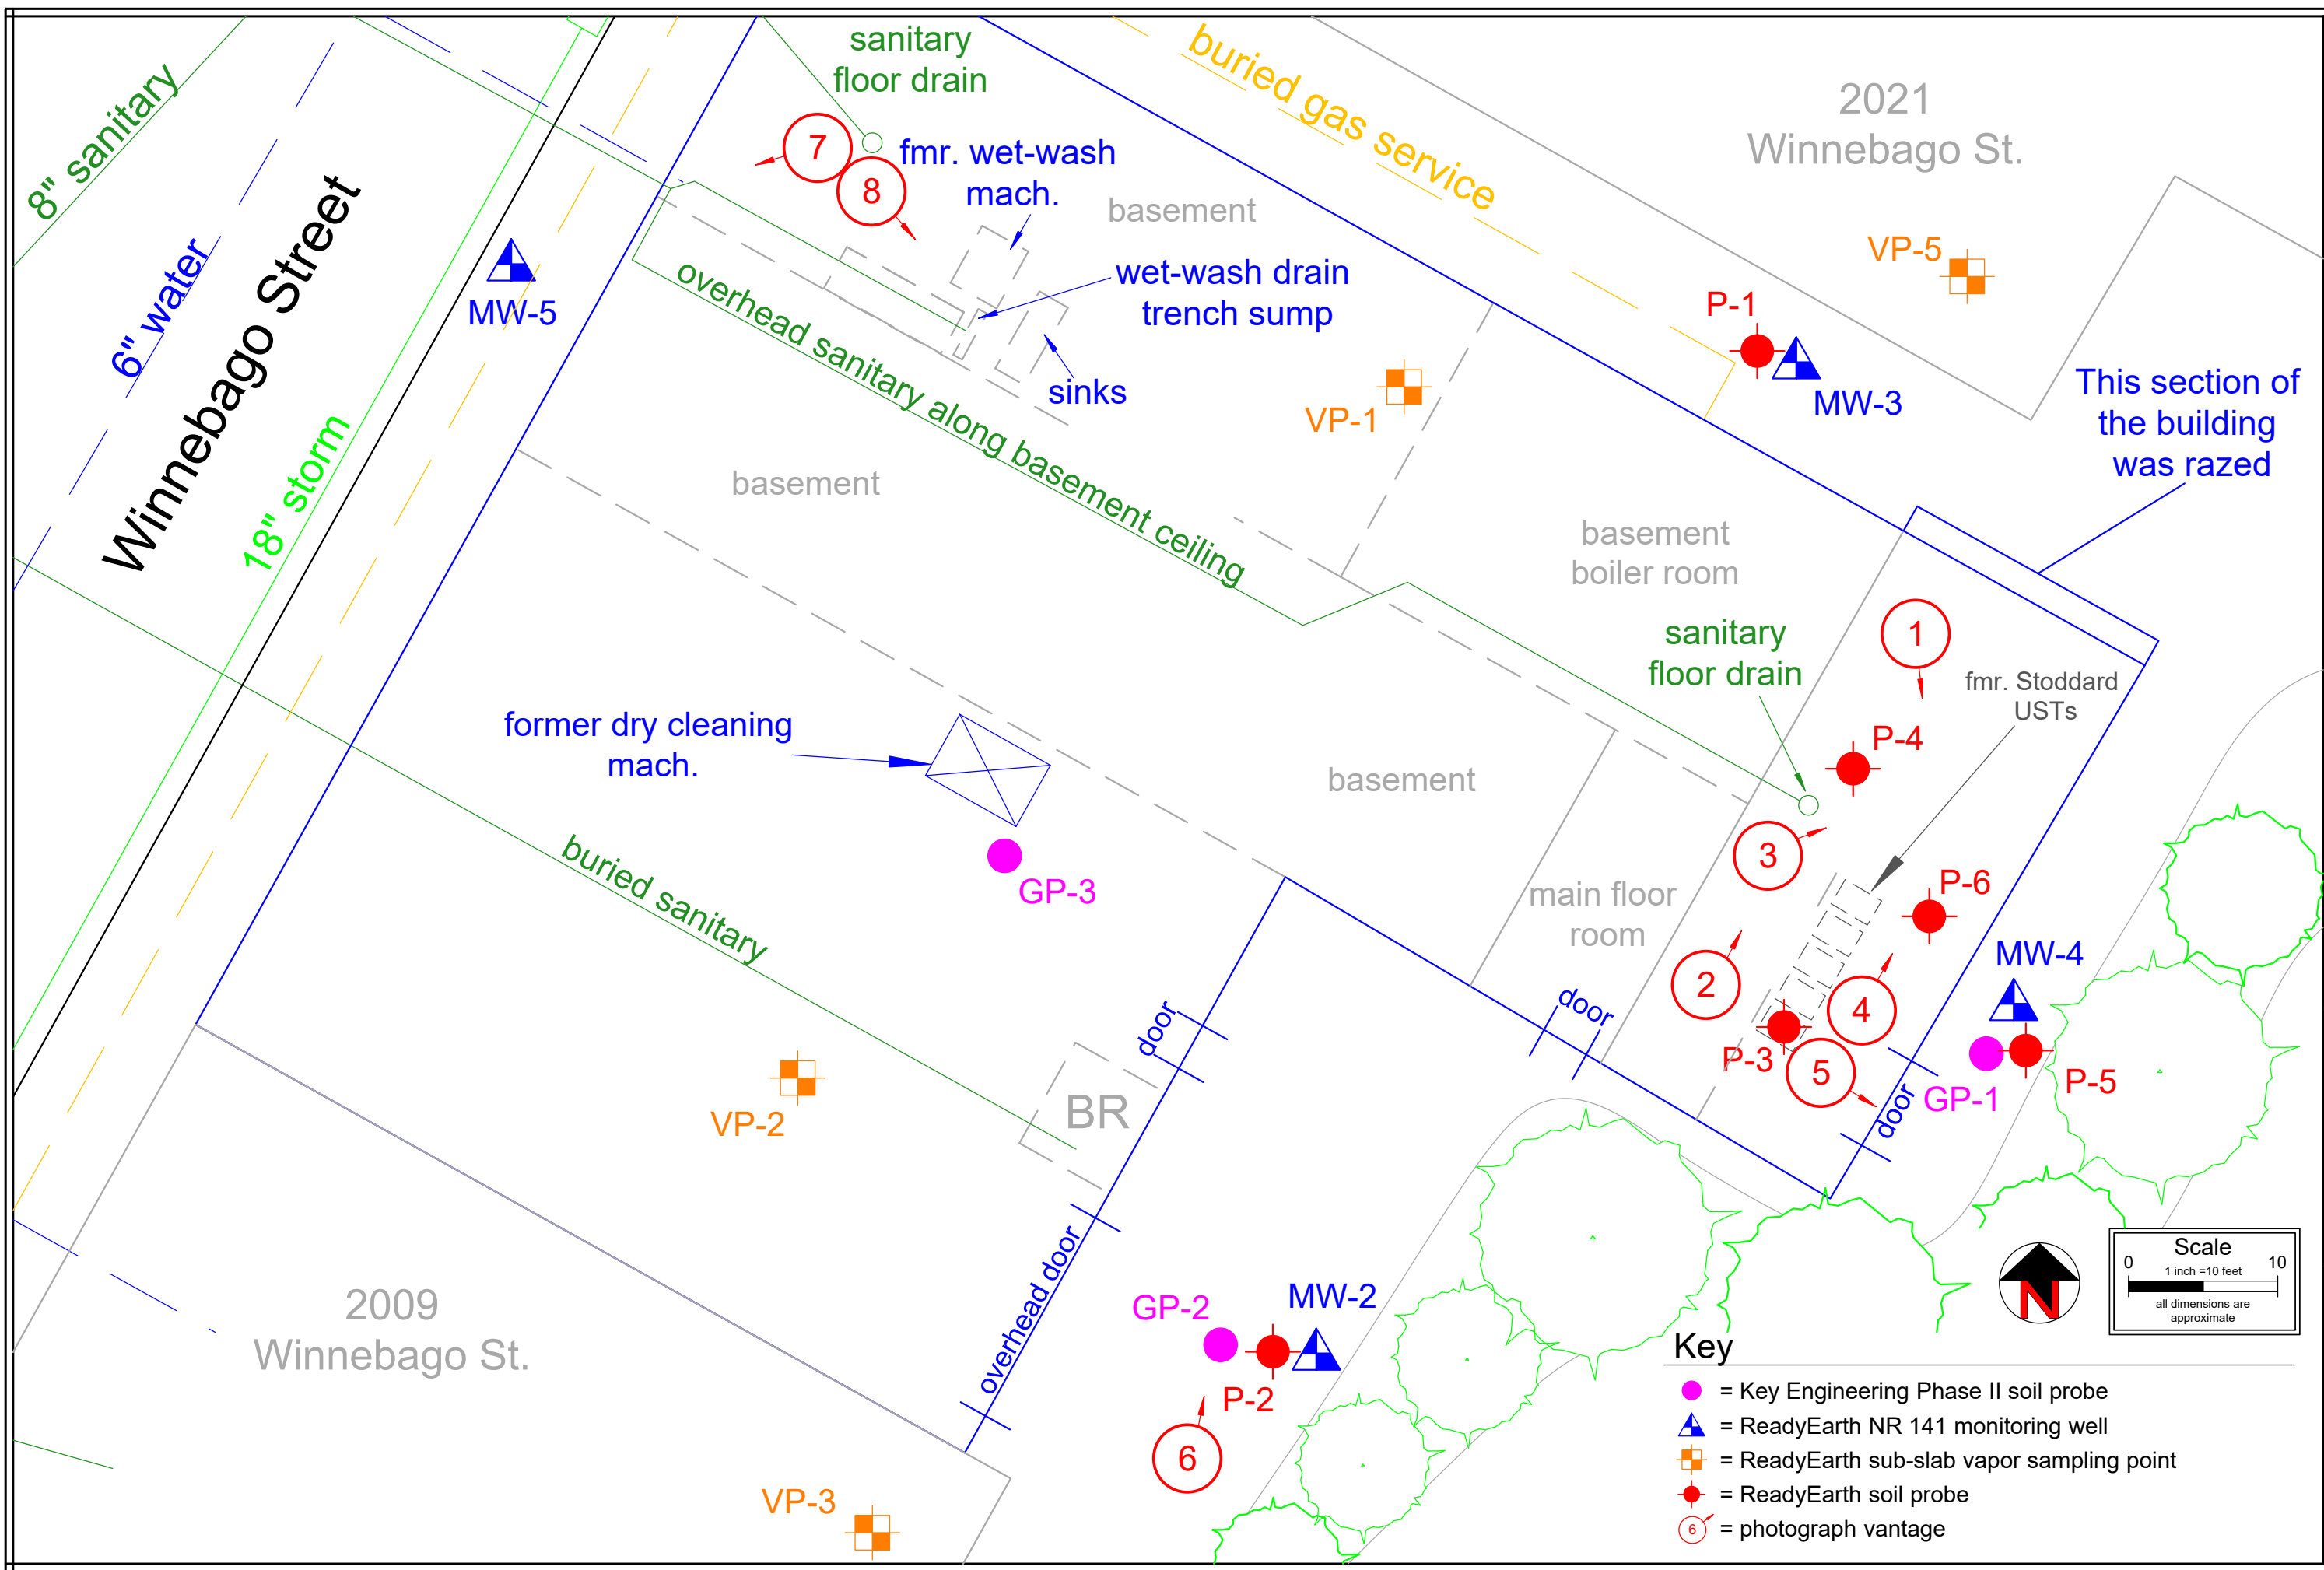
- Figure B.1.b.2 Detailed Site Map Zoom included in Attachment B highlights even more details in the vicinity of the most-likely former source area and basement of the Block building. That figure details the former floor drain previously referenced, the wet-wash trench sump discussed in our phone call, and exterior doors to the Block building near the former source area. Note that the wet-wash trench sump collected water from a typical powder detergent washer machine and is not a foundation sump. Water from the trench was pumped via traditional sump pump to the sanitary sewer on the Winnebago Street side of the building.

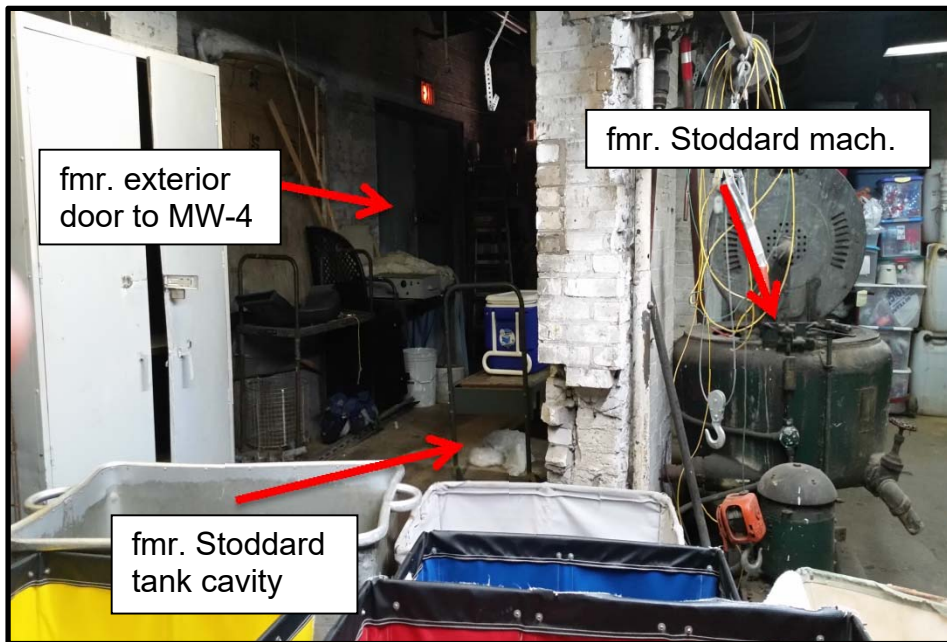
Photo 1 – This photograph looks south across the rear storage room. A rear exterior door shown in the left background leads from this room to the area where MW-4 is located. The building areas shown in this photo have been razed.

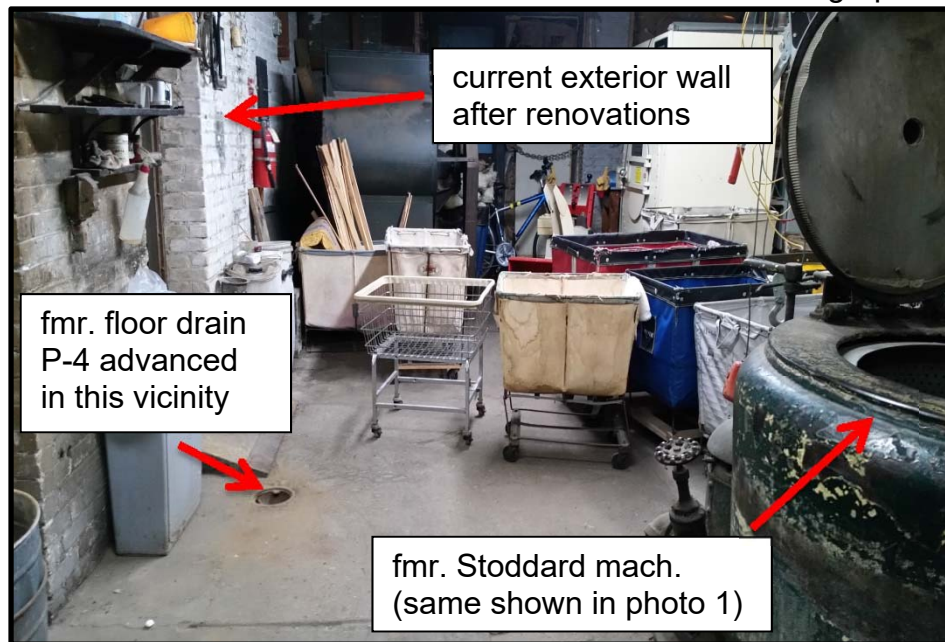
Photo 2 – This photograph looks north-northeast across the storage room. For orientation, the green former washer in the lower right foreground is the same shown in the previous photo. A floor drain referenced in the letter is show to the left of the photo.

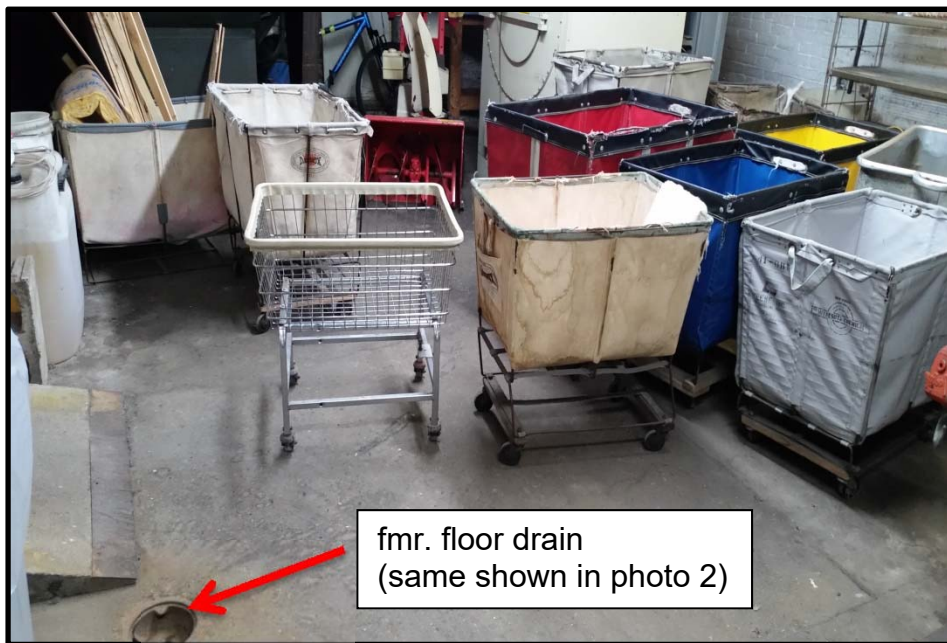
Photo 3 – This photograph shows another vantage of the floor drain shown in the previous photo.

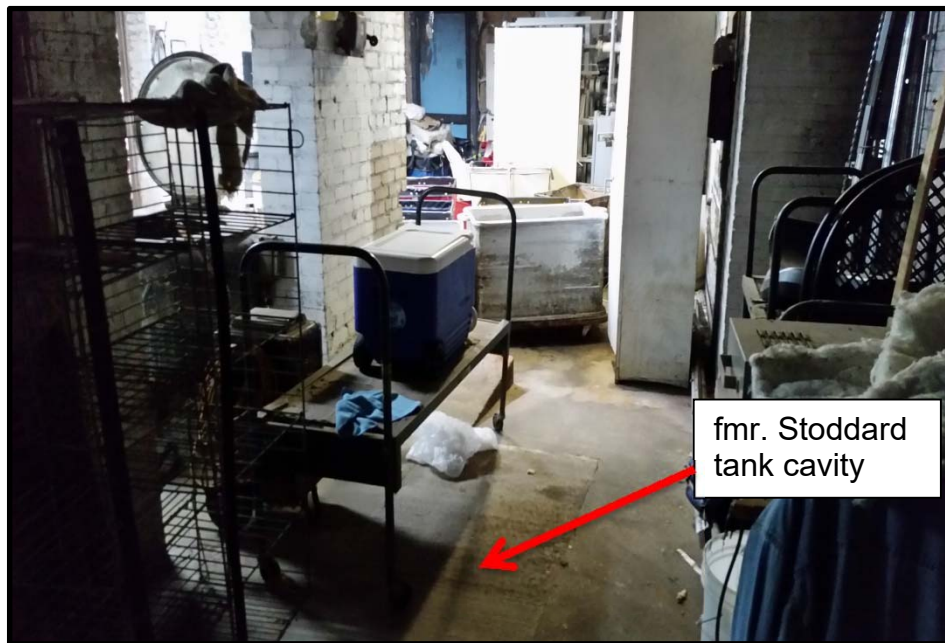
Photo 4 – This photograph looks north from the vantage of the exterior door shown in photo 1. The different concrete shown in the foreground is evidence of the former location of the Stoddard tanks.

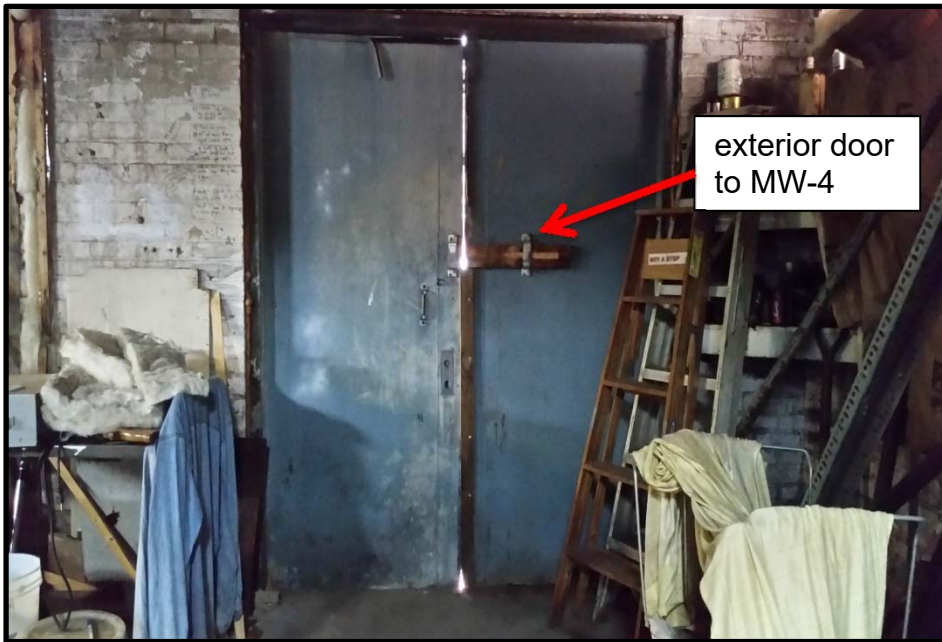
Photo 5 – This photograph shows the exterior door that leads to the area of MW-4. MW-4 is approximately 10 feet from this door. This door is illustrated in on the Detailed Site Map.

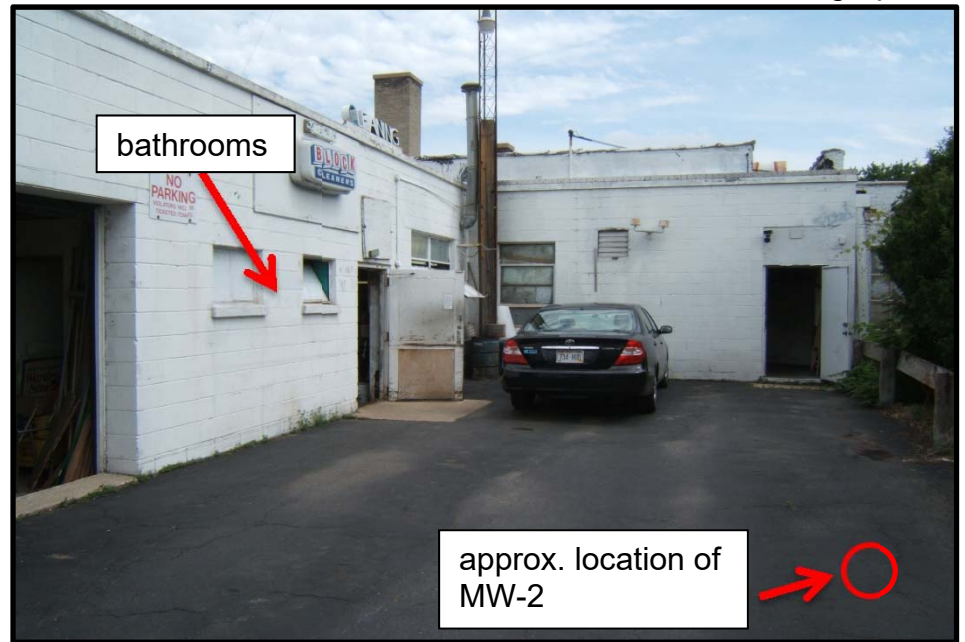
Photo 6 – This photograph shows the other exterior doors at the rear of the building. All exterior doors are shown on the Detailed Site Map. These exterior doors lead to the area of MW-2 (this photo was taken prior to MW-2 being installed).

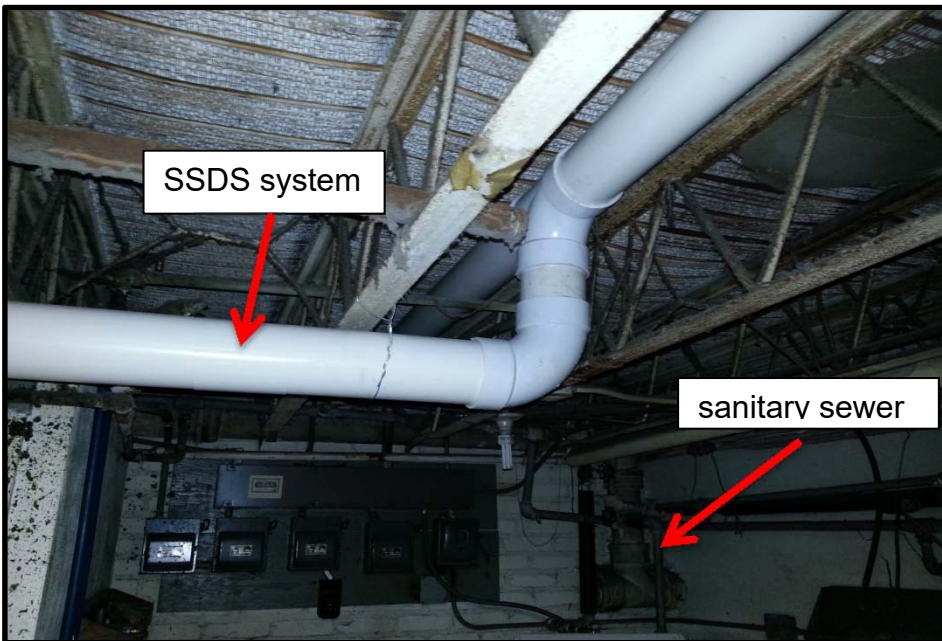
Photo 7 – This photograph looks west-southwest within the Block basement, and prominently shows a portion of the SSDS that remains operating at the site. Shown in the background is the sanitary sewer connection that accepted water from the former floor drain in photos 2 and 3.

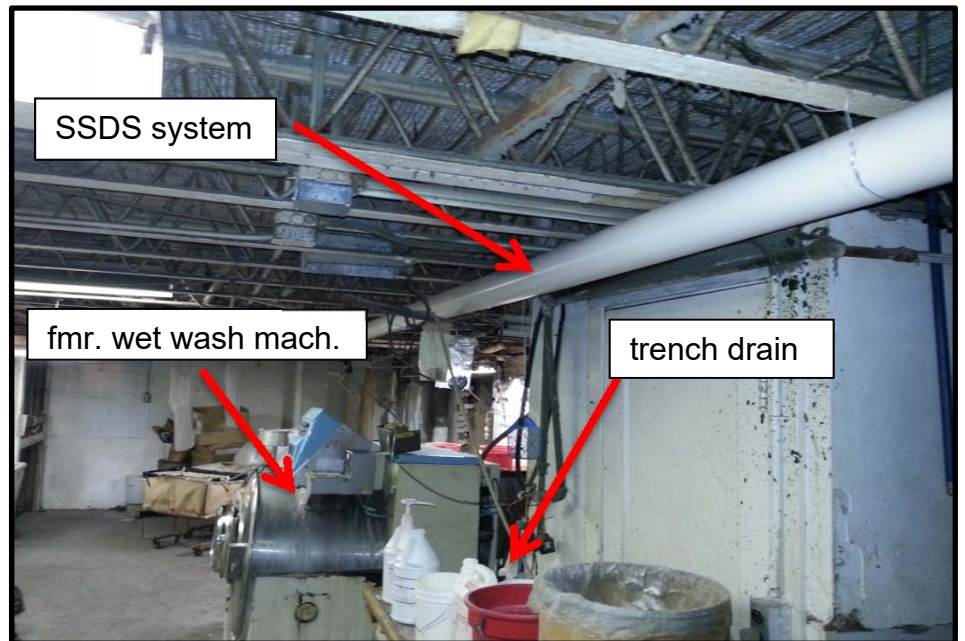
Photo 8 – This photograph is from a vantage just left of the previous photo. The machine in the foreground is the wet wash machine that discharges to a trench sump immediately behind the machine. The sump discharges to the sanitary sewer. The sump does not collect groundwater.

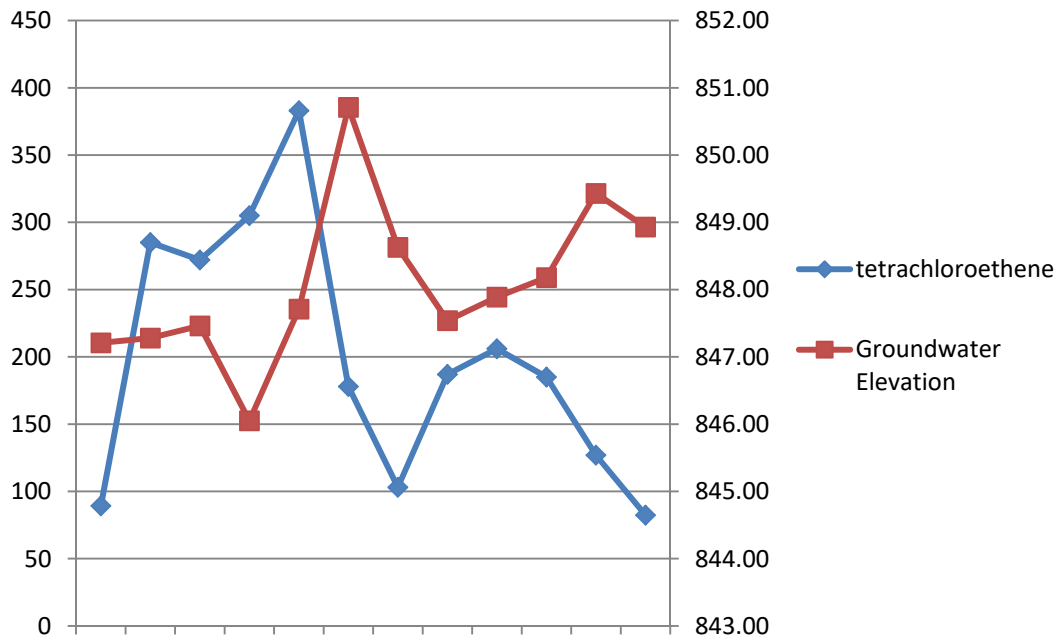
MW-4 PCE & GW Elevations vs Time

- The PCE concentrations in downgradient well MW-6 have demonstrated decreases over virtually ten consecutive events.
- Both the Stoddard and chlorinated concentrations in MW-4, which is closest to the likely former source area, have demonstrated consecutive decreases over the past three events:

- The Stoddard compounds have decreased to below detection limits.
 - The PCE concentrations have attenuated approximately 79% from its peak concentration in 2013.

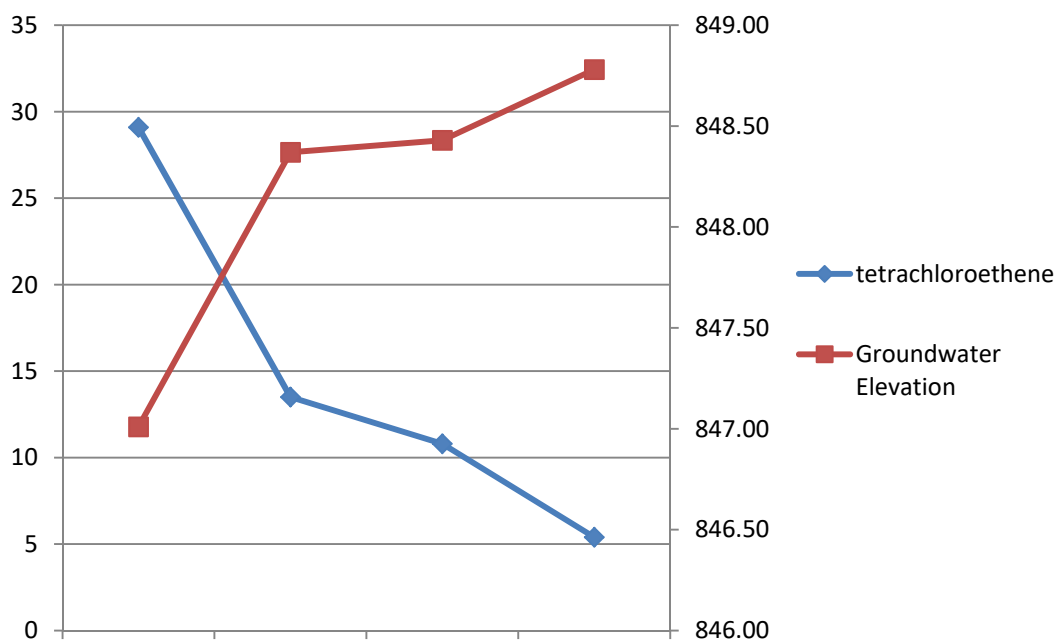
PZ-4 PCE & GW Elevations vs Time

- PZ-4 is nested with PZ-1 and is installed at approximately 60 feet bgs. PCE was initially detected in PZ-4 at a relatively low 29.1 ppb, and the PCE concentrations
