March 26, 2024  
File No. 25211374.54

Subject: Vapor Mitigation System Installation Documentation  
1131 N. Sherman Avenue, Madison, Wisconsin  
Laundry Land Cleaners (former), Northgate Shopping Center  
WDNR BRRTS #02-13-552183

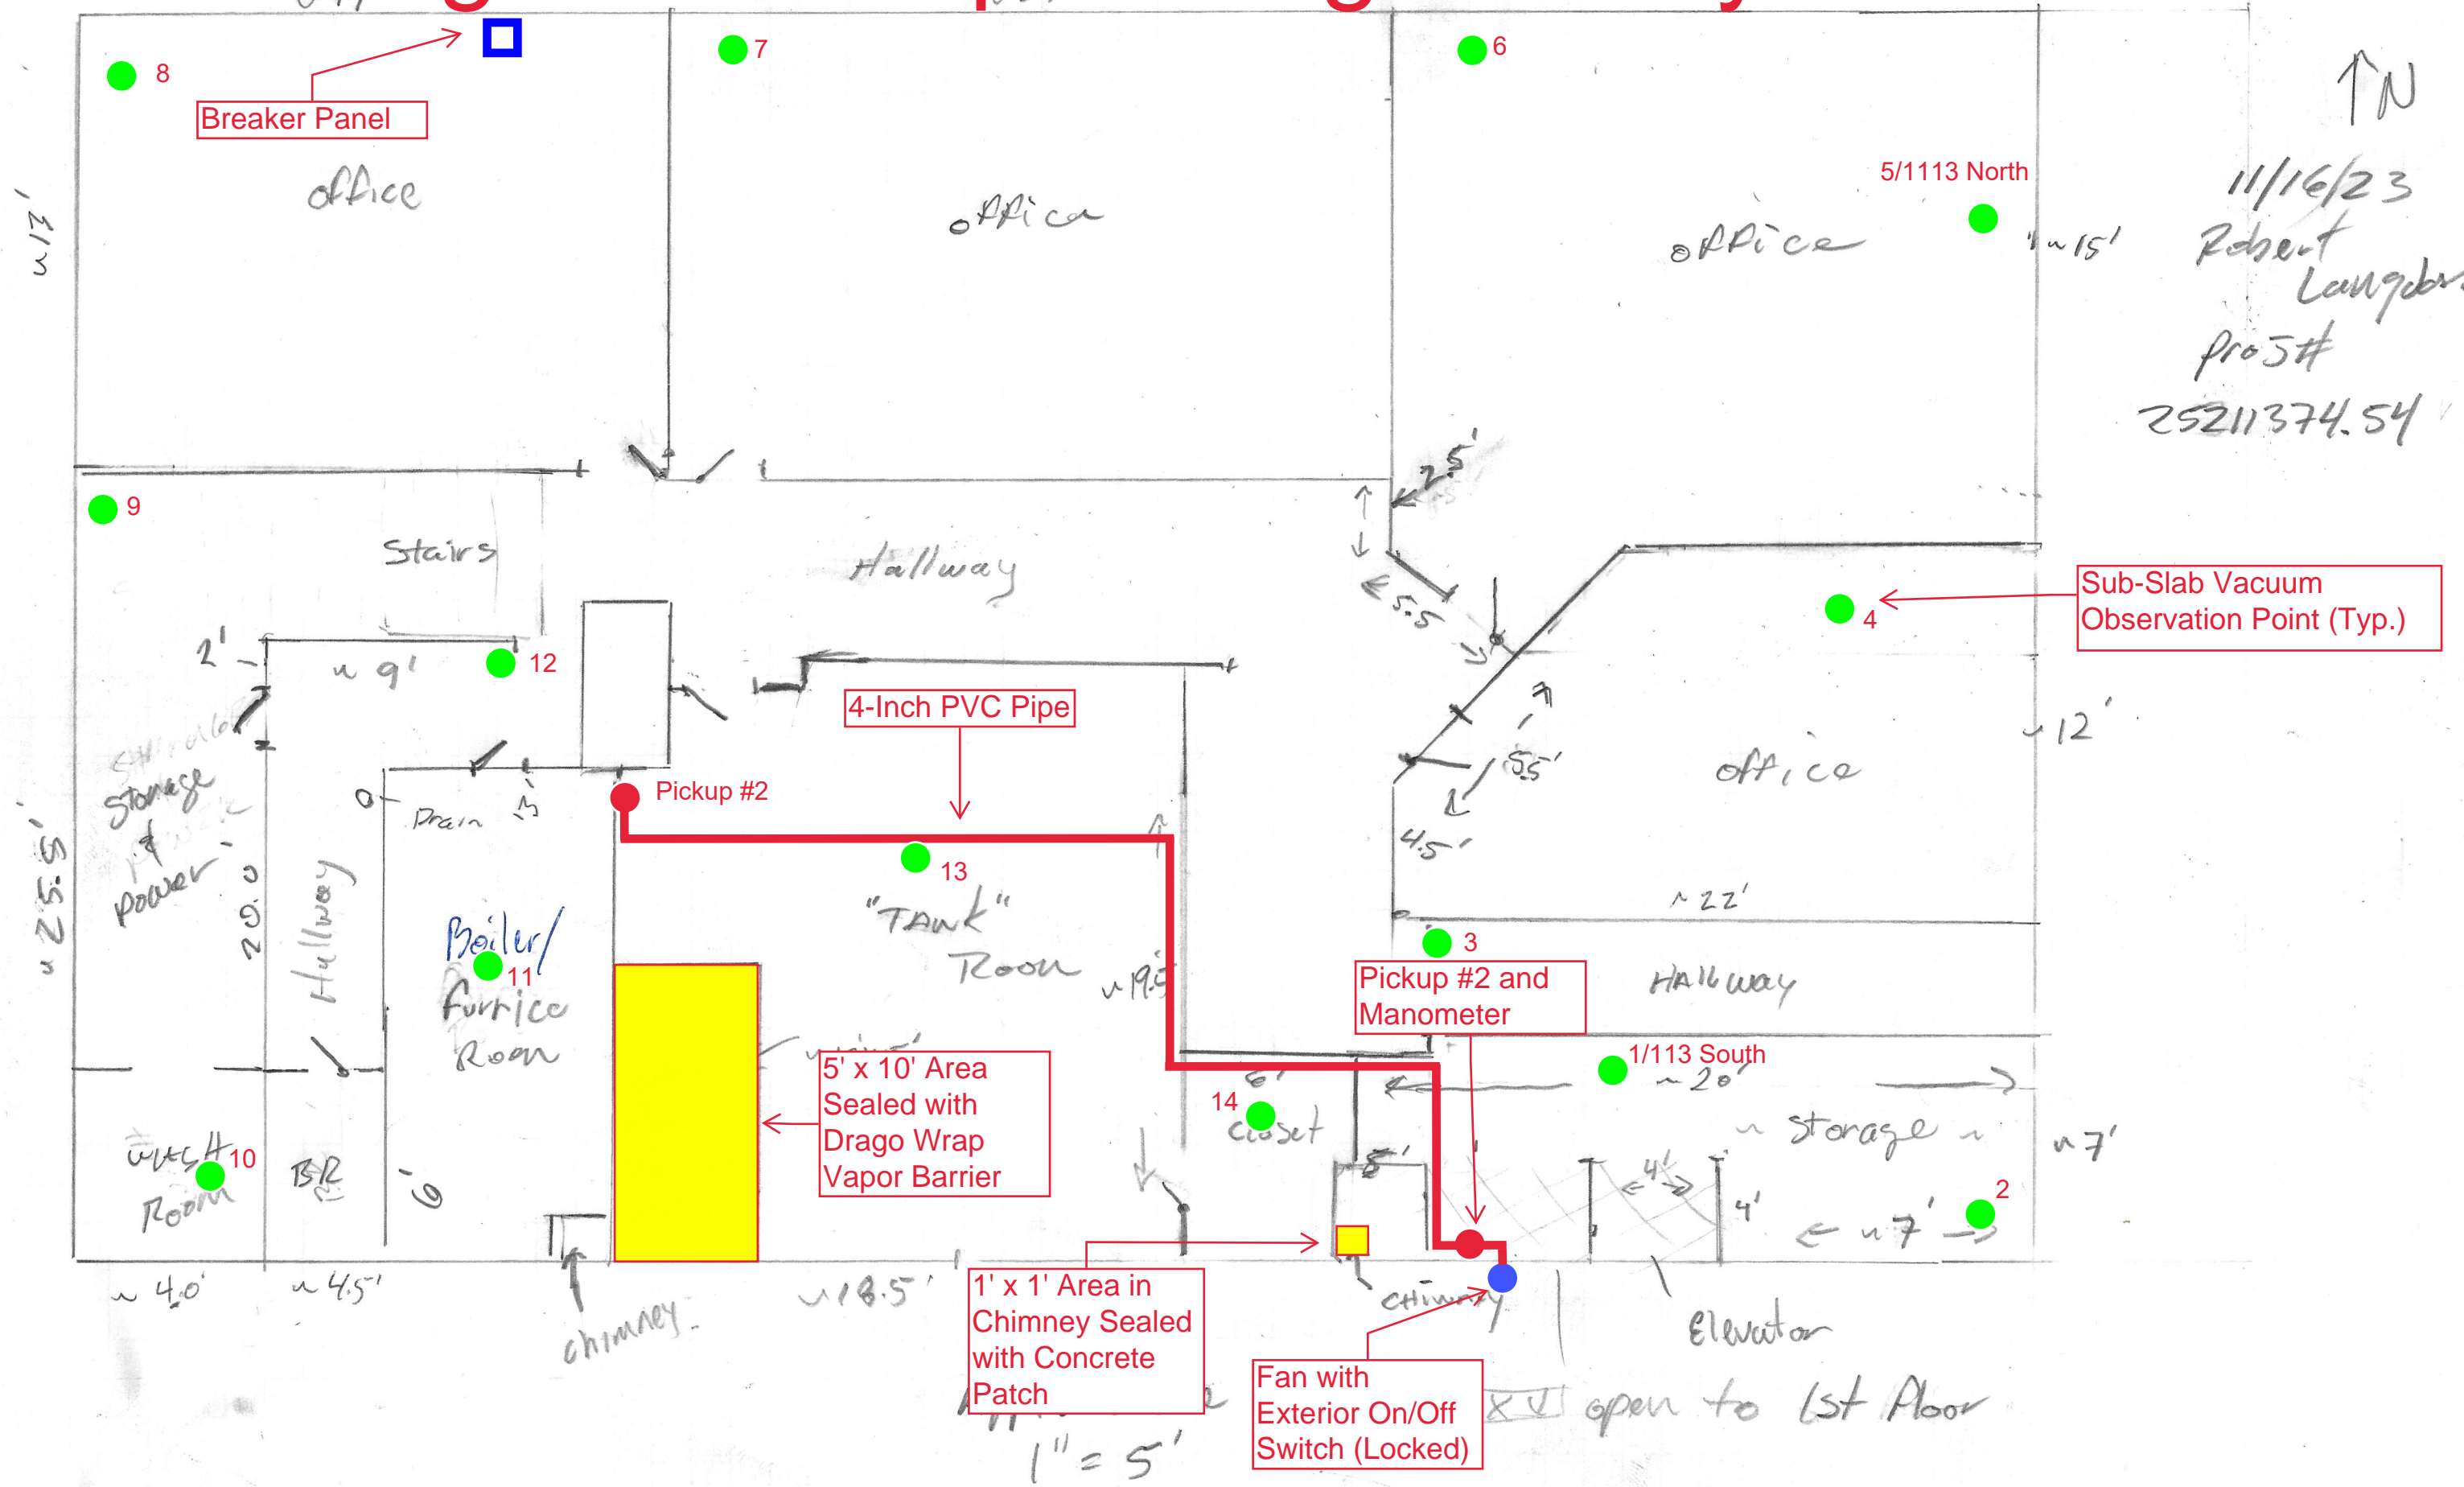
# Figure 1 - Vapor Mitigation System

The 1113 North Sherman Avenue VMS was installed in March 2024 by Lifetime Radon Solutions of Delafield, Wisconsin, with coordination by SCS. System details are provided on **Figure 1**. Photos of the VMS are included in **Attachment A**.

PFE vacuum measurements were taken at 14 sub-slab vacuum observations points using a UEi Test Instruments Model EM201B digital manometer capable of measuring vacuum to 0.001 inches of WC vacuum. PFE measurements were made while the neighboring VMS as 1117 North Sherman Avenue was temporarily turned off. Vacuum observation points are shown on **Figure 1**.

The PFE test results indicate good vacuum distribution in excess of WDNR's depressurization performance standard (0.004 inches WC) extending west beyond the east side of the basement where VRSL exceedances were observed in 2019. Based on these findings the VMS appears to effectively depressurize the sub-slab and should prevent vapor intrusion into the building.

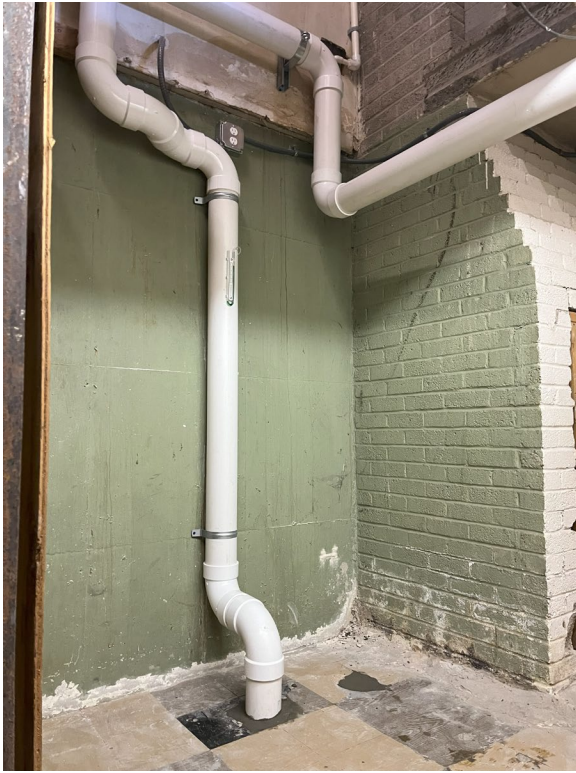
**Photo 1:** Looking southwest at Pickup #1.

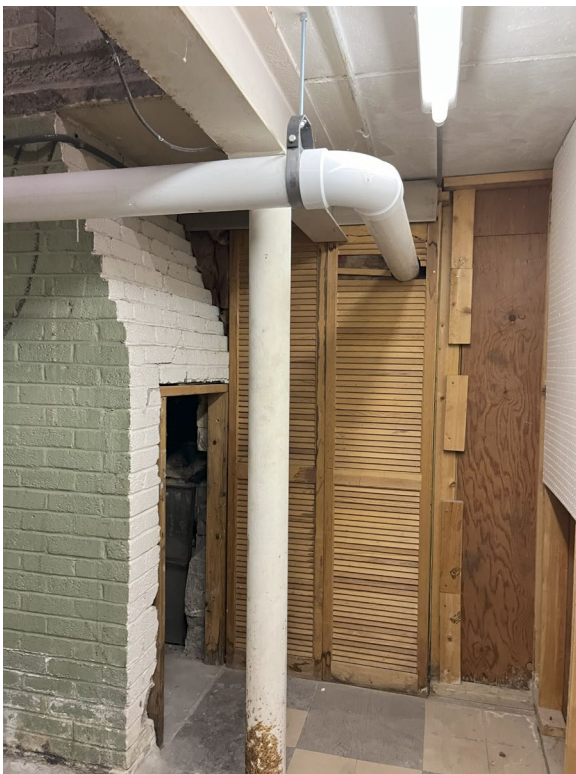
**Photo 2:** Looking west at piping from Pickup #1.

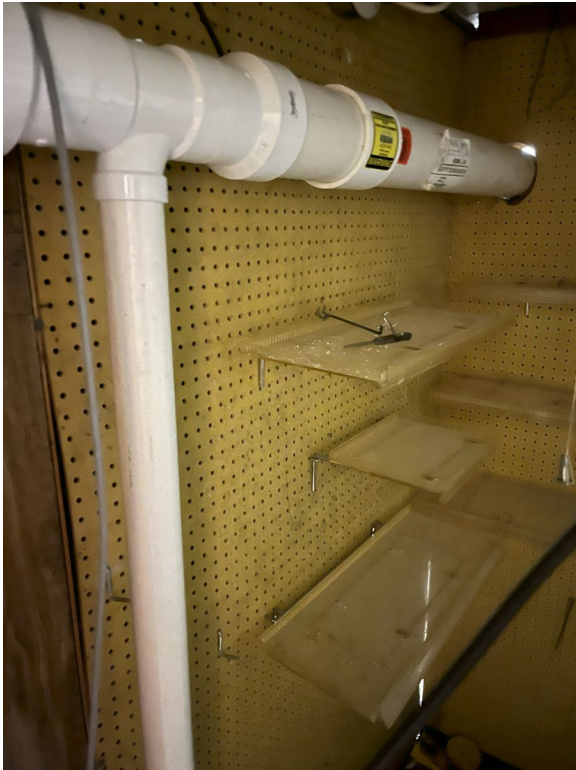
**Photo 3:** Looking east at piping inside closet. Smaller diameter vertical section of PVC is a moisture drop.

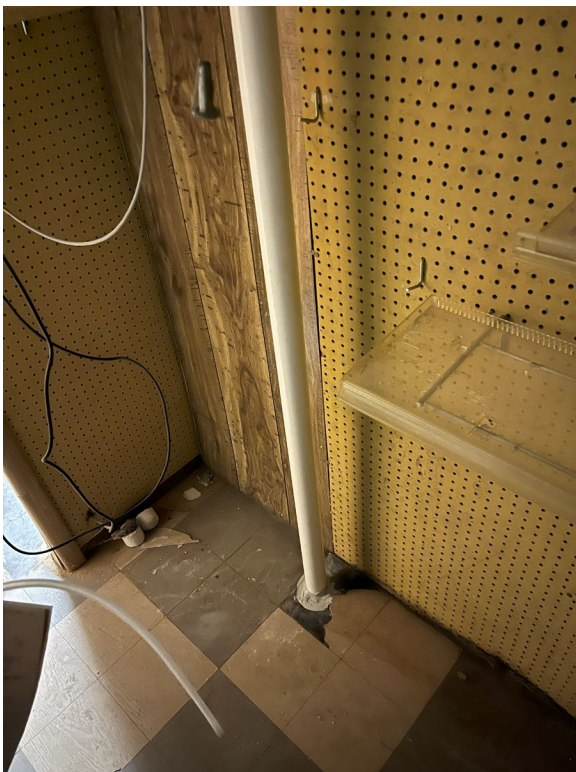
**Photo 4:** Looking northwest inside closet at moisture drop.

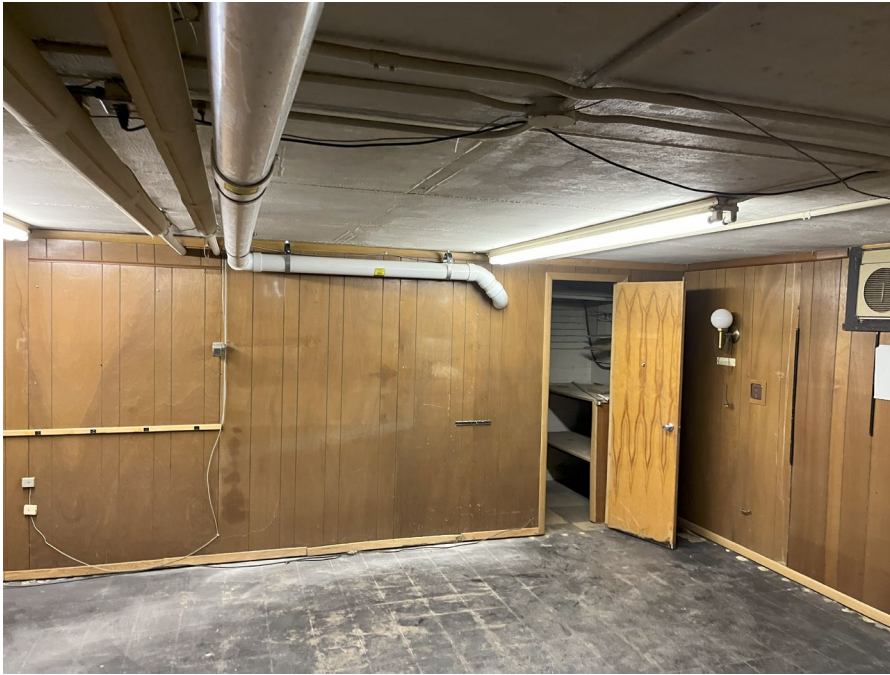
**Photo 5:** Looking east at piping which comes from the moisture drop line inside the closet and runs to Pickup #2.

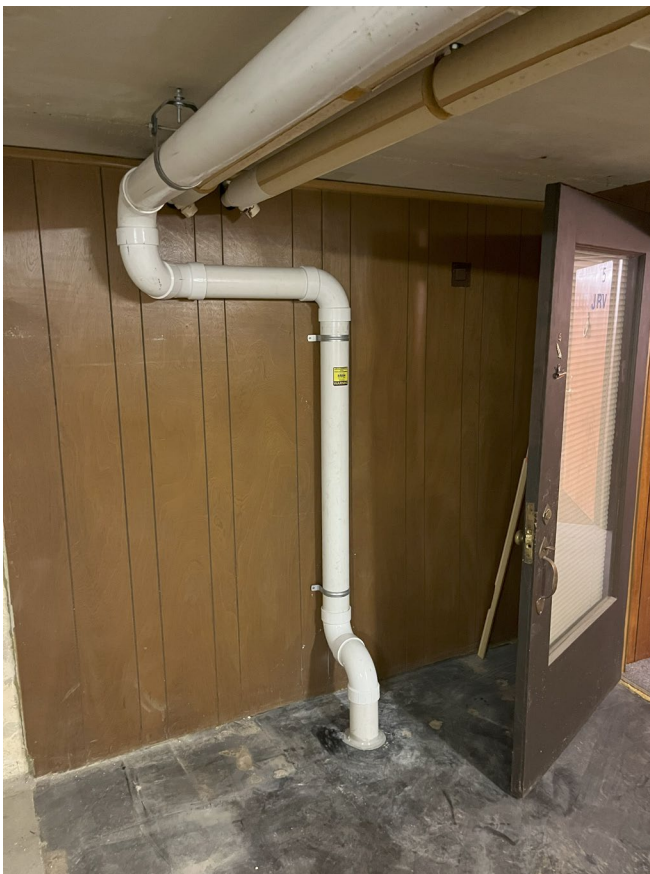
**Photo 6:** Looking northwest at Pickup #2.

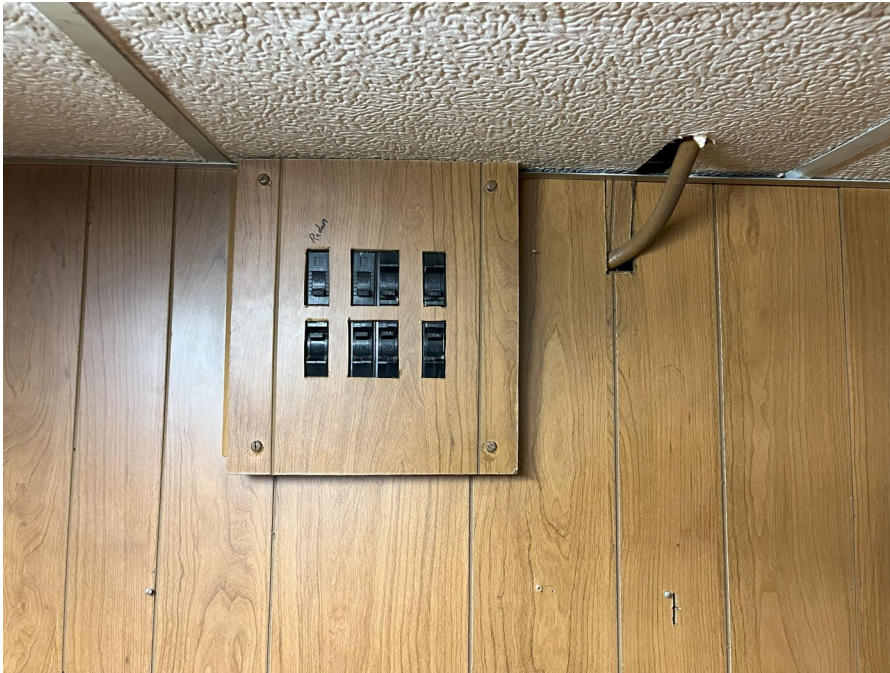
**Photo 7:** Looking north at breaker panel inside office at northwest corner of basement. Breaker at upper left is labeled "Radon" for radon/mitigation fan.

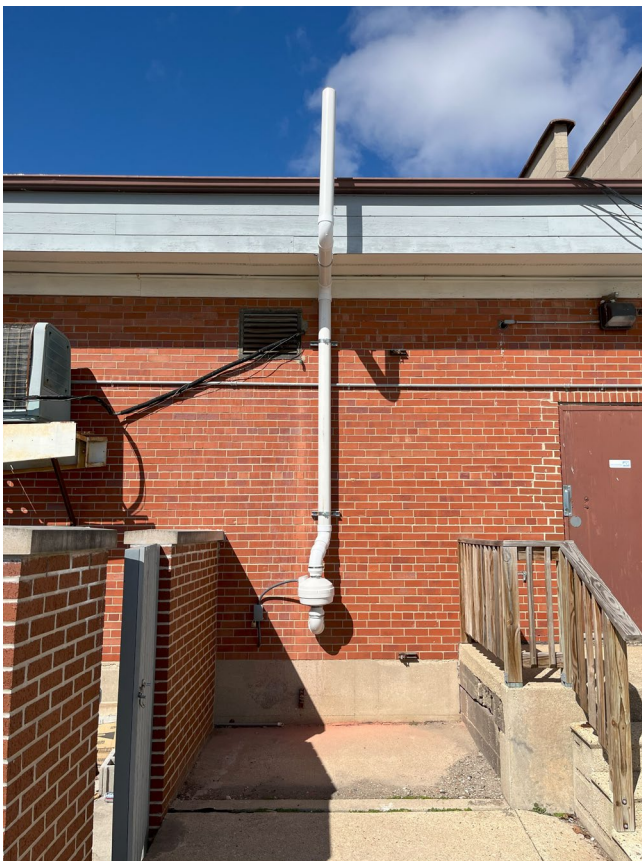
**Photo 8:** Looking north at mitigation system fan and exhaust line on south side of building.

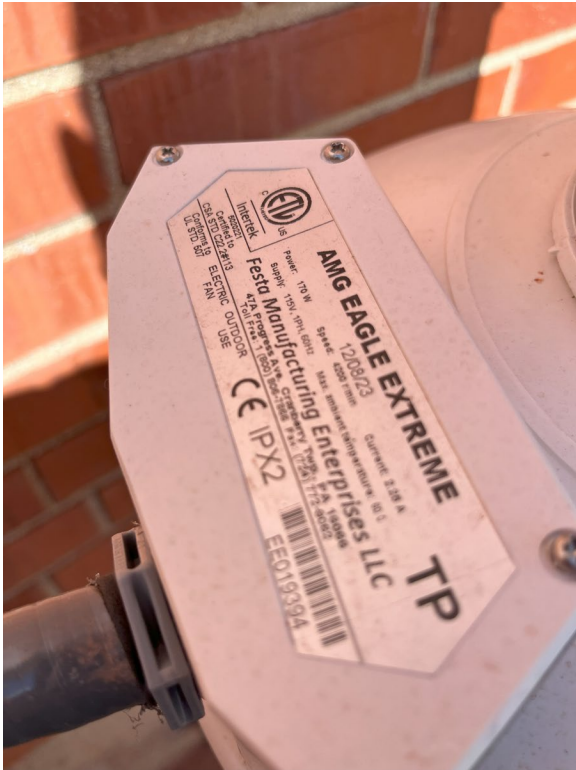
**Photo 9:** Fan label.

field extension (PFE) testing to verify adequate sub-slab vacuum distribution. VMS vacuum is supplied by a Fiesta Manufacturing Enterprises LLC AMG Eagle Extreme radon fan, capable of producing up to 4.75 inches of water column (WC) vacuum.

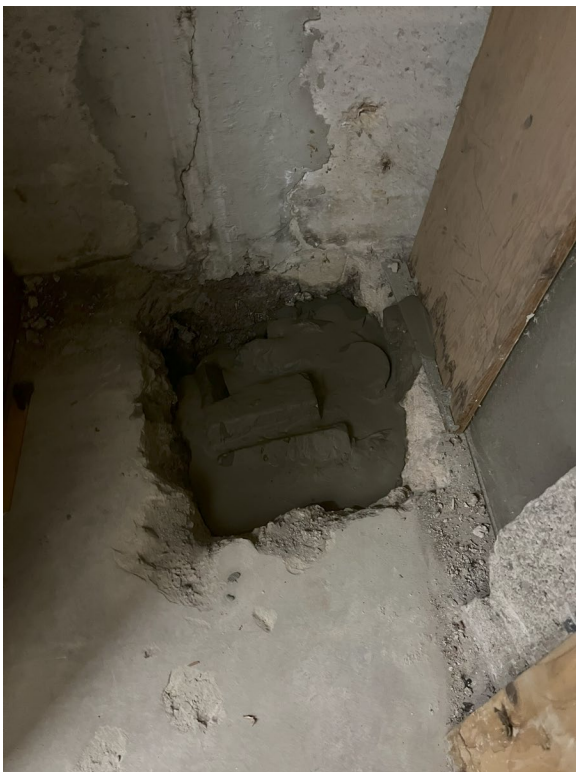
An approximate 50-square-foot opening in the floor at the former location of a heating oil tank was sealed using Drago Wrap vapor barrier and tape. An approximate 1-square-foot opening in the floor at the base of a chimney was sealed with concrete.

**Photo 10:** Looking south at concrete patch inside chimney at south side of basement.

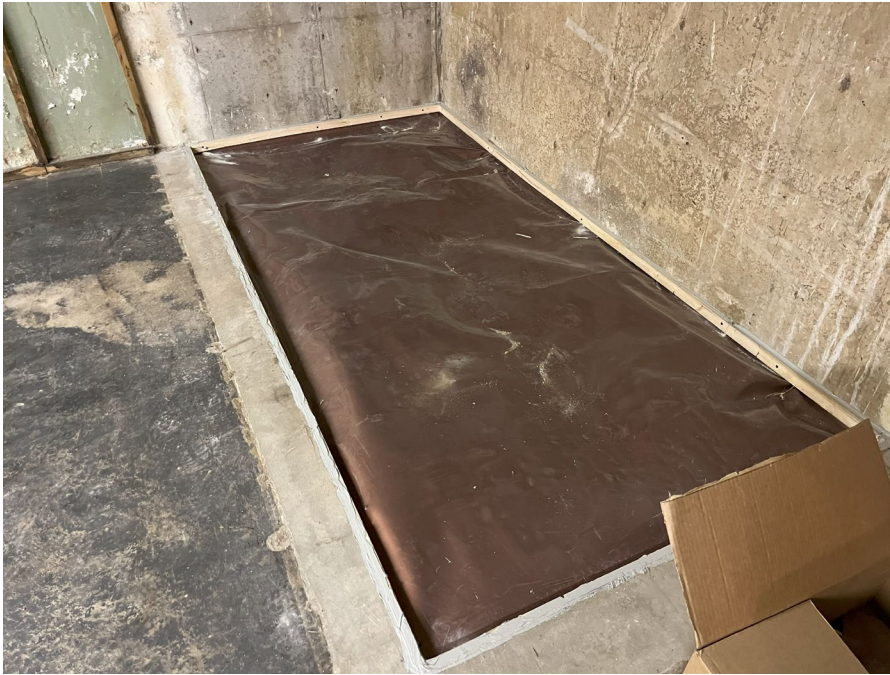
**Photo 11:** Looking southwest at Dregro Wrap vapor barrier covering opening in floor where fuel oil tank sat.

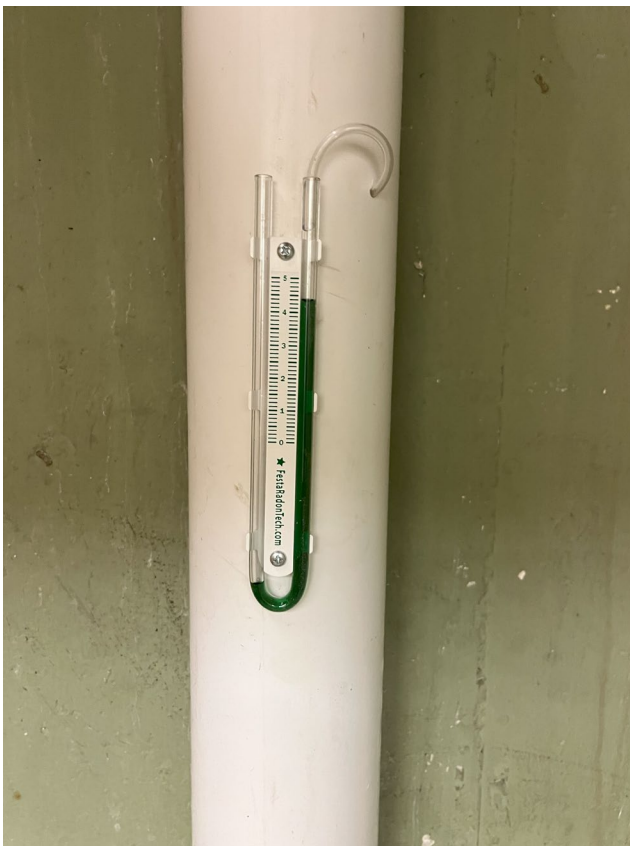
**Photo 12:** Looking south at manometer on Pickup #1.

A manometer was fitted to the southernmost pickup (Pickup #1) to show vacuum at the pickup points and to check fan operation. At startup the manometer read approximately 4.4 inches WC, which is at the upper end of the fan range.

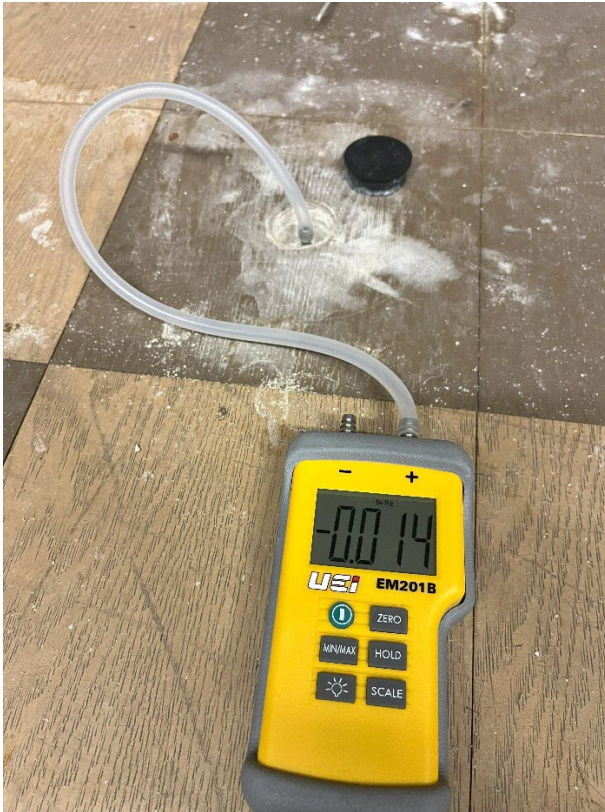
**Photo 13:** Looking at vacuum observation point 5 (1113 North) while measuring background vacuums using digital manometer.

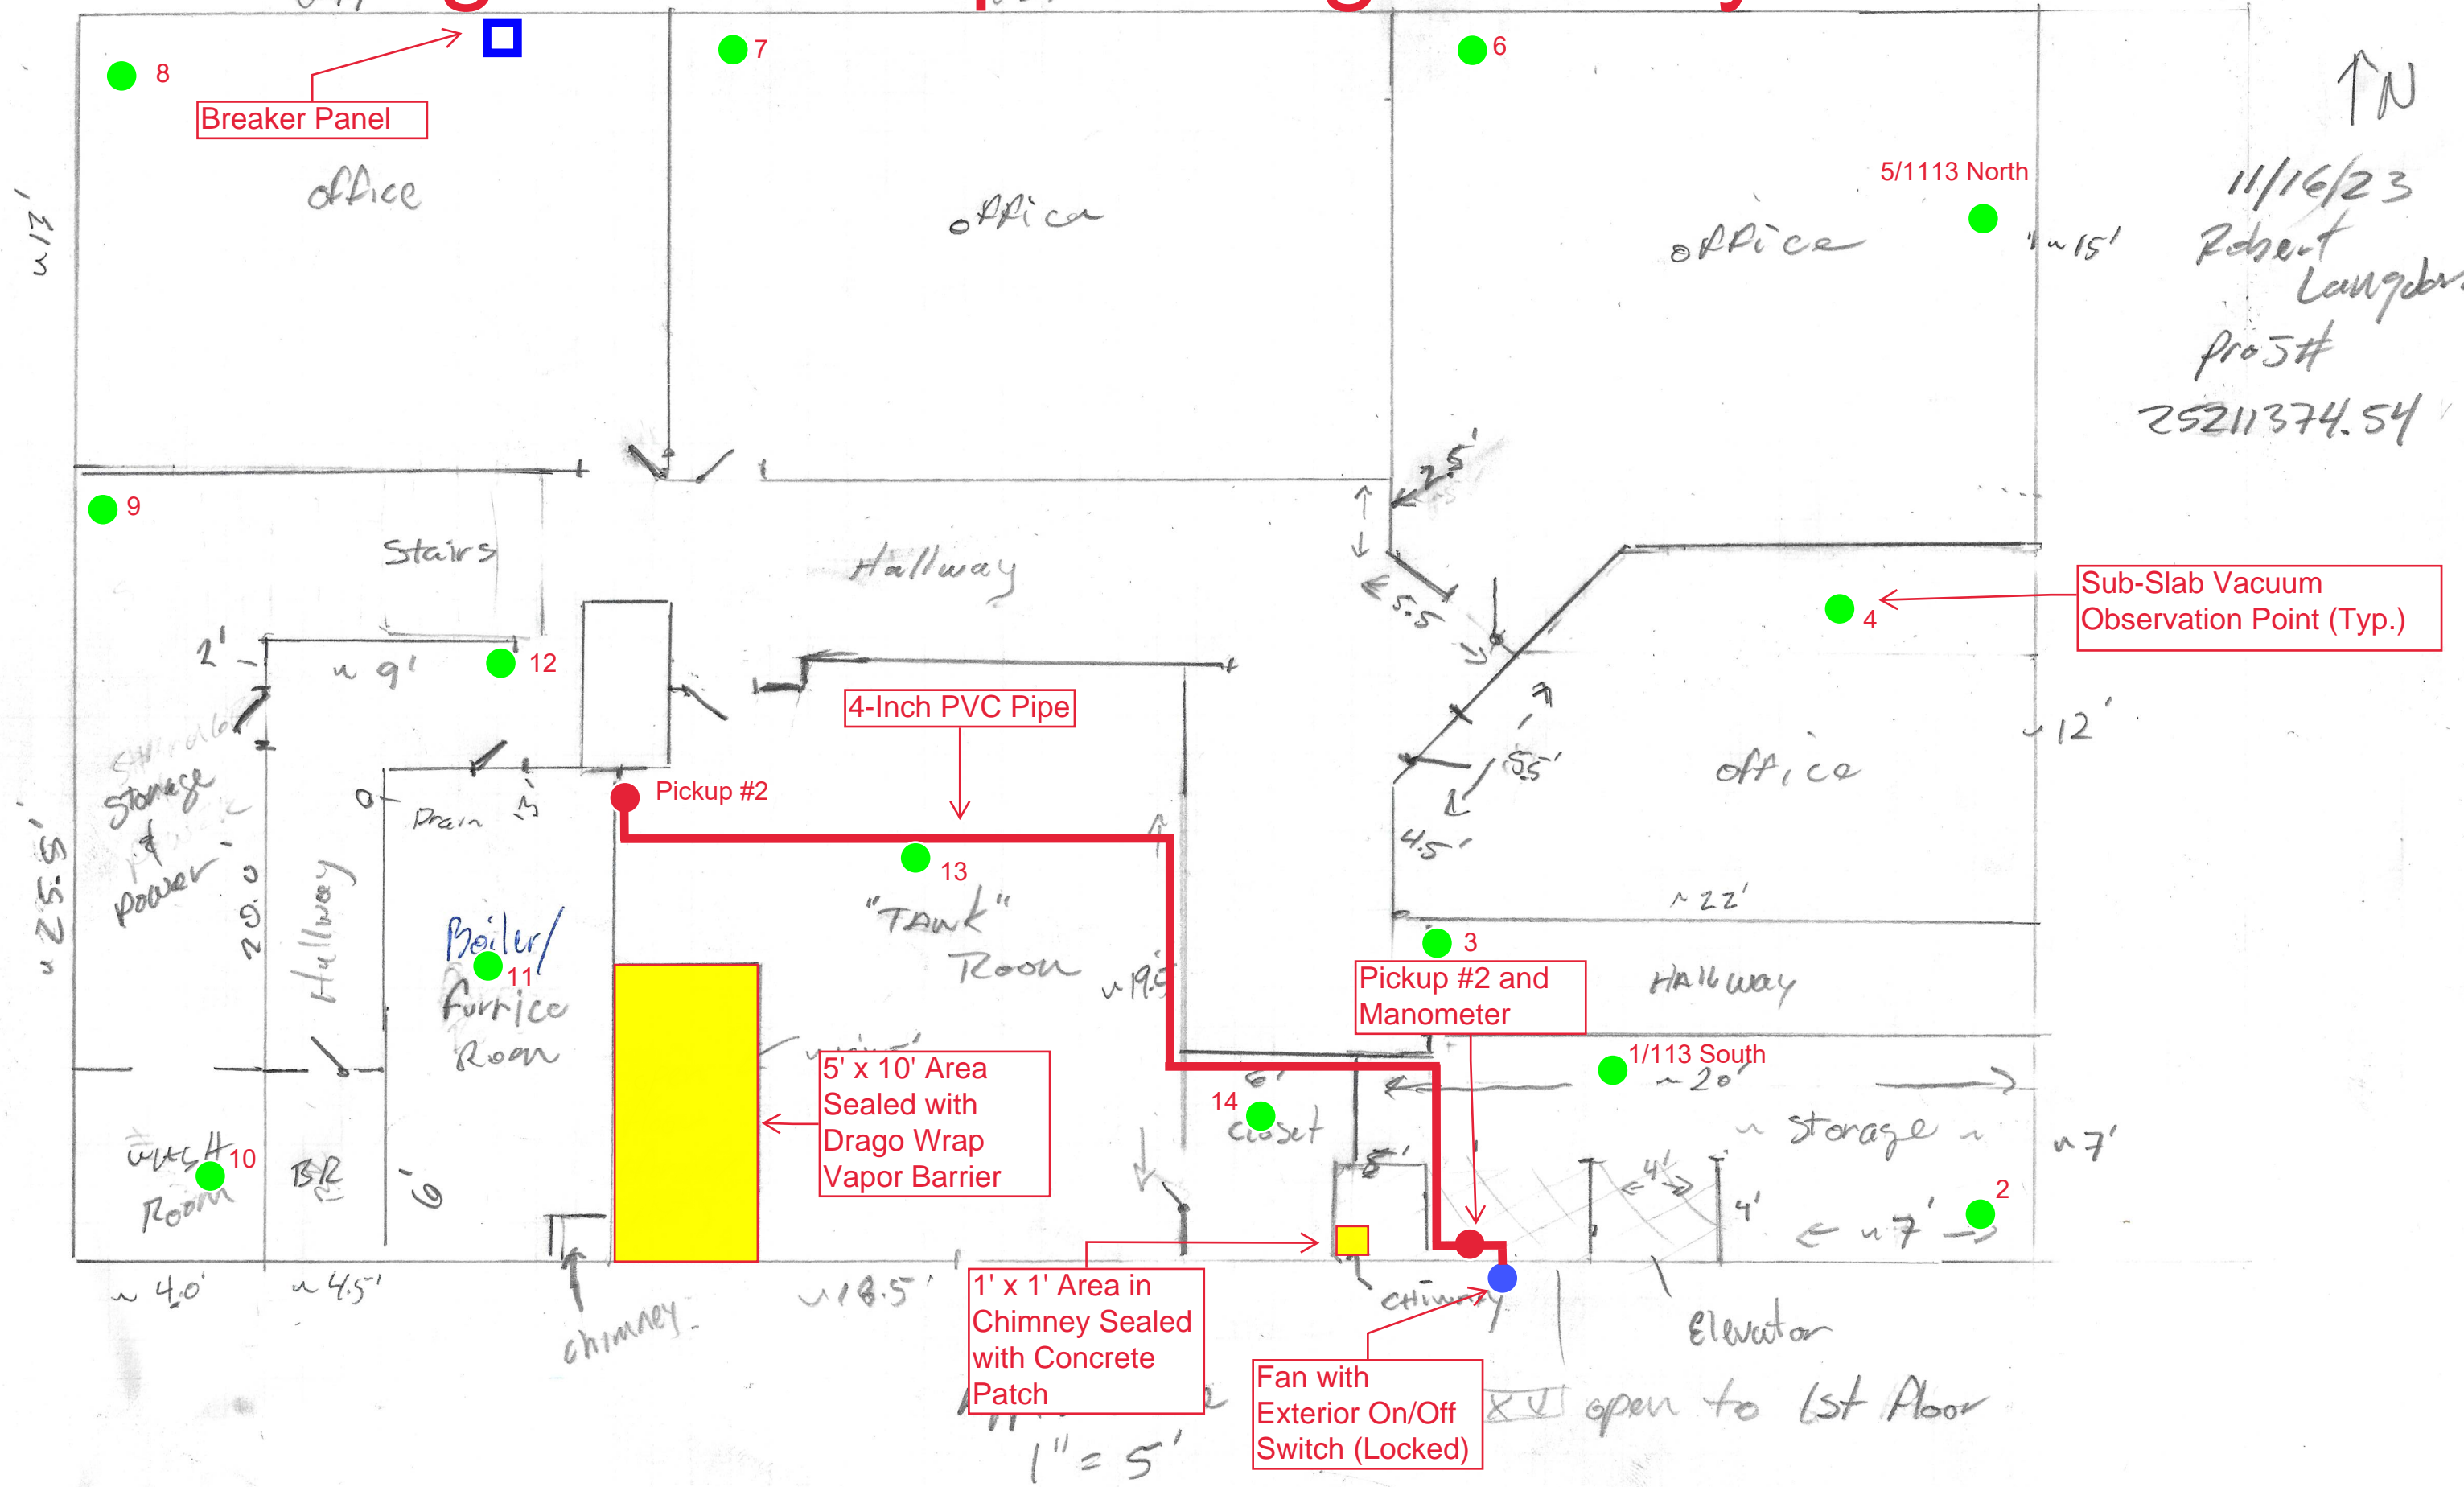
# Figure 1 - Vapor Mitigation System

The VMS was constructed by Lifetime Radon Solutions March 11 to 12, 2024. The VMS was designed to reduce the potential for vapor intrusion by depressurizing the building sub-slab where dry cleaning solvent (PCE) vapor was detected in underlying soil gas in excess of the WDNR's vapor risk screening level. The PCE vapor resulted from a historic release of dry cleaning solvent. VMS components are shown on **Figure 1**.

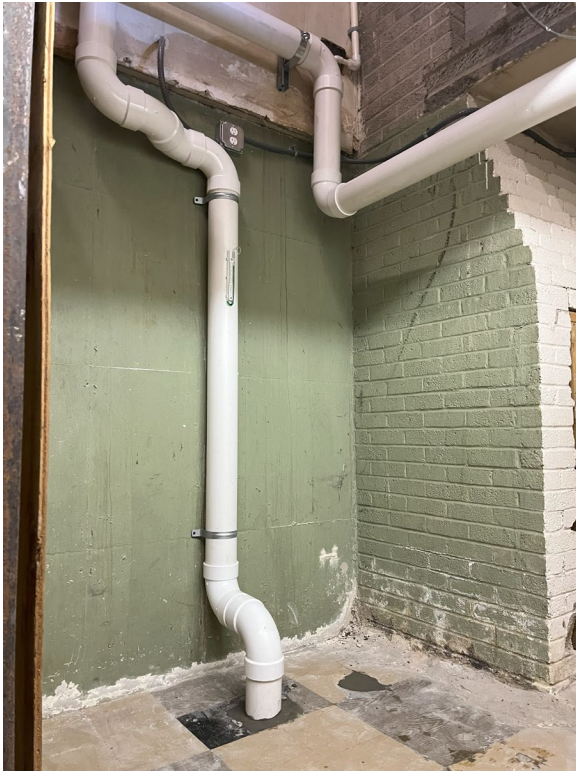
**Photo 1:** Looking southwest at Pickup #1.

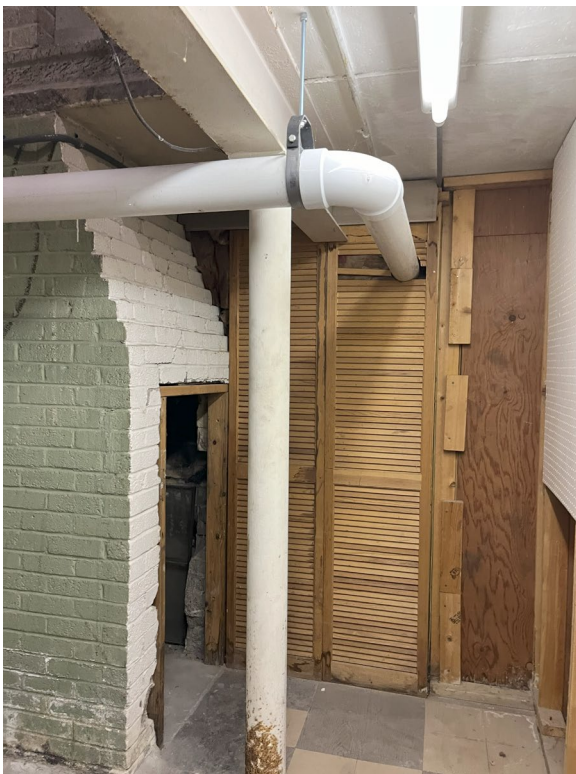
**Photo 2:** Looking west at piping from Pickup #1.

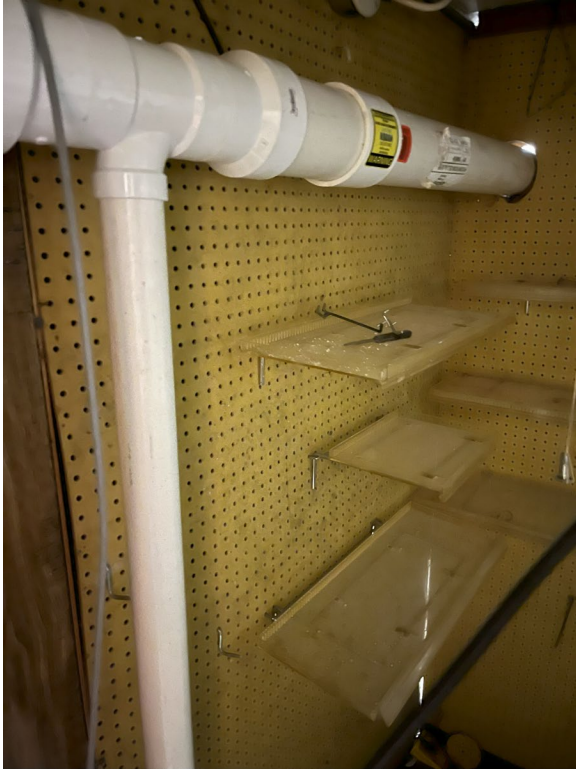
**Photo 3:** Looking east at piping inside closet. Smaller diameter vertical section of PVC is a moisture drop.

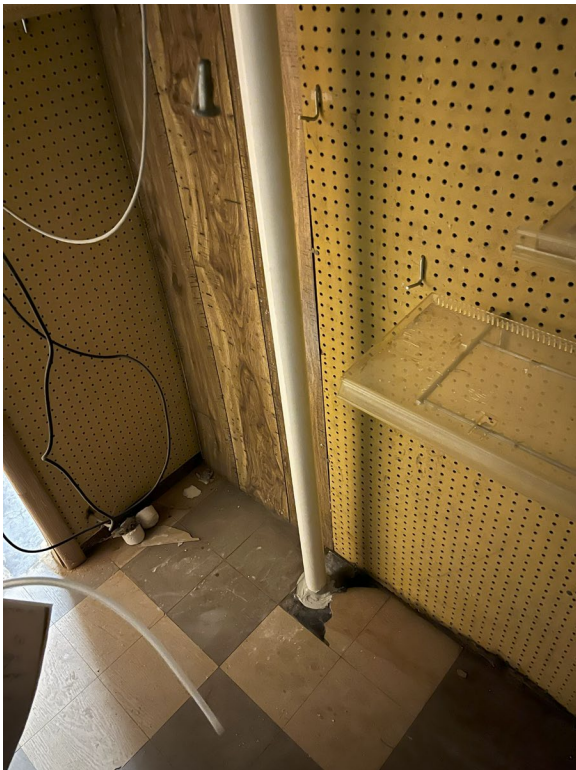
**Photo 4:** Looking northwest inside closet at moisture drop.

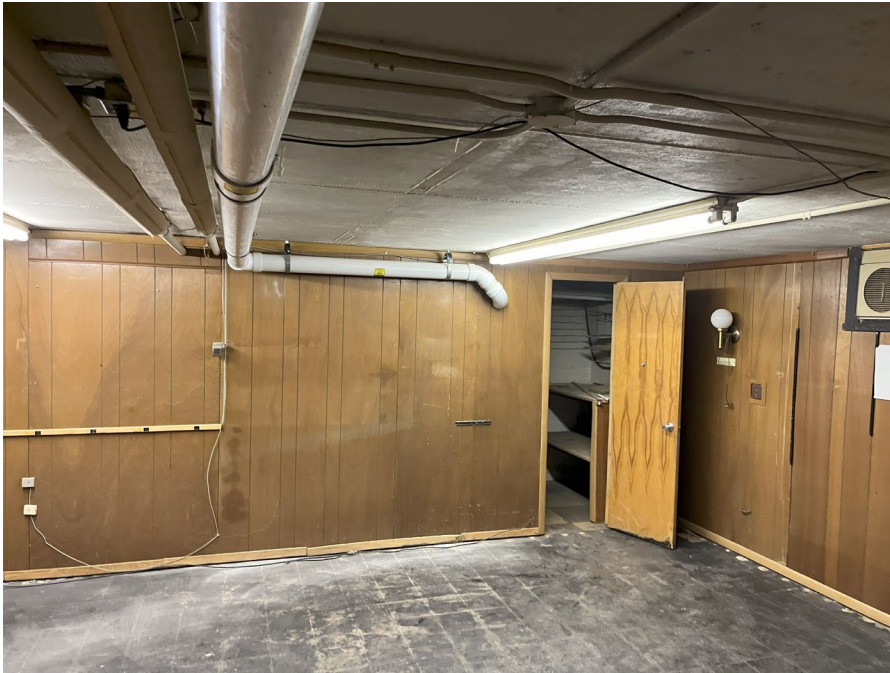
**Photo 5:** Looking east at piping which comes from the moisture drop line inside the closet and runs to Pickup #2.

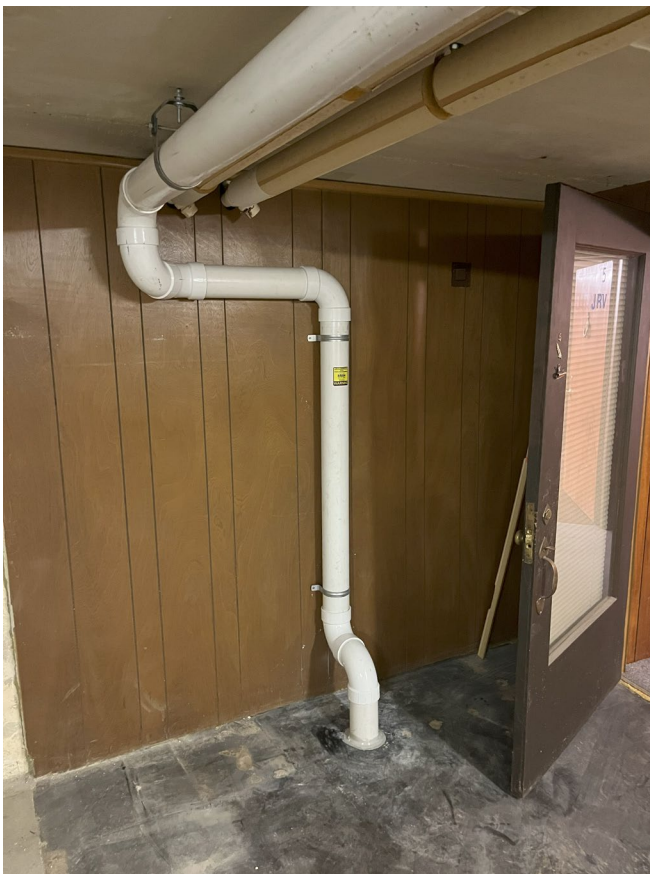
**Photo 6:** Looking northwest at Pickup #2.

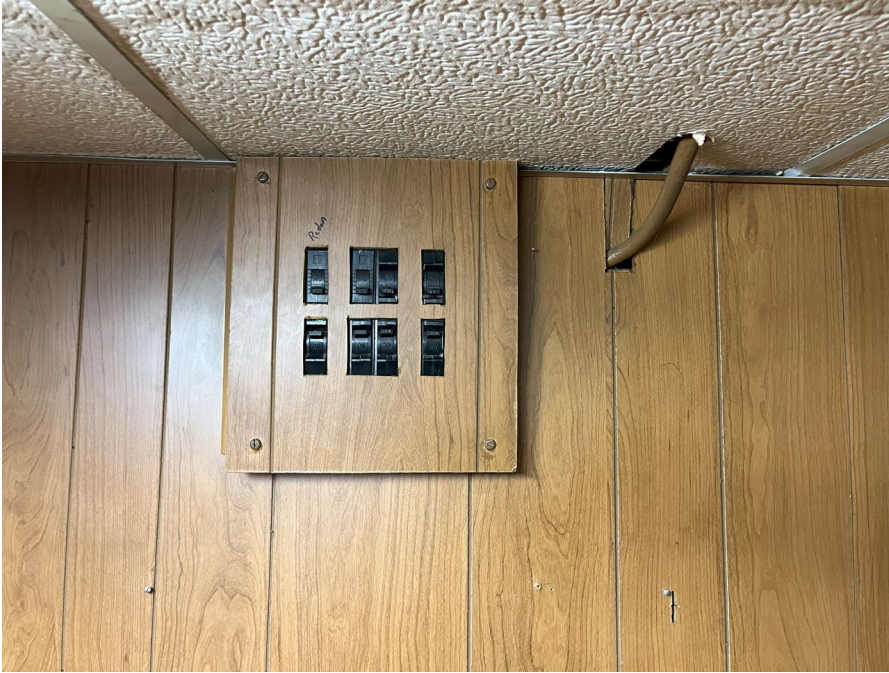
**Photo 7:** Looking north at breaker panel inside office at northwest corner of basement. Breaker at upper left is labeled "Radon" for radon/mitigation fan.

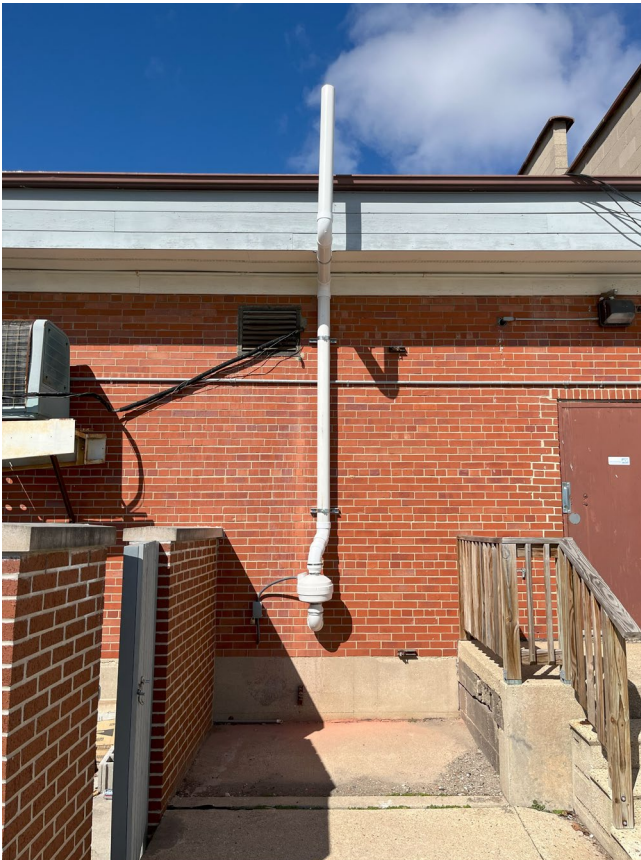
**Photo 8:** Looking north at mitigation system fan and exhaust line on south side of building.

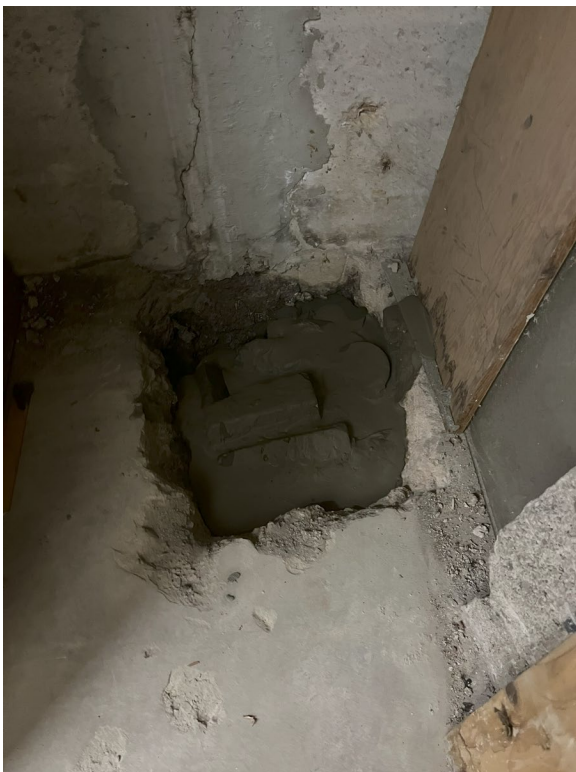
An approximate 50-square-foot opening in the floor at the former location of a heating oil tank was sealed using Drago Wrap vapor barrier and tape. An approximate 1-square-foot opening in the floor at the base of a chimney was sealed with concrete.

Photo 10: Looking south at concrete patch inside chimney at south side of basement.

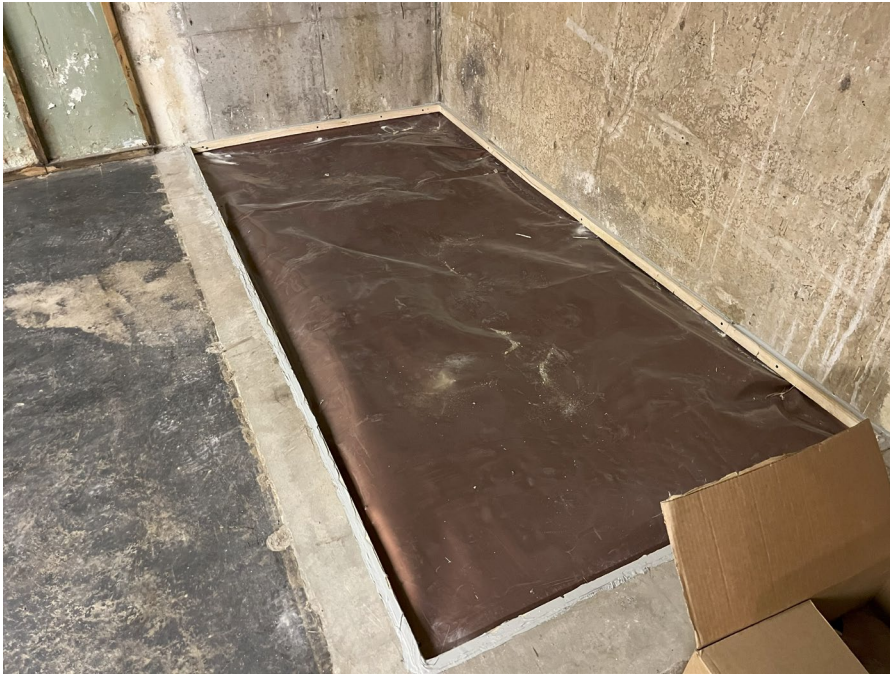
**Photo 11:** Looking southwest at Dregro Wrap vapor barrier covering opening in floor where fuel oil tank sat.

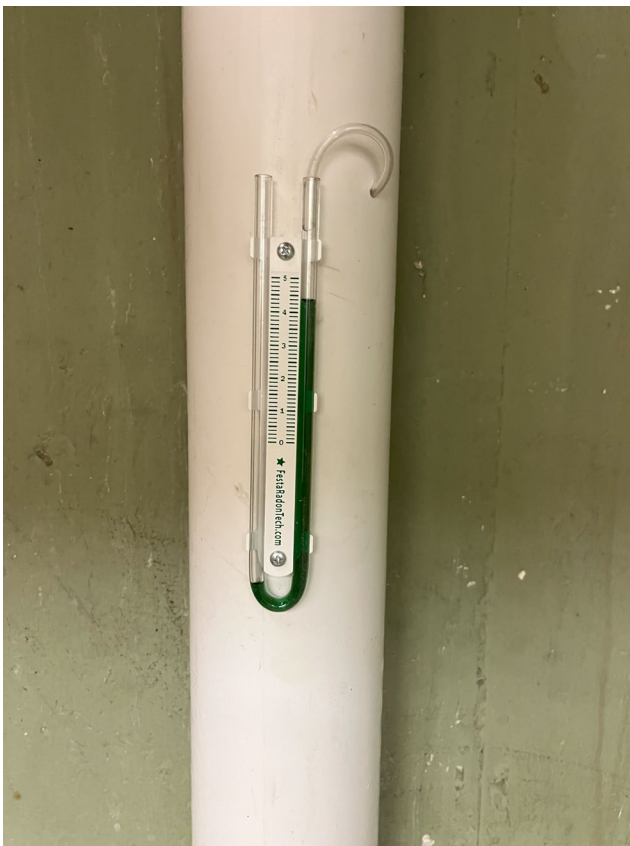
**Photo 12:** Looking south at manometer on Pickup #1.

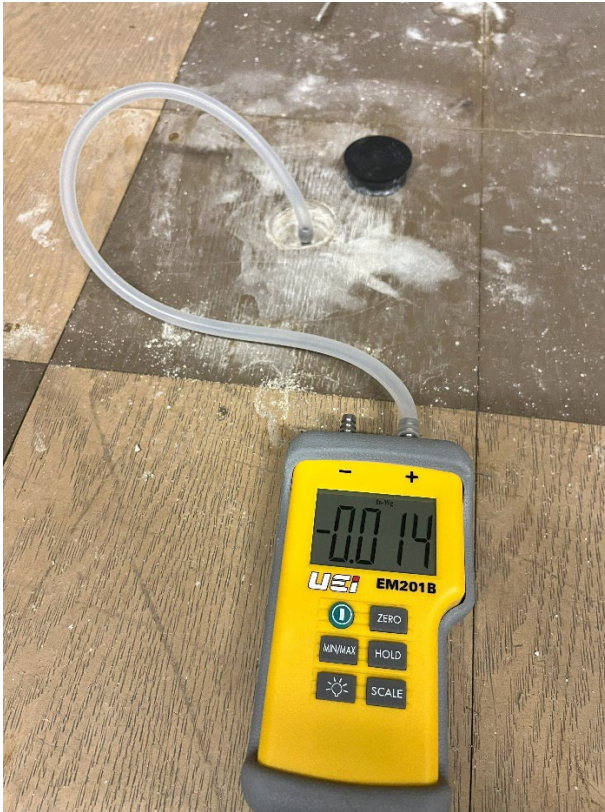
**Photo 13:** Looking at vacuum observation point 5 (1113 North) while measuring background vacuums using digital manometer.
