December 23, 2015

**Re: Site Investigation Report  
Martino's Master Dry Cleaners  
3917 52<sup>nd</sup> Street  
Kenosha, Wisconsin 53144  
BRRTS# 02-30-552186**

**WATER TABLE CONTOUR MAP  
 WITH ALL WELLS MAPPED  
 JUNE 2015  
 Martino's Cleaners  
 3917 52nd Street  
 Kenosha, Wisconsin**

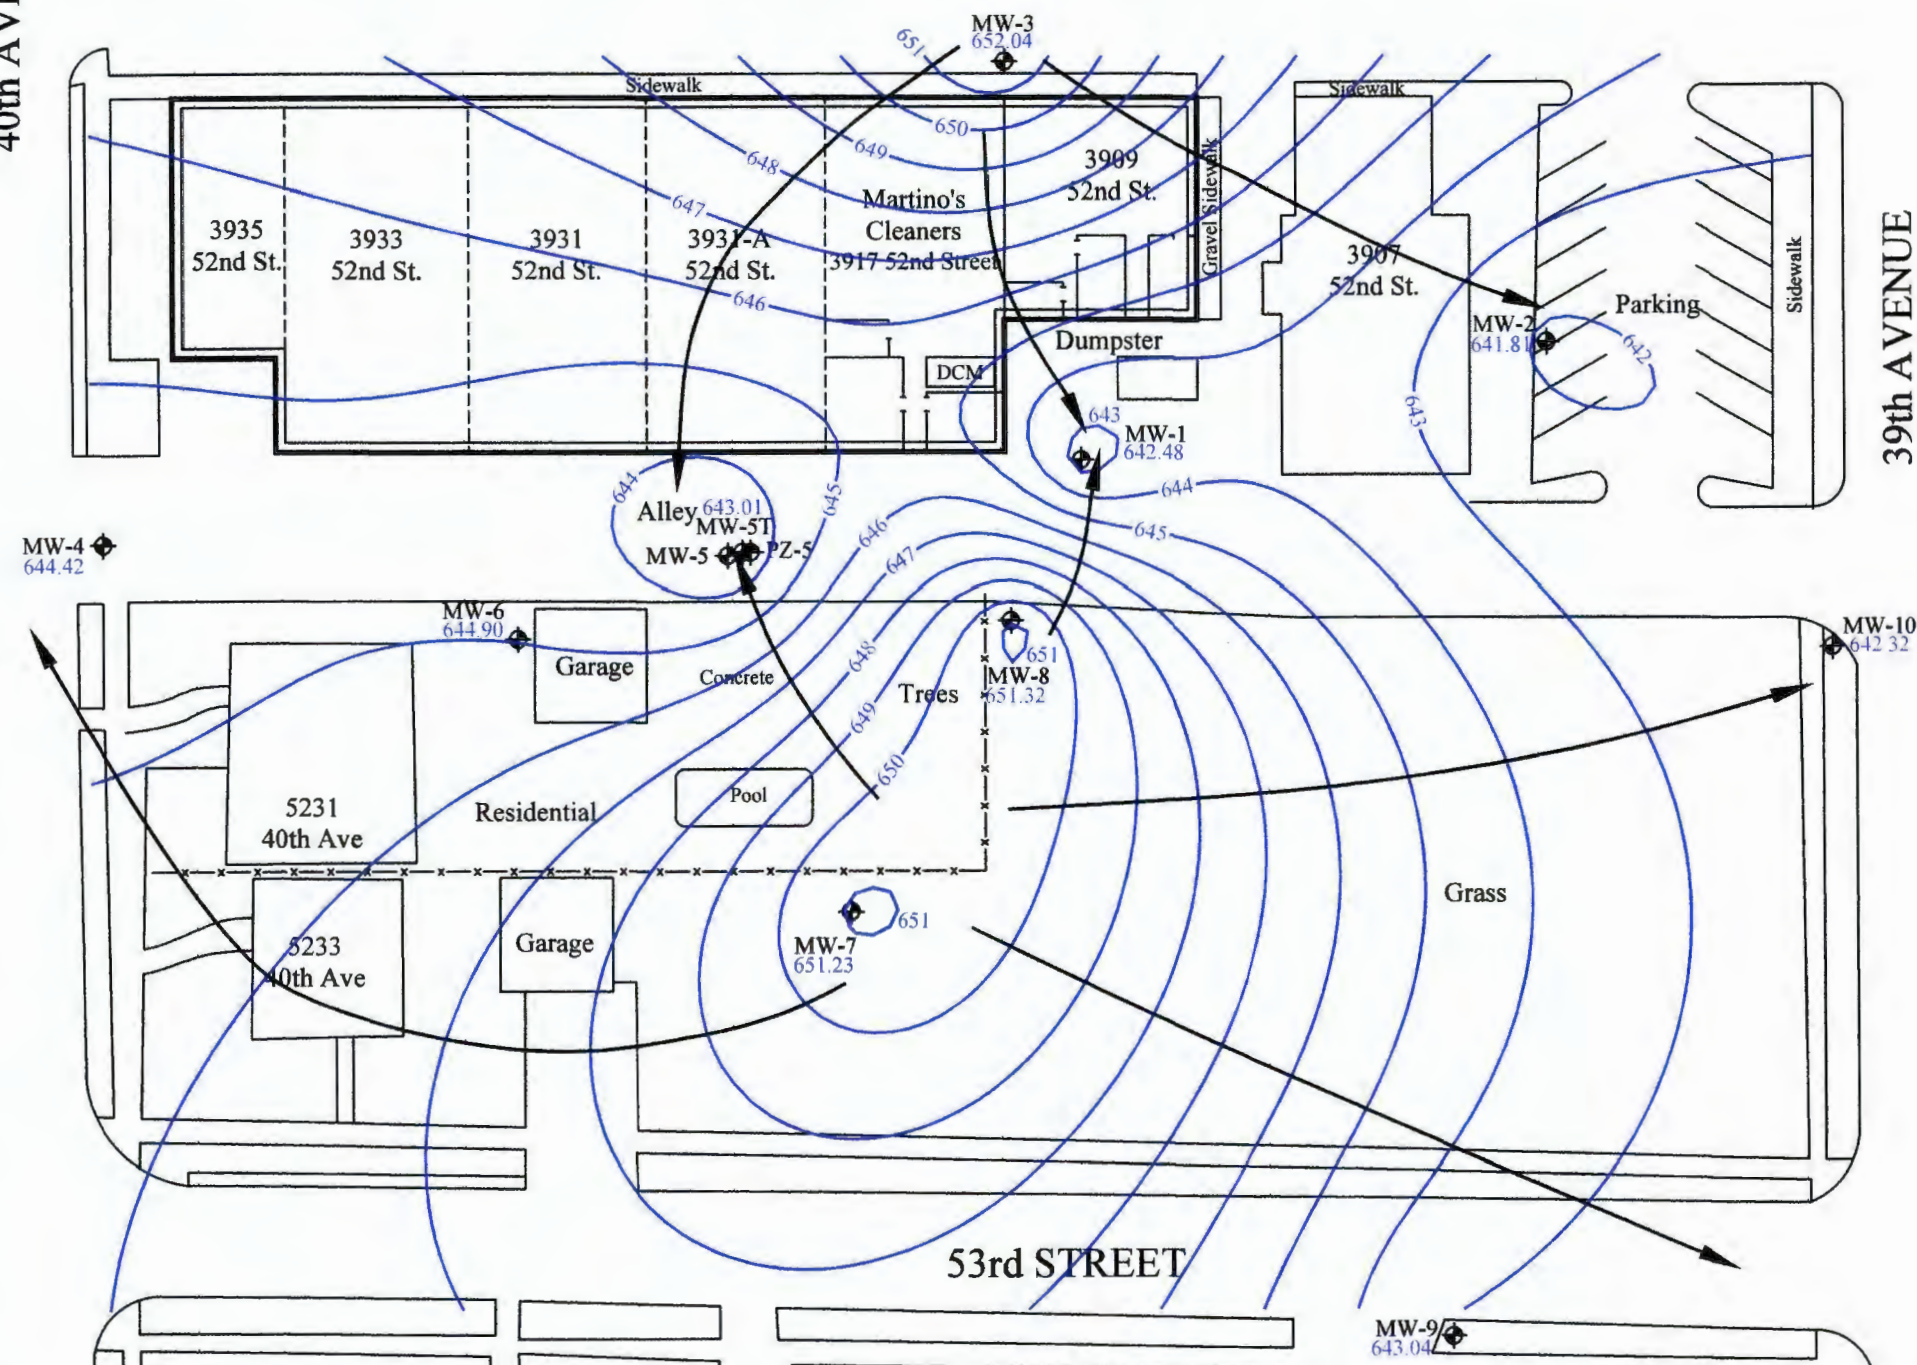
**EnviroForensics Response #5:** Depth to water in most wells has fluctuated between 10 to 15 feet below ground surface seasonally. However, in wells MW-3, MW-7, and MW-8 static groundwater levels are within two feet of ground surface. These non-conforming water levels when mapped with all other wells do not exhibit a continuous groundwater flow field, but instead skew groundwater flow in all directions away from the measured high water levels (see attached Figure 12).

The non-conforming water levels may be due to the geology at this site, which is a complex assemblage of discontinuous layers, lenses, and seams of sand, silt, and clay that are not well sorted. This is soil typically deposited by glacial action. There is also a layer of fill 3-5 feet thick along the alleyway that appears to continue to a lesser thickness under the commercial building. It is not unusual in this type of depositional environment for there to be zones of perched water. It is also not unusual under these conditions for static water levels to yield a potentiometric surface map without definitive or continuous groundwater

flow directions, given that fine clay and silt soils drain slowly and at different rates after precipitation events

EnviroForensics does not feel that further investigations to determine exact hydraulic linkages or mapping of the existing data is practical or needed for remedial planning, and in this type of depositional environment may not even be possible. Groundwater impacts appear to be limited in both depth and lateral extent, and not migrating extensively. We will likely implement actions to treat the higher concentrations in groundwater, along with removal of highly contaminated soil in the source area. Remaining residual groundwater impacts will likely be monitored for natural attenuation.
