## Supplemental Checklist for Vapor Mitigation Continuing Obligations

BRRTS Site Name A -1 Cleaners Activity Number 02-46-552192

System Address(es) 7027 W North Ave, Wauwatosa Current Site Use(s): Dry Cleaner/Offices/Res

CO Audit 8/23/2023

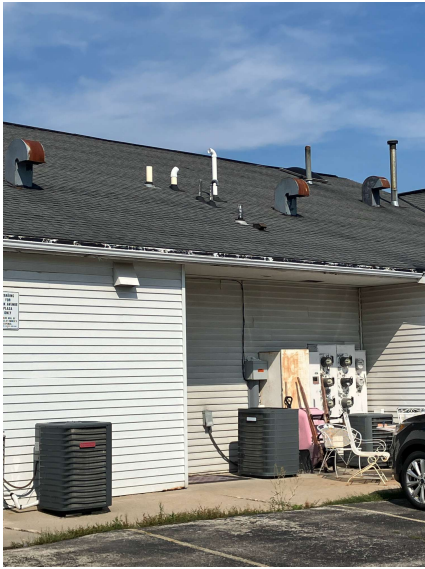
Description: View of rooftop discharge

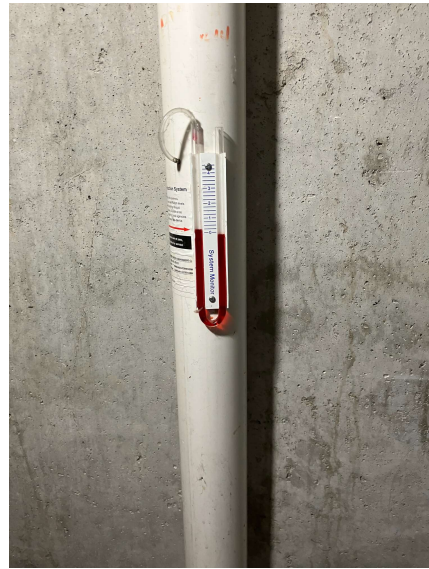
A pressure monitor is present, operating, and is accessible.  Y  N (active systems only, e.g., U-Tube manometer, cylinder, or gauge.) Pressure Reading: 0.2 inch h2o

Description: U-tube

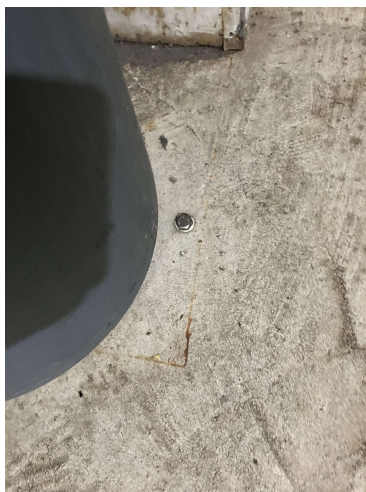
Description: Floor monitoring point

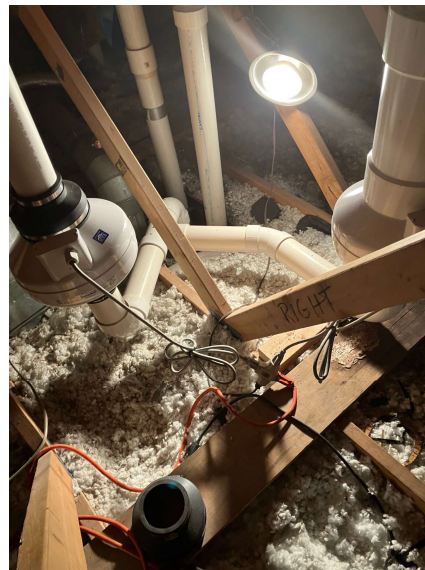
Both fans replace in August 2023. No documentation previously provided. fans recommended to be hard wired to dedicated circuit. No maintenance logs or O&M info present.

Description: Fans and power cords

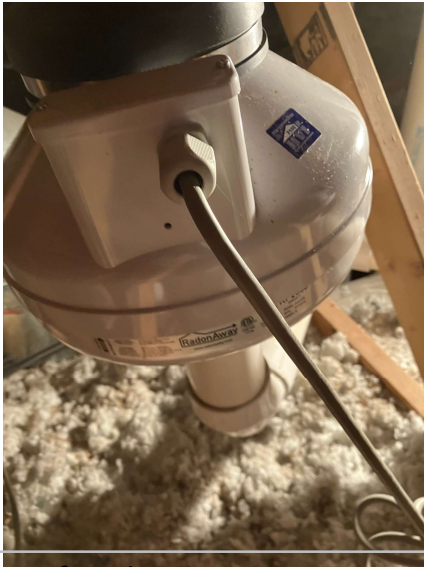
Description: fan close up

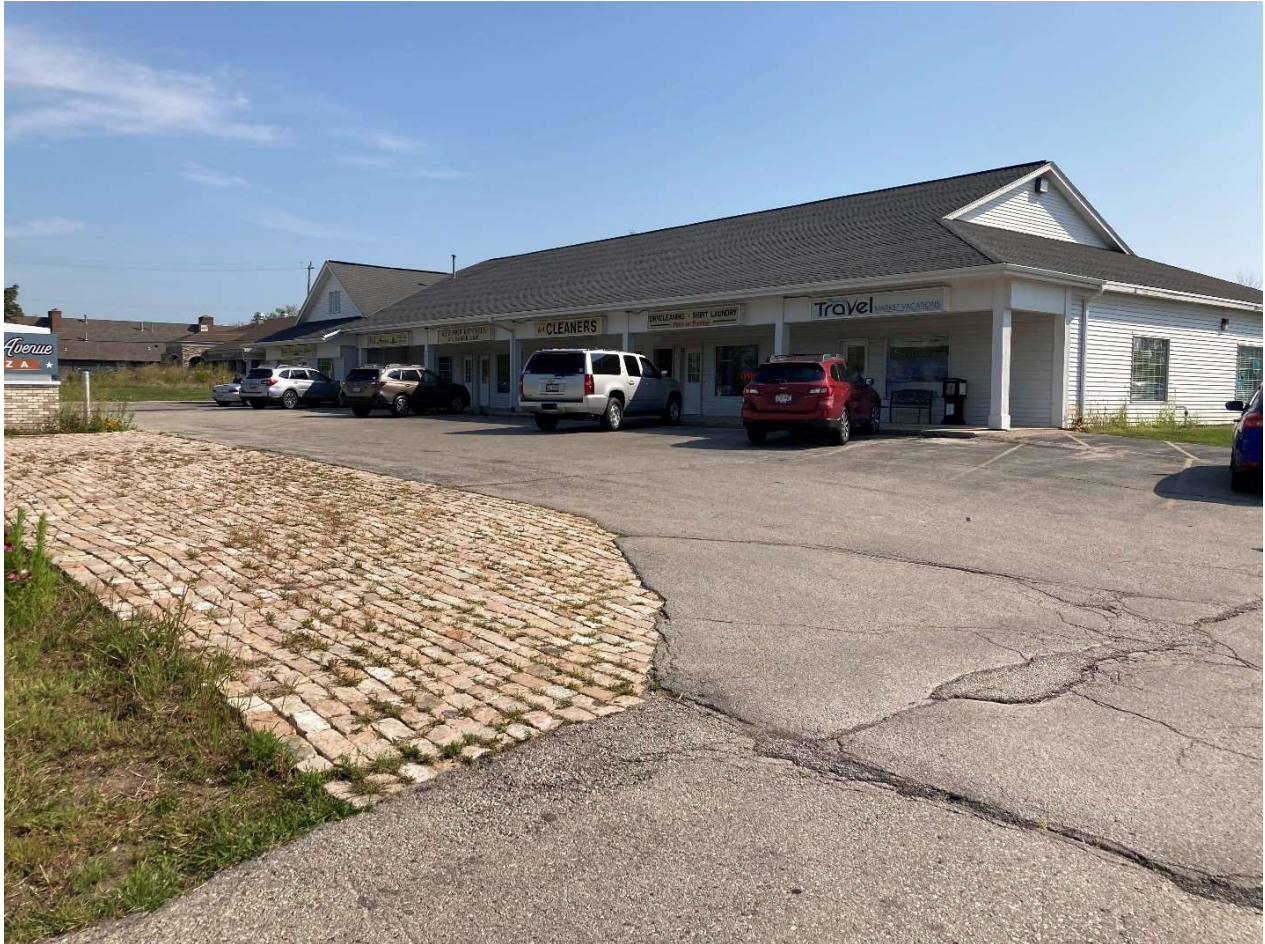
Existing Building and Pavement Cap – Front of Building

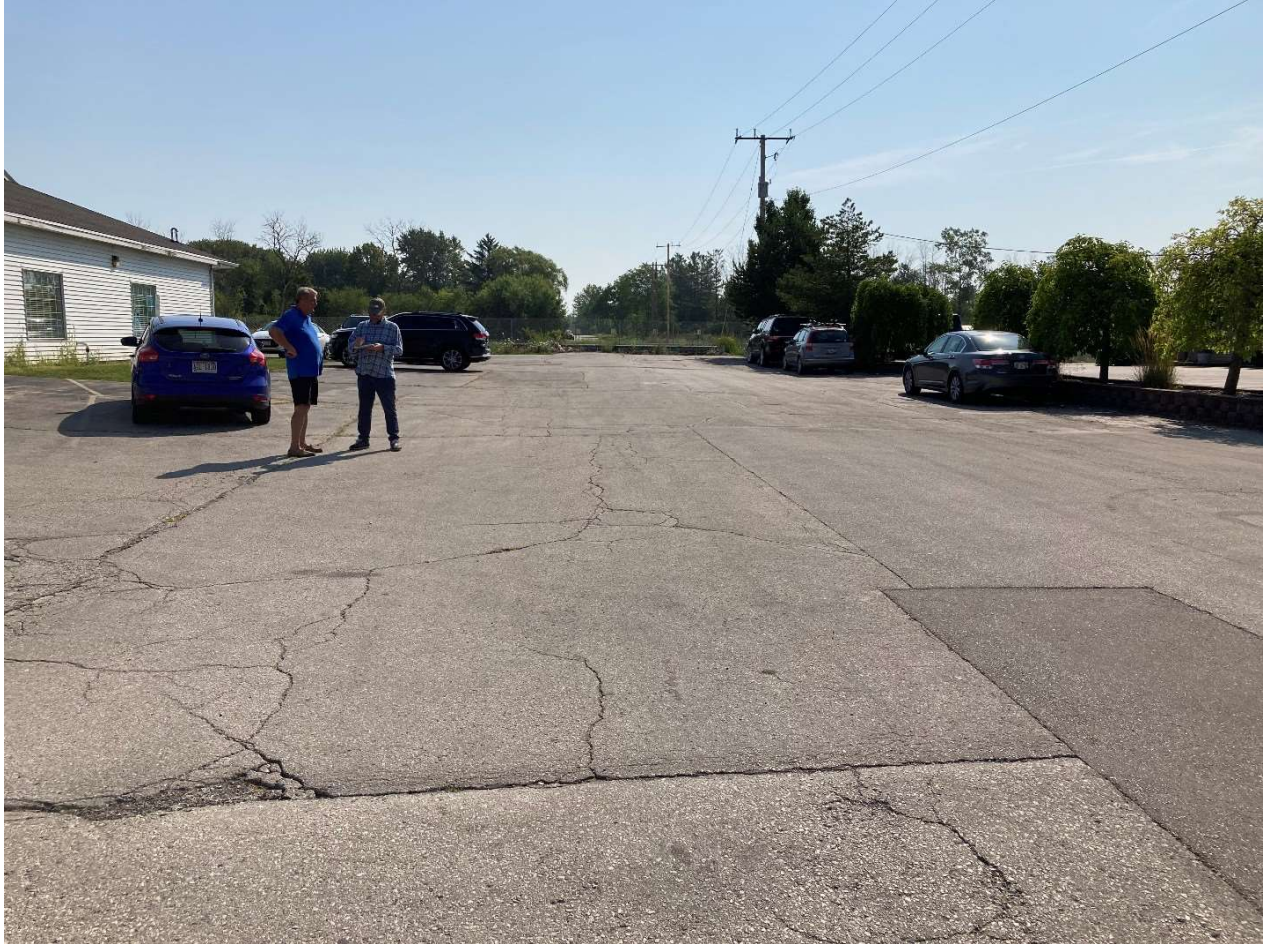
South side of property – Existing building and pavement cap

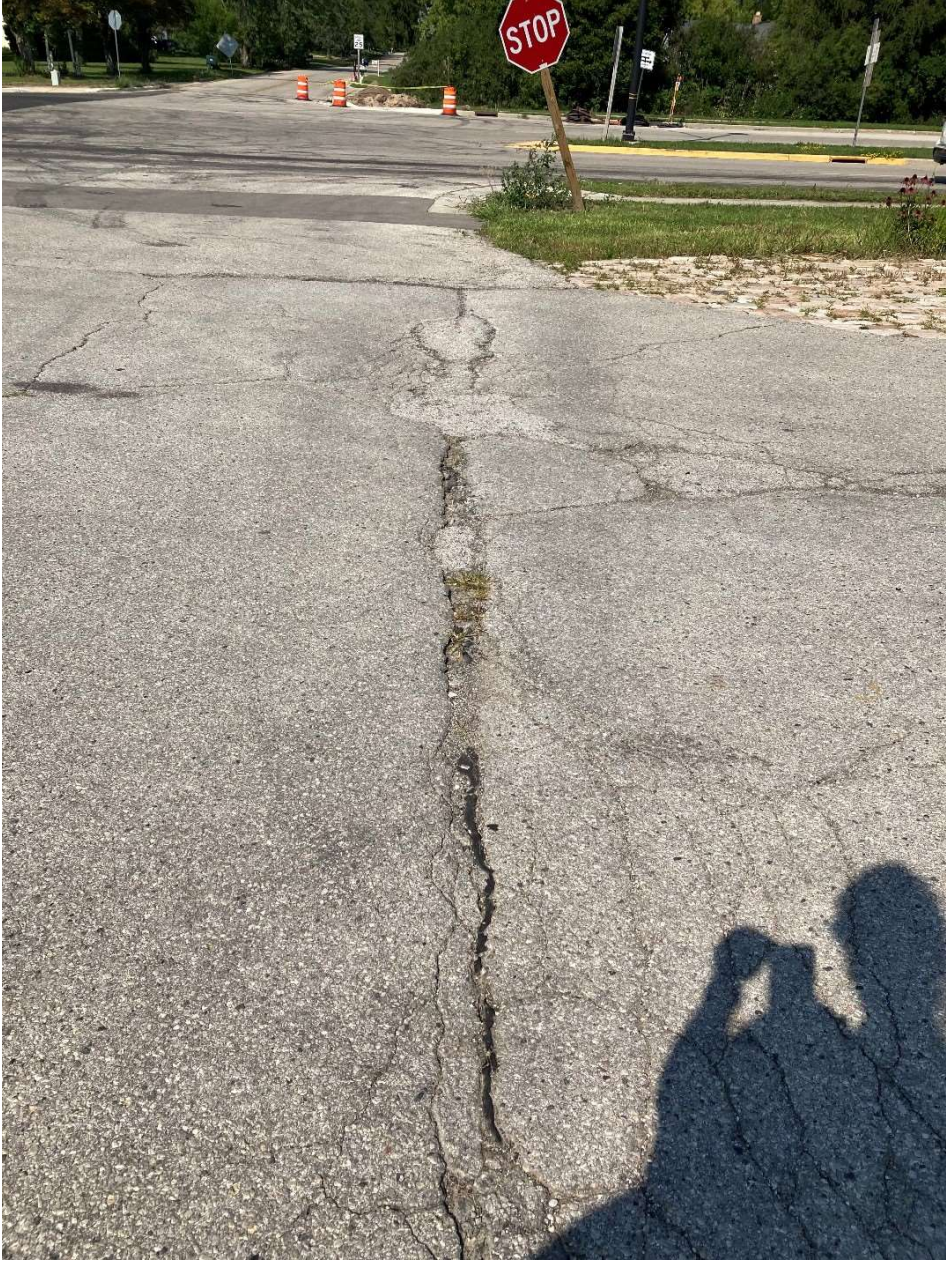
Entrance to property off N. Port Washington Road – Crack in asphalt pavement

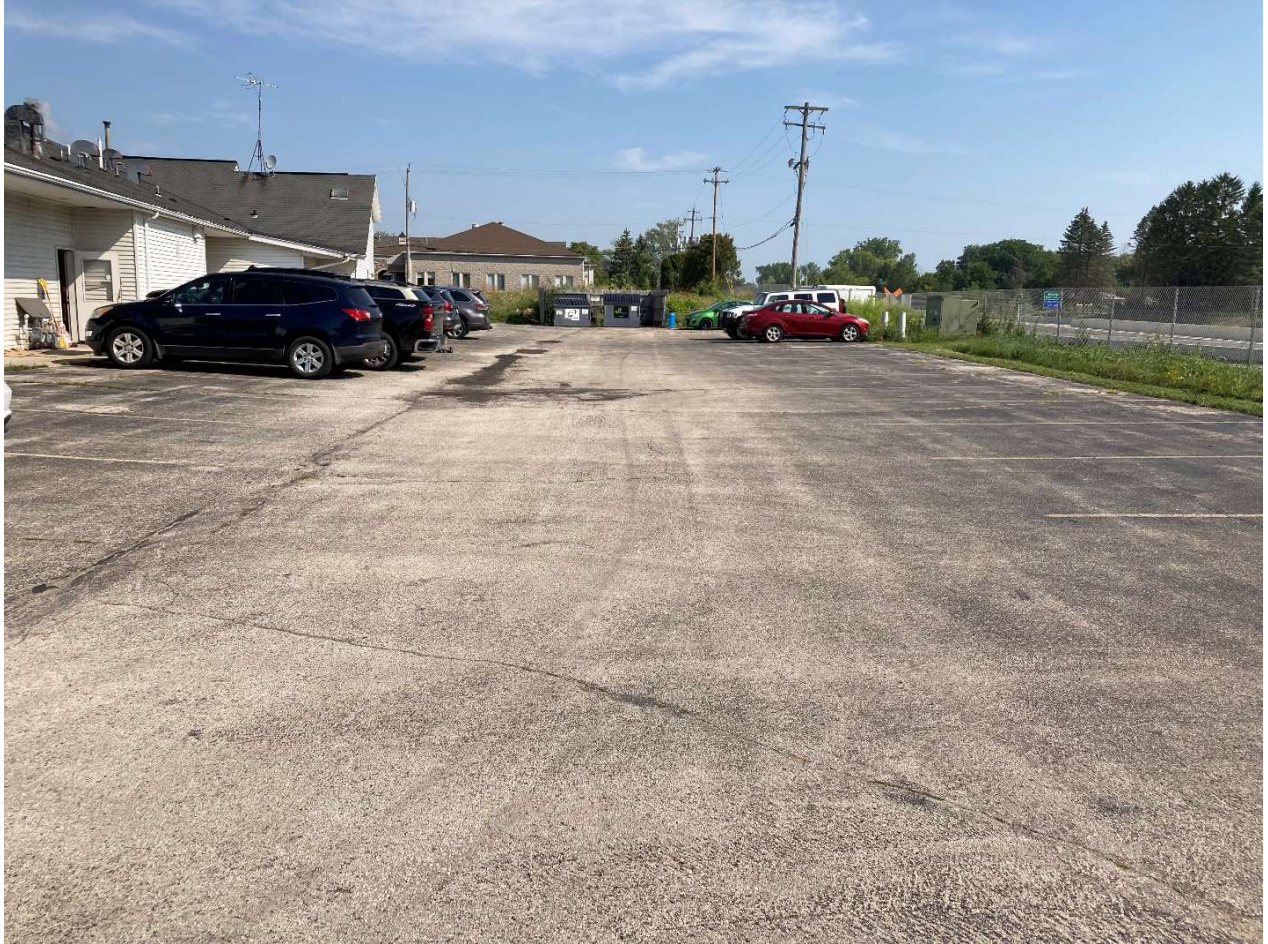
Existing building and pavement cap – East side, Rear of building

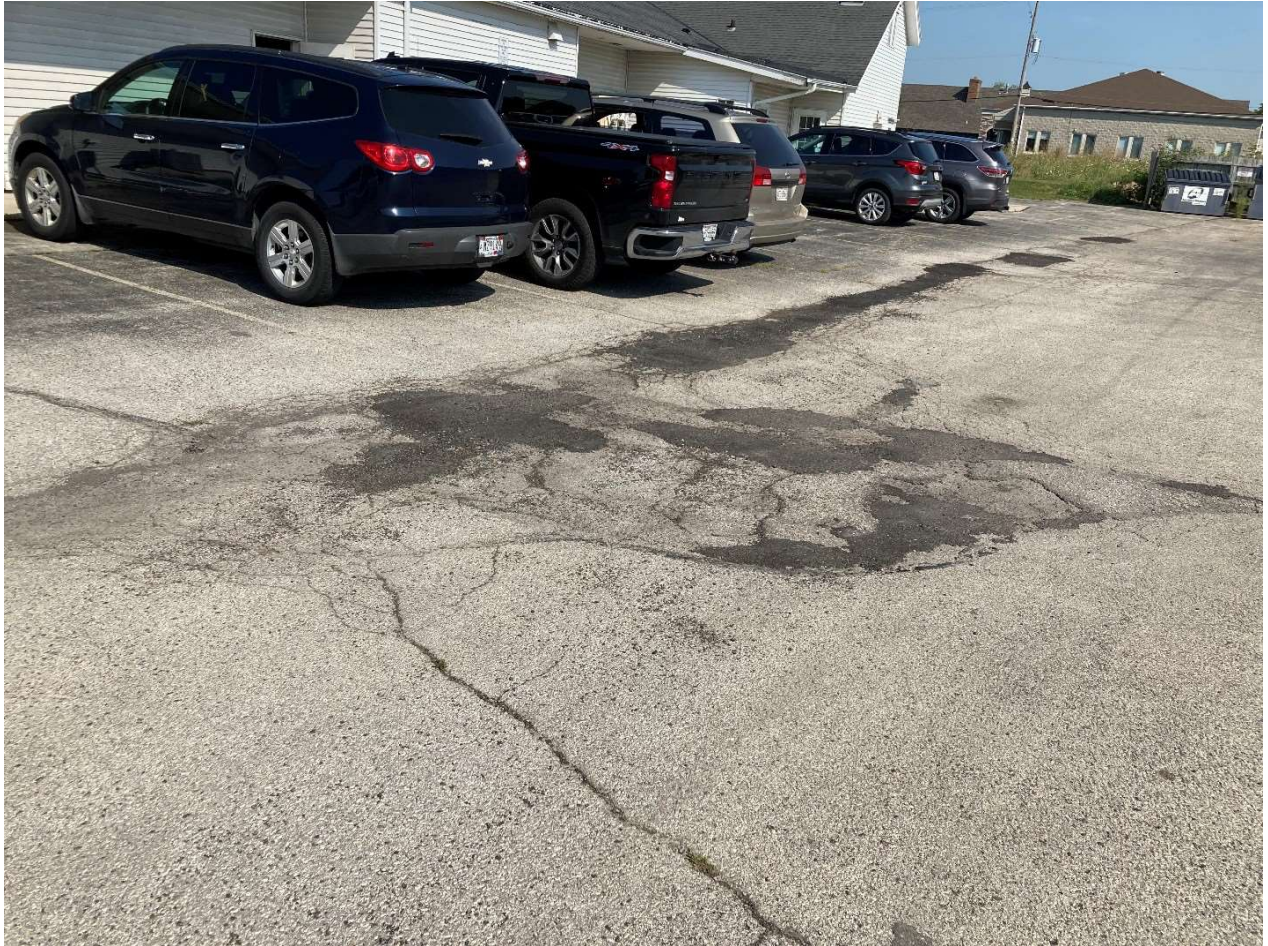
Rear (east) pavement cap – Patch work

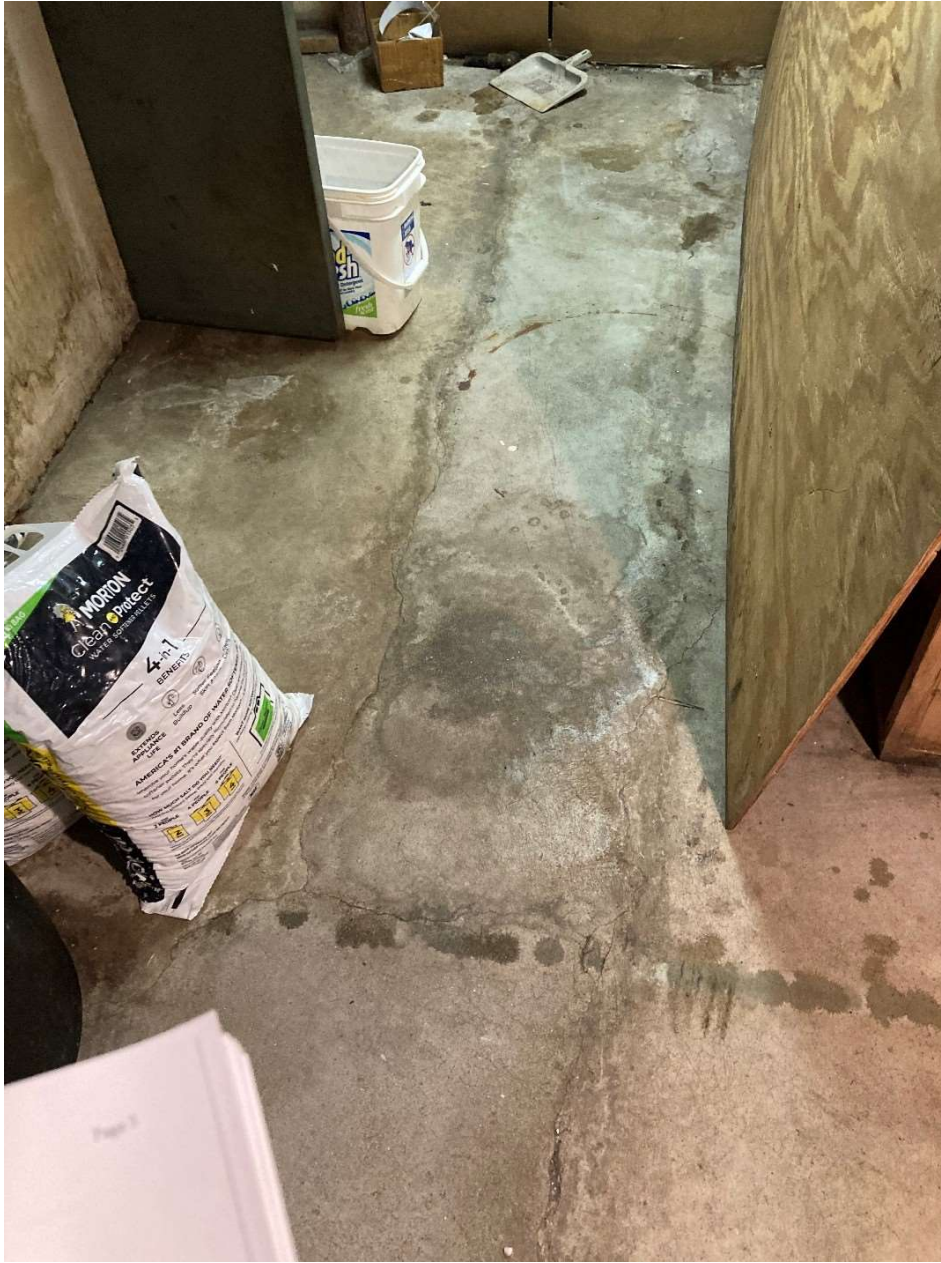
Basement Floor – Slight cracking

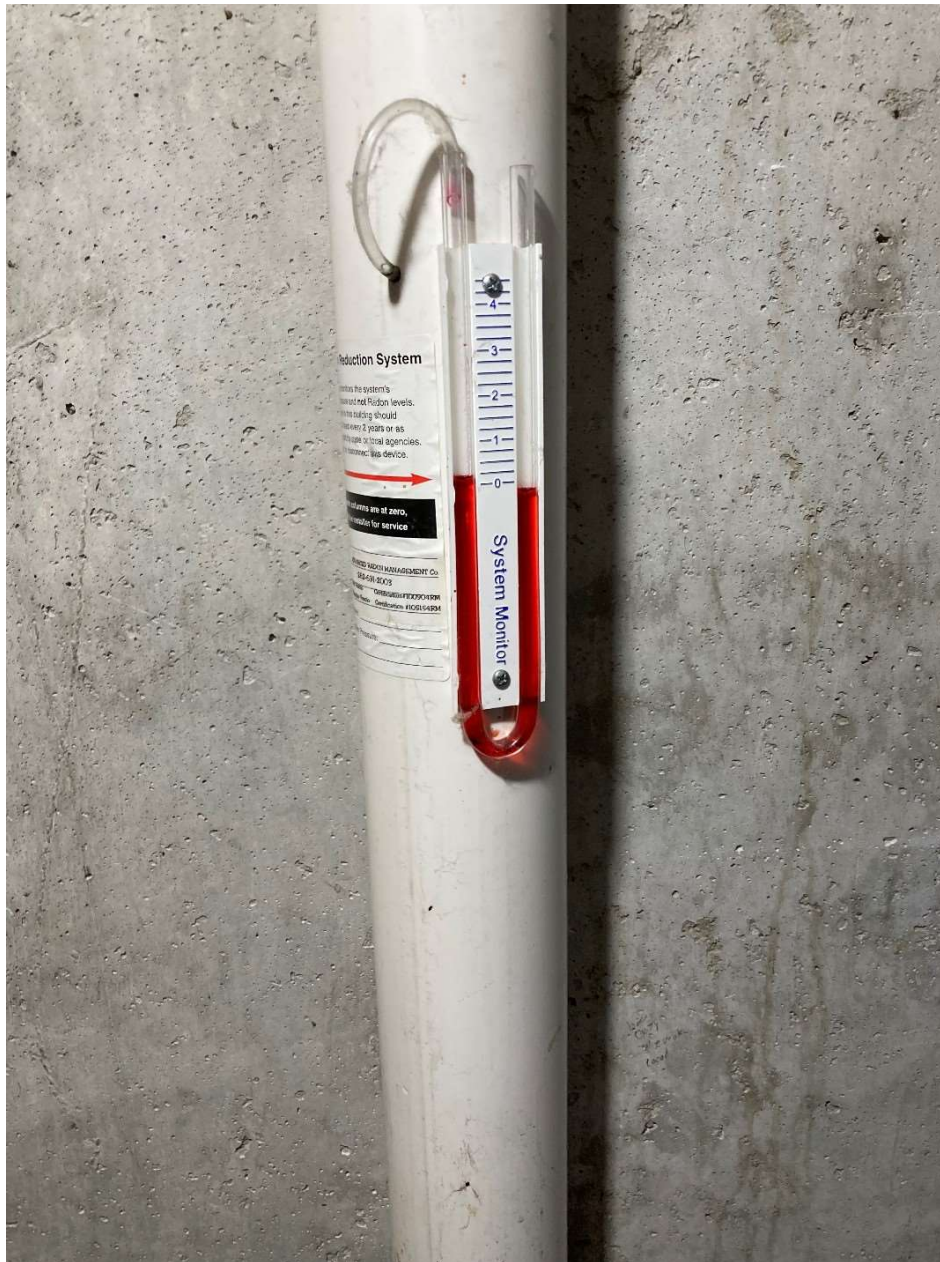
U-Tube Liquid Manometer located in building basement

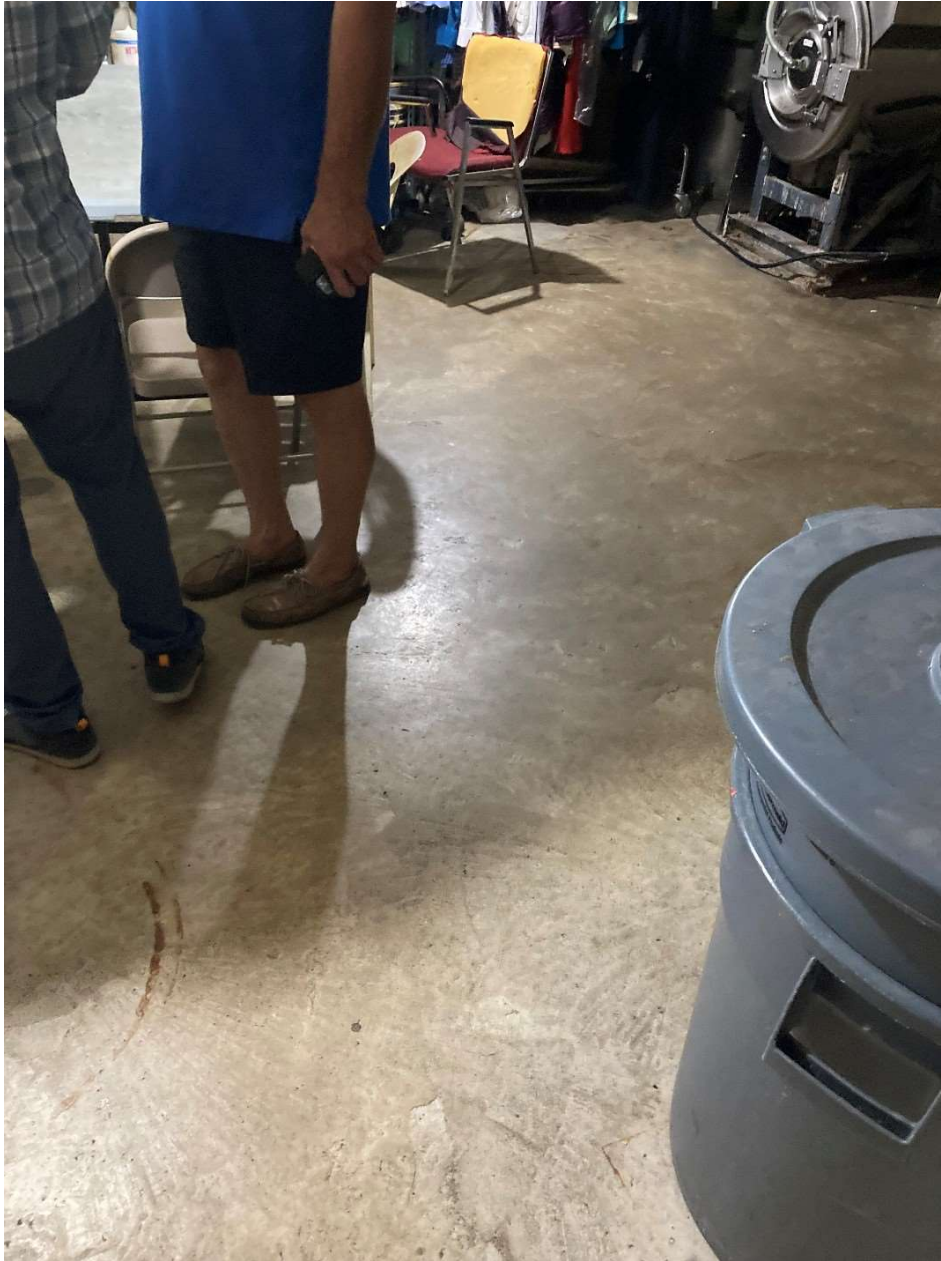
Basement flooring
