Subject: Response to WDNR Correspondence dated August 11, 2022  
One Hour Martinizing (Former)  
301 Main St., Racine, Wisconsin 53403  
BRRTS No. 02-52-552198 / FID No. 252010990  
Project No. 1E-2109011

**Attachment 1**  
**RP Map and Photos**

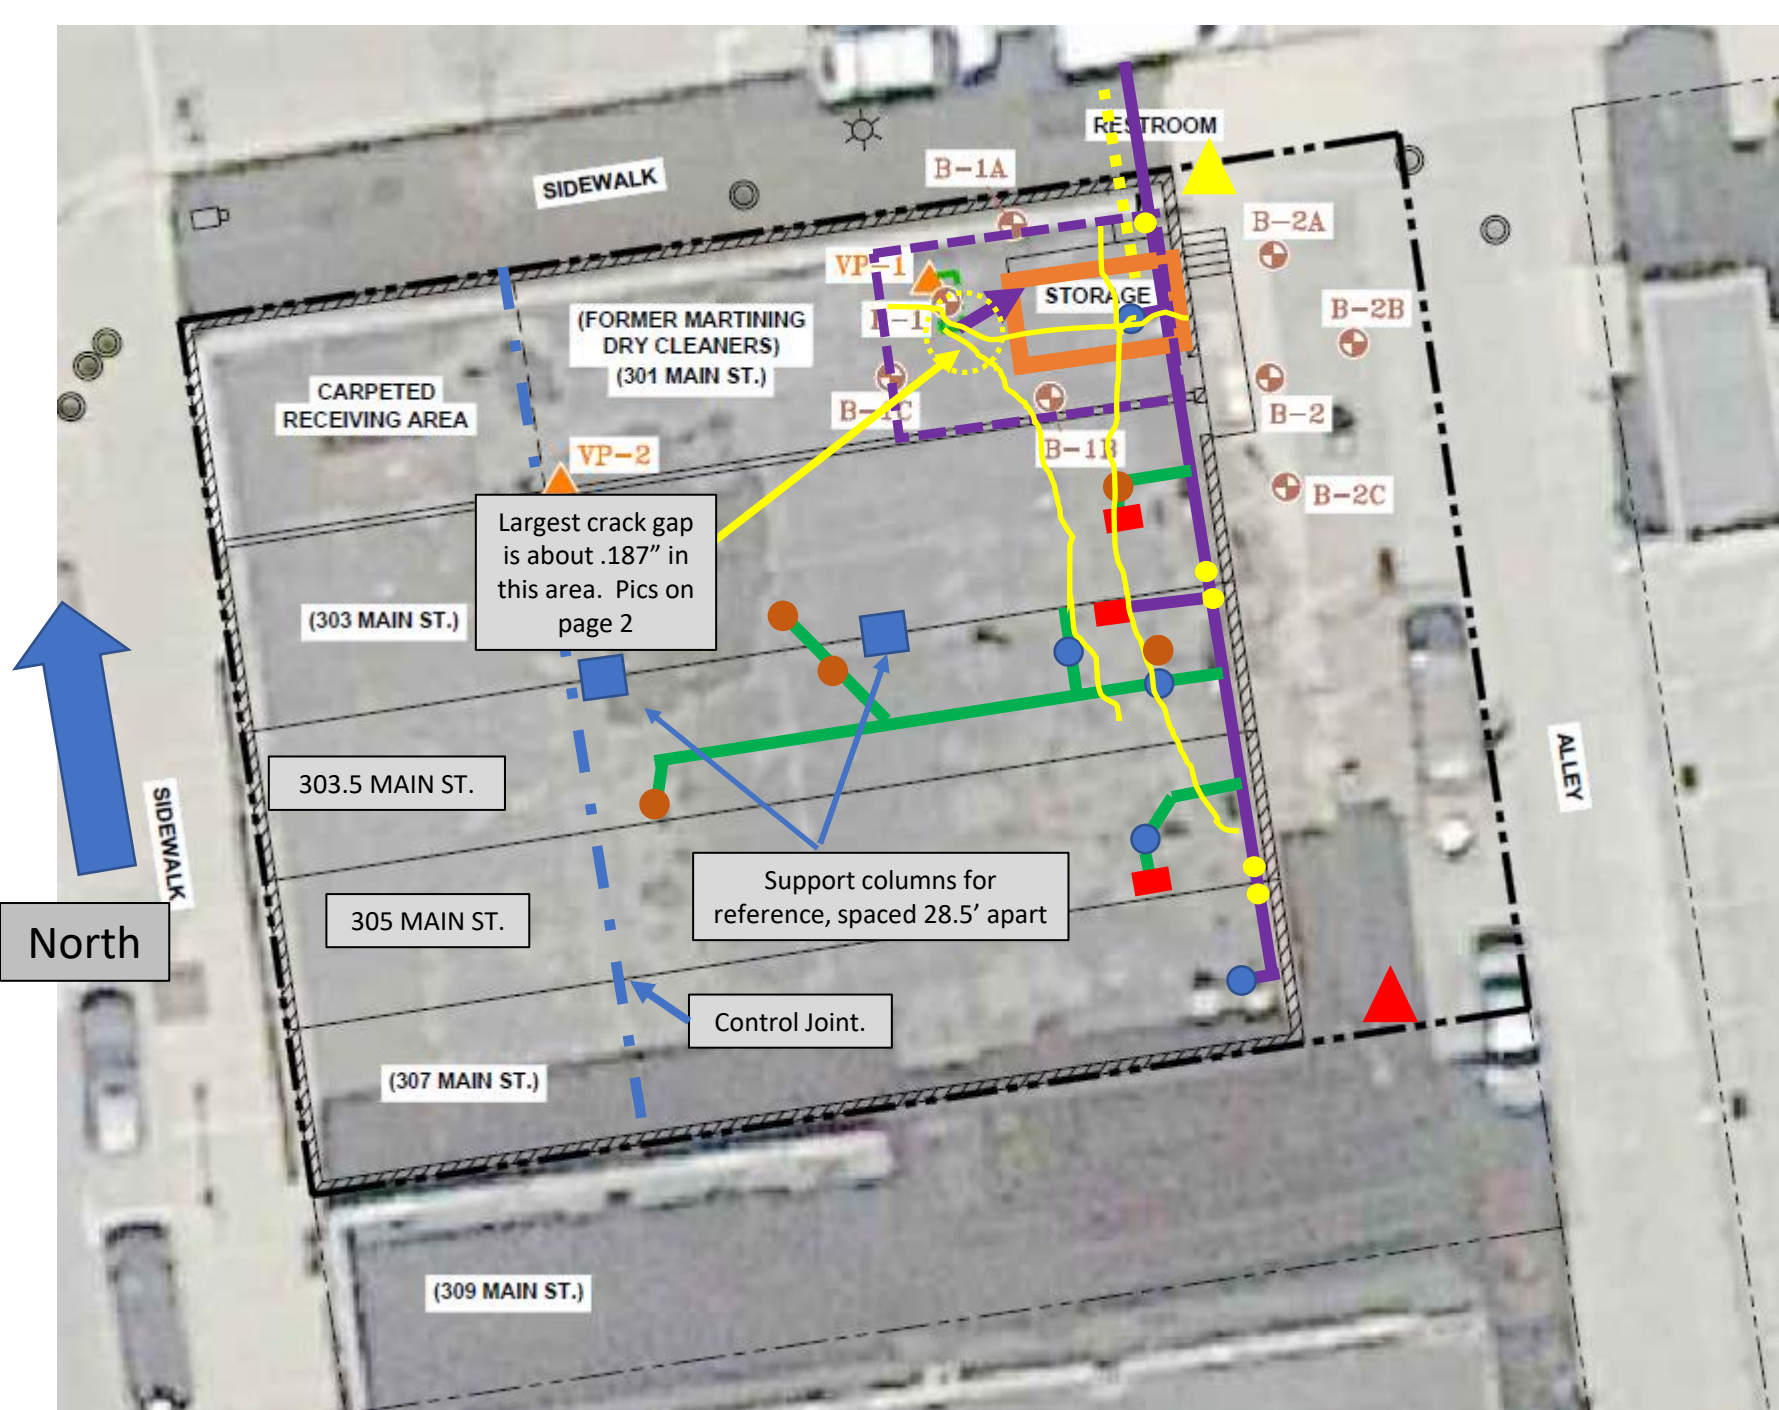
- Purple line cast iron sewer
- Green line PVC sewer
- Yellow circle toilets
- Blue circles floor drains
- Orange Circles clean outs
- Red Square Utility Sinks that connect to underground
- Yellow lines are cracks in the slabs.
- All water, gas and electric line are above the slab except for the main water into the building, shown in yellow dotted line, comes off 3rd street into the 301 Main storage room, orange rectangle
- Gas line runs outside of the building then into it 301 Storage area, northeast corner, yellow triangle.
- Electrical lines are pole fed from above on the southeast corner of the building, red triangle.
- The slab area highlighted in the purple dash rectangle has slope towards the northeast corner of the building, purple arrow.

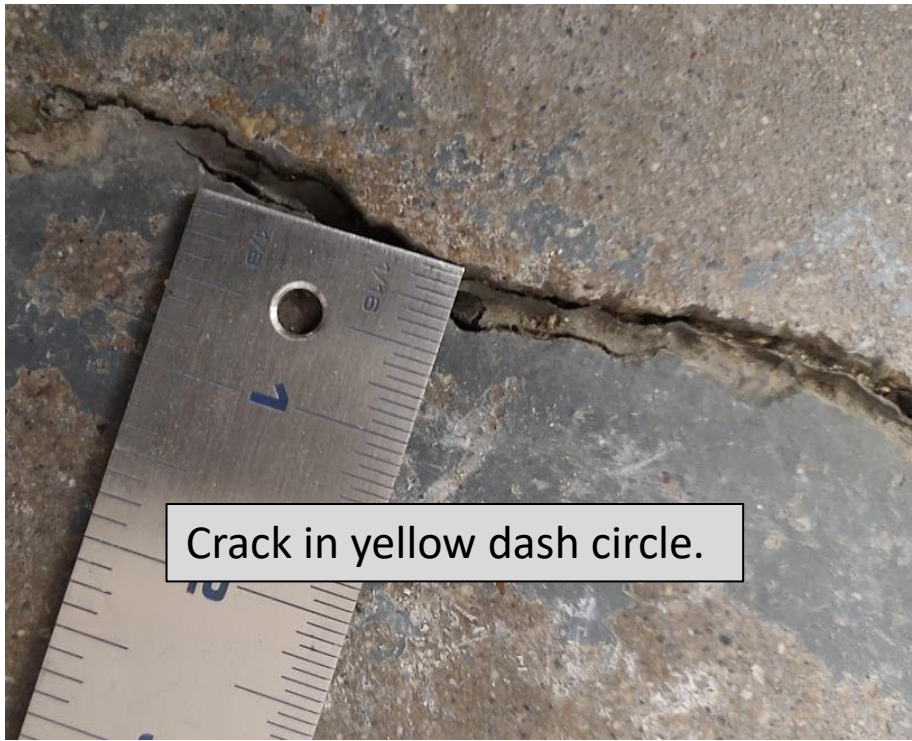
Crack in yellow dash circle.

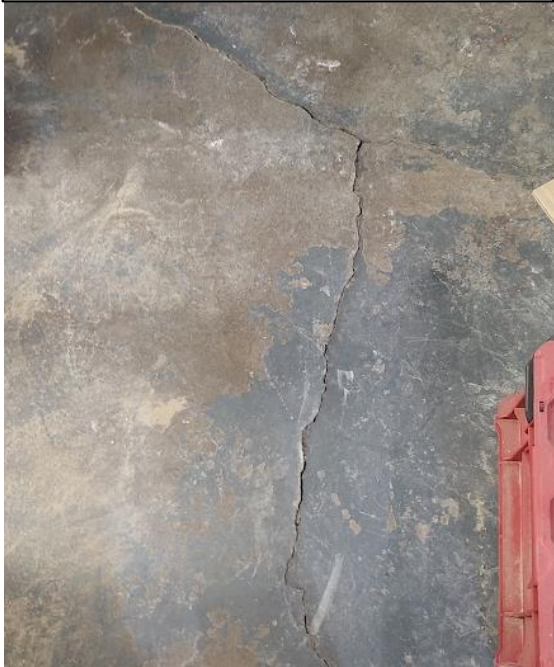
Crack in purple rectangle area.

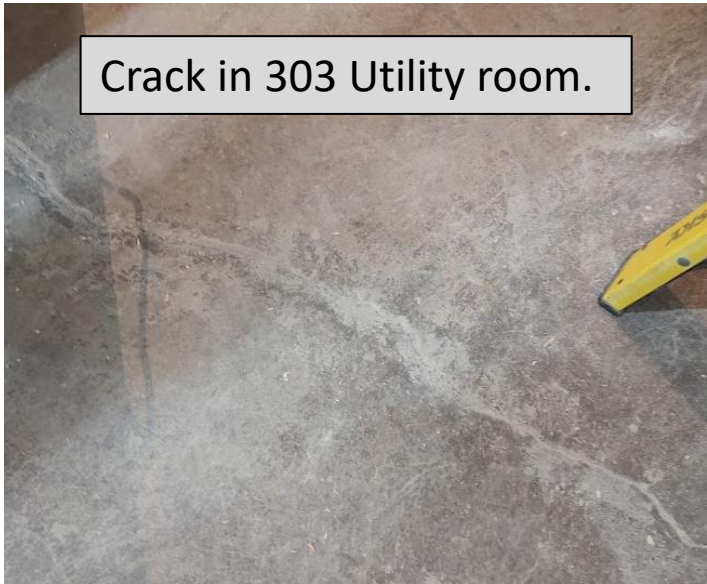
Crack in 303 Utility room.

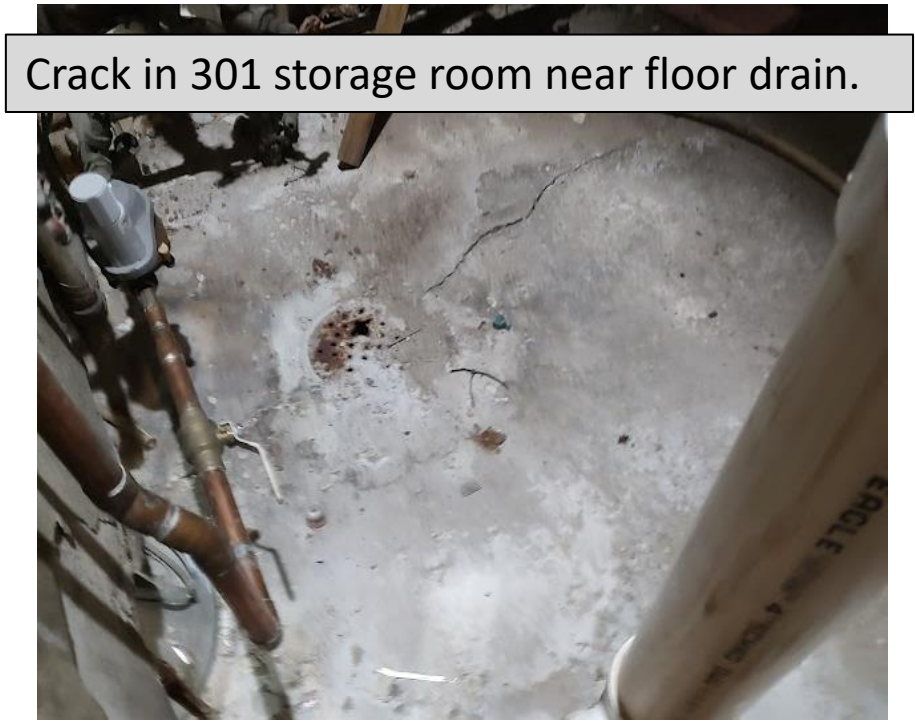
Crack in 301 storage room near floor drain.

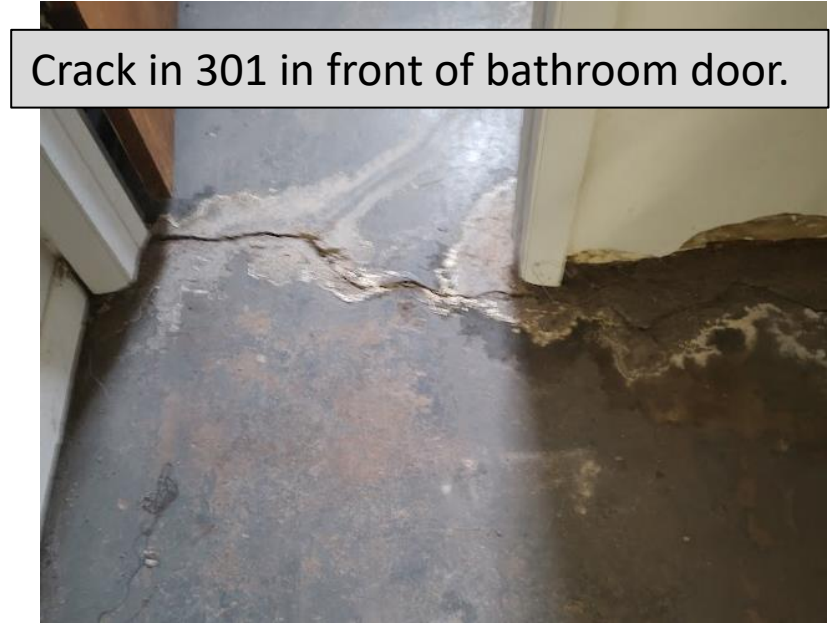
Crack in 301 in front of bathroom door.

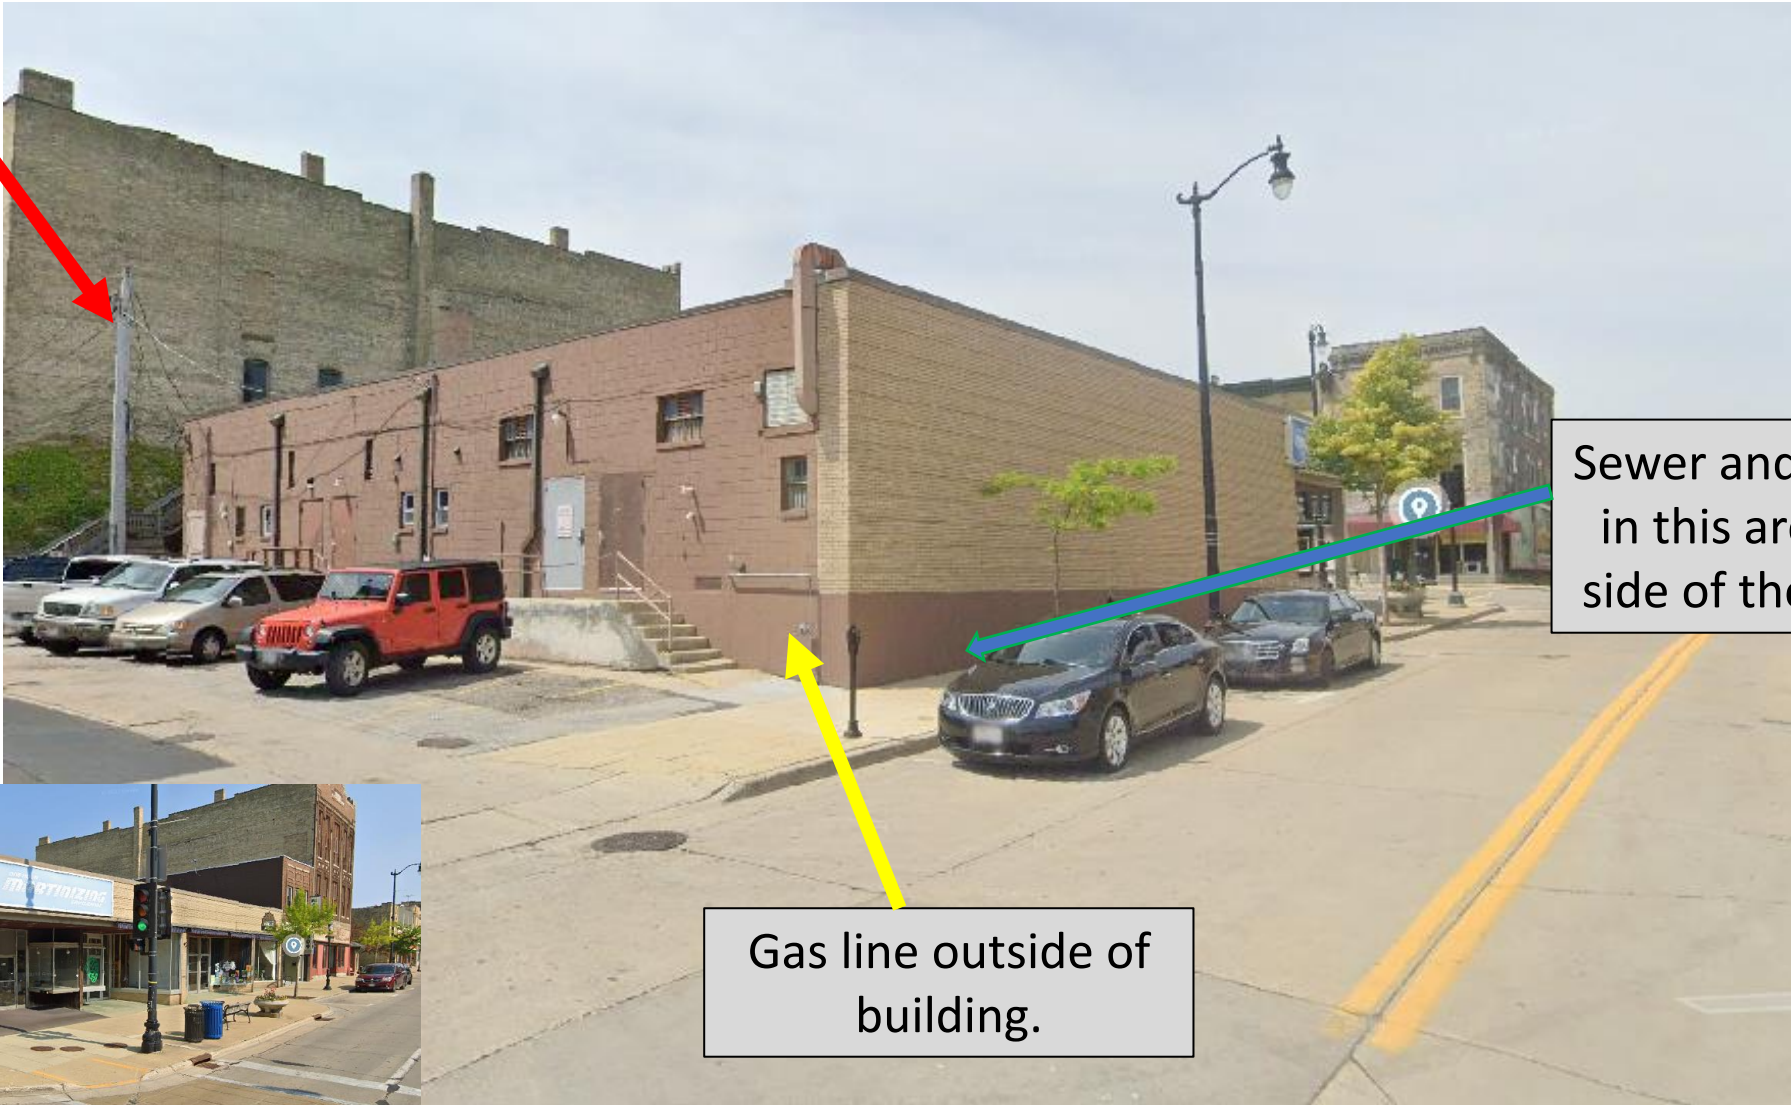
Backside of building sits about 4' above grade. Front is at grade.

Electrical from above into building.

Sewer and water are in this area on the side of the building.
