August 24, 2023
File No. 25222269.02

Subject: Inspection of Vapor Mitigation System
Sandie's Dry Cleaner & Laundry (Former) – BRRTS #02-45-55222
Off Site Residential Property – 135 W. Lincoln Ave

VAPOR MITIGATION SYSTEM INSPECTION

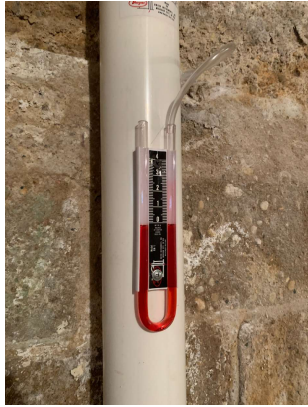
SCS visually inspected and photographed the VMS, including the VMS fan, piping, manometer, pickup point seals, exhaust, and building floor. Upon arrival, the manometer on the original pickup point piping indicated no vacuum. The fan did not appear to be running, and the circuit breaker labeled "Radon Fan" was observed to be flipped in the electrical box. After the breaker was flipped three times, the fan restarted and a vacuum of approximately 2.5 inches of water was observed at the manometer. With the exception of the electrical issue with the fan, the other visible VMS components appeared to be in working order with no damage or obstructions noted. The floor appeared to be in good condition with no significant cracks or damage noted. SCS is not aware of

<input type="checkbox"/> Not Applicable Manometer on Original Pickup Point as found upon arrival. No vacuum was observed. The fan did not appear to be running and the circuit breaker labeled "Radon Fan" was tripped in the electrical box.

- The existing fan should be replaced since it has shown signs of failure. The fan was installed in October 2013 and is likely near the end of its functional life. SCS recommends using the same fan model, or one with similar performance specifications.
- An alarm should be installed to warn about potential future shutdowns of the fan. After installation of a new fan, SCS recommends collection of sub-slab vacuum readings across the basement to confirm adequate depressurization of the sub-slab.
- Label pickup points and add contact information for SCS Engineers in the event of a system shutdown.
- The sump should be inspected visually and checked for potential leaks during the recommended repair activities.

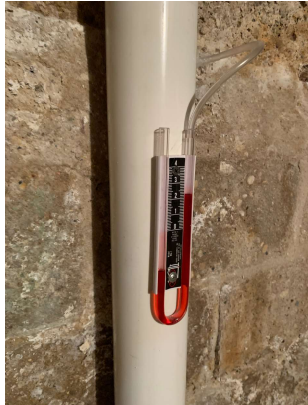
<p>NOTES: (Record the reading on the gauge. Identify specific building and location description:)</p> <p><input type="checkbox"/> Not Applicable</p> <p>Manometer on Original Pickup Point after breaker was flipped three times. The fan re-started, and vacuum of approximately 2.5 inches of water was observed at the manometer.</p>

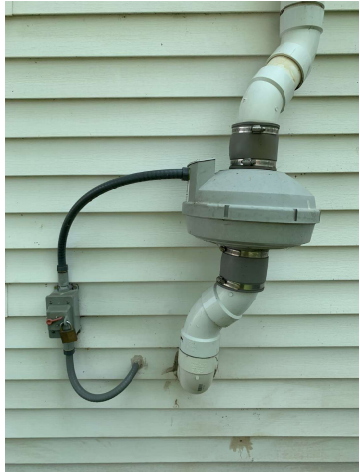
<p>NOTES: (Identify specific building and location description:)</p> <p><input type="checkbox"/> Not Applicable</p> <p>Fan was not running upon arrival, but re-started after flipping the "Radon Fan" circuit breaker three times. The fan motor was quiet and not noticeably loud once running. The fan was installed in October 2013, and is potentially failing, as evidenced by the fan not running upon arrival.</p>
---	---

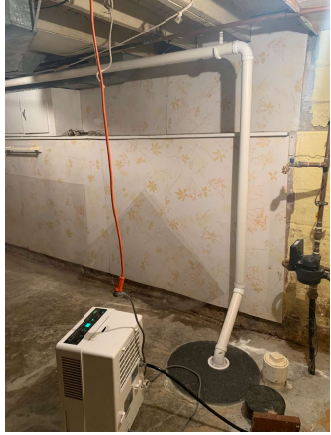
SYSTEM COMPONENT		Date of Inspection: 05/23/2023		
NAME	WHAT DOES IT DO?	WHAT DO I CHECK?	WHAT SHOULD I SEE?	WHAT TO FIX?
Suction Drop Point w/ Vent Pipe	<p>Suction Point : Soil gases are collected in a void space below the foundation, and tight seal prevents soil gas from getting inside the home.</p> <p>Vent Pipe: Pipe conveys the vacuum from the fan, and collects soil gases for discharge to the atmosphere.</p>	<p>Suction Point Seal</p> <p>Vent Pipe Condition</p>	<p>Seal is air tight around pipe penetration.</p> <p>Vent pipe is connected to fan, has not cracked.</p>	<p>Suction point seal or vent pipe may need to be sealed or replaced if cracks or leaks appear.</p> <p>If any piping or sealing of the system is altered or replaced, the system should be evaluated by a mitigation professional to verify effectiveness, which includes pressure readings.</p>
PHOTO		<p>NOTES: (Identify specific building and location description:)</p> <p><input type="checkbox"/> Not Applicable</p> <p>Pickup Point B. Vent piping is secure, no damage to piping observed. Used smoke pen to test pickup point floor seal one fan was re-started and found no leakage.</p>

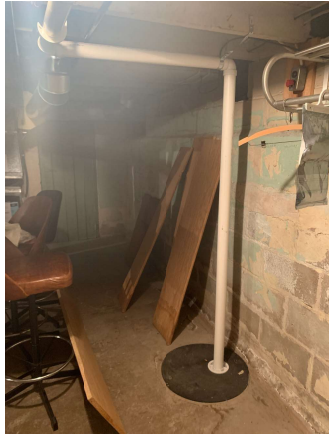
<p>Pickup Point A. Vent piping is secure, no damage to piping observed. Used smoke pen to test pickup point floor seal once fan was re-started and found no leakage.</p>

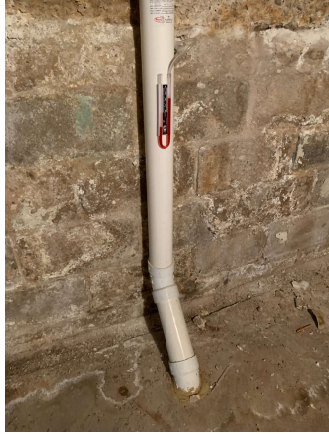
SYSTEM COMPONENT				Date of Inspection:	05/23/2023
NAME	WHAT DOES IT DO?	WHAT DO I CHECK?	WHAT SHOULD I SEE?	WHAT TO FIX?	
Suction Drop Point w/ Vent Pipe	<p>Suction Point : Soil gases are collected in a void space below the foundation, and tight seal prevents soil gas from getting inside the home.</p> <p>Vent Pipe: Pipe conveys the vacuum from the fan, and collects soil gases for discharge to the atmosphere.</p>	Suction Point Seal	Seal is air tight around pipe penetration.	Suction point seal or vent pipe may need to be sealed or replaced if cracks or leaks appear.	
		Vent Pipe Condition	Vent pipe is connected to fan, has not cracked.	If any piping or sealing of the system is altered or replaced, the system should be evaluated by a mitigation professional to verify effectiveness, which includes pressure readings.	
PHOTO			<p>NOTES: (Identify specific building and location description:)</p> <p><input type="checkbox"/> Not Applicable</p> <p>Original Pickup Point installed prior to Pickup Points A and B. Piping is secure and in good condition. Used smoke pen to check for leaks once fan was restarted, and none were observed.</p>

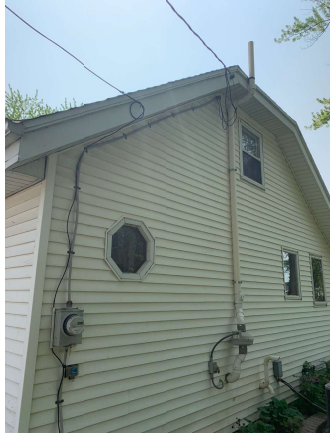
<input type="checkbox"/> Not Applicable		
			Vent pipe appears solid and connected to fan, no damage observed. Checked exhaust end for obstructions. No obstructions observed.

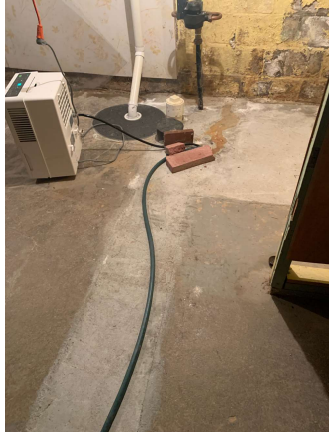
SCS observed an open floor drain near Pickup Point B during the inspection. The floor drain appears to be connected to the sanitary sewer lateral, which appears to have been replaced relatively recently based on the patched concrete floor. The drain is currently receiving water from the dehumidifier and the furnace/air conditioning unit condensate.

<input type="checkbox"/> Not Applicable		
			<p>The foundation floor is in generally good condition. The area shown in the photograph includes the patched section where the sanitary sewer lateral connection enters the building.</p>
