Re: WDNR BRRTS #02-41-552537
Indoor Air Sampling and Sub-slab Vapor Sampling Results Report
Westwood Dry Cleaners
8731 W. North Ave
Wauwatosa, WI 53226

Indoor Air Sampling & Sub-Slab Vapor Sampling Results Report

Prepared For
Westwood Cleaners
(WDNR BRRTS#02-41-552537)
8731 West North Avenue
Wauwatosa, Wisconsin 53226

December 13, 2021

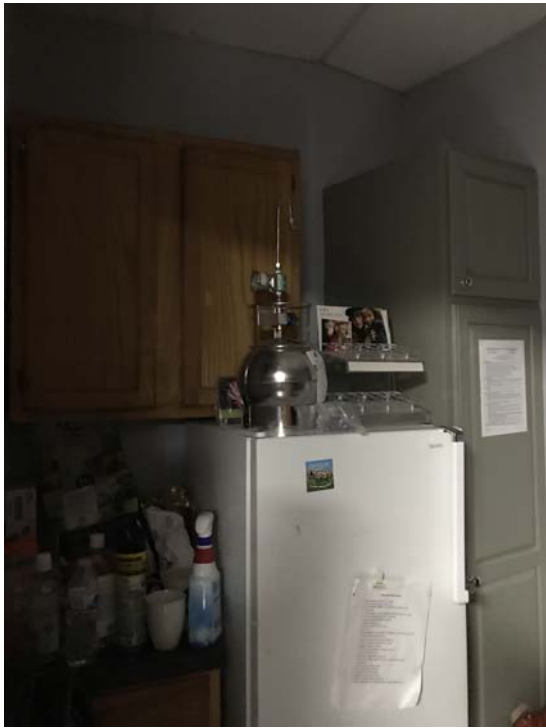
IA-1 in Nail Spa

3. Elevated concentrations of Isopropyl Alcohol are found in the SPA Nails ($3,500 \mu\text{g}/\text{m}^3$) and in the Super Cut ($2,200 \mu\text{g}/\text{m}^3$). However, they are not related to the drycleaning solvents;

4. Elevated concentrations of Isotone are found in the SPA Nails ($25,000 \mu\text{g}/\text{m}^3$) and in the Super Cut ($560 \mu\text{g}/\text{m}^3$). However, they are not related to the drycleaning solvents.

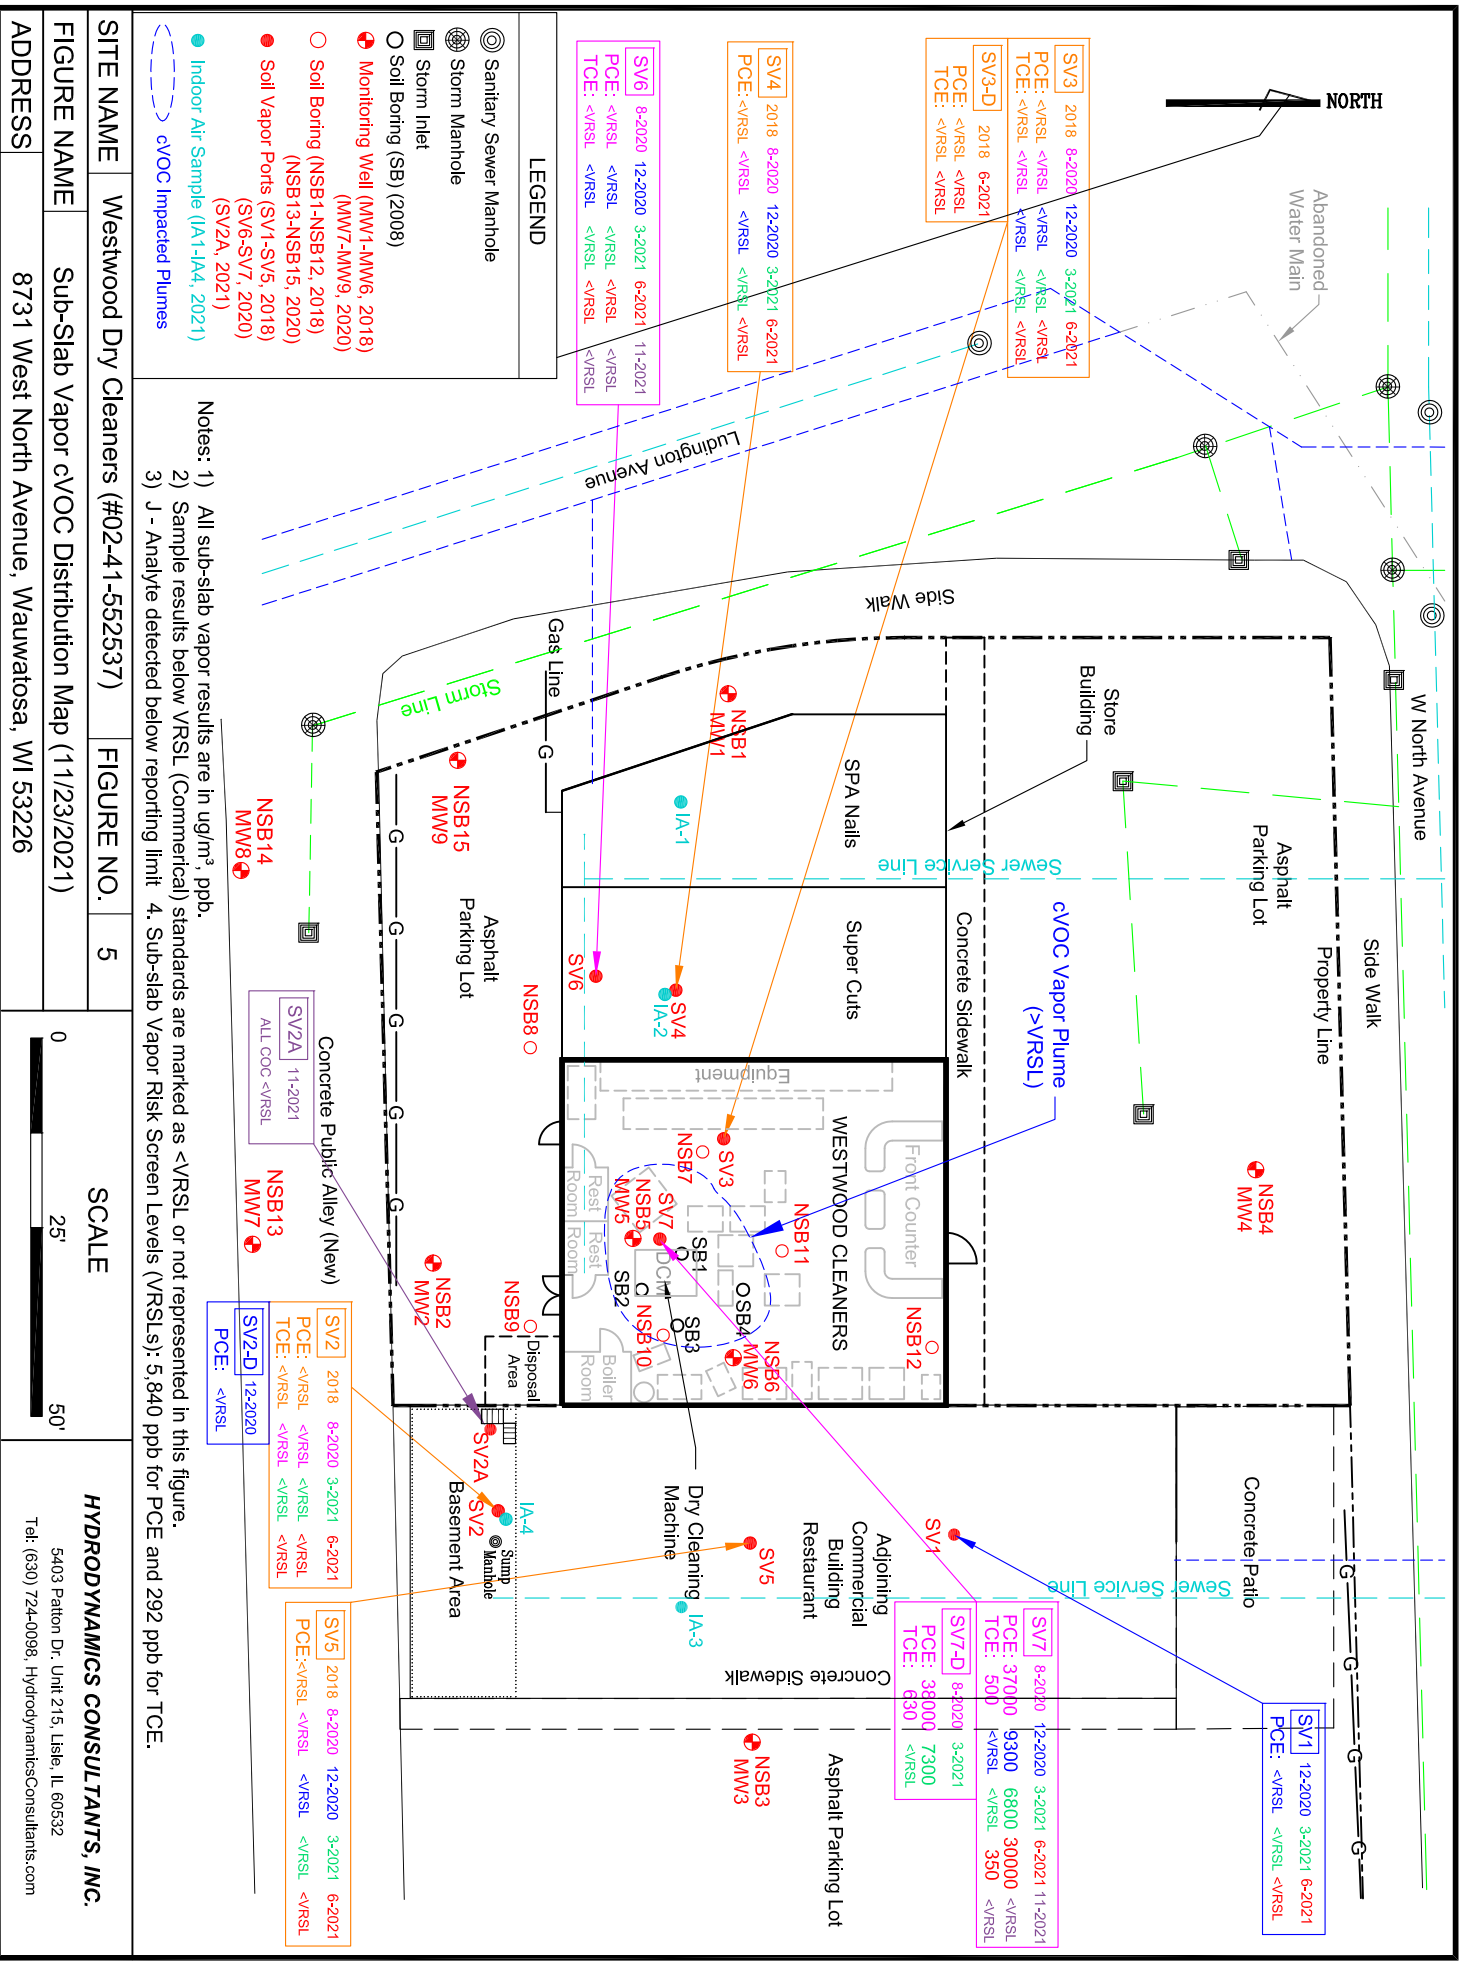
SITE NAME Westwood Dry Cleaners (#02-41-552537) FIGURE NO. 5

To avoid the influence of the sump manhole near SV2, this sampling port was moved to the northwest corner of the basement next to the stairs, and named SV2A. This location is closer to the source from Westwood Cleaners (see Figure 5).

Stat Analytical Corporation performed the VOC analysis with TO-15 Method. The analytical results are tabulated in Table 1 and illustrated in Figure 5. The analytical results can be summarized as follows:

1. All VOC concentrations are below the US EPA's Vapor Intrusion Screen Levels (VISLs) in all the samples;
2. Elevated PCE concentrations are present in the samples collected in SV6 (1,100 $\mu\text{g}/\text{m}^3$), in SV2A (880 $\mu\text{g}/\text{m}^3$), and in SV7 (280 $\mu\text{g}/\text{m}^3$). However, they are below the Vapor Risk Screening Levels (VRSL) for residential/commercial properties.
3. Slightly elevated concentrations of Isopropyl Alcohol, Acetone, TCE, Xylenes, and others are found in the samples.

Based on the sampling results, HDC believes that it is not necessary to install the sub-slab depressurization system (SSDS) since no exceedance of Contamination of Concerns (COCs, PCE and related by-products) in the soil vapor samples for commercial properties. As a result, HDC recommends WDNR to grant an official letter to bring the site closure for environmental concerns regarding the existing contamination.

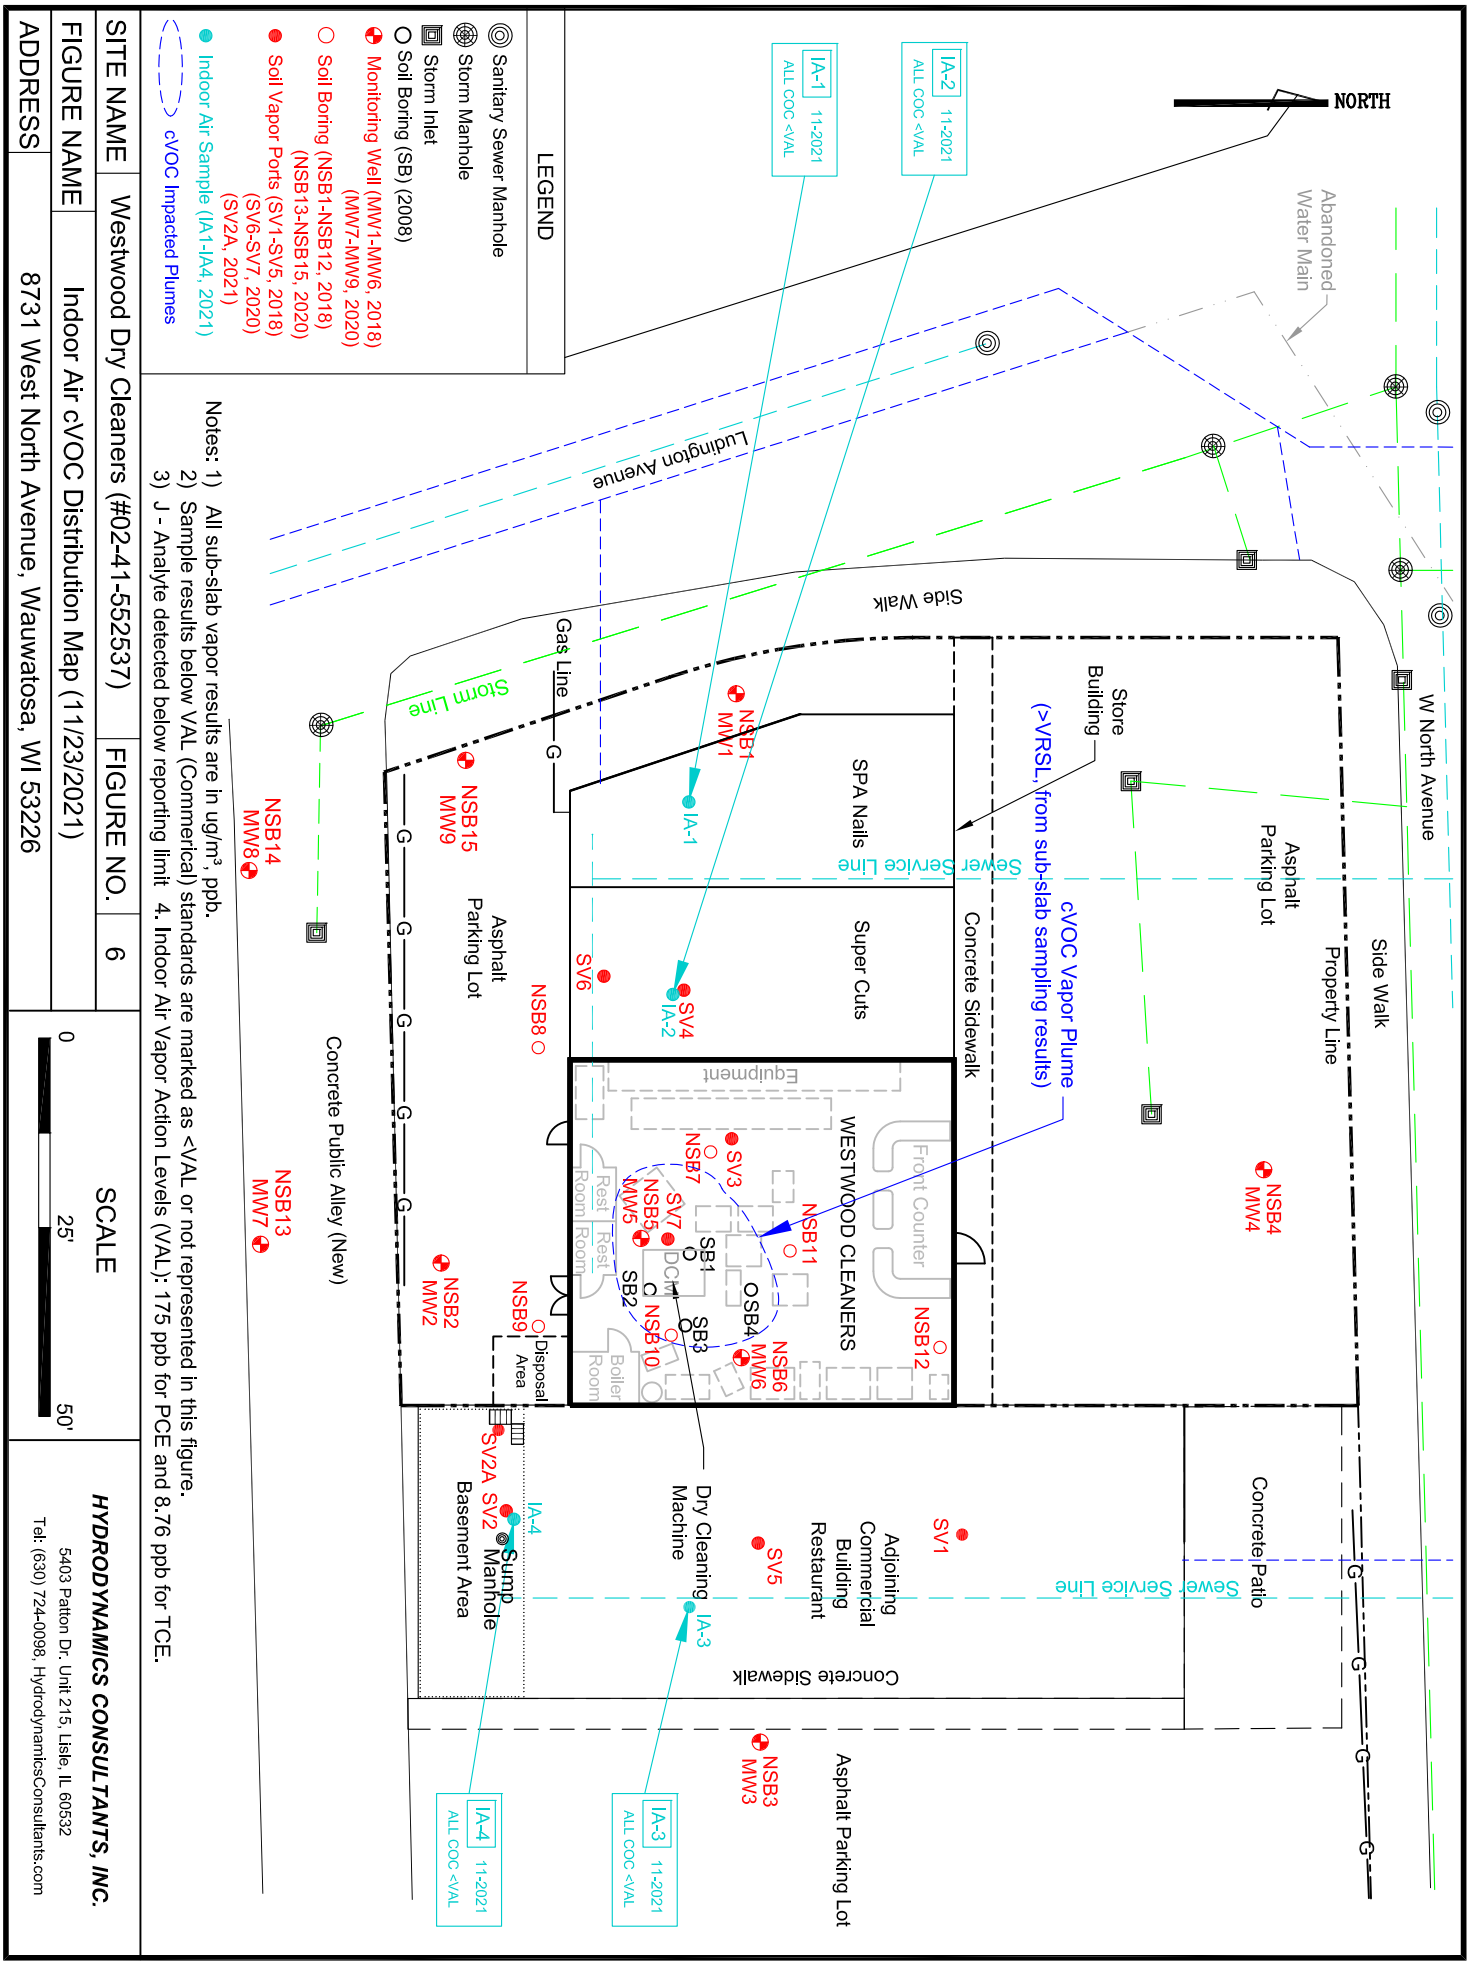
SITE NAME	Westwood Dry Cleaners (#02-41-552537)	FIGURE NO.	6
FIGURE NAME	Indoor Air cVOC Distribution Map (11/23/2021)		
ADDRESS	8731 West North Avenue, Wauwatosa, WI 53226

The sampling locations are illustrated in Figure 6, with sample IA-1 in SPA Nails, IA-2 in Super Cut, IA-3 on the first floor of the restaurant, and IA-4 in the basement of the restaurant.

Stat Analytical Corporation performed the VOC analysis with EPA's TO-15 Method. The analytical results are tabulated in Table 2 and illustrated in Figure 6. The analytical results can be summarized as follows:

1. All VOC concentrations are below the US EPA's Vapor Intrusion Screen Levels (VISLs) in all the samples;
2. Elevated PCE concentrations are present in the samples collected in the Super Cut ($100 \mu\text{g}/\text{m}^3$), in SPA Nails ($40 \mu\text{g}/\text{m}^3$), and in the Restaurant ($8 \mu\text{g}/\text{m}^3$ on first floor and $17 \mu\text{g}/\text{m}^3$ in the basement), however, they are below Indoor Air Vapor Action Level (VAL) of $175 \mu\text{g}/\text{m}^3$ for commercial properties;
