Re: WDNR BRRTS #02-41-552537
Indoor Air Sampling and Sub-slab Vapor Sampling Results Report
Westwood Dry Cleaners
8731 W. North Ave
Wauwatosa, WI 53226

Indoor Air Sampling & Sub-Slab Vapor Sampling Results Report

Prepared For
Westwood Cleaners
(WDNR BRRTS#02-41-552537)
8731 West North Avenue
Wauwatosa, Wisconsin 53226

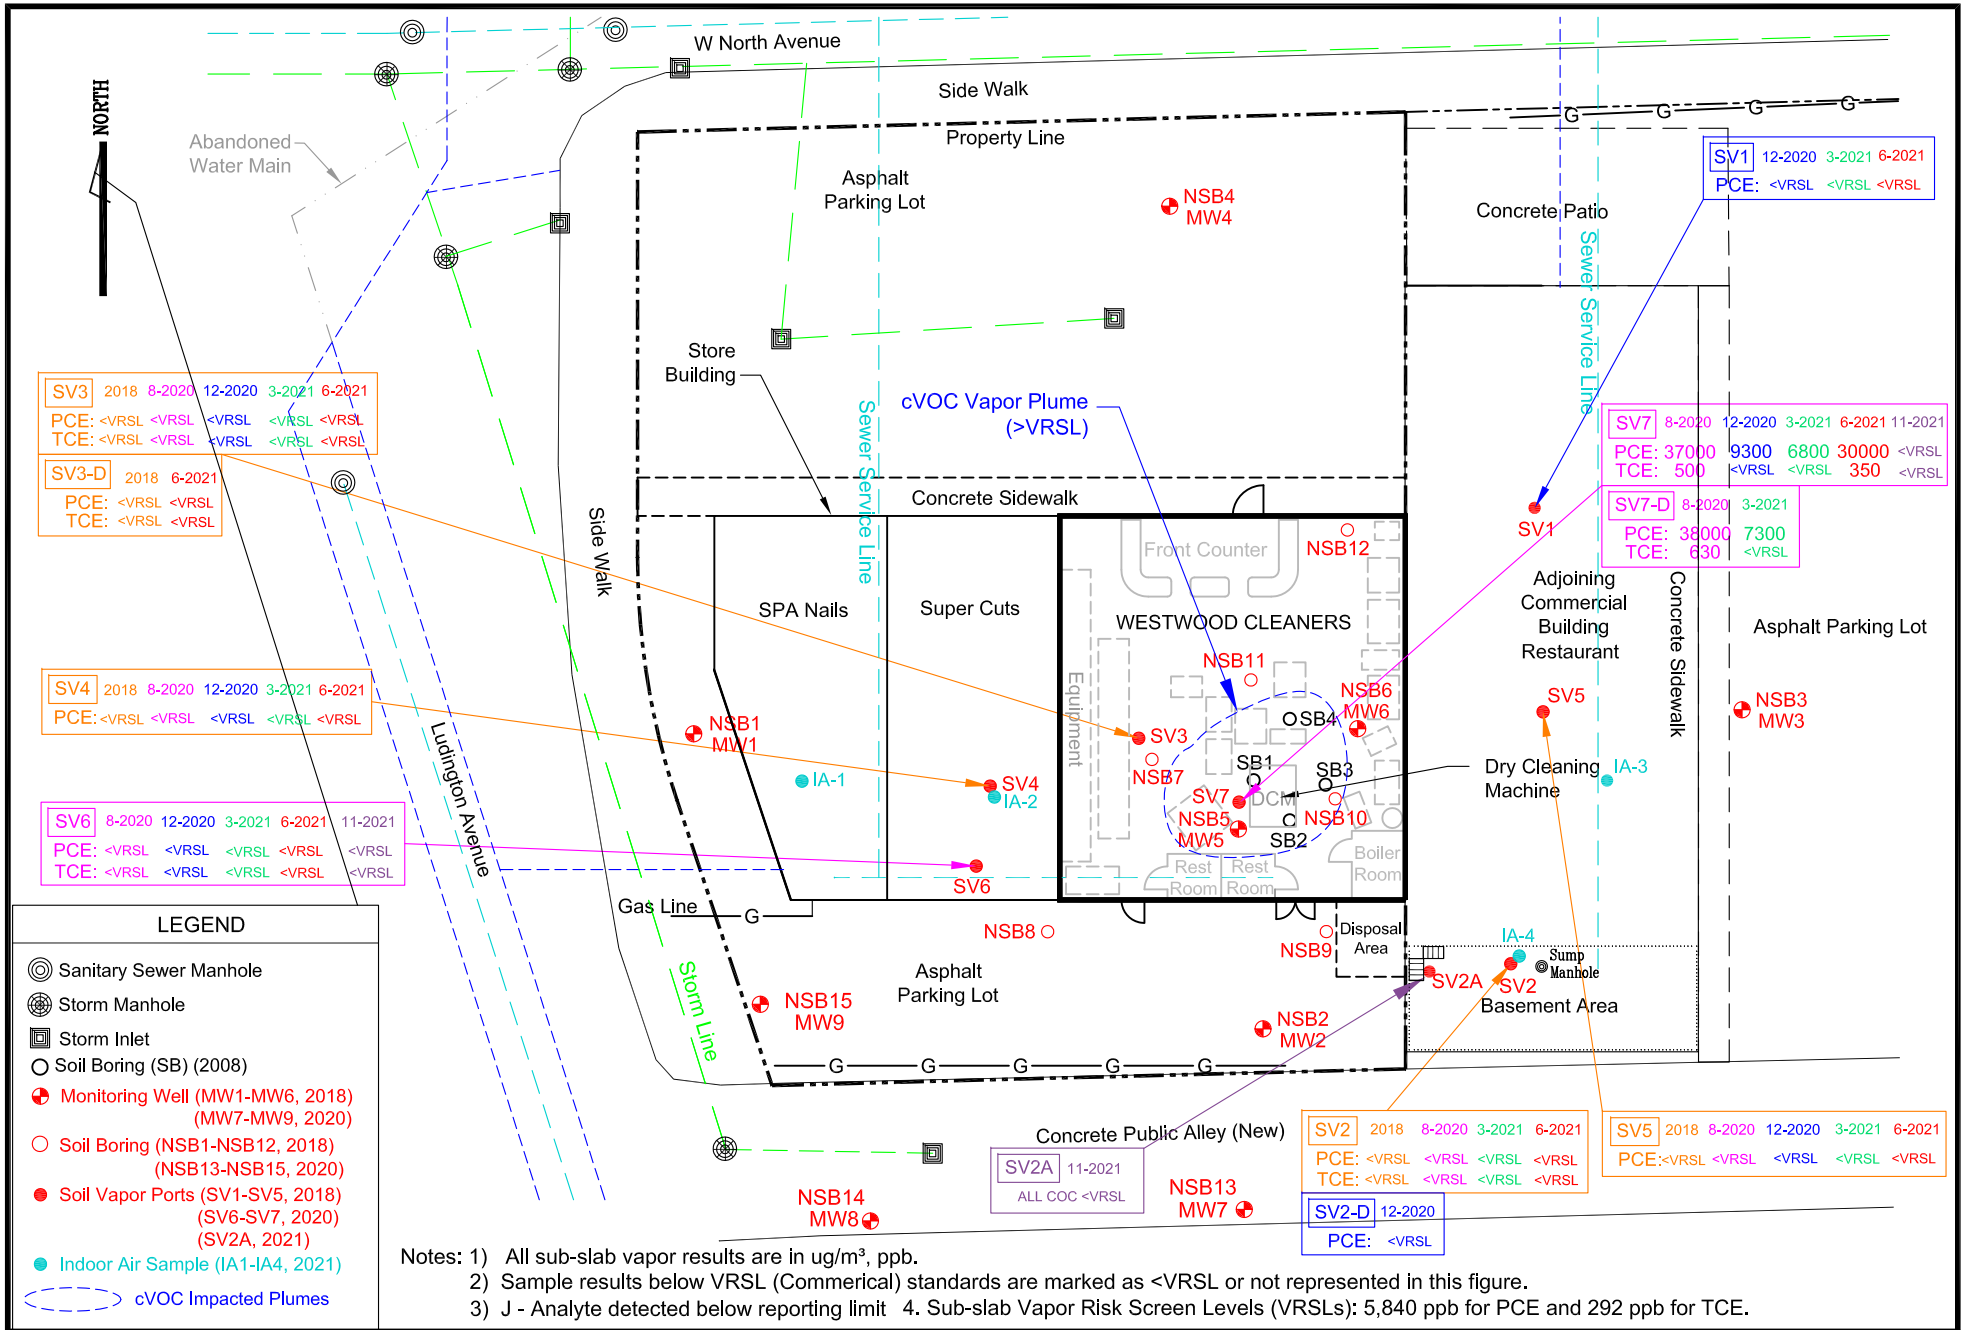
To avoid the influence of the sump manhole near SV2, this sampling port was moved to the northwest corner of the basement next to the stairs, and named SV2A. This location is closer to the source from Westwood Cleaners (see Figure 5).

Stat Analytical Corporation performed the VOC analysis with TO-15 Method. The analytical results are tabulated in Table 1 and illustrated in Figure 5. The analytical results can be summarized as follows:

1. All VOC concentrations are below the US EPA's Vapor Intrusion Screen Levels (VISLs) in all the samples;
2. Elevated PCE concentrations are present in the samples collected in SV6 (1,100 $\mu\text{g}/\text{m}^3$), in SV2A (880 $\mu\text{g}/\text{m}^3$), and in SV7 (280 $\mu\text{g}/\text{m}^3$). However, they are below the Vapor Risk Screening Levels (VRSL) for residential/commercial properties.
3. Slightly elevated concentrations of Isopropyl Alcohol, Acetone, TCE, Xylenes, and others are found in the samples.

Based on the sampling results, HDC believes that it is not necessary to install the sub-slab depressurization system (SSDS) since no exceedance of Contamination of Concerns (COCs, PCE and related by-products) in the soil vapor samples for commercial properties. As a result, HDC recommends WDNR to grant an official letter to bring the site closure for environmental concerns regarding the existing contamination.

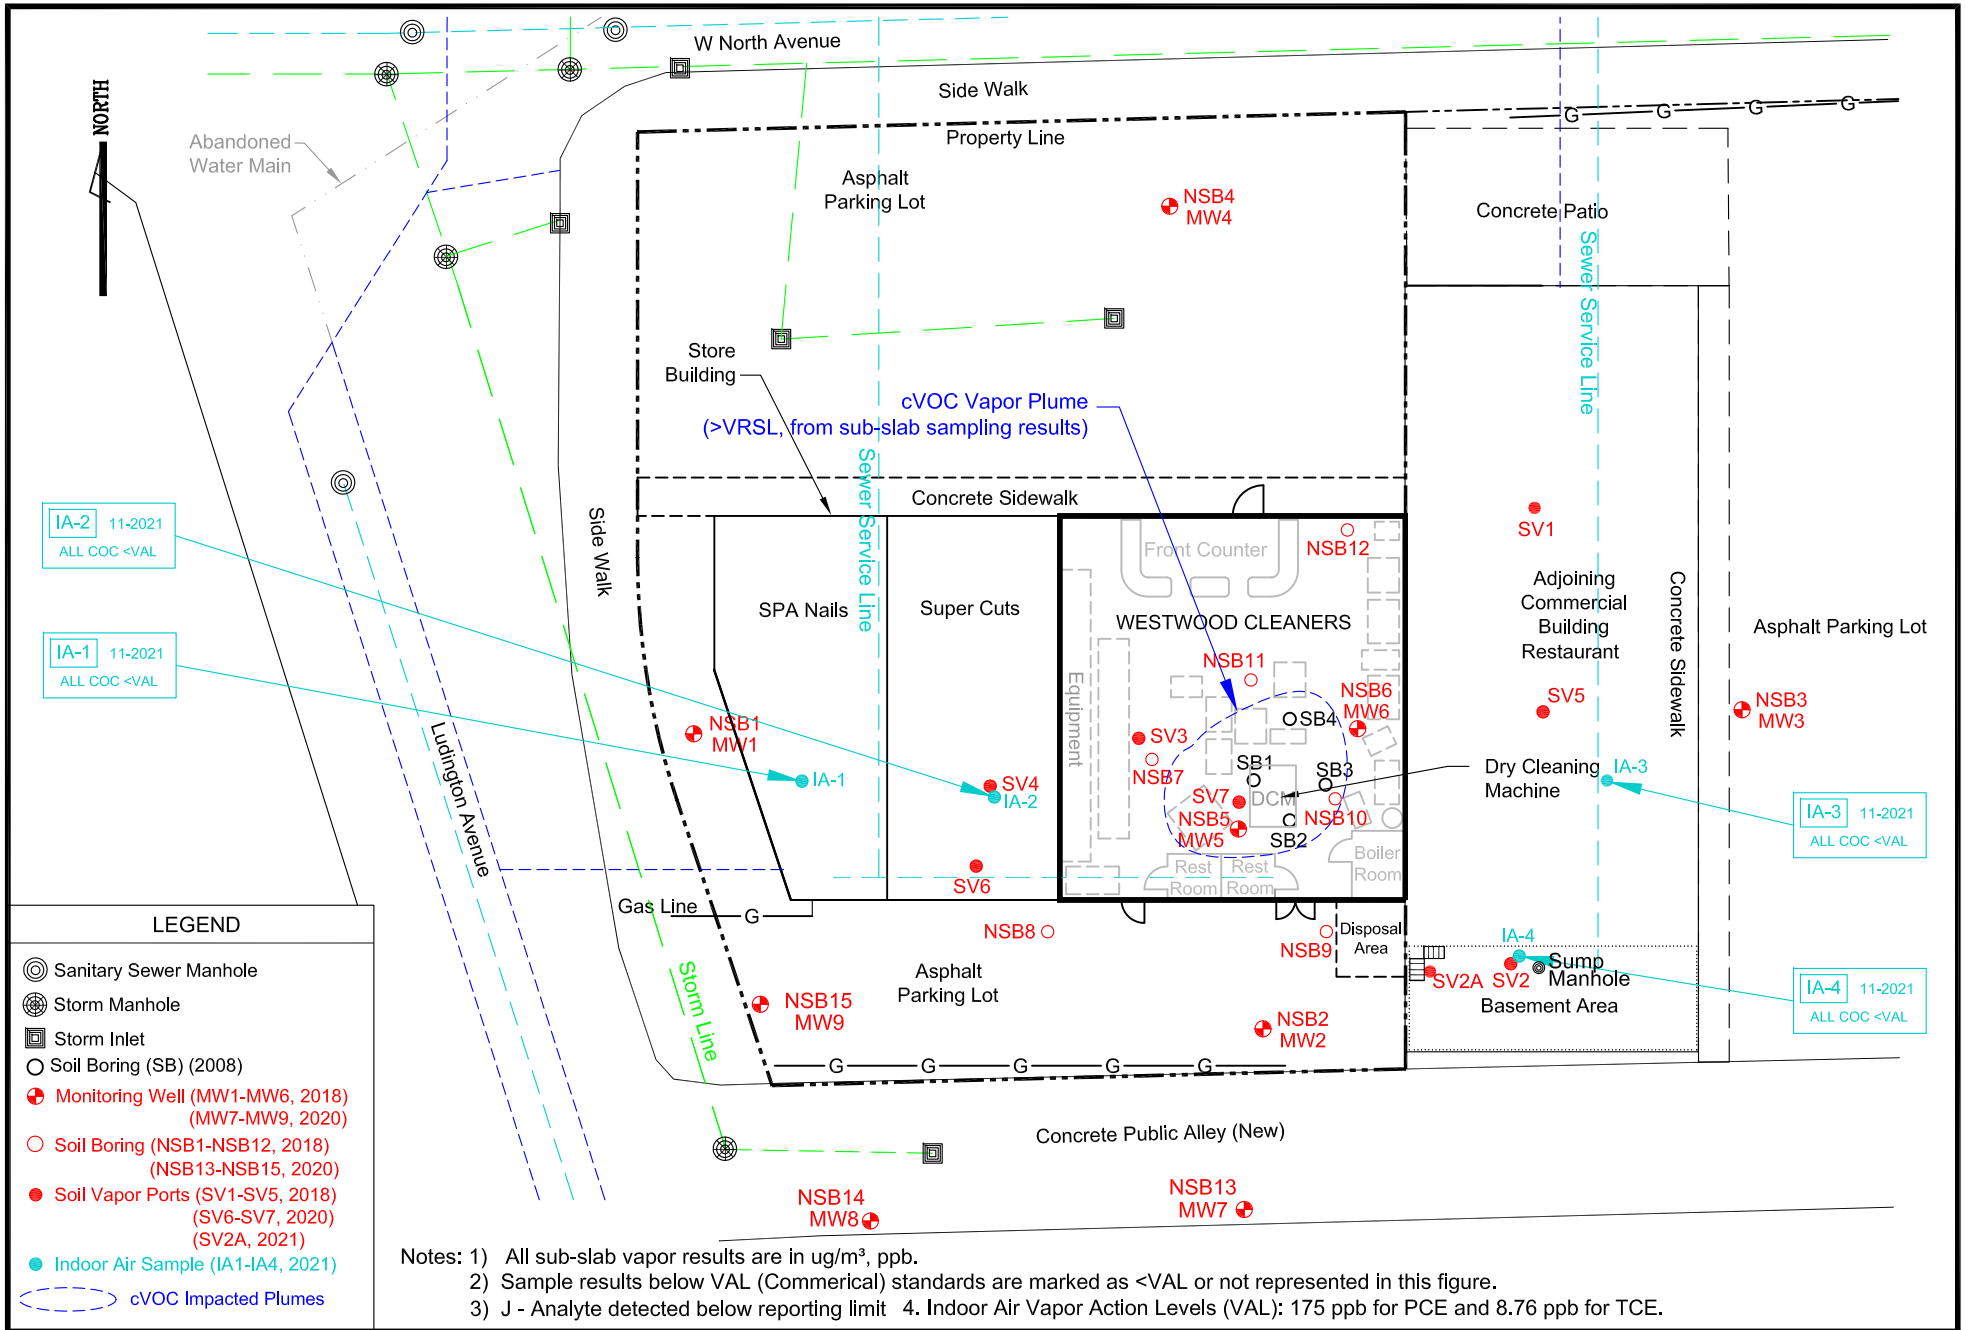
The sampling locations are illustrated in Figure 6, with sample IA-1 in SPA Nails, IA-2 in Super Cut, IA-3 on the first floor of the restaurant, and IA-4 in the basement of the restaurant.

Stat Analytical Corporation performed the VOC analysis with EPA's TO-15 Method. The analytical results are tabulated in Table 2 and illustrated in Figure 6. The analytical results can be summarized as follows:

1. All VOC concentrations are below the US EPA's Vapor Intrusion Screen Levels (VISLs) in all the samples;
2. Elevated PCE concentrations are present in the samples collected in the Super Cut ($100 \mu\text{g}/\text{m}^3$), in SPA Nails ($40 \mu\text{g}/\text{m}^3$), and in the Restaurant ($8 \mu\text{g}/\text{m}^3$ on first floor and $17 \mu\text{g}/\text{m}^3$ in the basement), however, they are below Indoor Air Vapor Action Level (VAL) of $175 \mu\text{g}/\text{m}^3$ for commercial properties;
