January 31, 2023

**POST-CONSTRUCTION MONITORING REPORT
FOR JUNE 2022 ANNUAL MONITORING AND
SEPTEMBER 2022 STORM-RELATED
MONITORING**

**BURNHAM CANAL SUPERFUND ALTERNATIVE SITE
MILWAUKEE, MILWAUKEE COUNTY, WISCONSIN**

MILLER COMPRESSING COMPANY

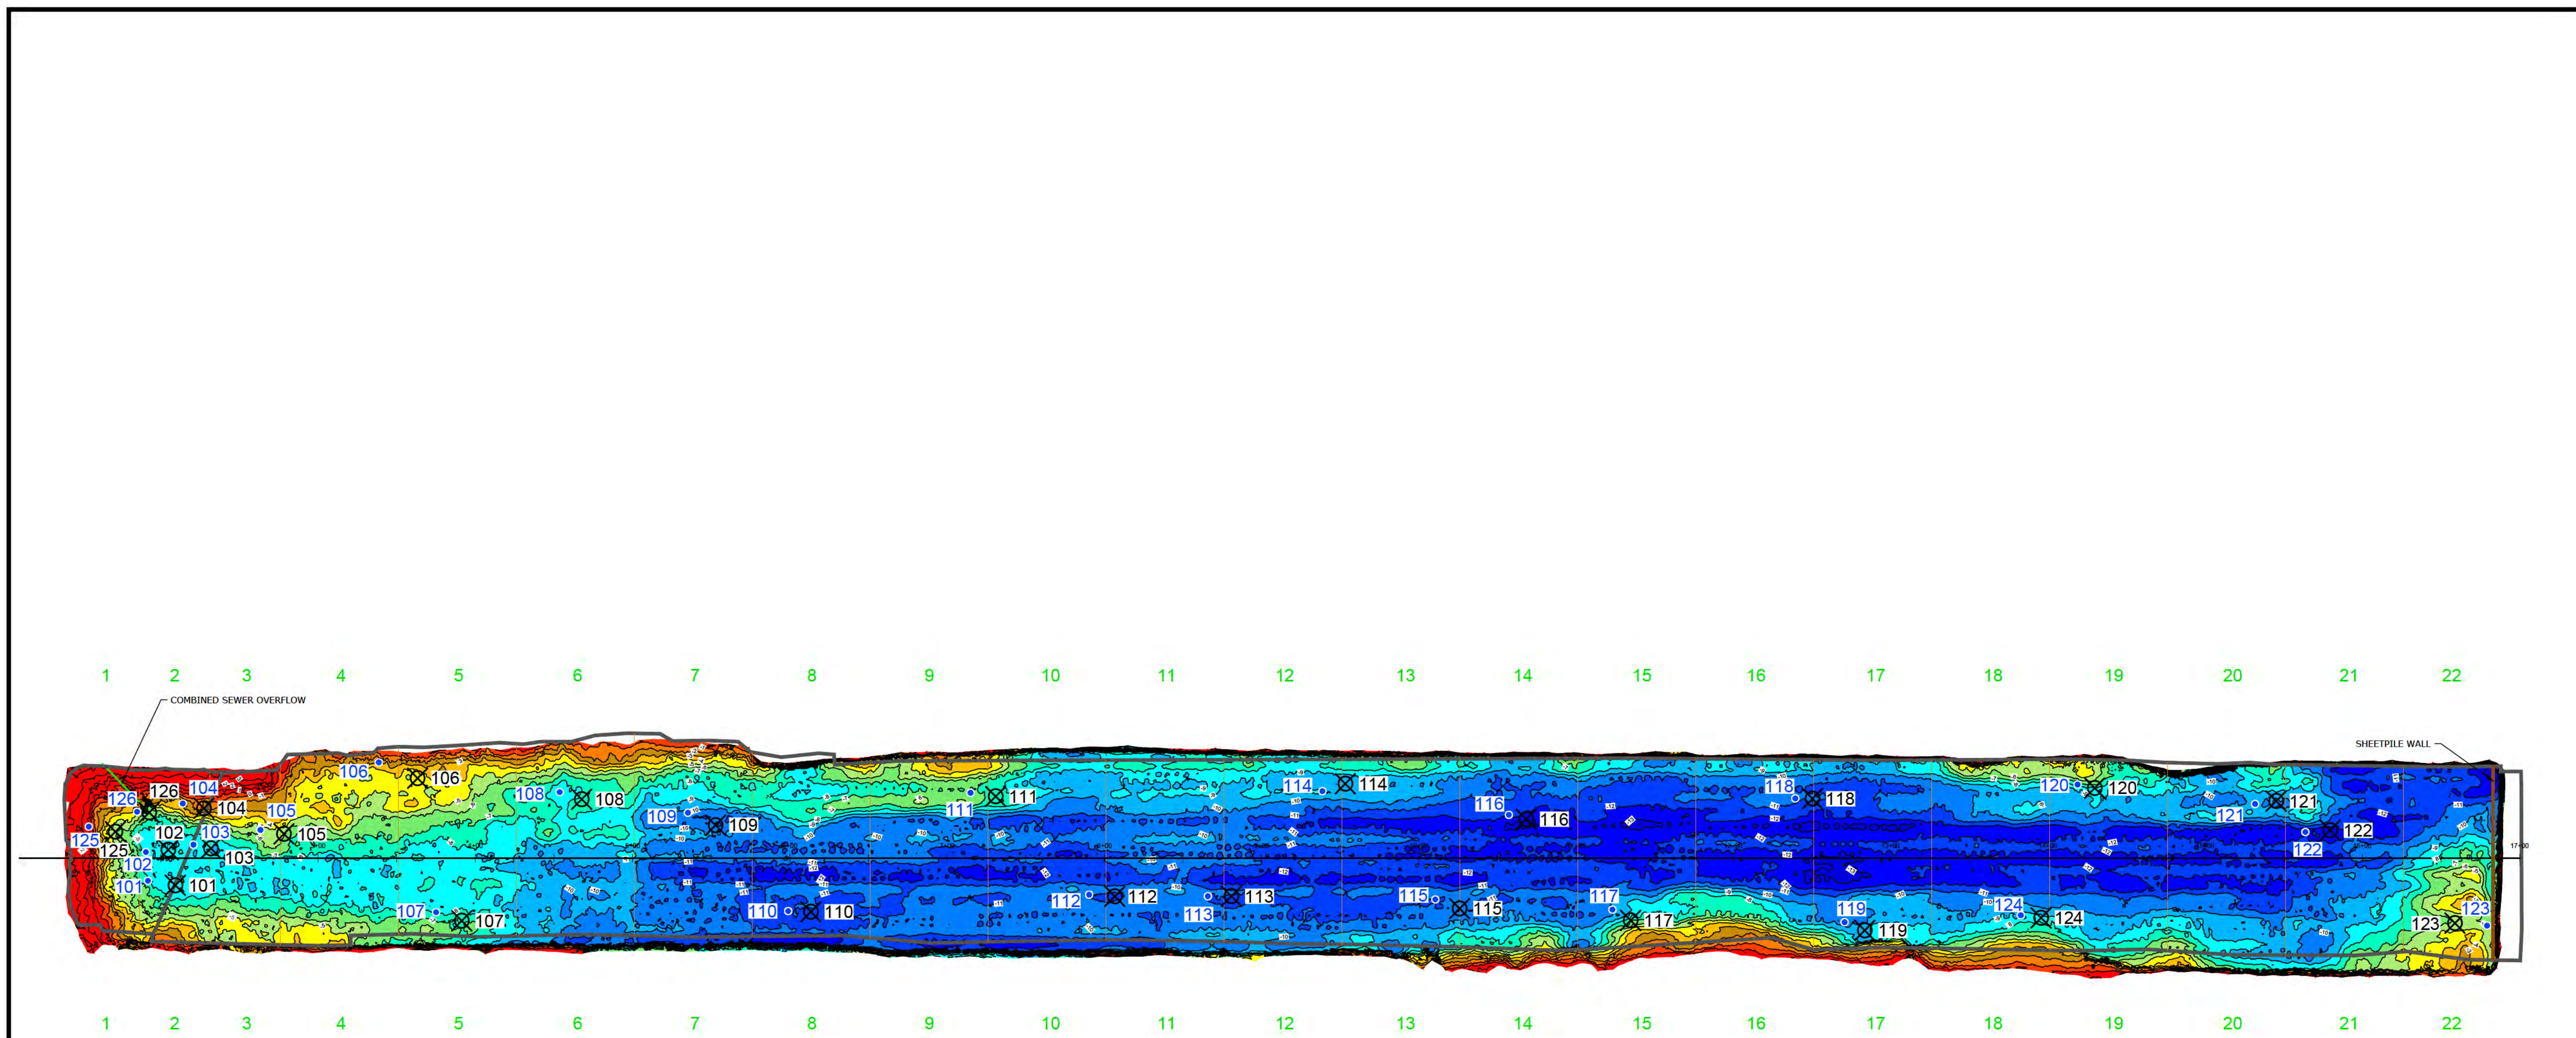
The annual poling of the portion of the Unpaved Engineering Control Area below the Burnham Canal water level (0.3 CMD feet) was conducted by Ramboll on June 9, 2022. Post-construction as-built Betterment surface contours in **Figure 1** and aerial imagery in **Figure 2a** were both overlaid with as-built poling locations from the June 2022 inspection event. Poling location 125 was included in the poling event to represent Approval Unit 1 and the submerged portion of the Unpaved Engineering Control Area. Poling observations and measurements are summarized in **Table 1** and indicate that riprap is present in the portion of the Unpaved Engineering Control Area below the Burnham Canal water level. Per the COMMP (Ramboll, 2021a), no further action is required as a result of the annual poling based on the confirmation of the presence of riprap.

The annual poling of the Subaqueous Engineering Control Area was conducted by Ramboll on June 9, 2022. Post-construction as-built Betterment surface contours in **Figure 1** and aerial imagery in **Figure 2a** were both overlaid with as-built poling locations from the June 2022 poling event. Poling locations 101 through 124 are in the Subaqueous Engineering Control Area and were selected based on proposed verification locations provided on Figure 3 of the COMMP (Ramboll, 2021a). As described in the previous section, poling location 125 was included in the poling event to represent Approval Unit 1 and the submerged portion of the Unpaved Engineering Control Area. Poling location 126 is in the Subaqueous Engineering Control Area and was included in the poling event to evaluate conditions near the pipe outlet of combined sewer outfall (CSO)-194 (formerly CSO-211).

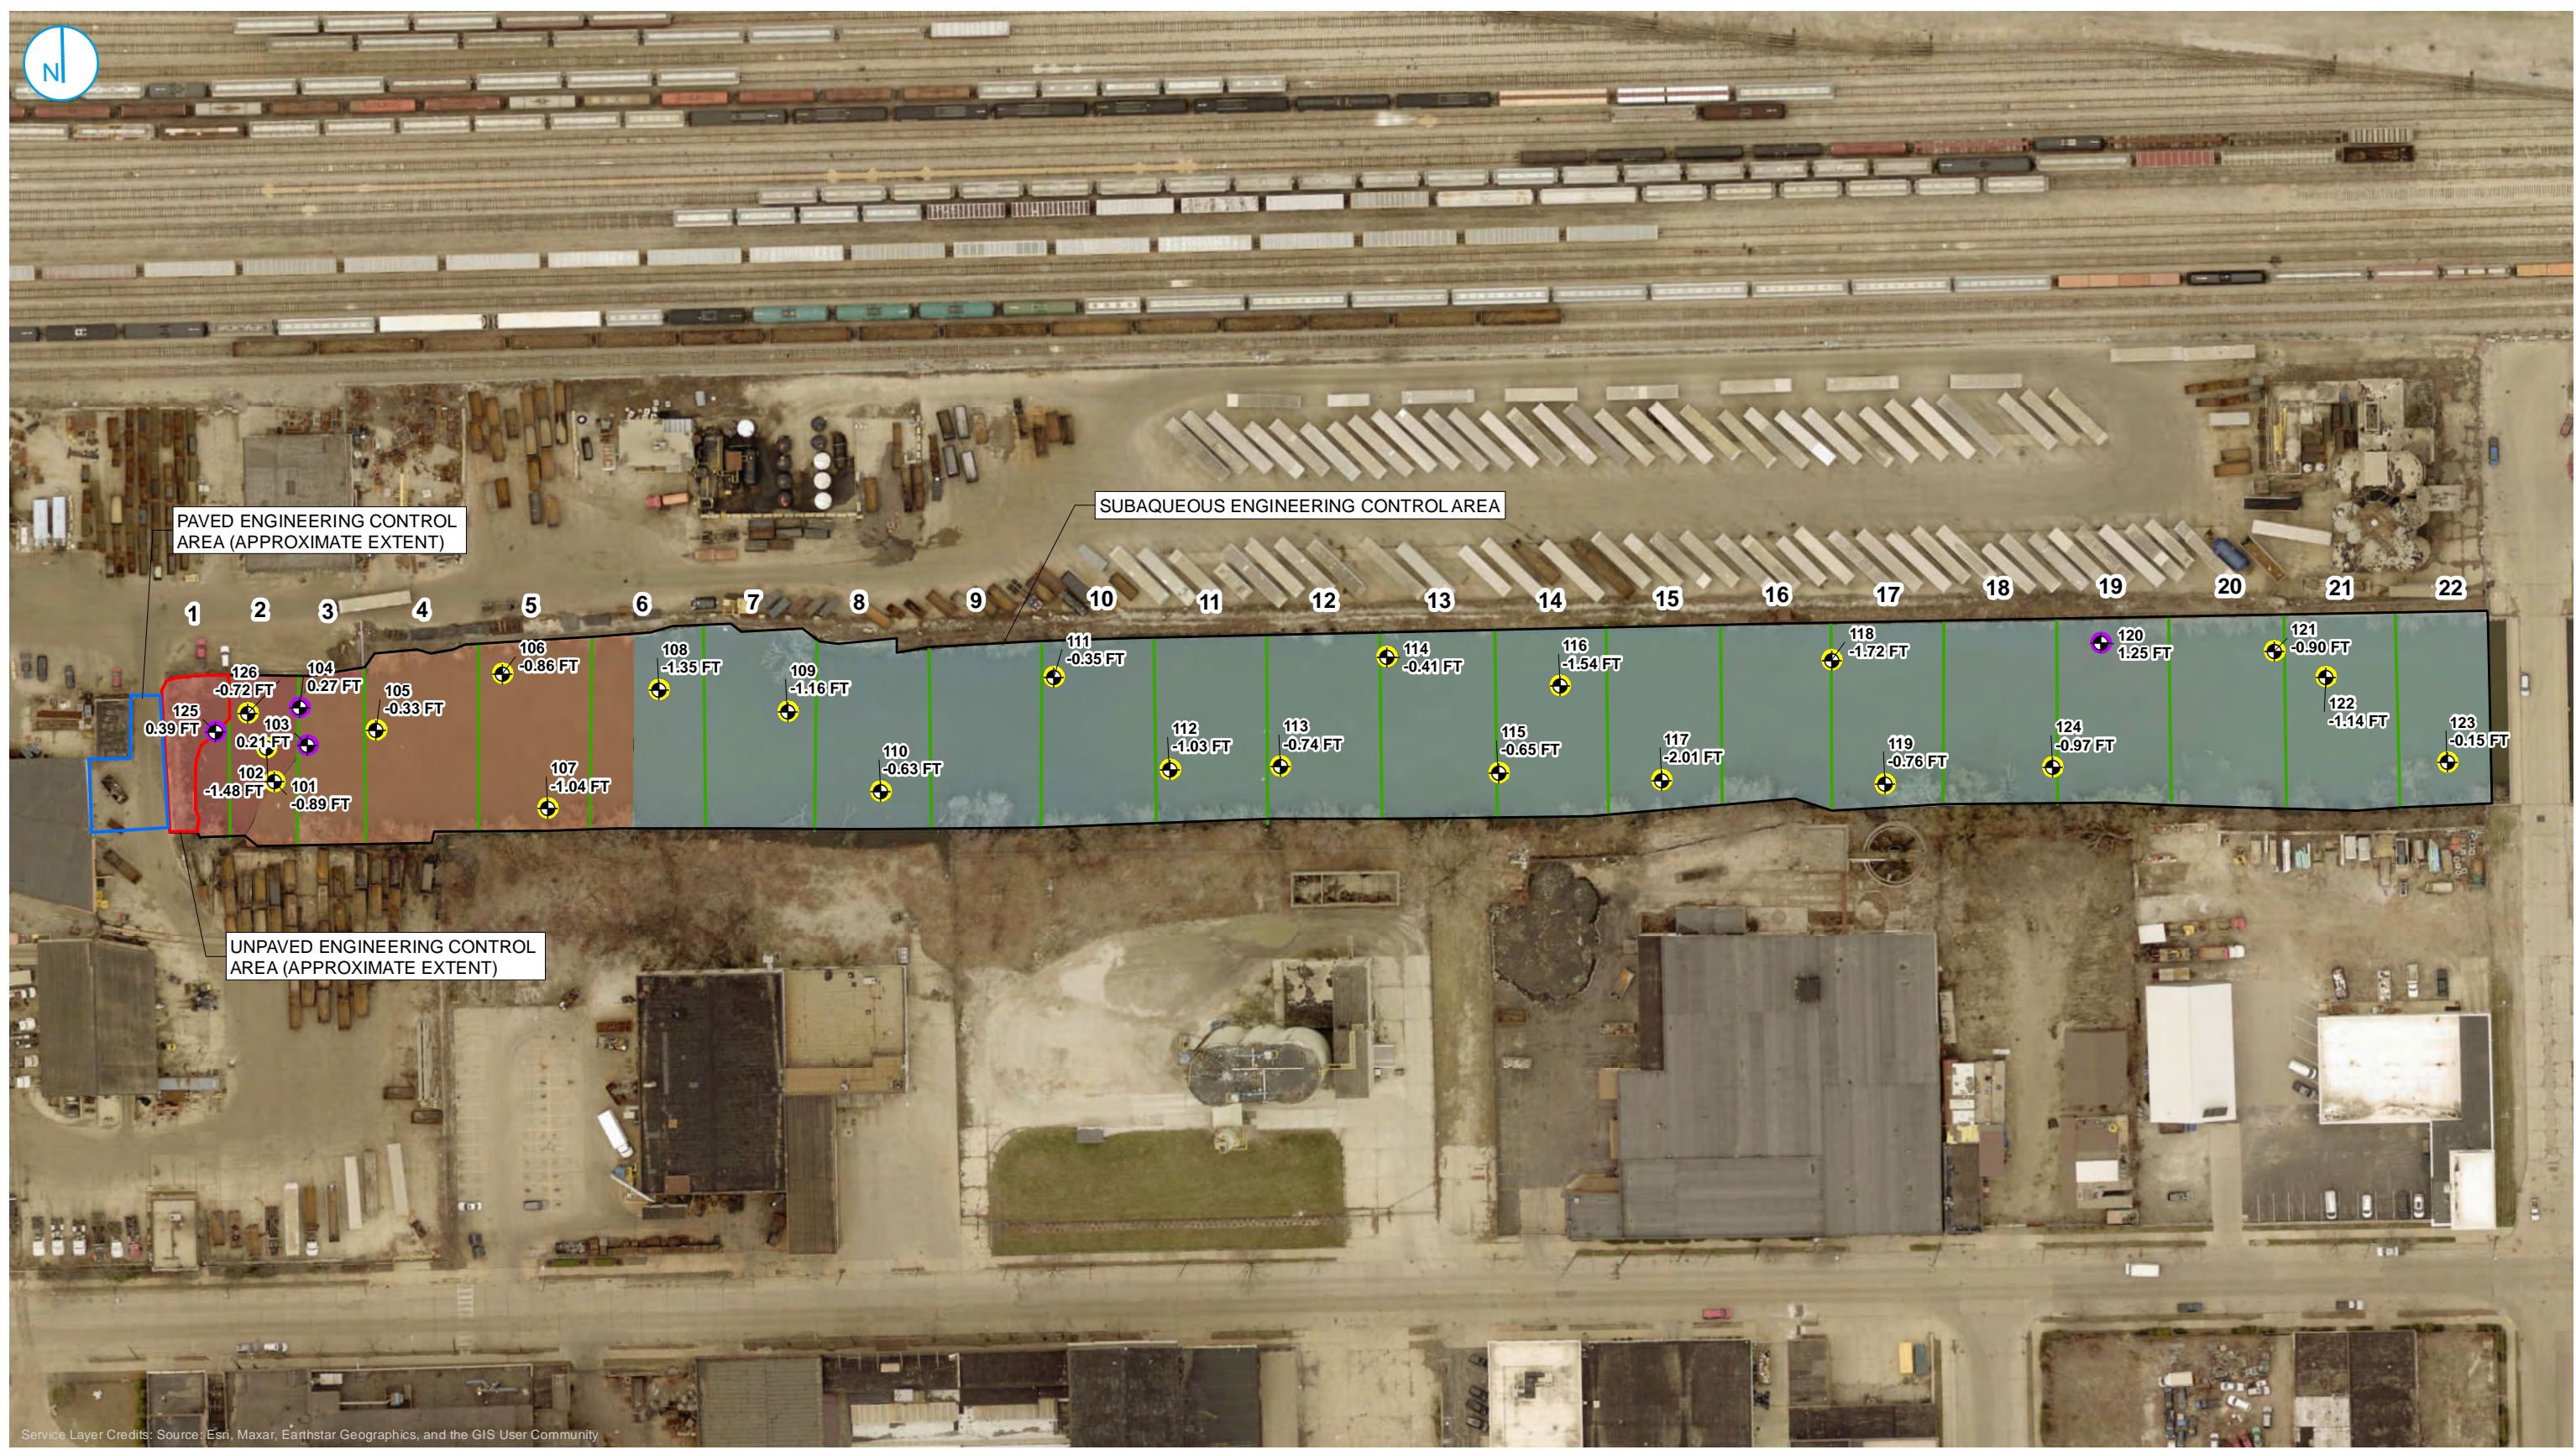
FIGURE 2a

As summarized in **Table 1**, the presence of riprap or select crushed (Betterment) was confirmed at all poling locations in the Subaqueous Engineering Control Area. As such, per the COMMP (Ramboll, 2021a), no further action is required as a result of the annual poling.

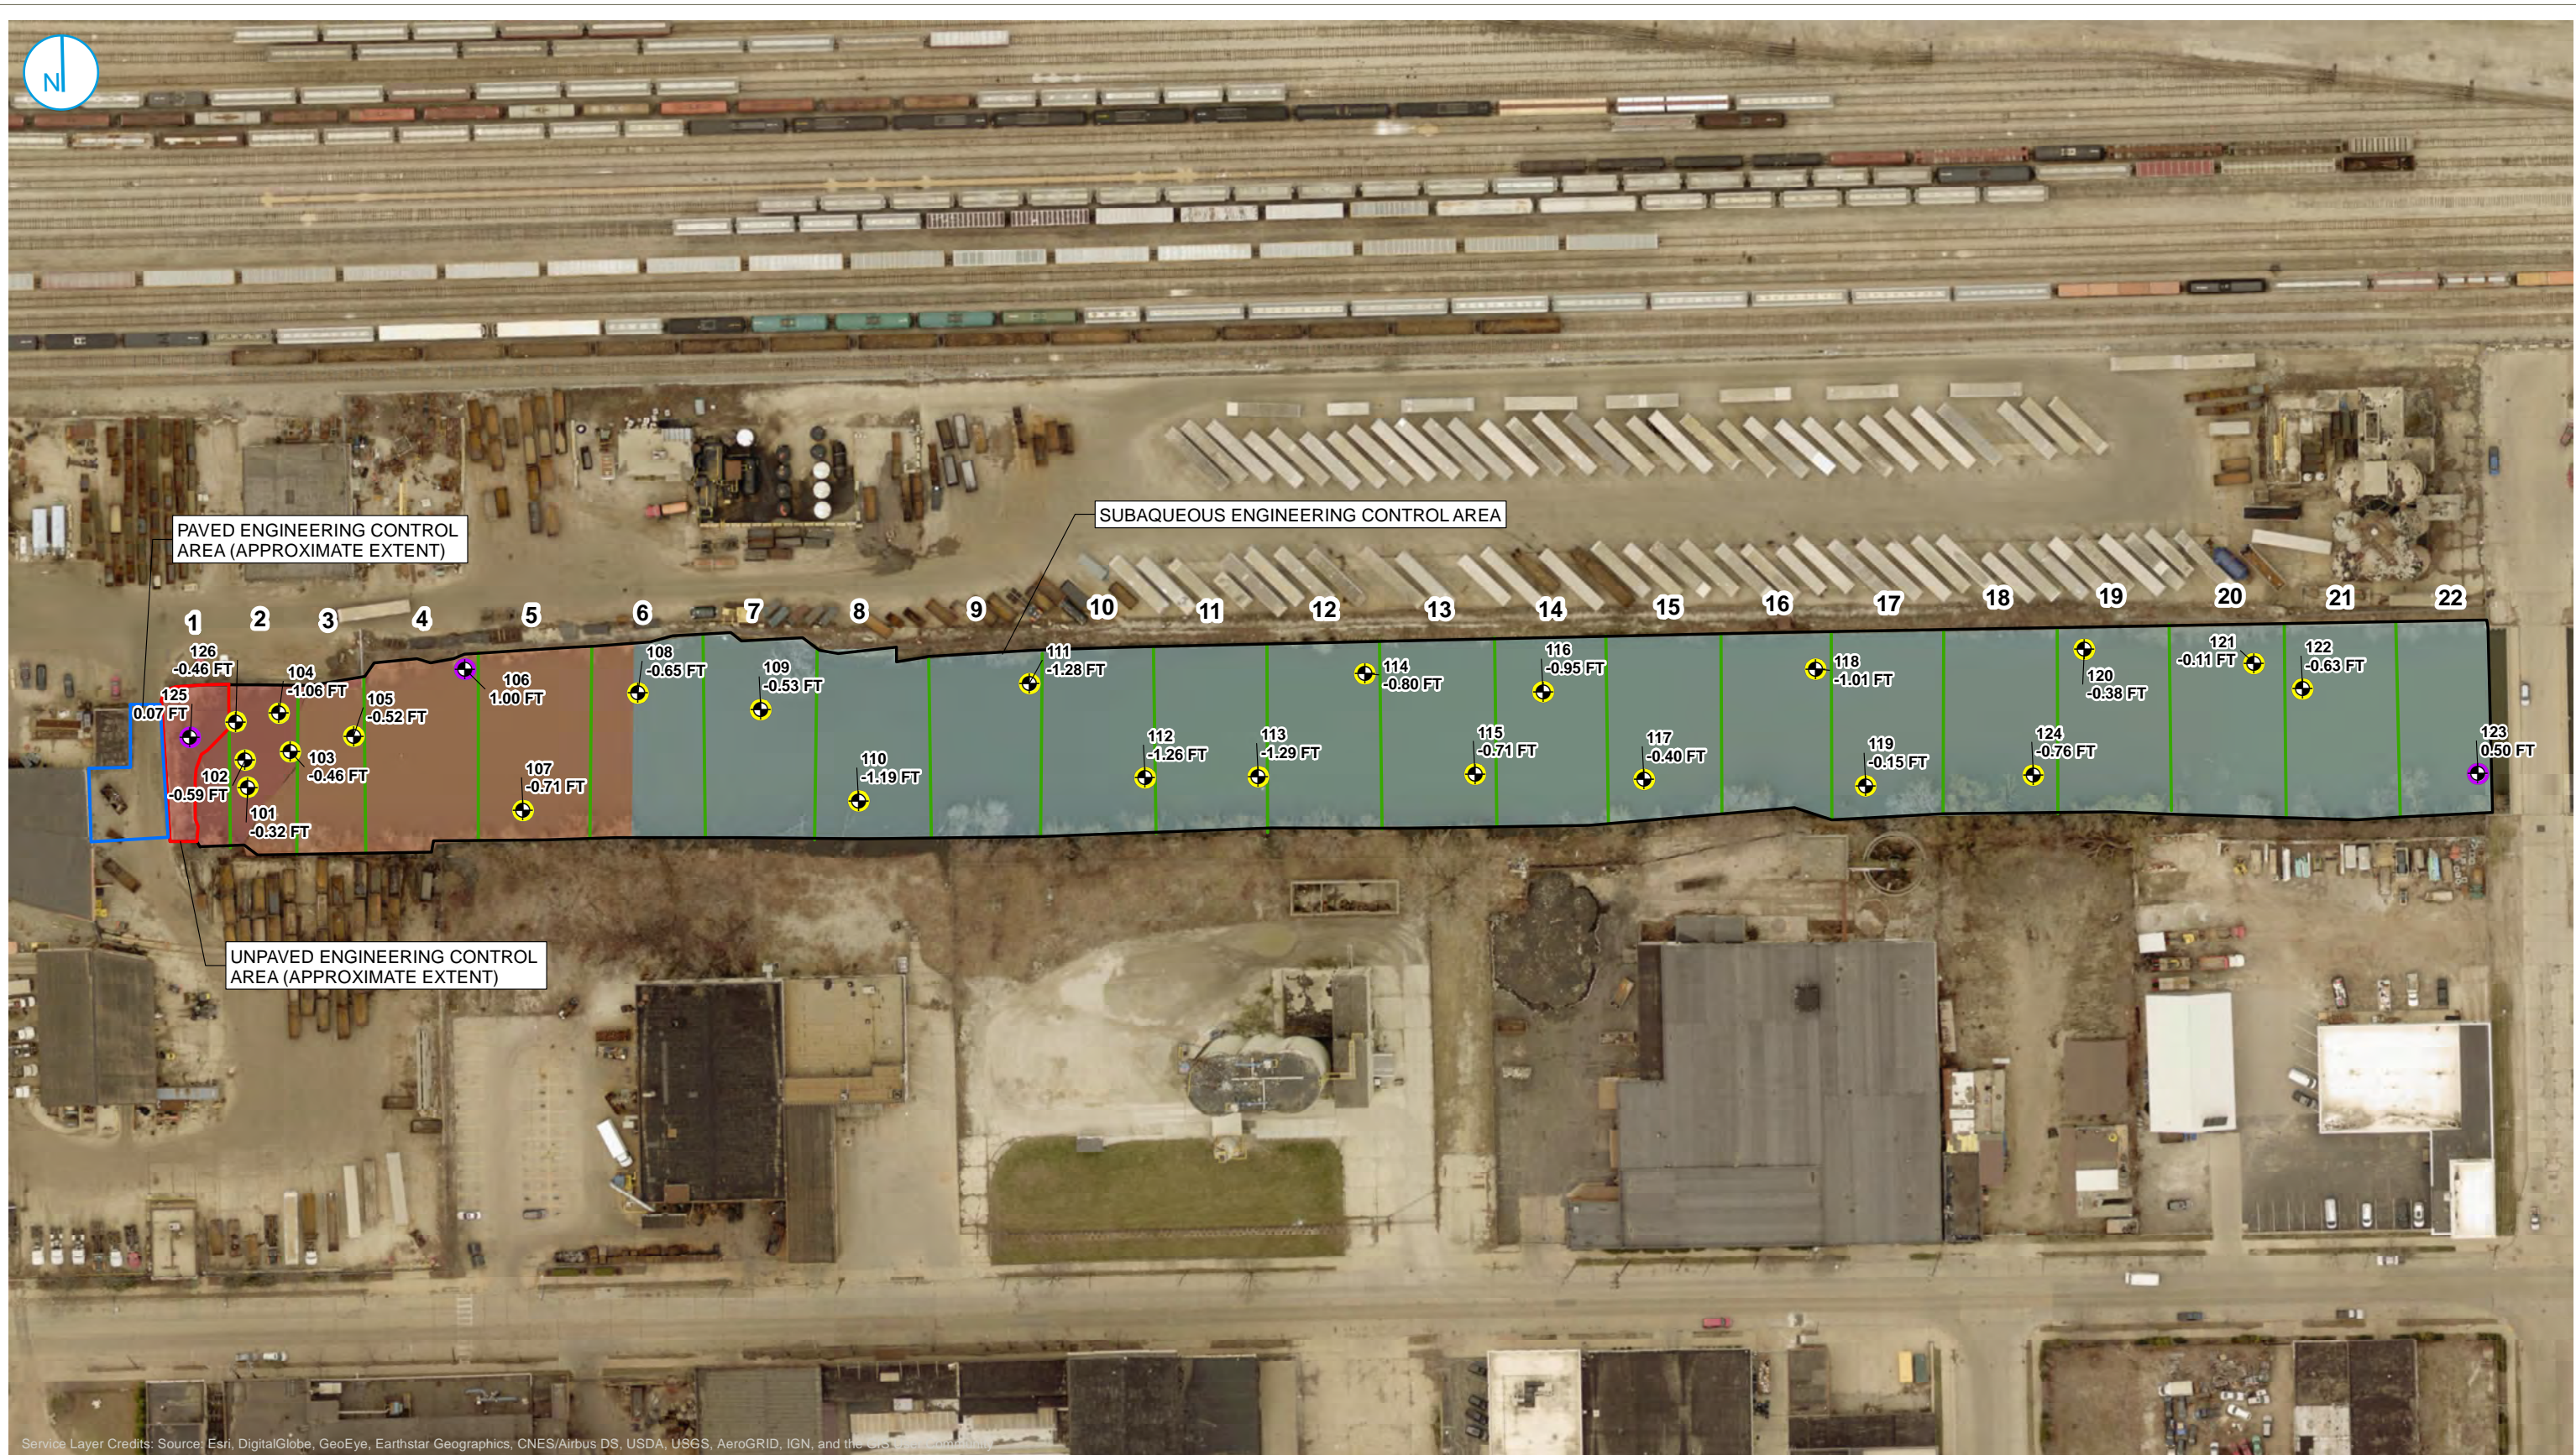
FIGURE 2b

As summarized in **Table 2**, the presence of riprap or select crushed (Betterment) was confirmed at all poling locations in the Subaqueous Engineering Control Area. As such, per the COMMP (Ramboll, 2021a), no further action is required at this time.

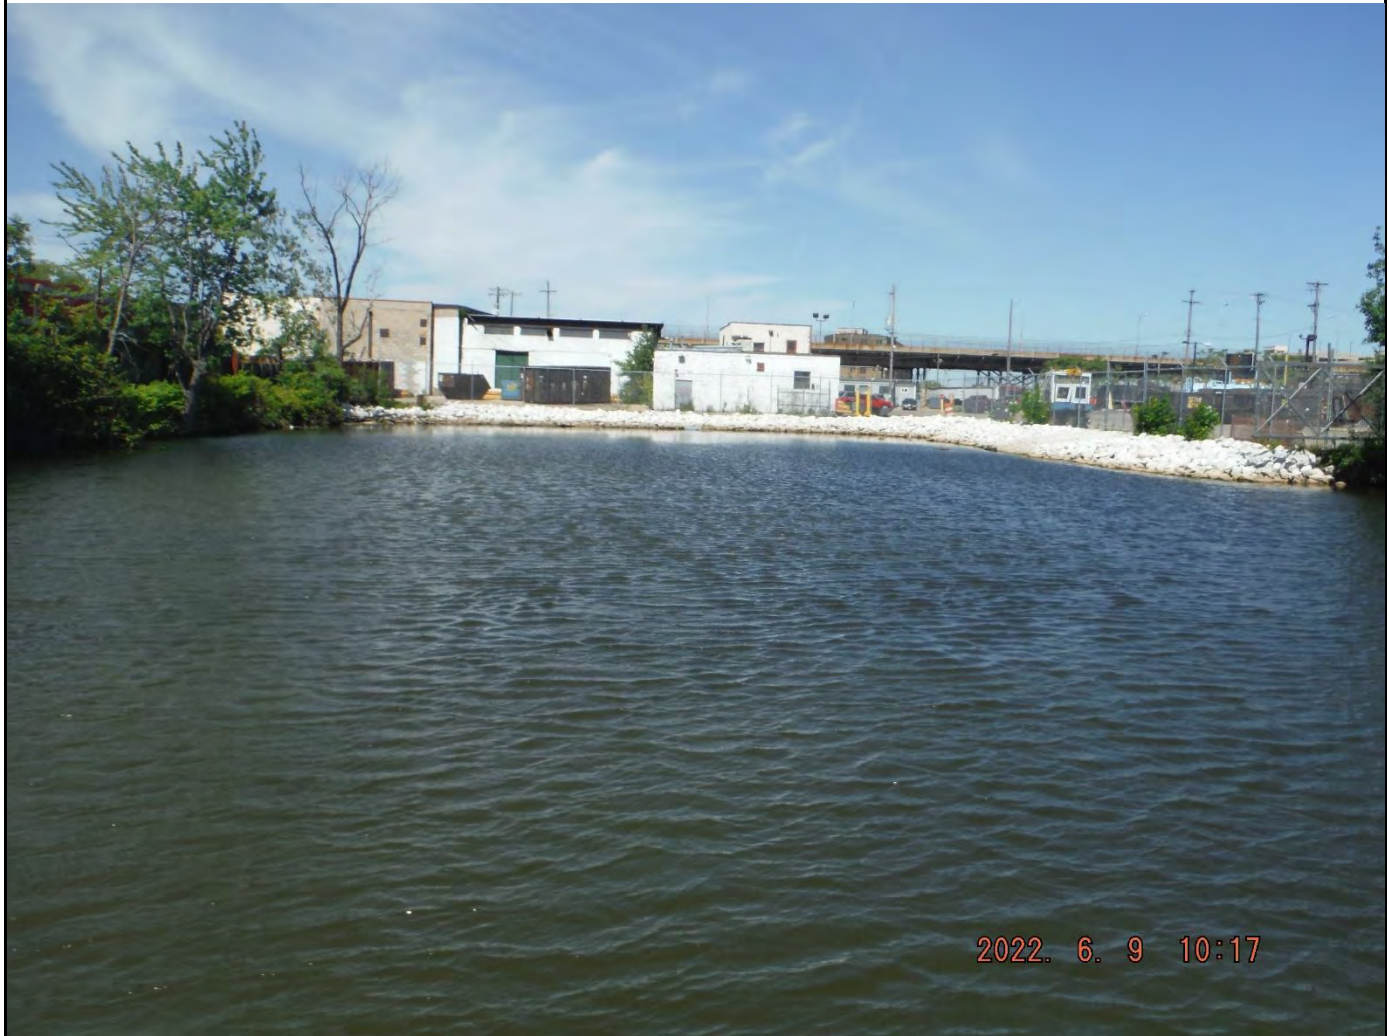
Photograph ID: 2

Milwaukee Datum (CMD) feet at the time of the inspection. As shown in the photo log included as **Appendix B**, the riprap placed along the west bank of the Burnham Canal is in good condition. No evidence of erosion was observed, and no repair or maintenance activities are necessary at this time.

Comments: View of medium riprap along northeastern portion of Unpaved Engineering Control Area, looking northwest.

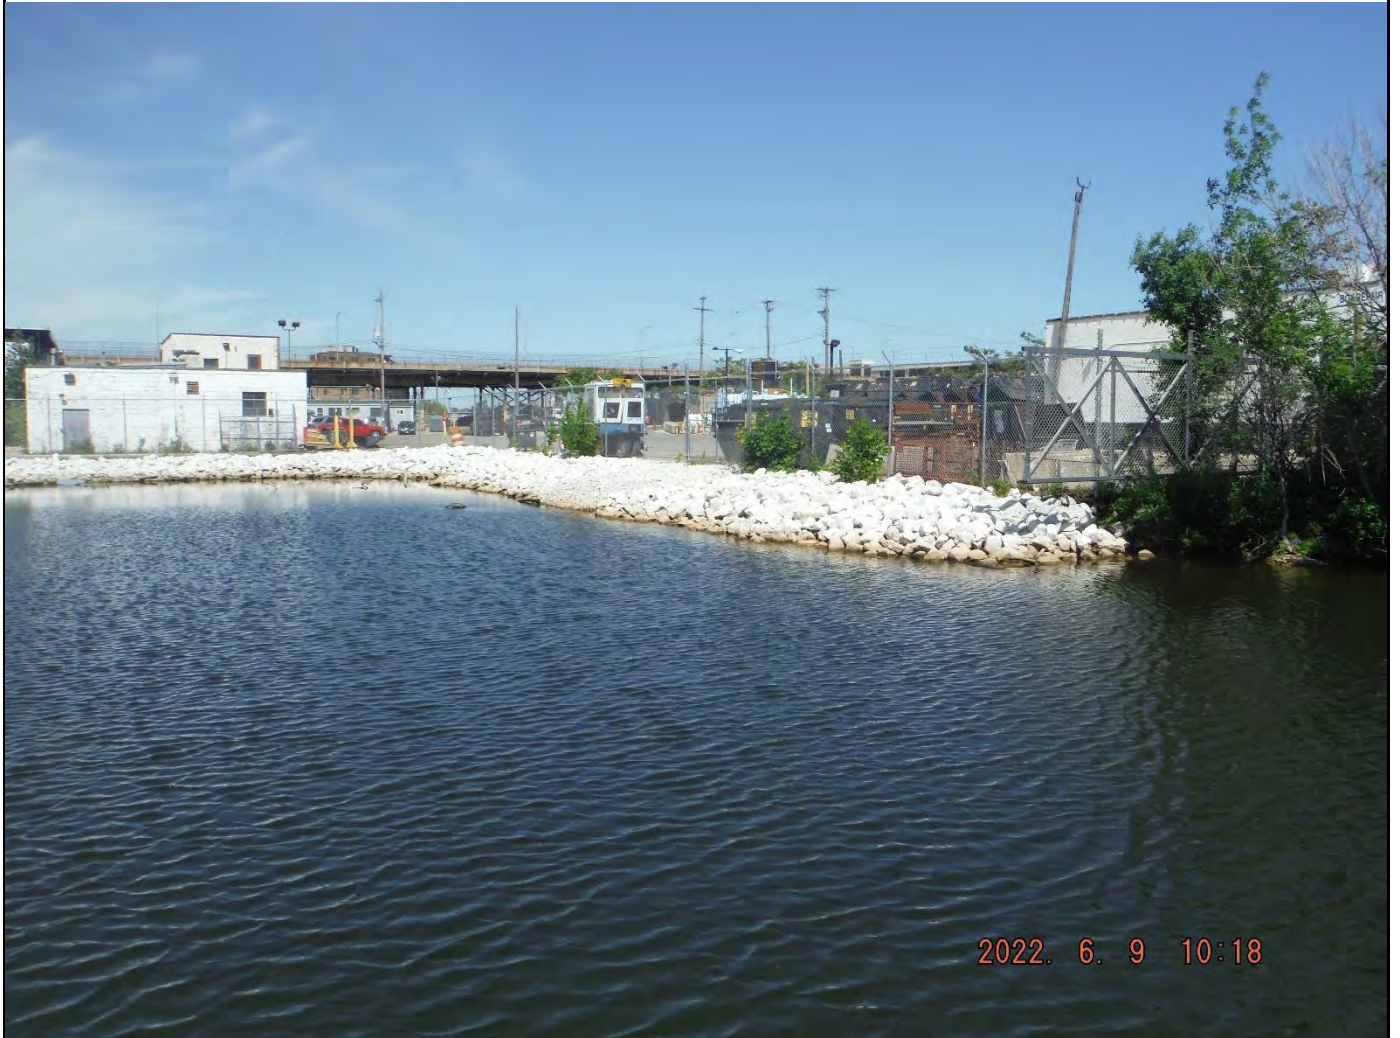
Photograph ID: 3

During the storm-related inspection conducted by Ramboll on September 16, 2022, the entire Unpaved Engineering Control Area was either above the Burnham Canal Water level (0.2 CMD) or was visible beneath shallow water. As shown in the photo log included as **Appendix B**, the riprap placed along the west bank of the Burnham Canal and other portions of the Unpaved Engineering Control Area is in good condition. No evidence of erosion was observed, and no repair or maintenance activities are necessary at this time.

Comments: View of medium riprap along northeastern portion of Unpaved Engineering Control Area, looking east.

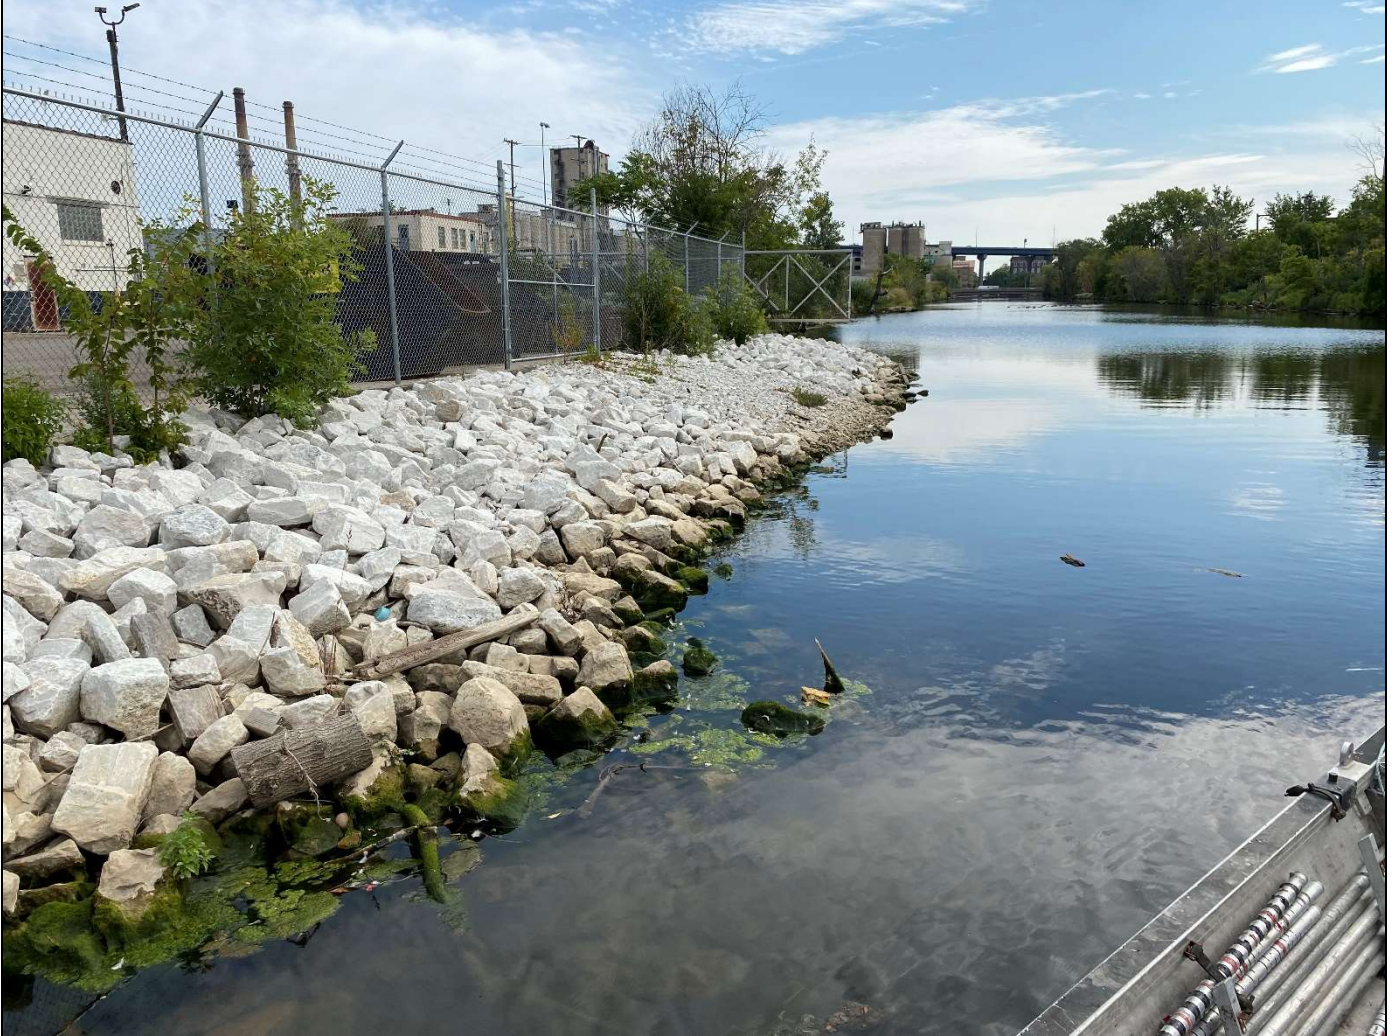
Photograph ID: 4

Comments: View of medium riprap along eastern portion of Unpaved Engineering Control Area, looking north.

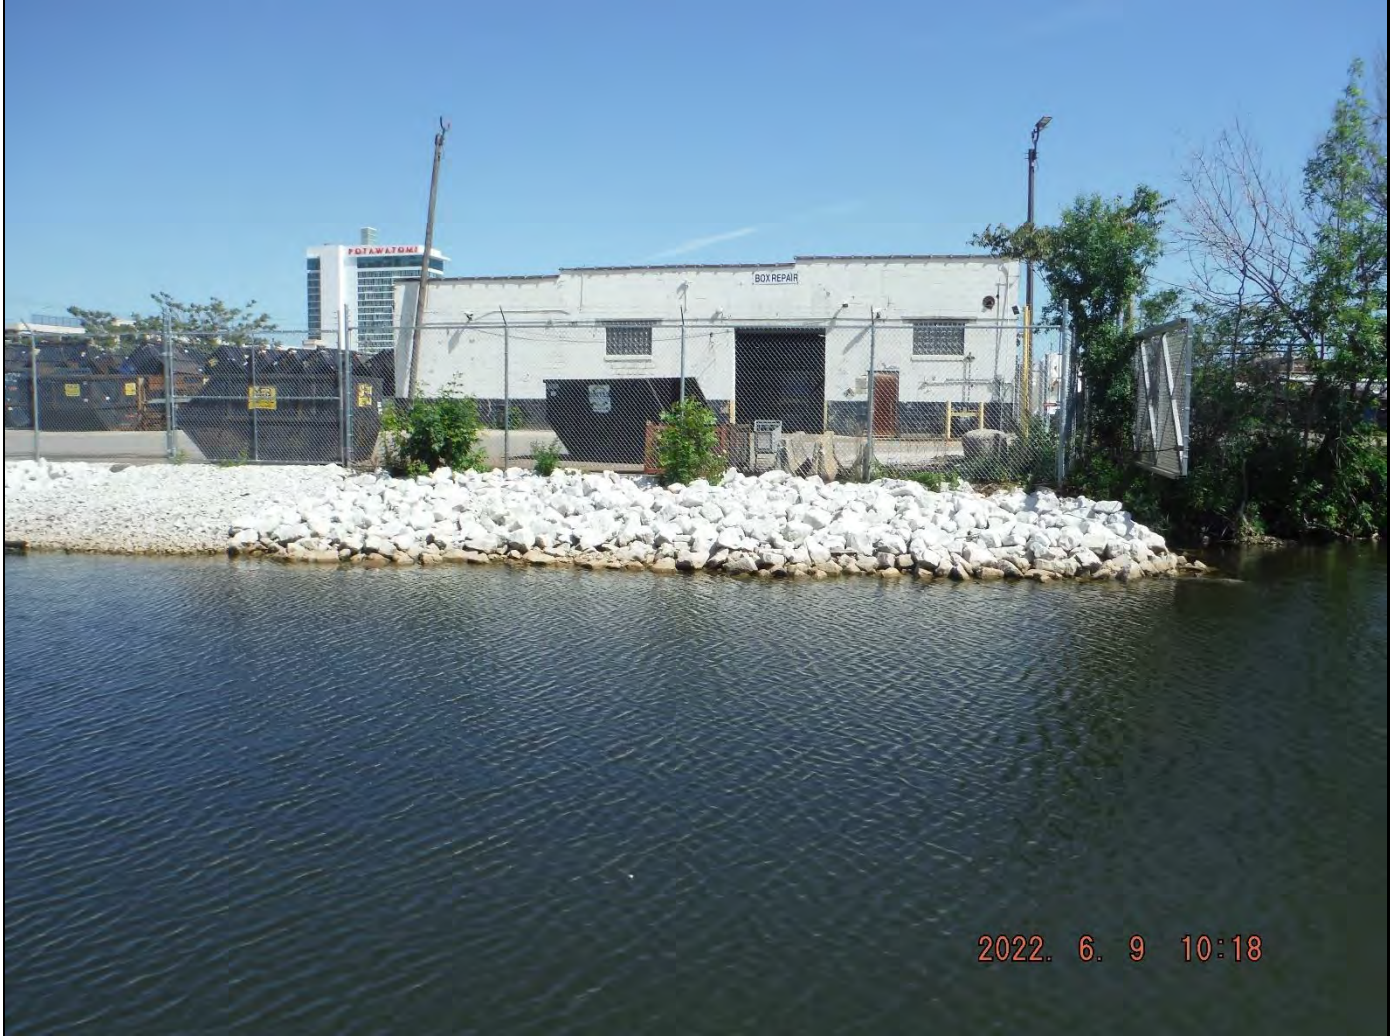
Photograph ID: 5

Comments: View of select crushed aggregate beneath water surface adjacent to north bank east of the Unpaved Engineering Control Area, looking north.

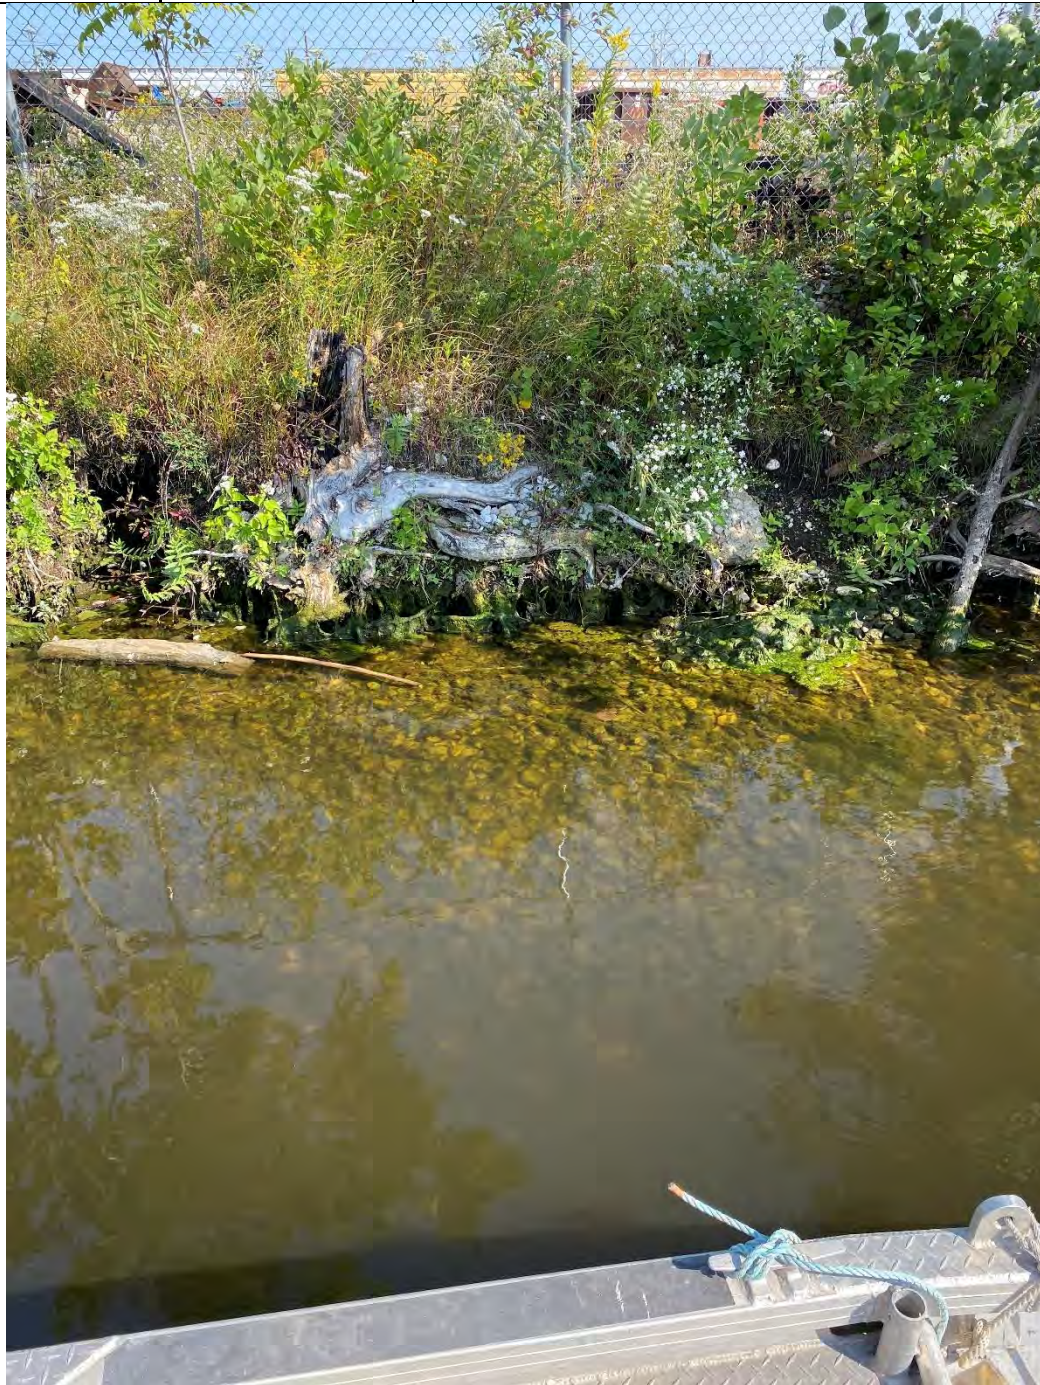
Photograph ID: 6

Comments: View of medium riprap in the Unpaved Engineering Control Area near CSO-194, looking northwest.

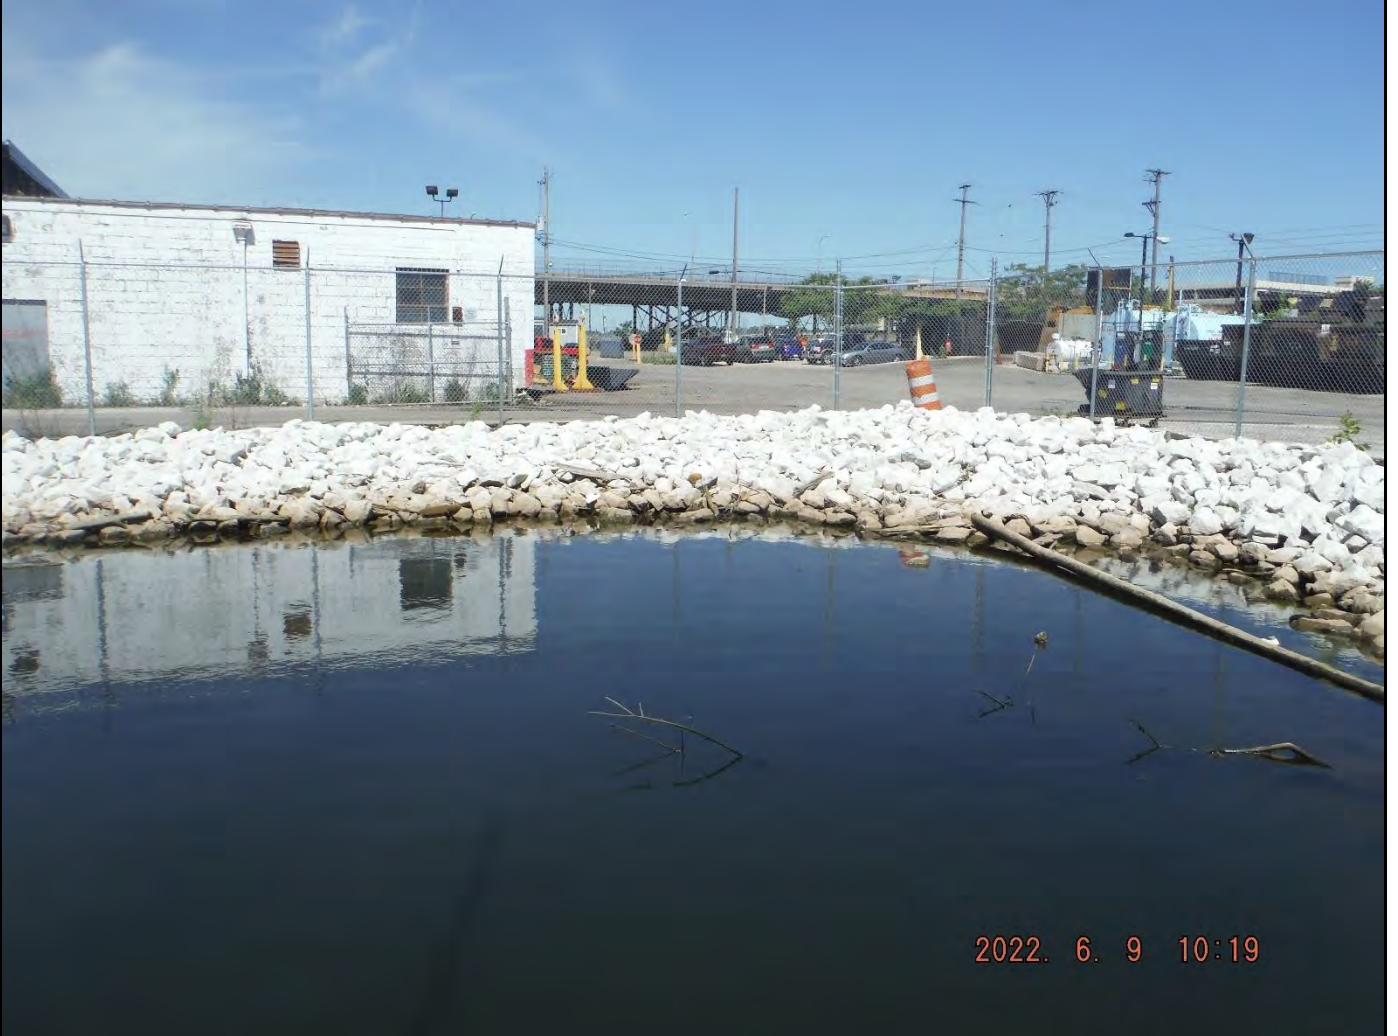
Photograph ID: 7

Comments: View of medium riprap in the Unpaved Engineering Control Area near CSO-194, looking northwest.

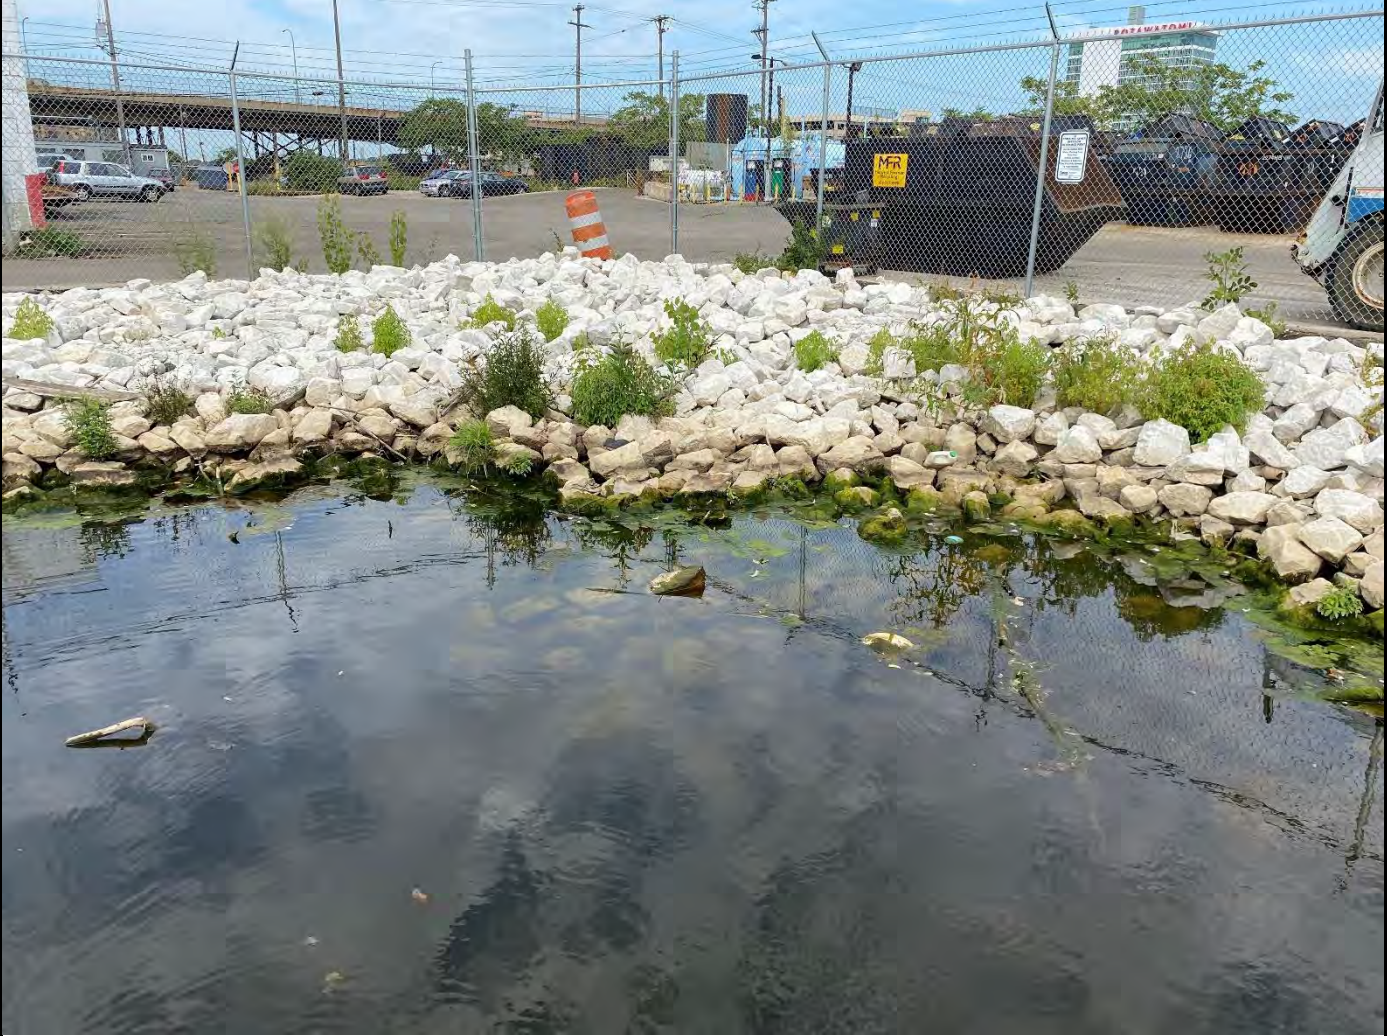
Photograph ID: 8

Comments: View of medium riprap along western portion of Unpaved Engineering Control Area, looking west.

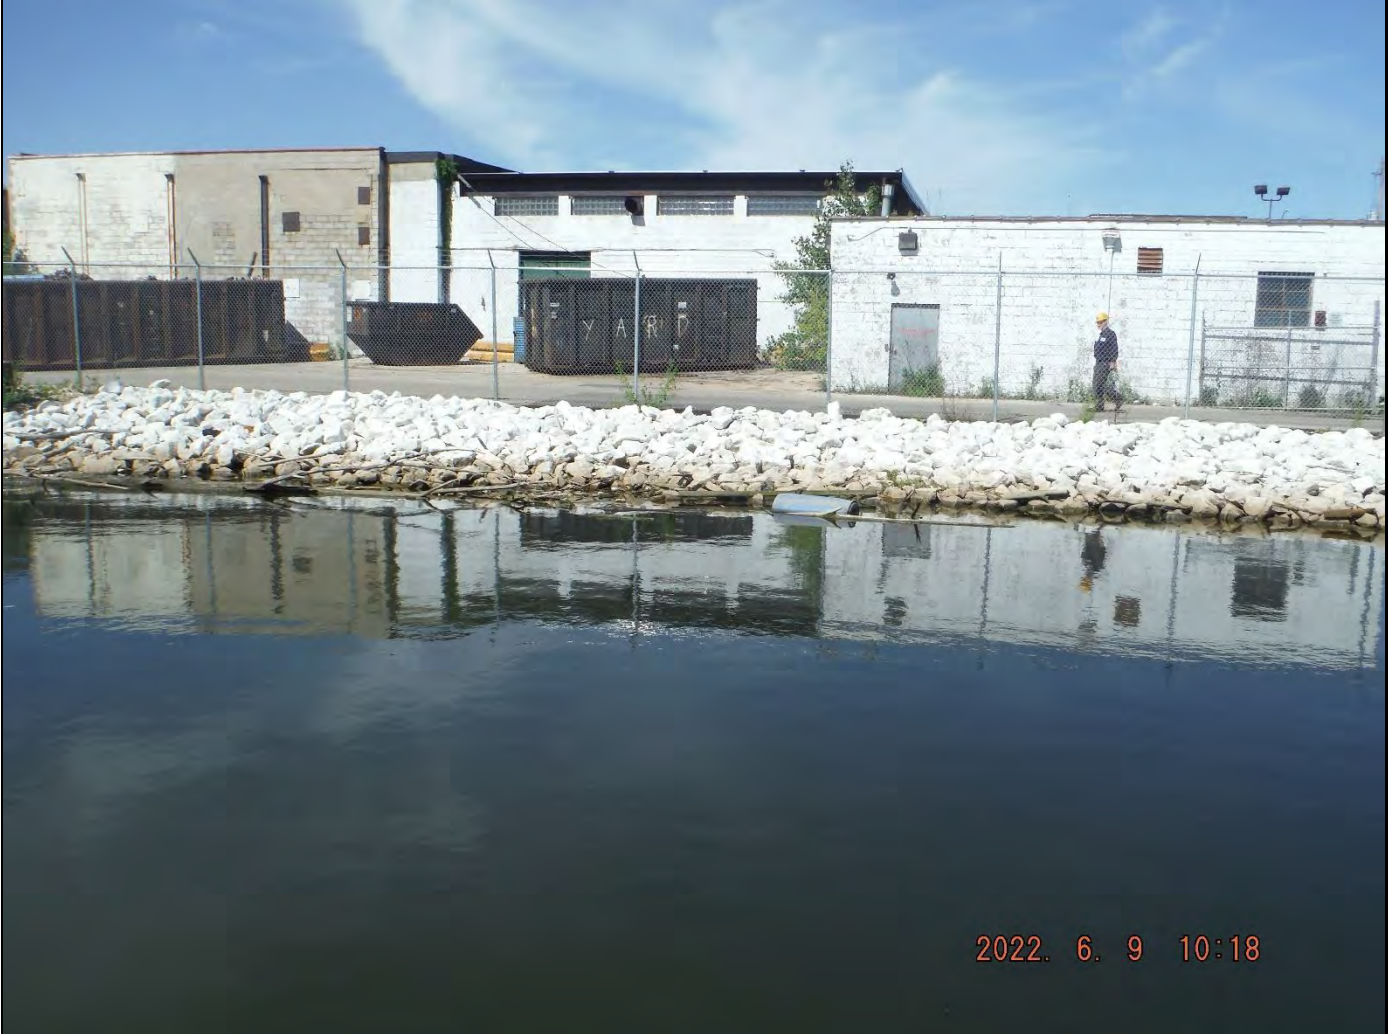
Photograph ID: 9

Comments: View of medium riprap along western portion of Unpaved Engineering Control Area, looking west.
