January 31, 2023

**POST-CONSTRUCTION MONITORING REPORT
FOR JUNE 2022 ANNUAL MONITORING AND
SEPTEMBER 2022 STORM-RELATED
MONITORING**

**BURNHAM CANAL SUPERFUND ALTERNATIVE SITE
MILWAUKEE, MILWAUKEE COUNTY, WISCONSIN**

MILLER COMPRESSING COMPANY

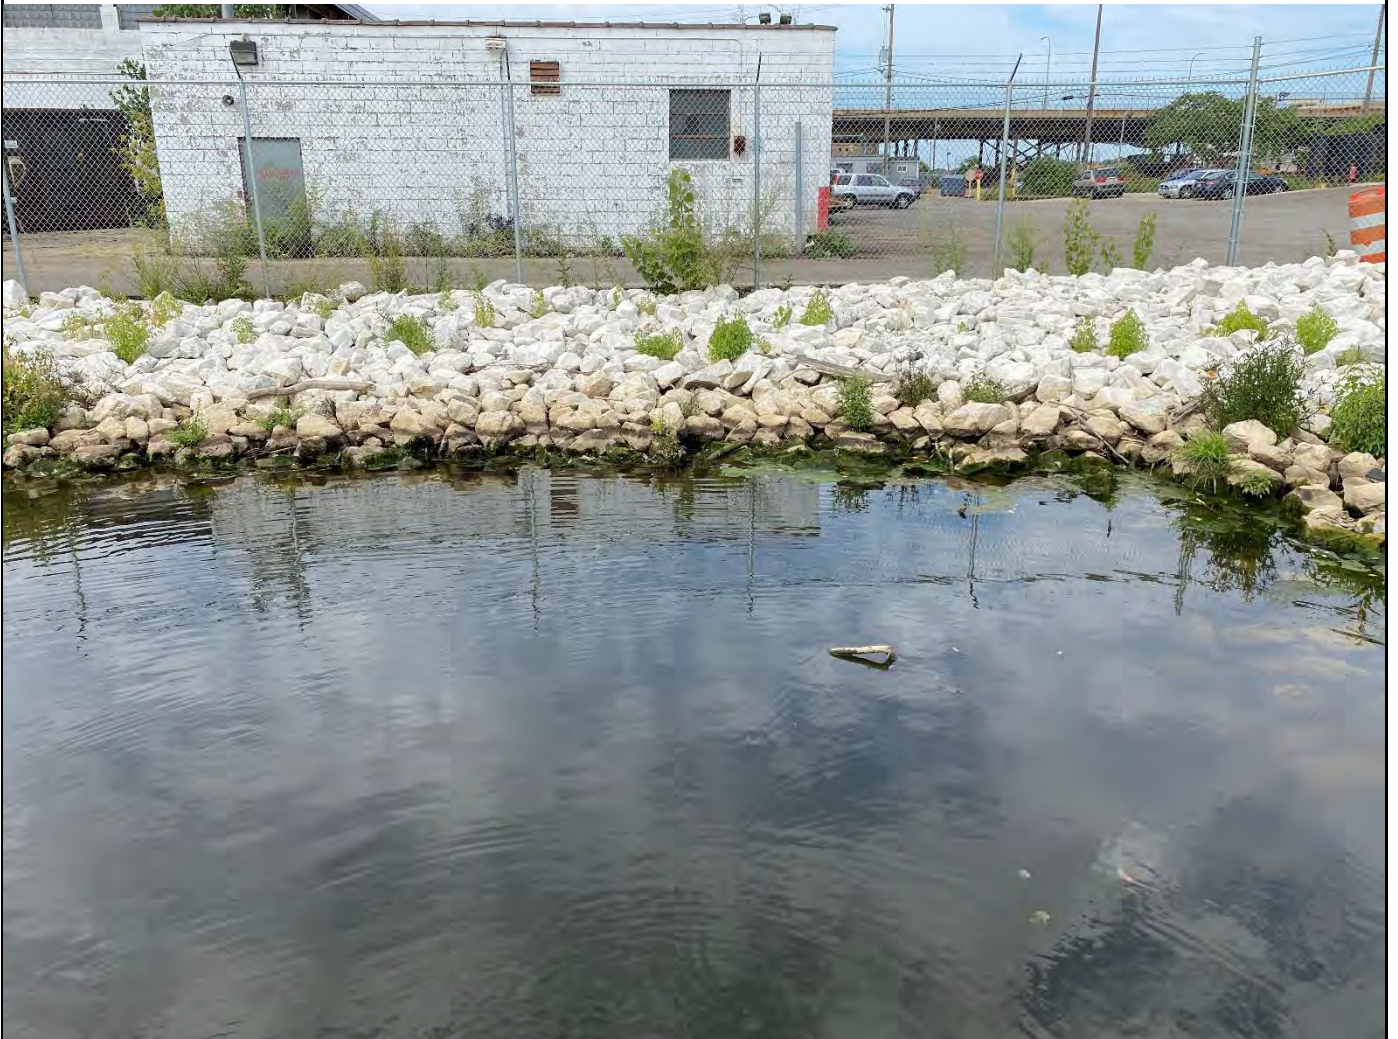
Photograph ID: 10

Comments: View of medium riprap along southwestern portion of Unpaved Engineering Control Area looking southwest.

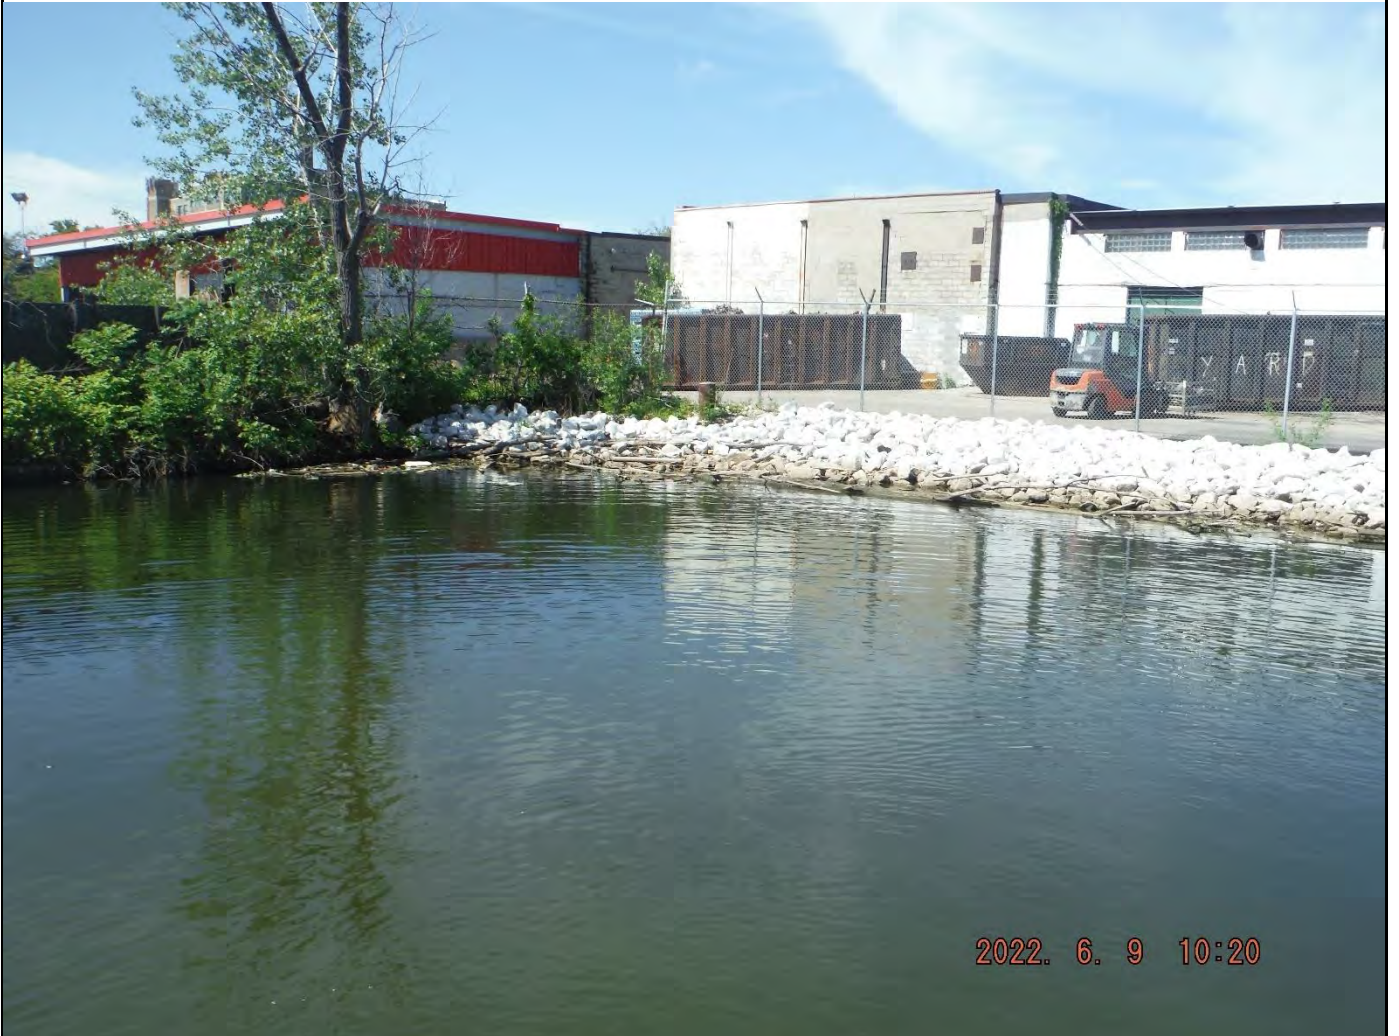
Photograph ID: 11

Comments: View of medium riprap along western portion of Unpaved Engineering Control Area looking south.

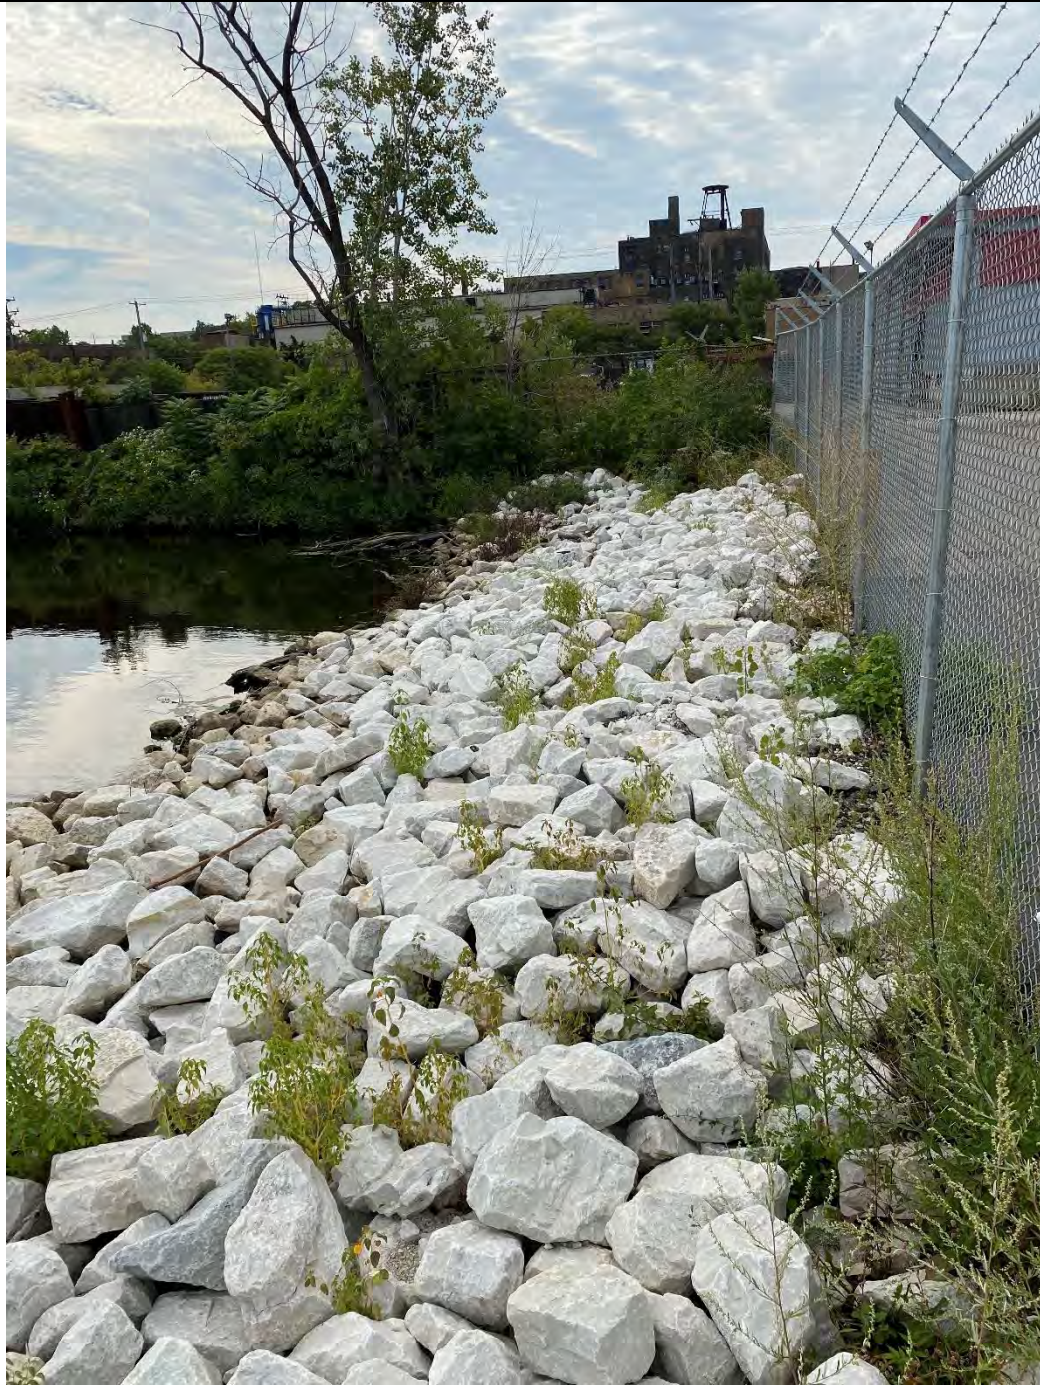
Photograph ID: 12

Additionally, Ramboll used a global positioning system (GPS) to measure the surface elevation of poling location 125, which was above the water surface at the time of the inspection. Location 125 was included in the poling network to represent Approval Unit 1 and, when applicable at times of higher water levels and limited visibility beneath the water surface, the submerged portion of the Unpaved Engineering Control Area. Post-construction as-built Betterment surface contours in **Figure 1** and aerial imagery in **Figure 2b** were both overlaid with as-built poling locations from the September 2022 inspection event. Poling observations and measurements are summarized in **Table 2** and results from location 125 indicate that, in addition to riprap being visually present, the surface elevation of the Unpaved Engineering Control Area on September 16, 2022 is generally the same as its as-built elevation. Per the COMMP (Ramboll, 2021a), no further action is required at this time based on the confirmation of the presence of riprap.

Comments: GPS measurement of Unpaved Engineering Control Area surface elevation at poling location 125 (above water surface), looking east.
