December 1, 2023

**POST-CONSTRUCTION MONITORING REPORT
FOR JUNE 2023 ANNUAL MONITORING
BURNHAM CANAL SUPERFUND ALTERNATIVE SITE
MILWAUKEE, MILWAUKEE COUNTY, WISCONSIN
MILLER COMPRESSING COMPANY
WDNR BRRTS #: 02-41-552940
EPA ID: WIN000510222**

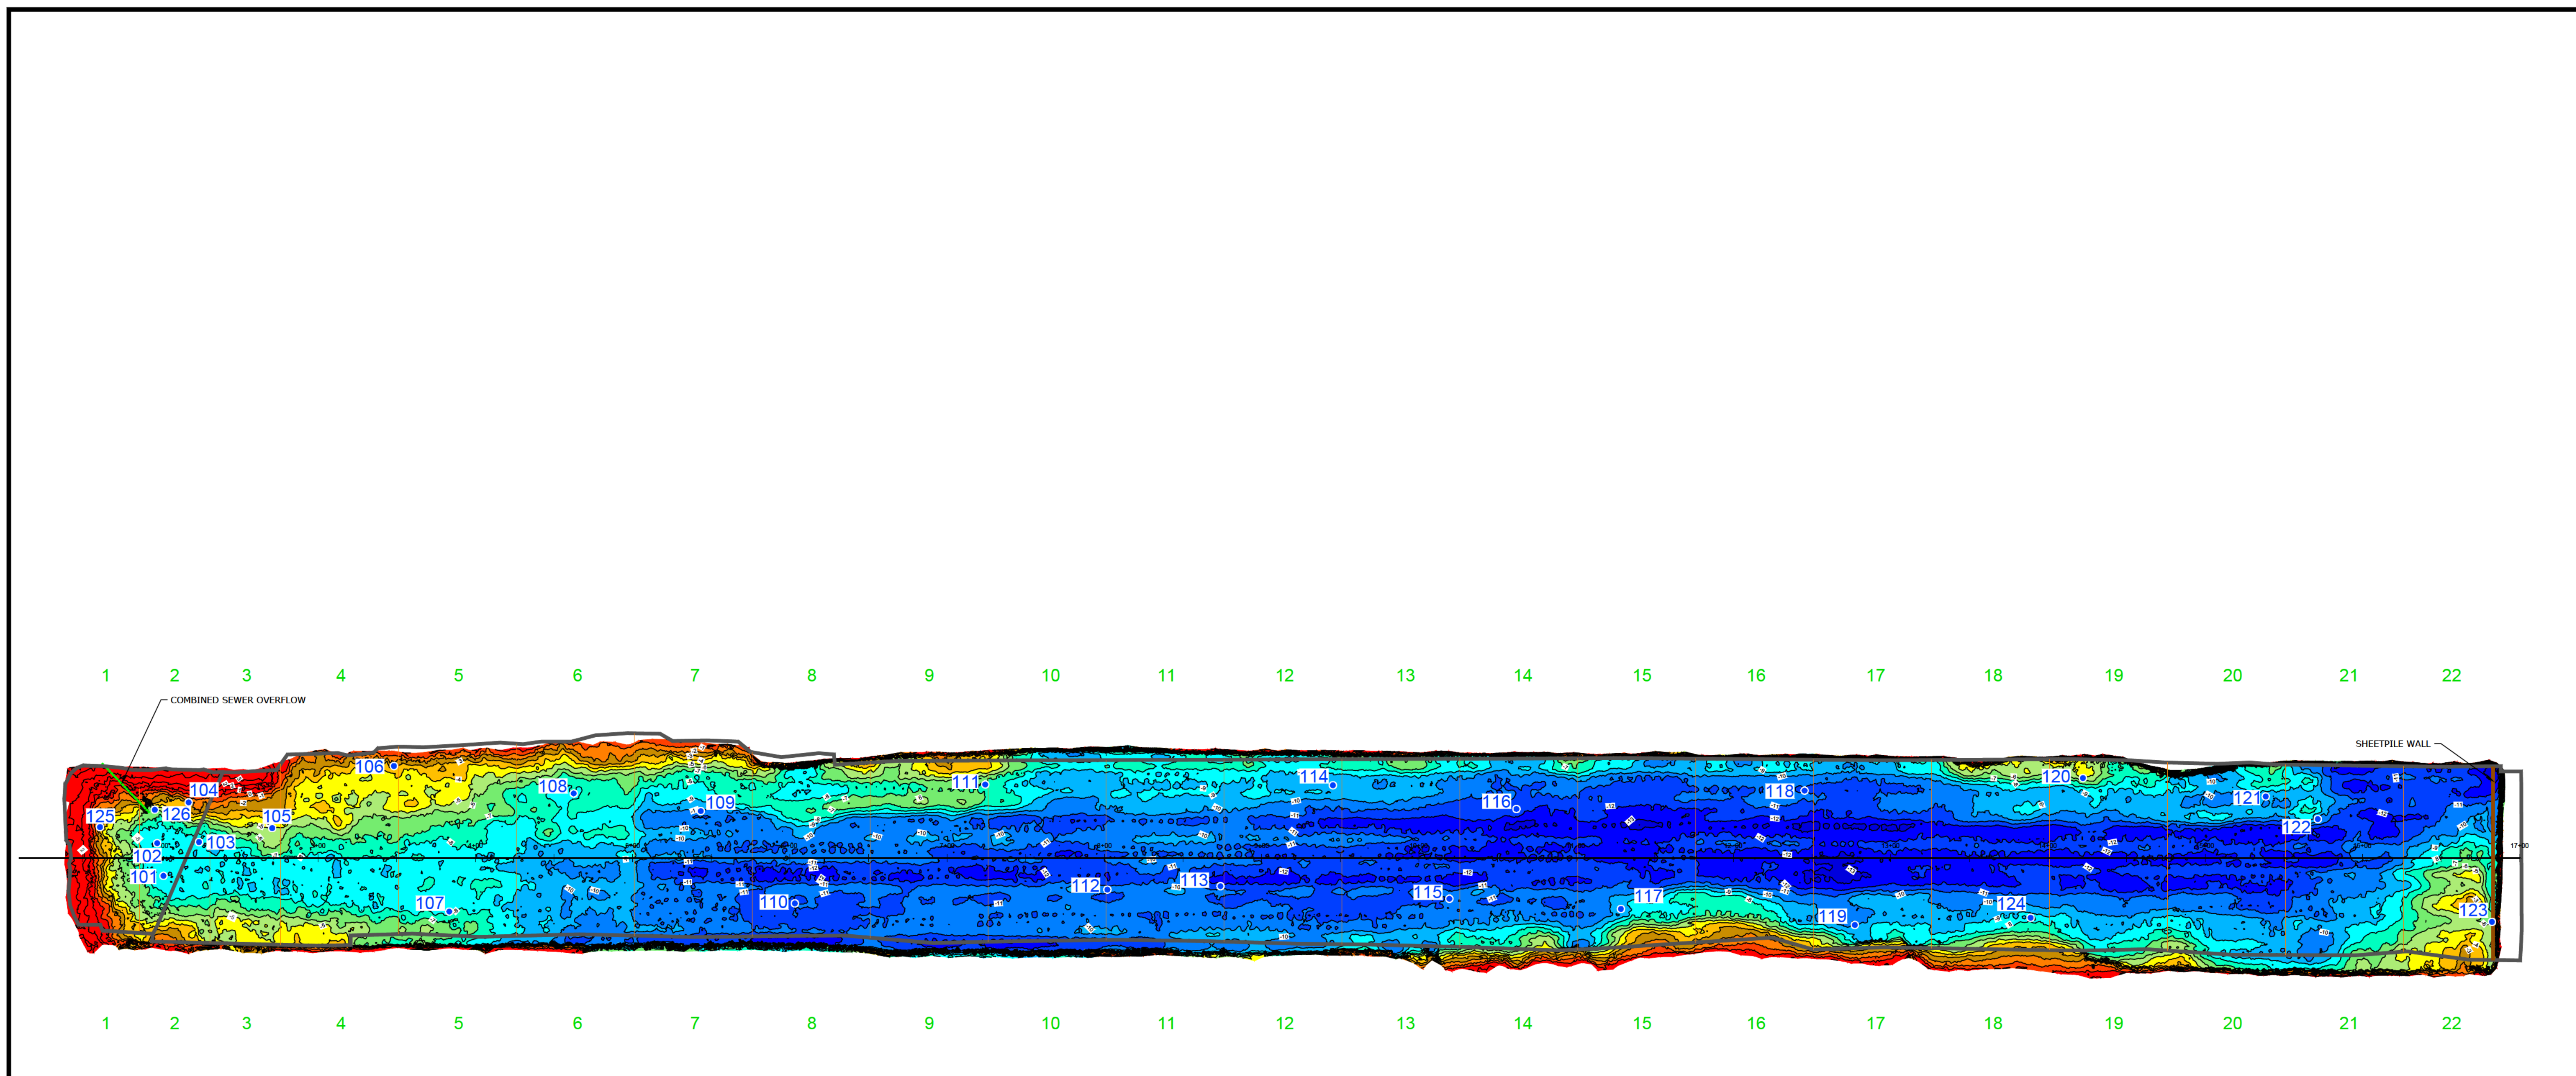
The annual poling of the Subaqueous Engineering Control Area was conducted by Ramboll on June 19, 2023. Post-construction as-built Betterment surface contours in **Figure 1** and aerial imagery in **Figure 2** were both overlaid with as-built poling locations from the June 2023 poling event. Poling locations 101 through 124 are in the Subaqueous Engineering Control Area and were selected based on proposed verification locations provided on Figure 3 of the COMMP (Ramboll, 2021a). As described in the previous section, poling location 125 was included in the poling event to represent Approval Unit 1 and the submerged portion of the Unpaved Engineering Control Area. Poling location 126 is in the Subaqueous Engineering Control Area and was included in the poling event to evaluate conditions near the pipe outlet of combined sewer outfall (CSO)-194 (formerly CSO-211).

(6 inches), respectively. The maximum approximate elevation increase (0.6 feet [7 inches]) was noted at poling location 123 and the maximum approximate elevation decrease (1.3 feet [16 inches]) was noted at poling location 110. Poling locations 123 and 110 are both located in the Full-Thickness Betterment area. All approximate elevation decreases are within the range of probable settlement of 1.8 feet (22 inches) in the Low-Profile Betterment area and 2.6 feet (32 inches) in the Full-Thickness Betterment area. Furthermore, due to the accuracy limitations noted above, these estimates should be used for informational purposes only for general characterization of the anticipated settlement. Additionally, note that many locations at which elevation increases are indicated are on slopes where an accuracy limitation of a few lateral feet could be the cause of apparent elevation increases or exaggerated decreases rather than an actual change in elevation. Finally, note that the location at which the maximum approximate elevation increase was observed, poling location 123, is adjacent to the eastern boundary of the Canal which is adjacent to a downstream canal filling operation conducted by the Milwaukee Metropolitan Sewerage District from April through August of 2022.

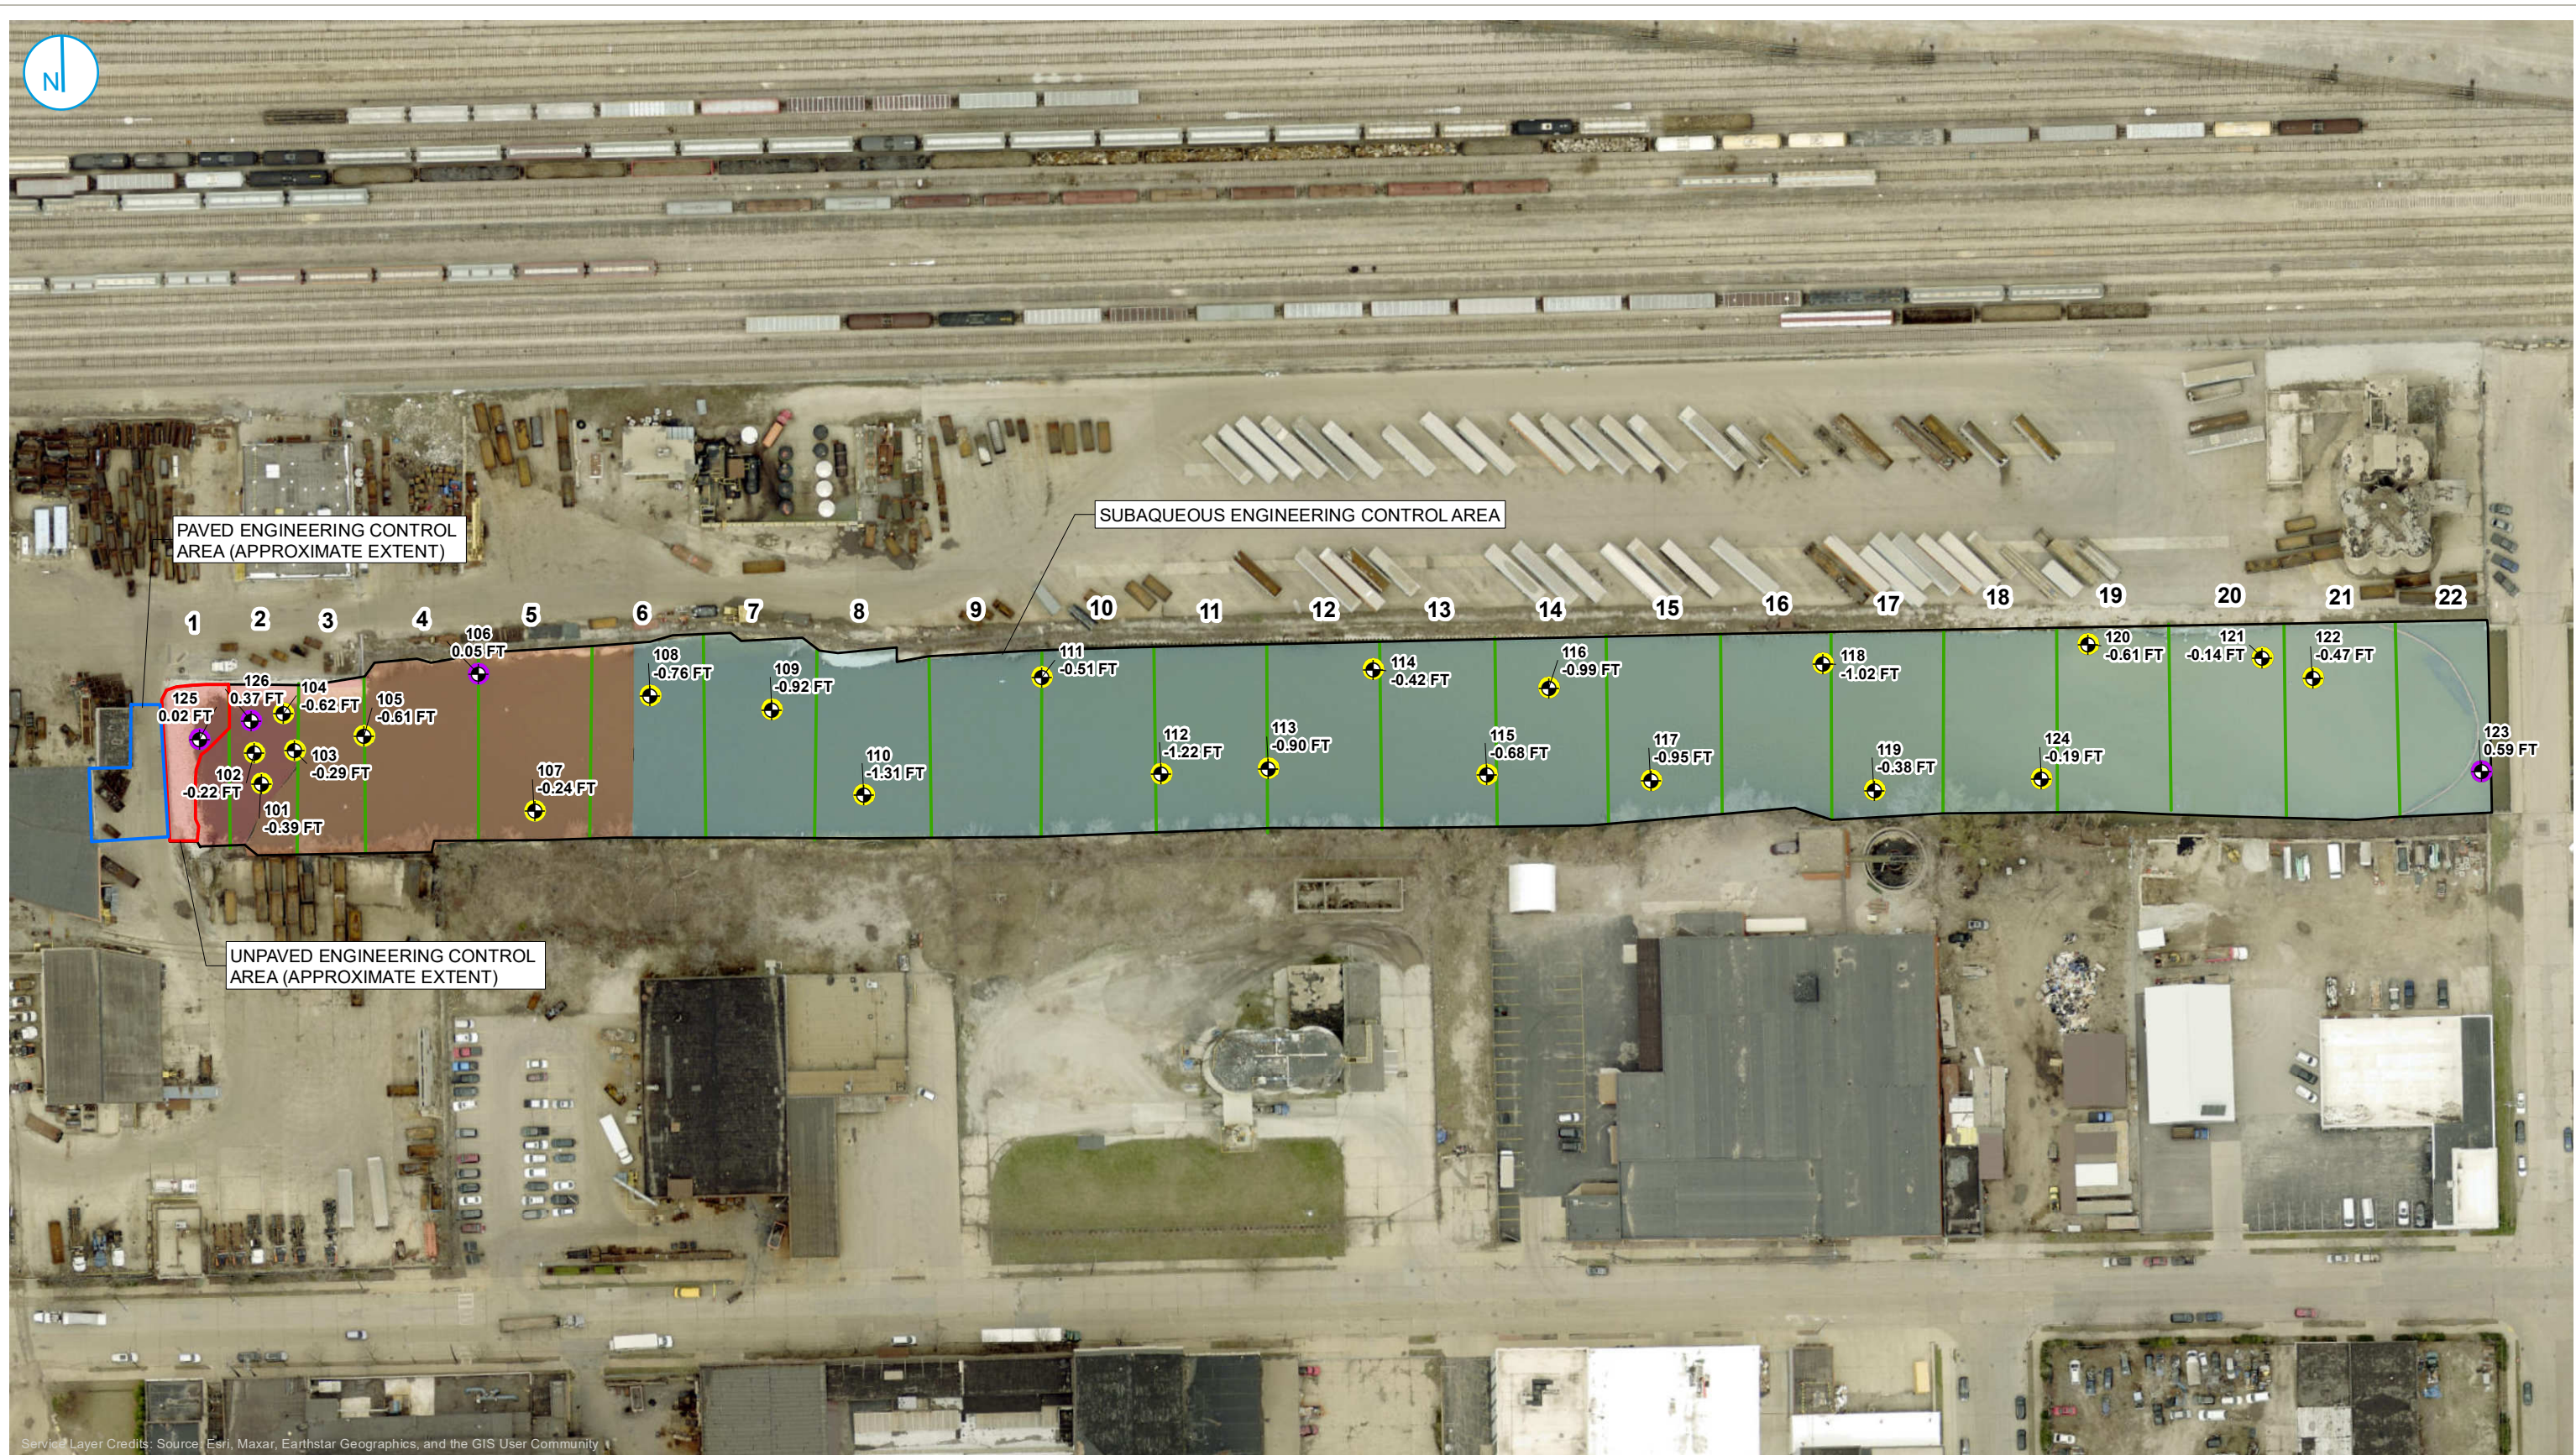
FIGURE 2

The annual poling of the portion of the Unpaved Engineering Control Area below the Burnham Canal water level (0.1 CMD feet) was conducted by Ramboll on June 19, 2023. Post-construction as-built Betterment surface contours in **Figure 1** and aerial imagery in **Figure 2** were both overlaid with as-built poling locations from the June 2023 inspection event. Poling location 125 was included in the poling event to represent Approval Unit 1 and the submerged portion of the Unpaved Engineering Control Area. Poling observations and measurements are summarized in **Table 1** and indicate that riprap is present in the portion of the Unpaved Engineering Control Area below the Burnham Canal water level. Per the COMMP (Ramboll, 2021a), no further action is required as a result of the annual poling based on the confirmation of the presence of riprap.

As summarized in **Table 1**, the presence of riprap or select crushed (Betterment) was confirmed at all poling locations in the Subaqueous Engineering Control Area. As such, per the COMMP (Ramboll, 2021a), no further action is required as a result of the annual poling.

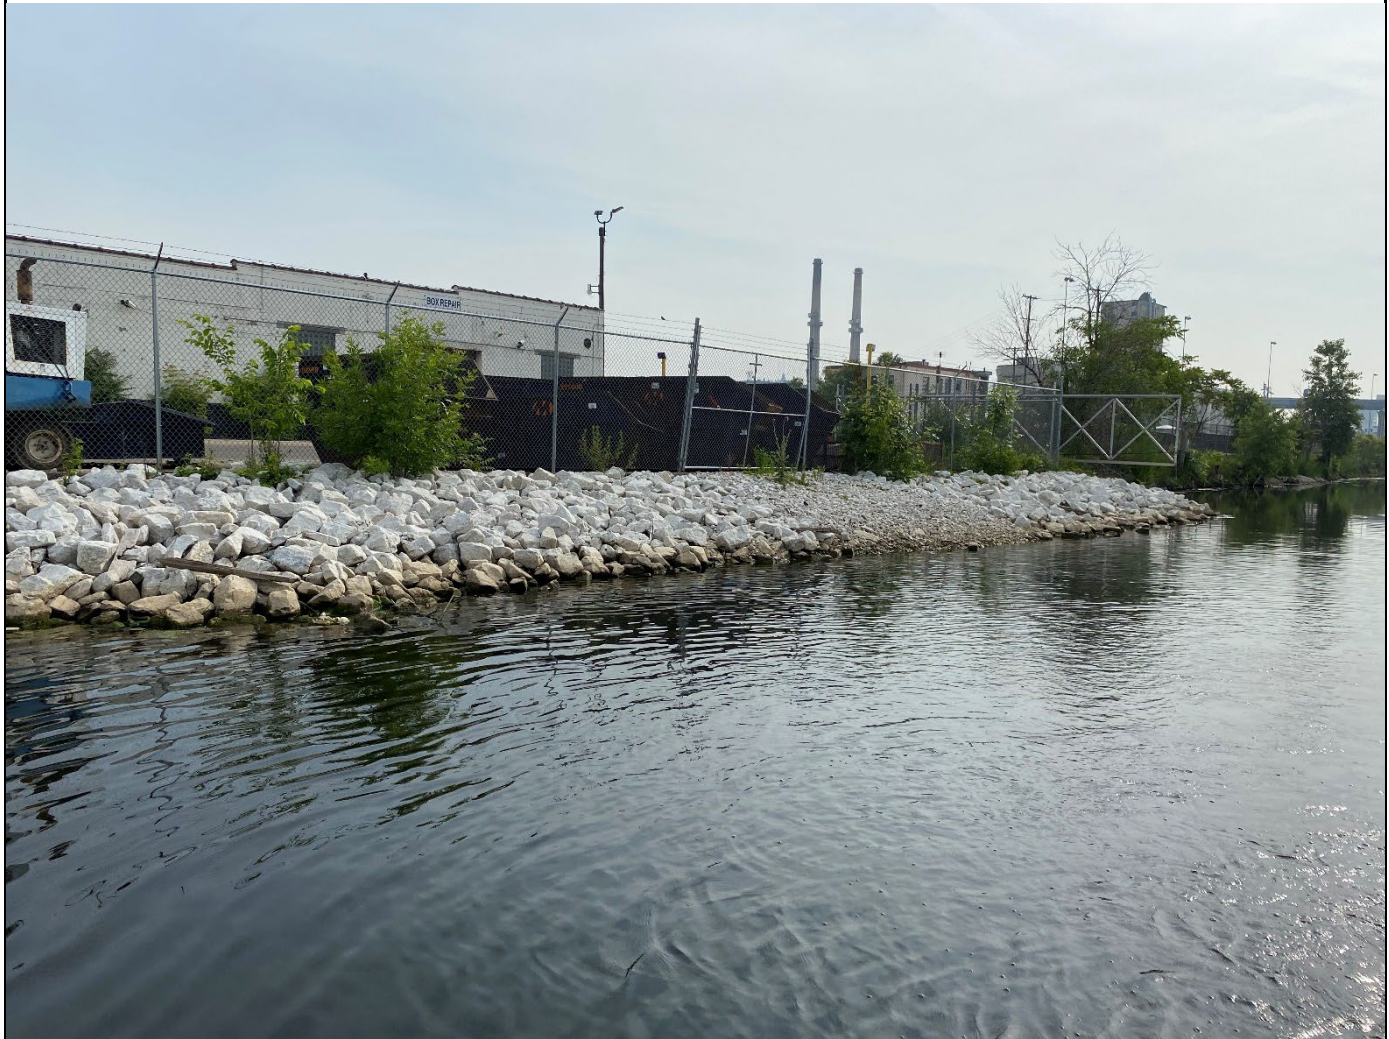
The annual visual inspection of the portion of the Unpaved Engineering Control Area above the Burnham Canal water level was conducted by Ramboll on June 19, 2023. The water elevation was 0.1 City of Milwaukee Datum (CMD) feet at the time of the inspection. As shown in the photo log included as **Appendix B**, the riprap placed along the west bank of the Burnham Canal is in good condition. No evidence of erosion was observed, and no repair or maintenance activities are necessary at this time.

Client: Miller Compressing Company	Project: Burnham Canal Post-Construction Monitoring	
Site Name: Burnham Canal SAS	Site Location: Milwaukee, Wisconsin	
Photograph ID: 1	Date: 6/19/2023	Comments: View of medium riprap along northeastern portion of Unpaved Engineering Control Area, looking northeast.

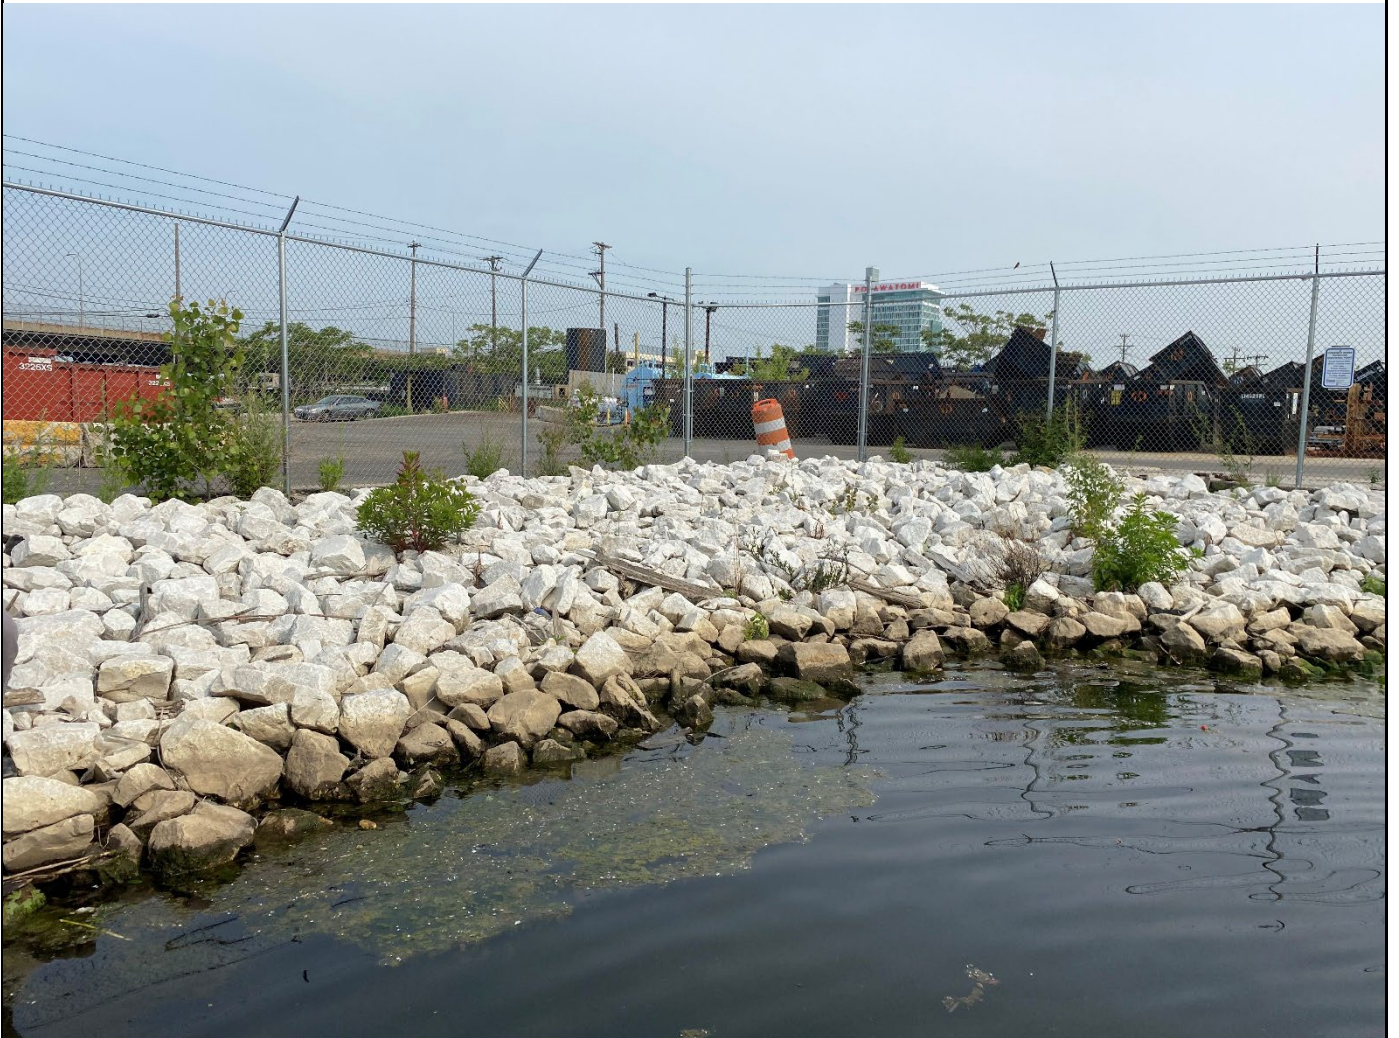
Photograph ID: 2

Comments: View of medium riprap within Unpaved Engineering Control Area, looking northwest.

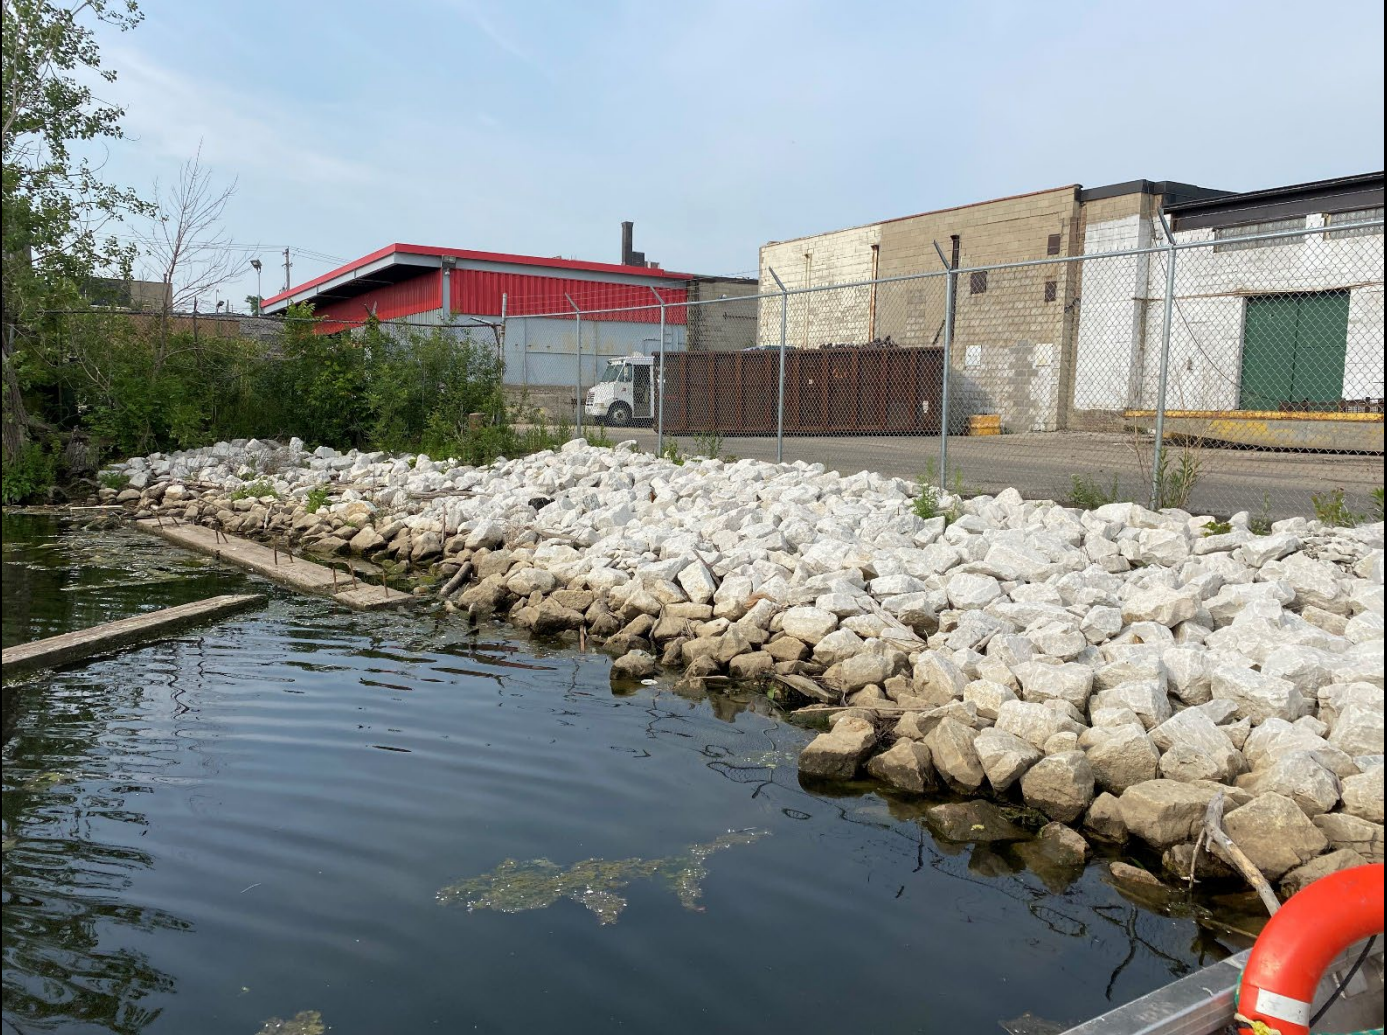
Photograph ID: 3

Comments: View of medium riprap within Unpaved Engineering Control Area, looking southwest.

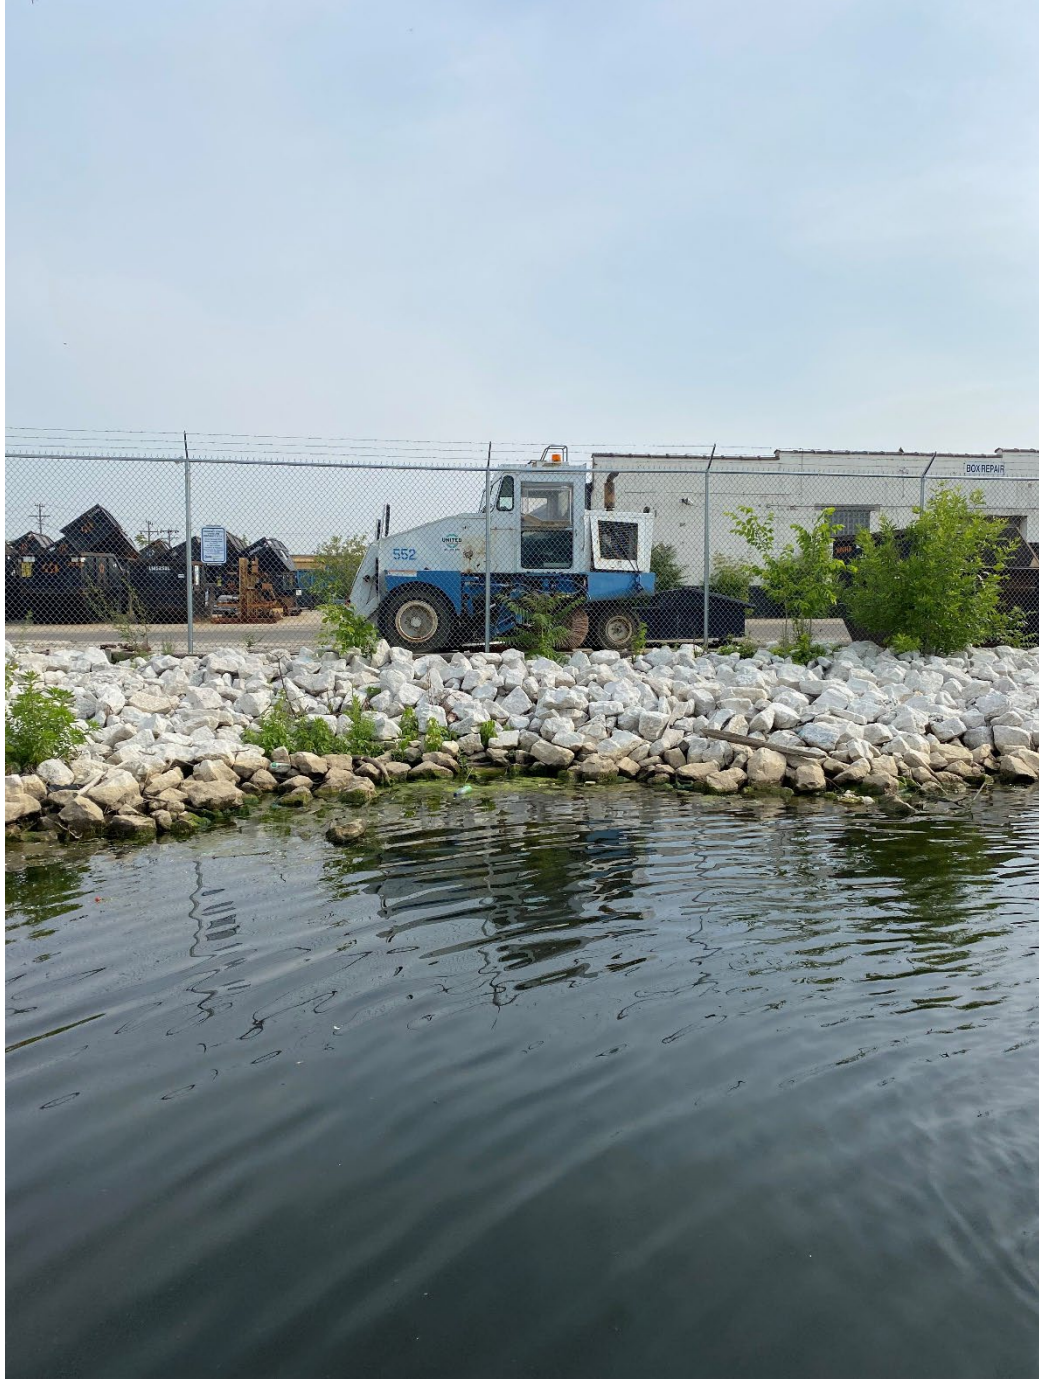
Photograph ID: 4

Comments: View of medium riprap within Unpaved Engineering Control Area, looking north.

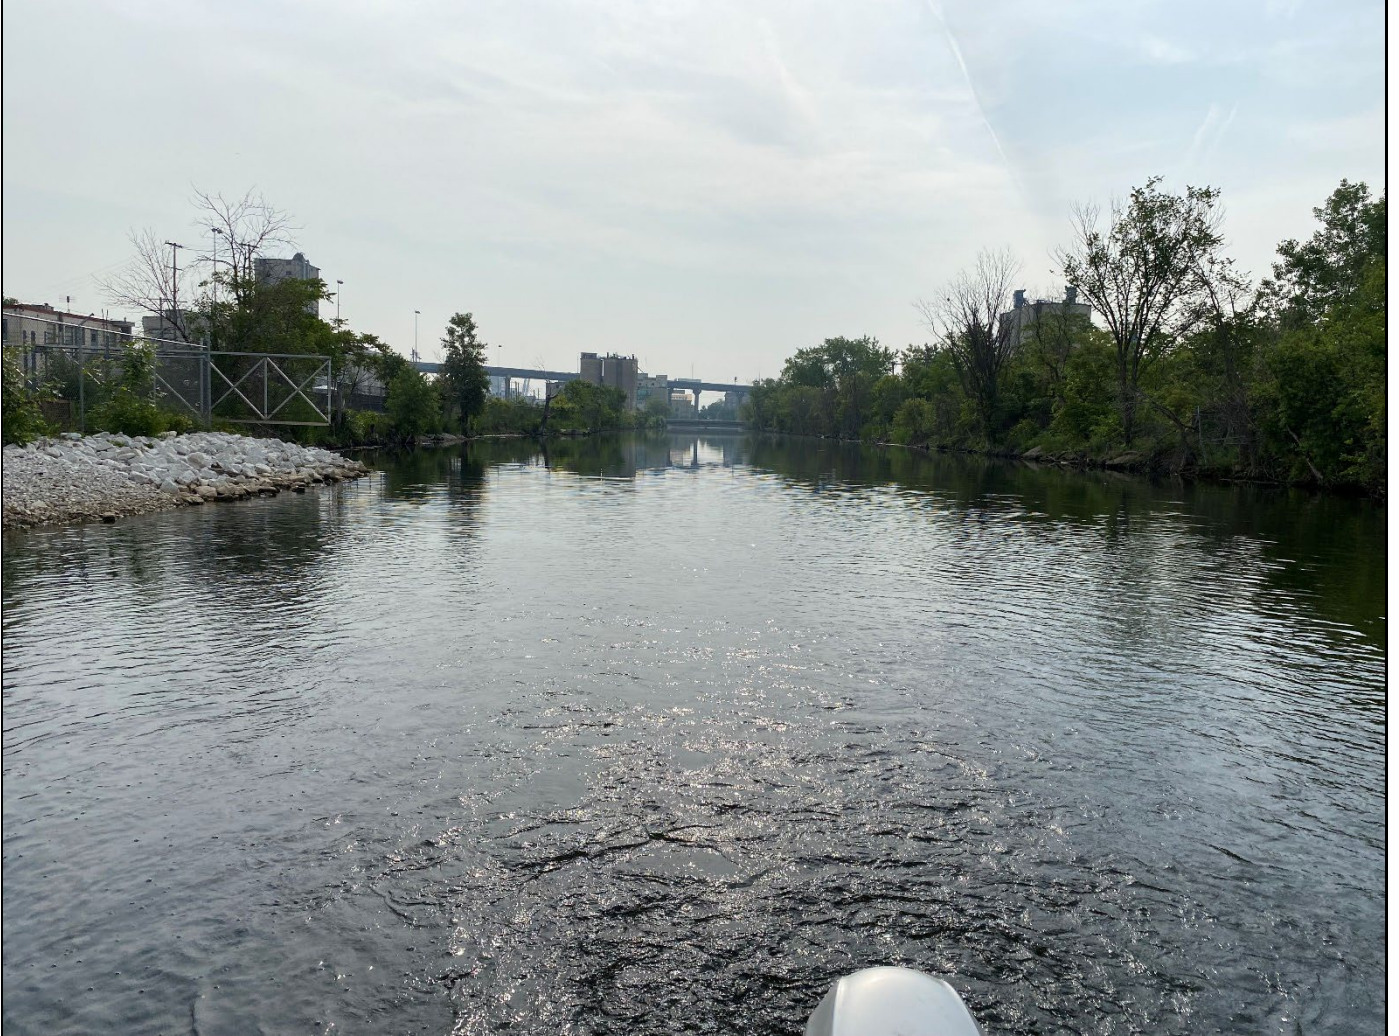
Photograph ID: 5

Comments: View of Burnham Canal from within Unpaved Engineering Control Area looking east.

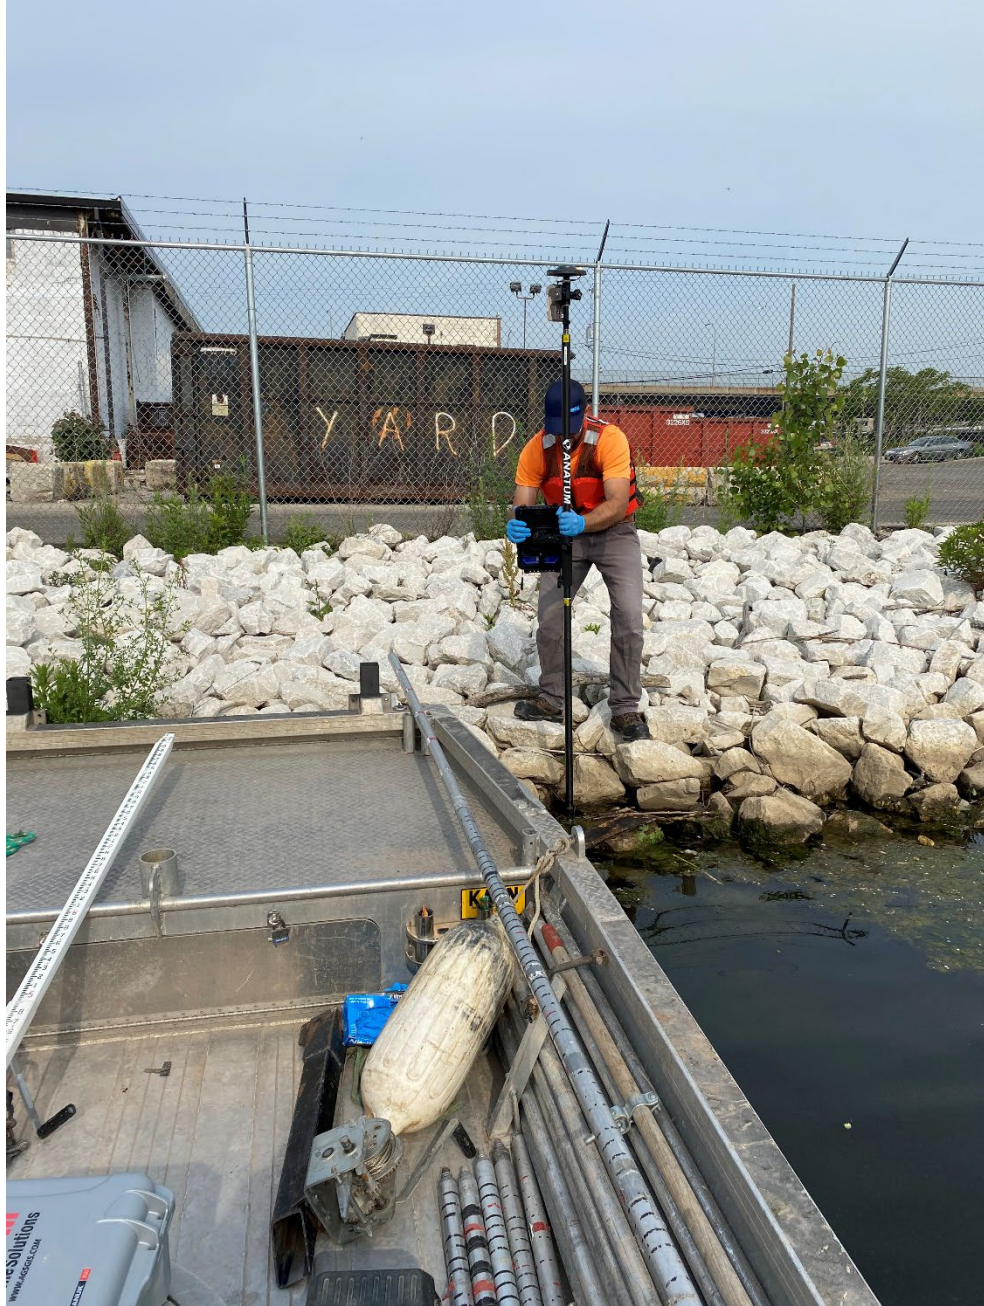
Photograph ID: 6

Comments: Inspection of Unpaved Engineering Control Area and GPS data collection operations, looking west.

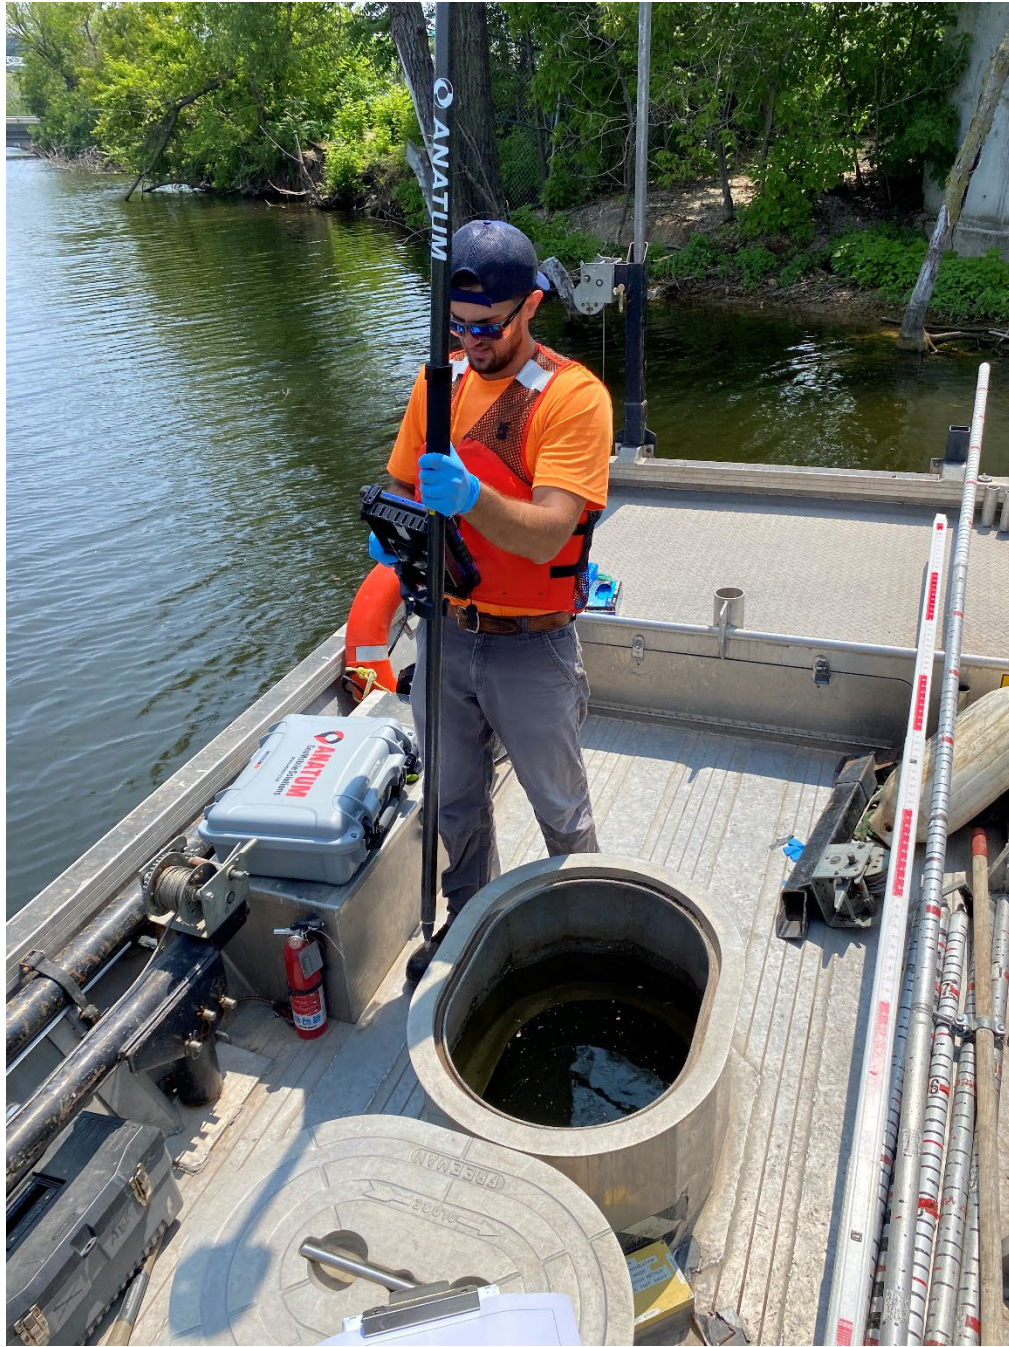
Photograph ID: 7

Comments: Inspection of subaqueous Betterment surface and GPS data collection operations, looking southeast.
