RE: *Additional Information for Proposed Site Investigation*, Jagemann Plating Company,
1324 South 26th Street, Manitowoc, WI 54220; BRRTS #02-36-555544

ATTACHMENT A

SITE INVESTIGATION REPORT – PAGE 4 REVISION

SSD VAPOR EXTRACTION FINAL REPORT

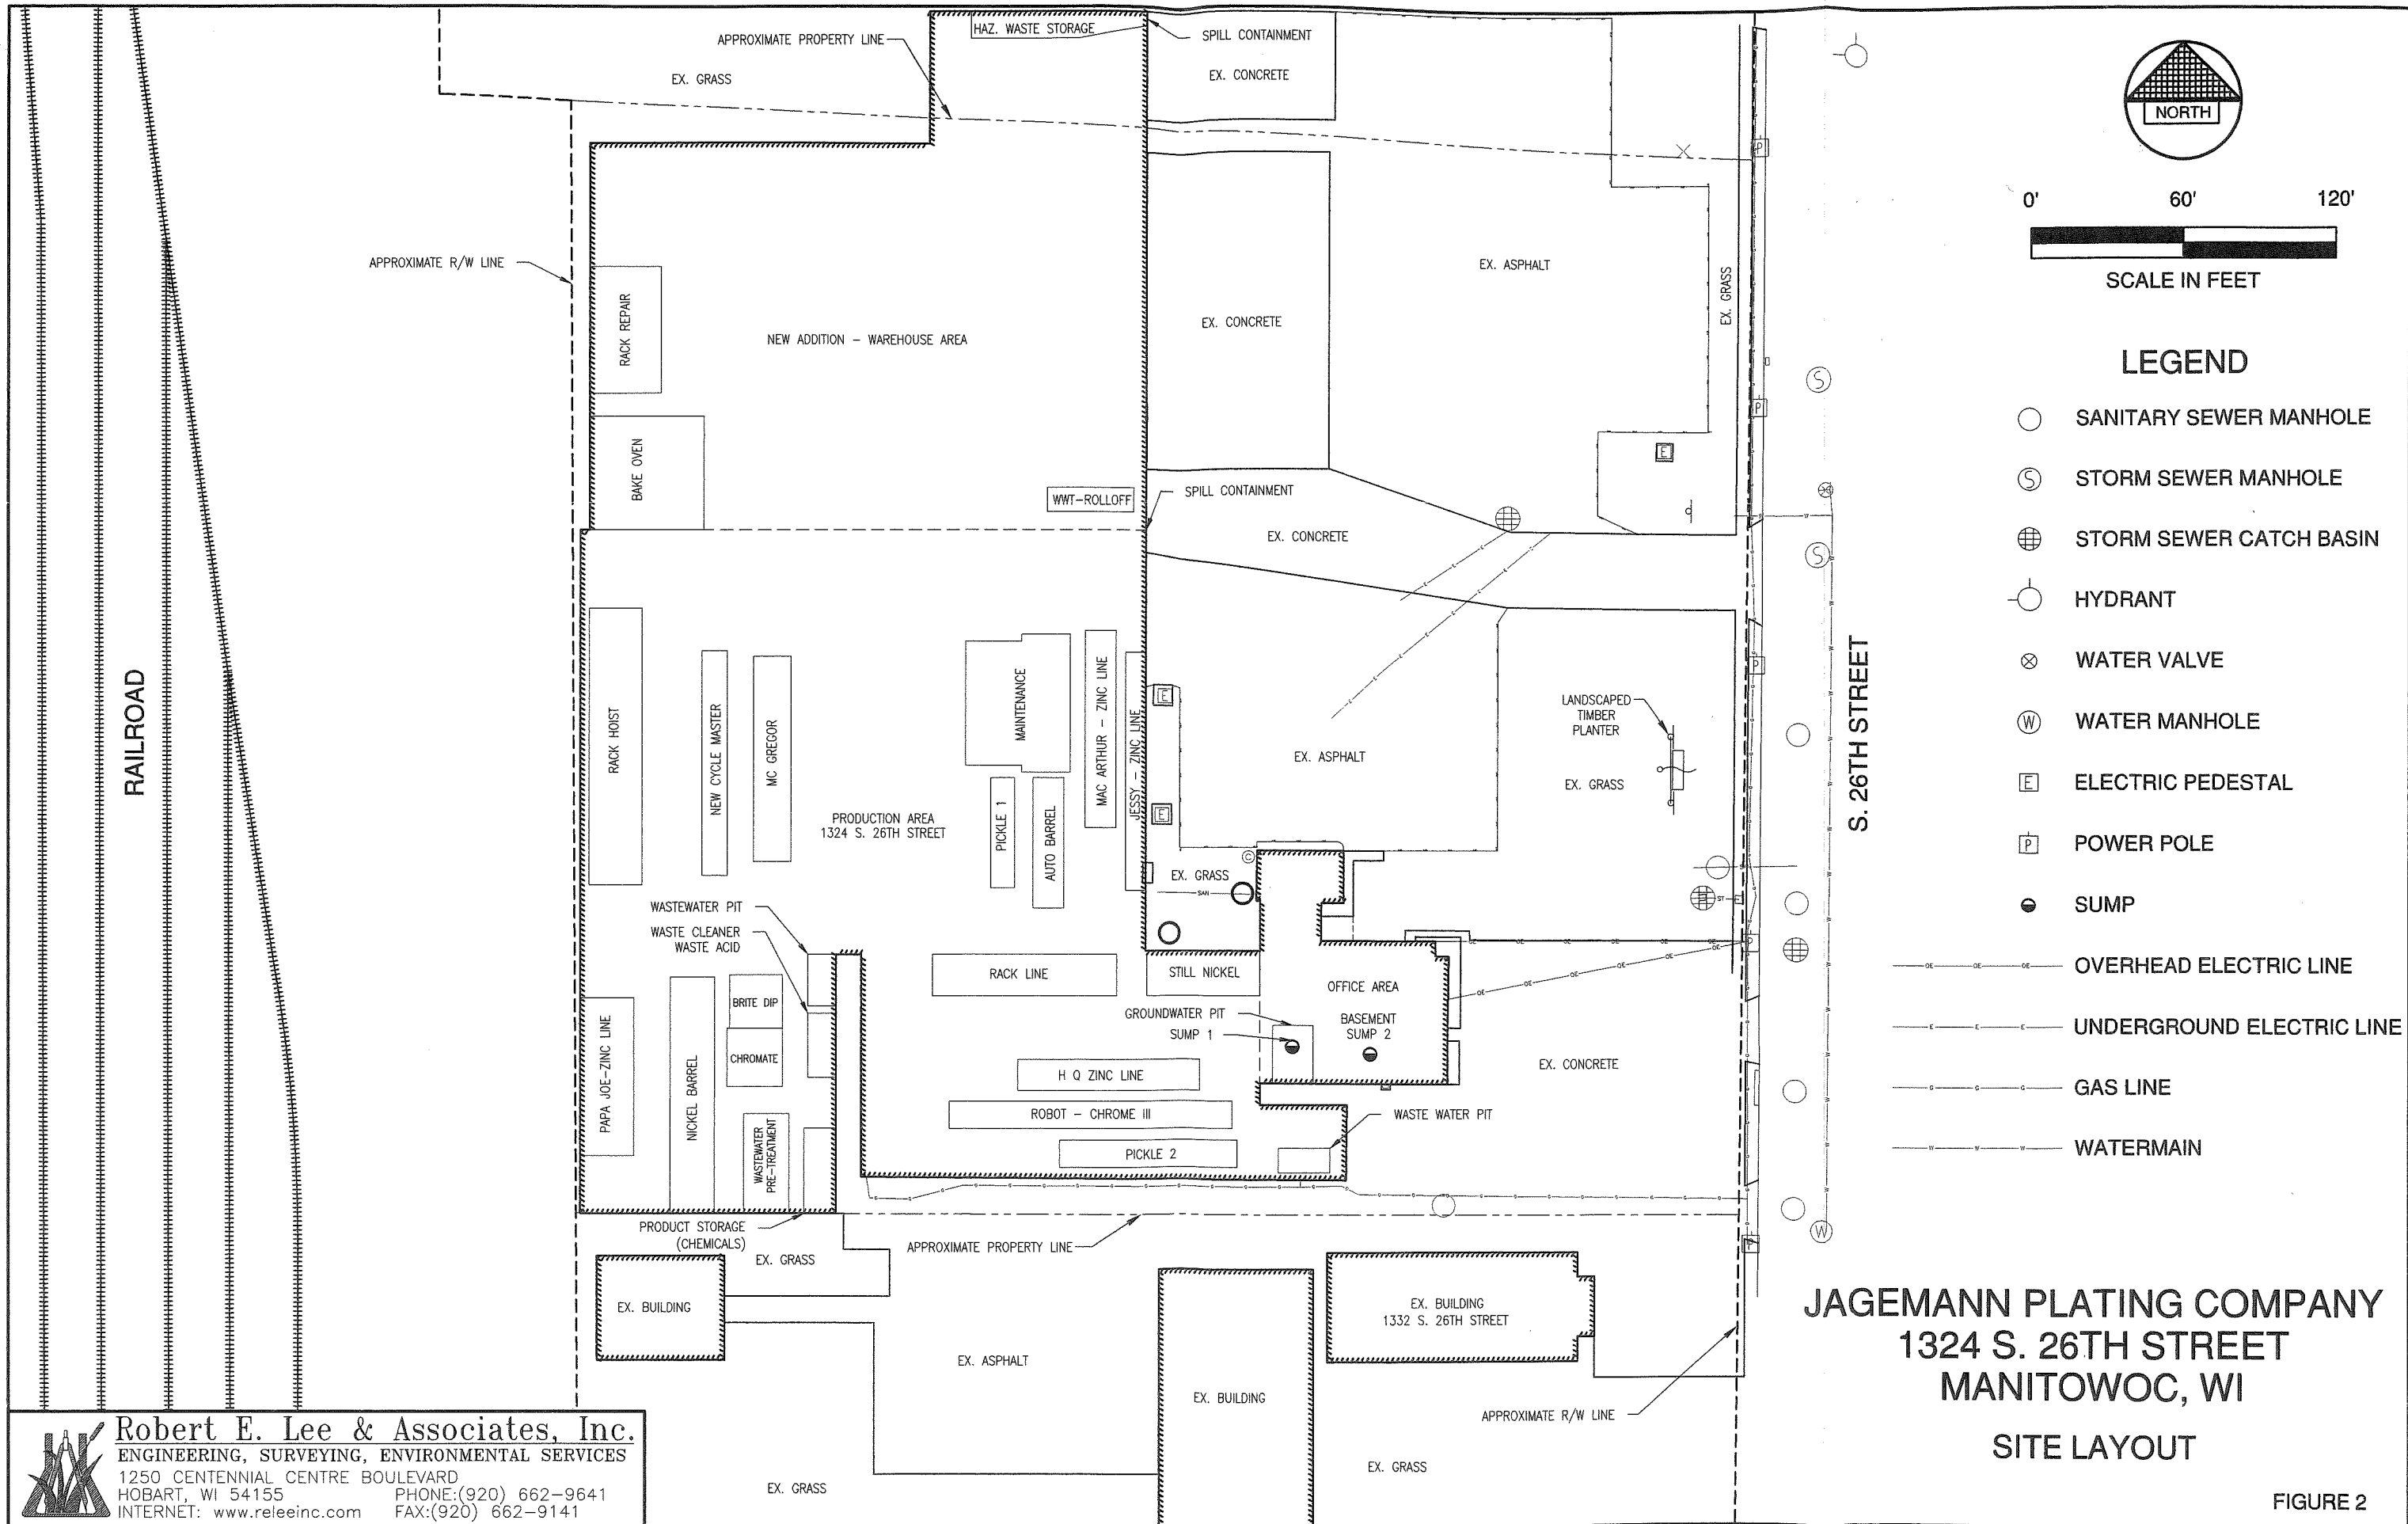
FIGURE 2

The source of the chromium contamination at the Site is from a leak in a chromium line beneath the floor of the building in the production area. The chromium tank drained into the pit located in the Maintenance Room. The chromium was pumped back into the tank, the plumbing was inspected, and the broken pipe was discovered and repaired. The chromium that was not recovered and re-used was treated in the on-site wastewater treatment system. A sump (Sump 1) was installed in the pit to capture any remaining chromium released by the pipe break. The sump is pumped directly to the wastewater treatment system. The location of the chromium tank, the pit in the Maintenance Room, Sump 1, and on-site wastewater treatment system are shown in Figure 2, included in Attachment C.
