Client:	SaberCor, LLC 8440 W. National Ave. West Allis, WI 53227	Property Inspected:	Landmark Credit Union 106 E. Main Street Beaver Dam, WI 53916
On-site Inspector:	Patrick Stearns	Inspection Date:	May 15, 2018

A site visit and visual inspection took place on May 15, 2018. Both Lots #9 & #10 were inspected. This report provides information regarding the current state of the pavement and our recommendations on how to best fulfill the required objective.

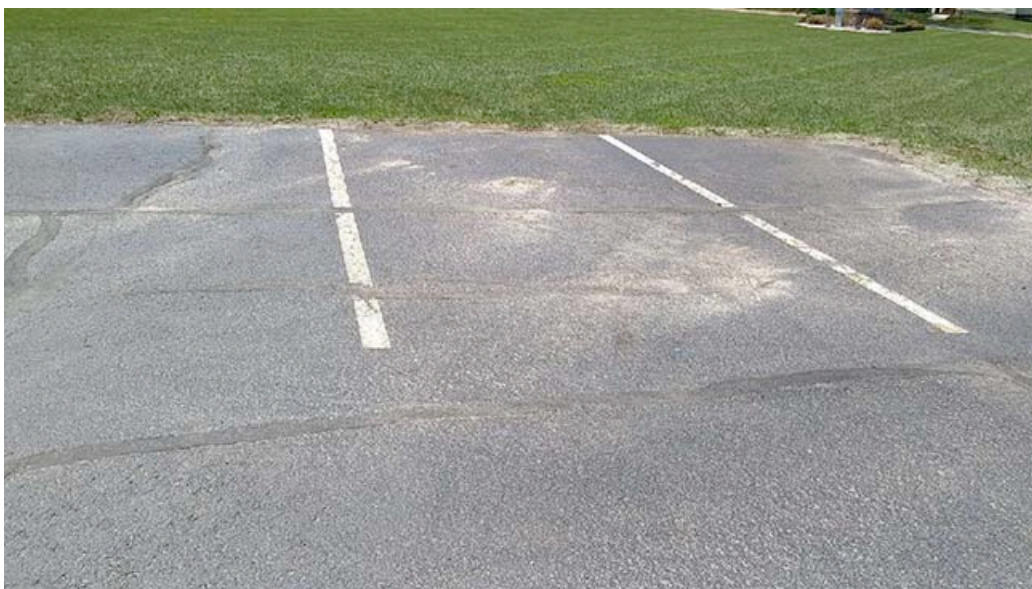
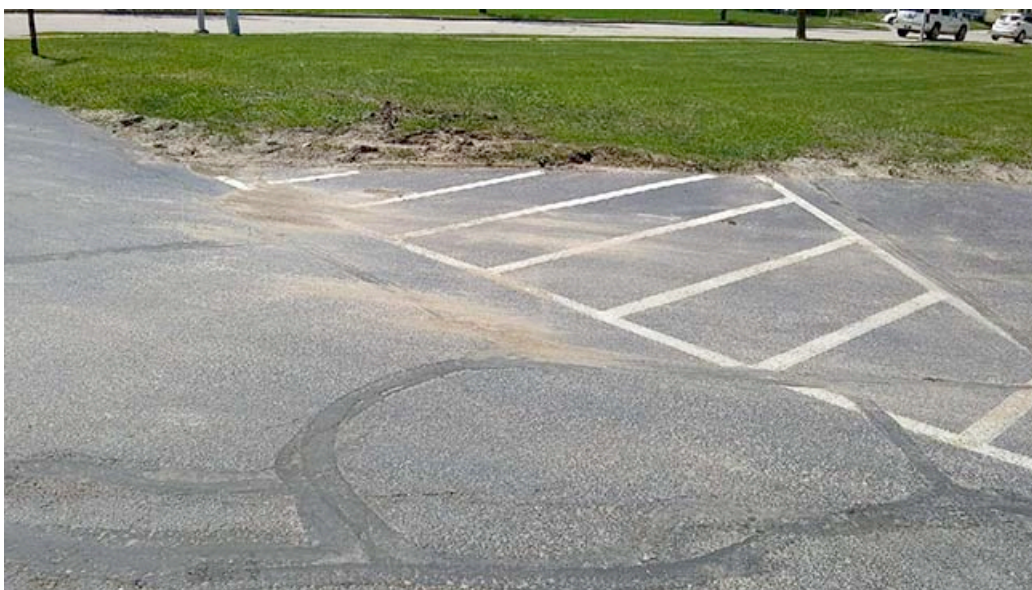
You'll notice from the photos below, the pavement is currently showing signs of minor structural cracking. This type of distress is considered normal and should be properly maintained by either a crack-filling *or* crack-sealing procedure. The pavement surface has been professionally seal coated within the past 3-years and there are no indications or signs of any surface failure. Overall, the pavement surface is in very good condition with only minor areas of thermal cracking due to cold weather conditions.

These are actual photos taken at the Landmark Credit Union in Beaver Dam on the day of the inspection. Thermal cracks can be found throughout various areas of the parking lot due to freeze / thaw cycles commonly associated with our Midwest climate.

1. Clean & crack-fill longitudinal and transverse thermal cracks that are ¼- inch wide or wider, by either simple band-aid method or standard recessed & band-aid method, to ensure water is kept out of the pavement sub-grade and sub-base.

2. The parking lot was last seal coated in 2015. On average, sealcoat pavement protection in Wisconsin has a service-life of 3-4 years. The credit union should consider having the parking lot sealed in 2018 or 2019. This will help to preserve the asphalt pavement and extend its overall life while “capping-off” the asphalt from rain, snow, and motor vehicle drippings.
3. Monitor and maintain a proper height of all adjoining topsoil and sod along the perimeter of the parking lot (lawn areas and landscape areas) to ensure that storm water can easily drain away from the parking lot and into turf areas, so as to not undermine the pavement structure and its sub-base/sub-grade layer. Currently, there are areas along the edge of the parking lot that may require re-grading in order to maintain proper elevations as recommended.
