State of Wisconsin - Department of Natural Resources
 Substance Release Notification Report (SERTS)
 Report created on 08/27/2012

SPILL ID# 20120510NE36-1 BRRTS# 04-36-559234

Subject: Spill Summary & Request for Closure – Minor Coolant Spill at Skana Aluminum Company, Manitowoc

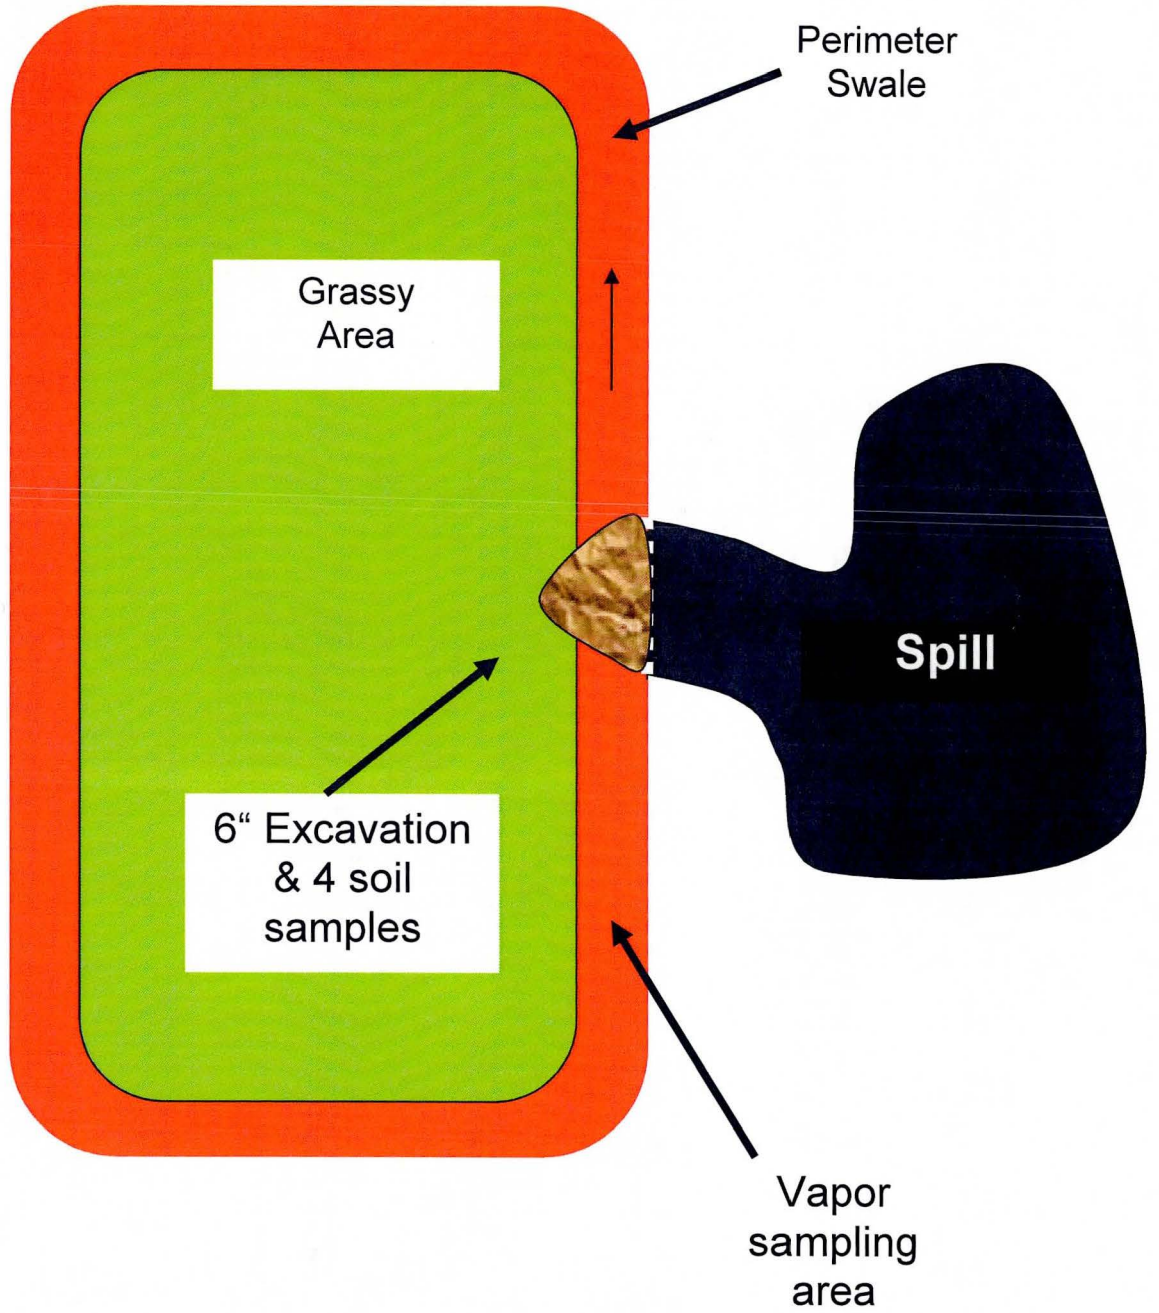
Figure 3 – Excavation and Sampling Locations

On May 10, a similar accidental release occurred at the intake of a tanker, causing approximately 100-150 gallons of the MagieSol coolant to spill on the asphalt parking area. Most of the spilled liquid was contained on impervious surfaces; a small quantity ran off the east edge of the pavement and discolored a thin upper layer of soil. The WDNR was called to report the spill and Cardinal Environmental personnel were called to the site and excavated the impacted area of soil (3ft. x 12 ft. x 6 in.). No staining or free liquid was observed below the depth of the excavation. The excavated soil and oil residue was collected and tested by TCLP for metals and organic compounds, and ultimately disposed of at Veolia's Hickory Meadows landfill as non hazardous soil. Four samples were collected from the floor and walls of the excavation and tested for DRO; all were non-detectable. Copies of the lab reports are attached..

Because Skana wished to be certain that none of the oil had migrated onto or around the grassy area immediately south of the spill, on July 12, Mike Hebert of ECT and Jim Bolger of Cardinal inspected the site and took vapor measurements above the soil as shown on Figure 3 with a ppbRAE vapor analyzer. Most of the readings along the swale leading away from the spill site were Non Detectable (< 1 ppb), with random occasional hits in the very low ppm to very low ppb range. None of the detectable points could be reasonably associated with the spill area.
