Re: Summary Letter Report and Work Plan, Letsos Property - Belknap Street  
902-904 Belknap Street, Superior, WI 54880  
BRRTS# 02-16-560359

**SITE LOCATION MAP**  
 902-904 BELKNAP STREET  
 SUPERIOR, WI

902-904 Belknap Ave Site Investigation

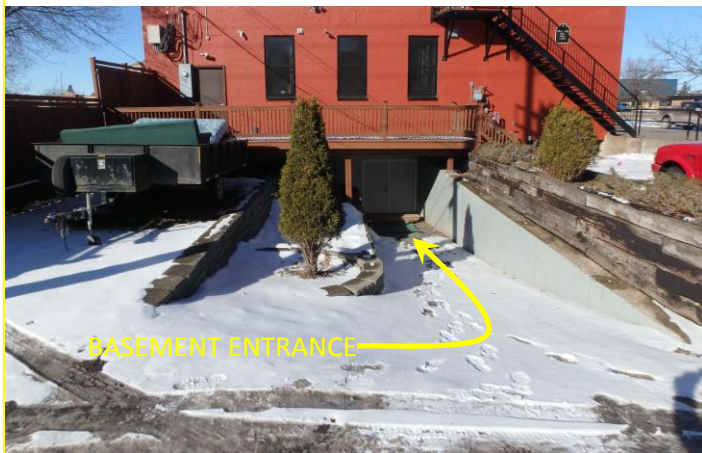
South side of building showing basement entrance.

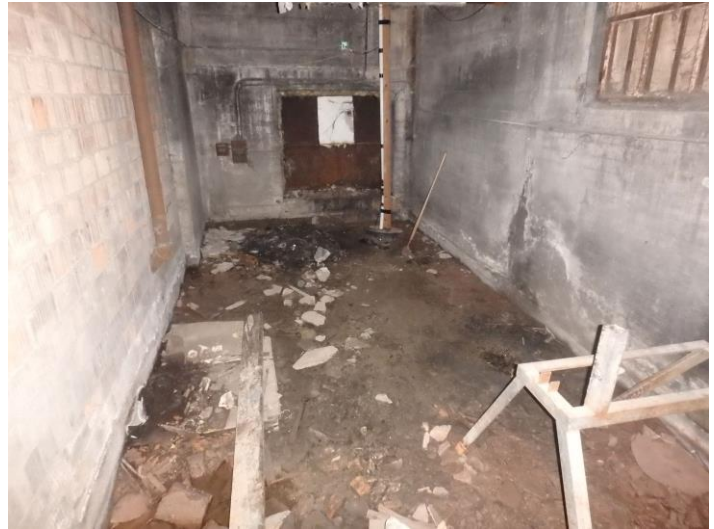
**Another view of basement room subject to corrective action.**

MSA has initiated the excavation of the earthen floor in the room on the southwest corner of the basement on December 2, 2016 and will complete soil sampling at points within the base of the excavation to confirm contamination has been removed and what residual contamination remains. A lined roll-off was mobilized to the property for stockpiling of the contaminated media removed from the basement earthen floor. This process is expected to be completed by the end of January 2017. Following excavation activities, a passive sub slab depressurization (SSD) system and concrete floor will be installed in the basement of the building to prevent remnant volatile organic vapors in the soil from seeping through the basement slab and accumulating in the building. For the interim, a COPPUS® portable ventilator is being used at the site to vent basement air to the outside to prevent soil vapors from entering occupied areas of the building. An activated carbon treatment unit will be installed to address any sump discharge.

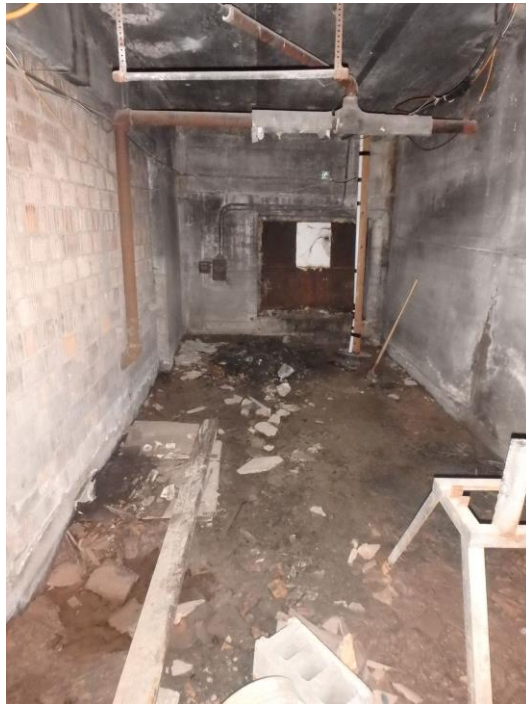
feet of the ground surface beneath the footprint of the 902-904 Belknap Street building. Soil contamination within the building footprint is expected to be from spills of dry cleaning solvents in the basement associated with the building's former use as a dry cleaning facility. It also appears that petroleum soil and groundwater contamination exists in the immediate area of GP-1. This contamination appears to be the likely result of a release from a former underground storage tank (UST) located in that approximate area and referenced on the attached Sanborn Fire Insurance Map (**Attachment 3**).

**Interior view of earthen floor room looking south with contaminated soil and debris.**

MSA has recommended that contaminated soils within the earthen portion of the basement of the building be excavated to remove impacted soils identified on the property. Based upon analytical data collected at the site, exposed soils in the basement of the building present a soil direct contact and vapor intrusion hazard into the remainder of the building.

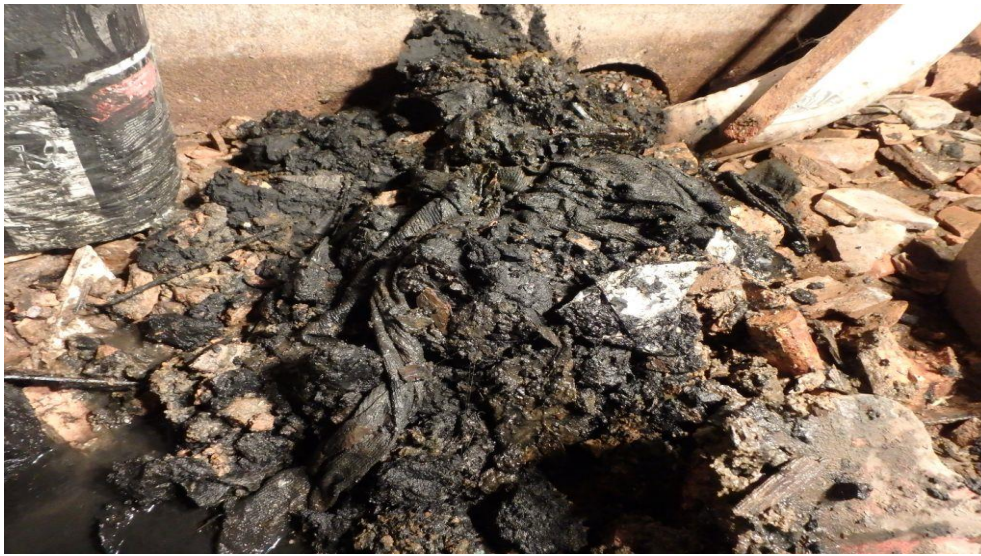
Closeup of contaminated media encountered during initial removal activities.

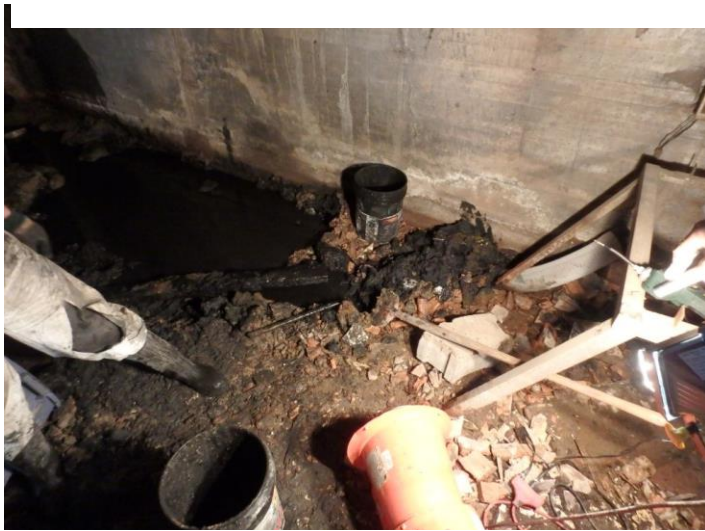
Contaminated media encountered during initial cleanup.

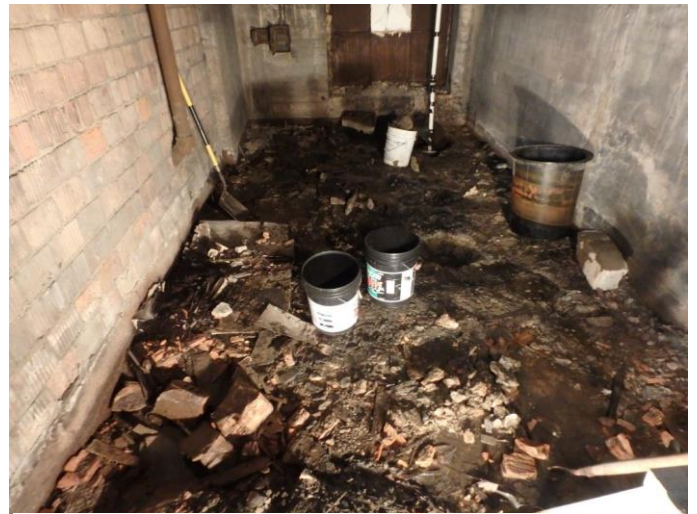
Closeup of earthen floor room prior to initial removal activities.
