**FINAL BUILDING MATERIALS ASSESSMENT
Tecumseh Products/Heus Manufacturing
1604 Michigan Avenue
City of New Holstein, Calumet County, Wisconsin**

Contractor Organization:	Tetra Tech, Inc.
Contract Name:	START IV-TBA Program
Contract No.:	EP-S5-13-01
Technical Direction Document No.:	S05-0003-1804-202
Document Control No.:	2502
ACRES ID No.:	128501

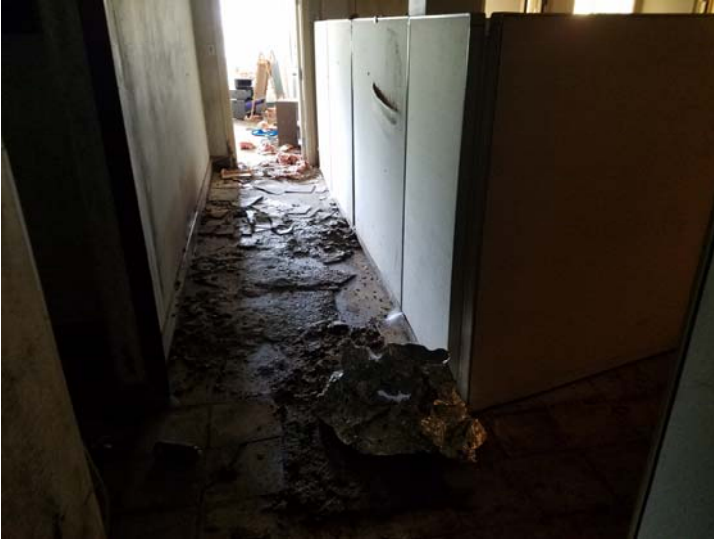
Building Area:	Description of Visible or Discovered Microbial Activity:	
Building #1 – Offices (sample 755-1) (photo 1)	- Visible standing water or water staining - Musty odor detected - Elevated surface moisture identified - Visible microbial growth identified - High humidity levels identified	
Building #3C – Office (sample 755-2) (photo 2)	- Visible standing water or water staining - Musty odor detected - Elevated surface moisture identified - Visible microbial growth identified - High humidity levels identified	
Building #10 – Center (sample 755-3) (photo 3)	- Visible standing water or water staining - Musty odor detected - Elevated surface moisture identified - Visible microbial growth identified - High humidity levels identified	
Exterior	- Multiple roof leaks.	
	Temperature: 65.1° F	Humidity: 50.8%

Photo 1: Building #1 - Offices

Currently, there are elevated levels of airborne microbial spores within the building. Respiratory protection and Tyvek suits are recommended while working inside the building.

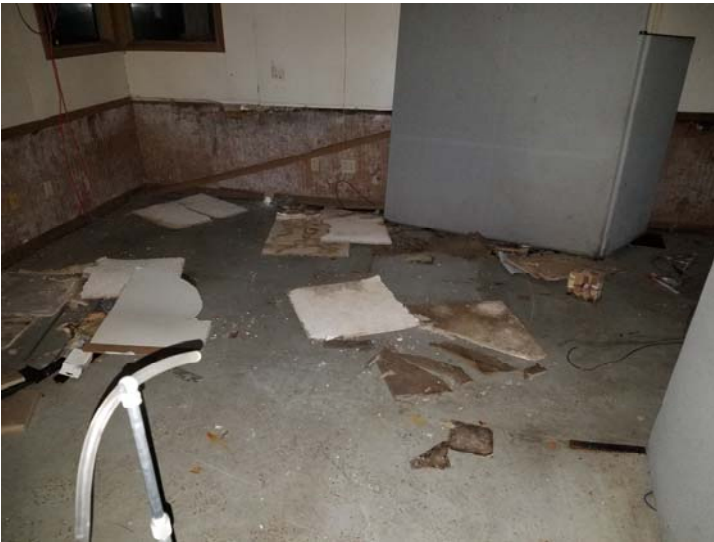
Photo 2: Building #3C - Office

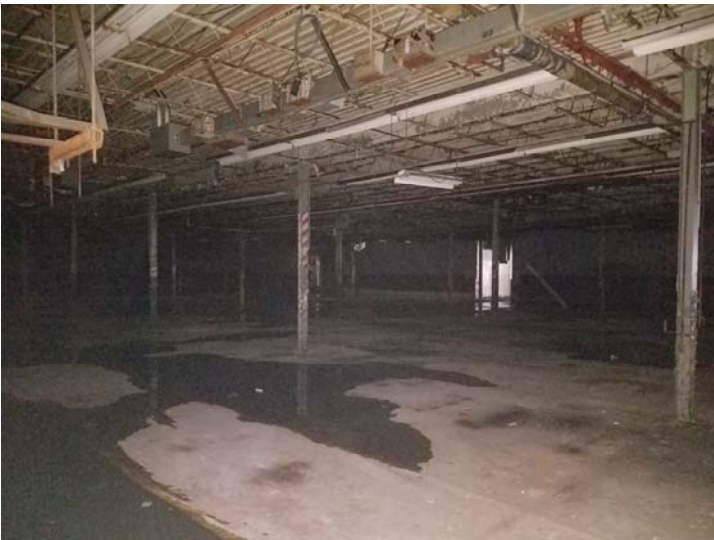
Photo 3: Building #10 - Center

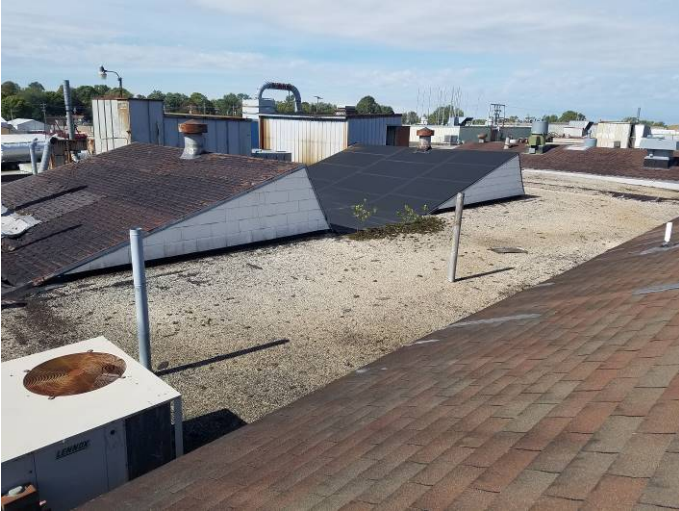
Photo 1) Transite Siding – Bldg 3 Roof

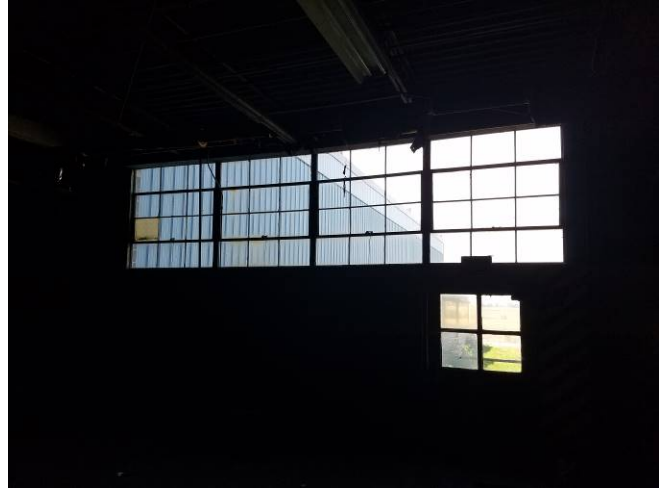
Photo 4) Typical Window Glazing

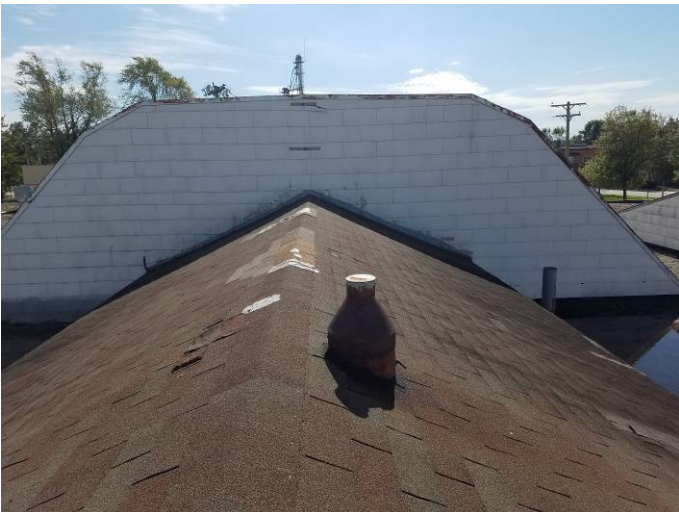
Photo 2) Transite Siding – Building 2 Roof

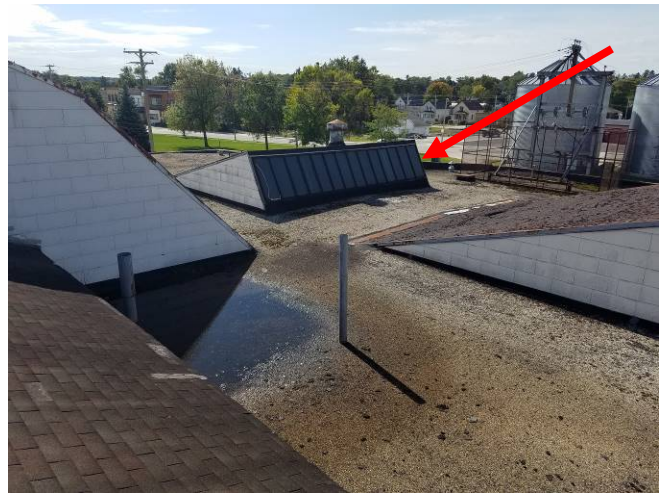
Photo 5) Window Glazing – Bldg 3 Skylights

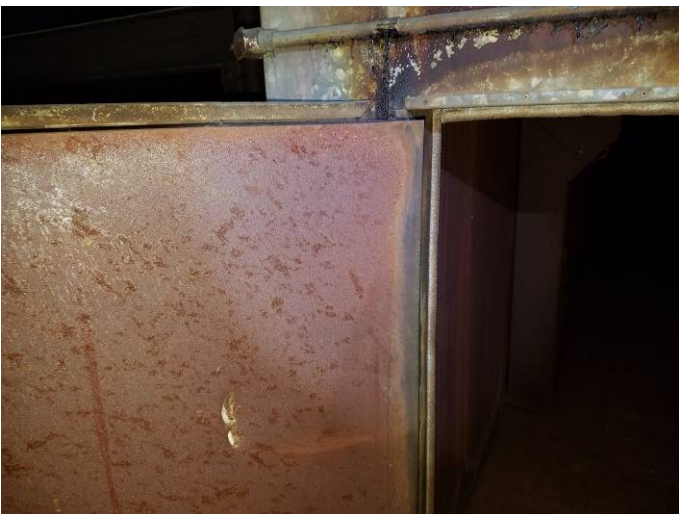
Photo 3) Silver Air Handler Door Gasket –
Bldg 8A Mezzanine

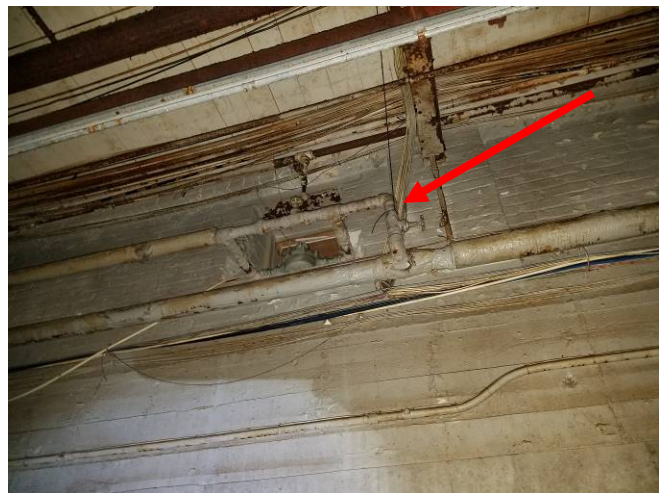
Photo 6) White Pipe Insulation – Bldg 2
(west wall – upper)

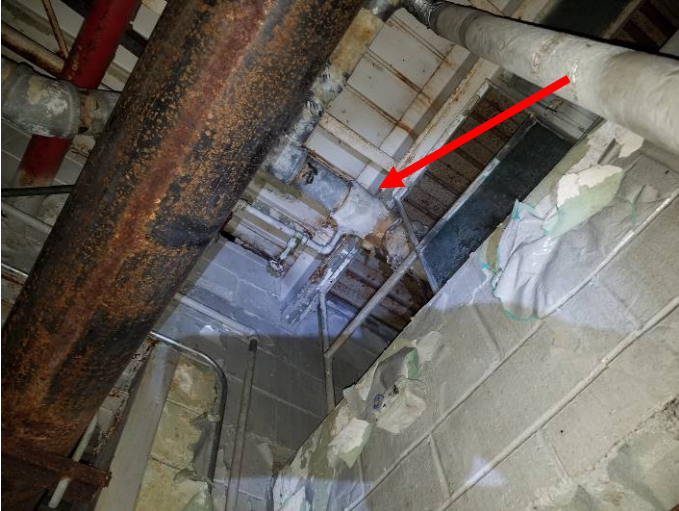
Photo 7) Typical Pipe Fitting Insulation

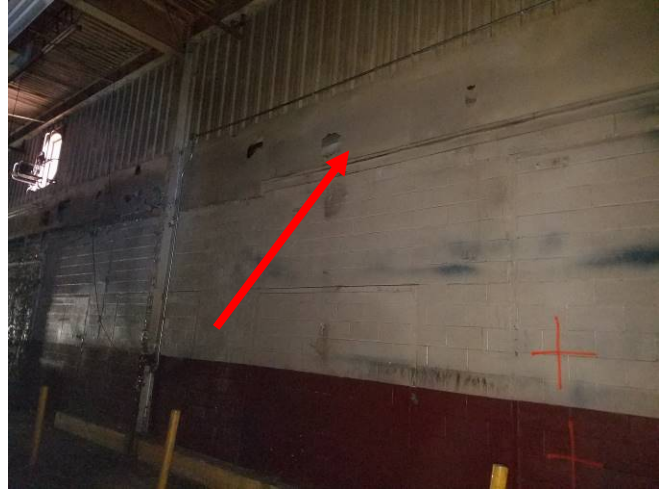
Photo 10) Transite Paneling – Bldg 17

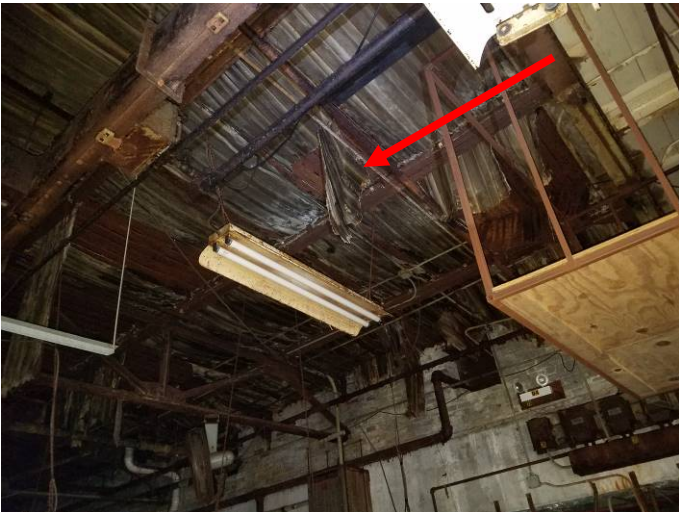
Photo 8) Brown Roofing Paper – Bldg 3

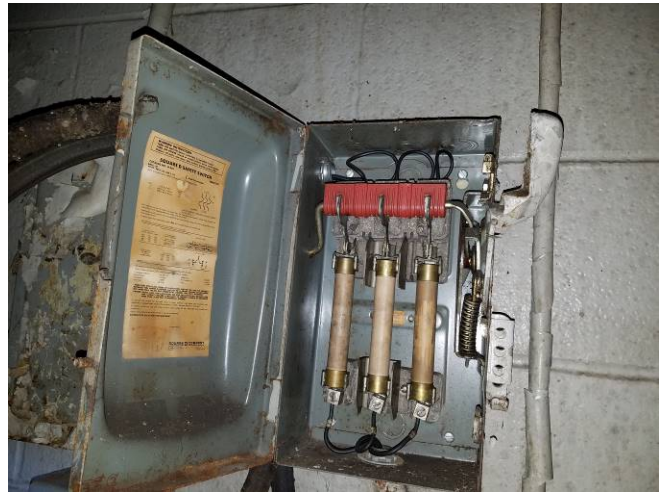
Photo 11) Typical Electrical Panel

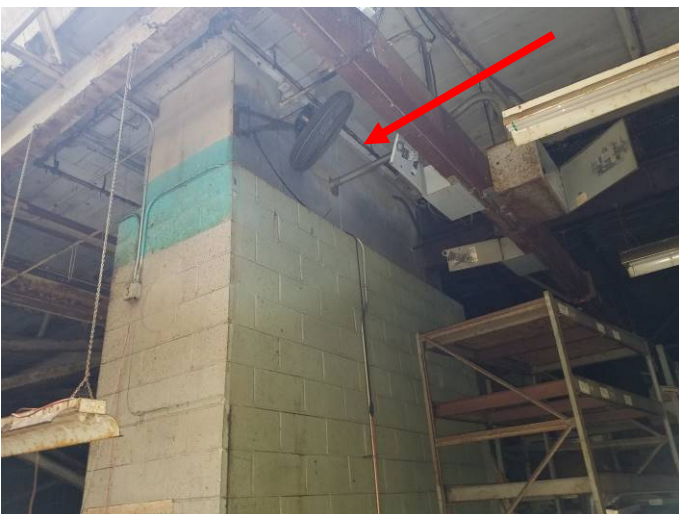
Photo 9) Transite Paneling – Bldg 3

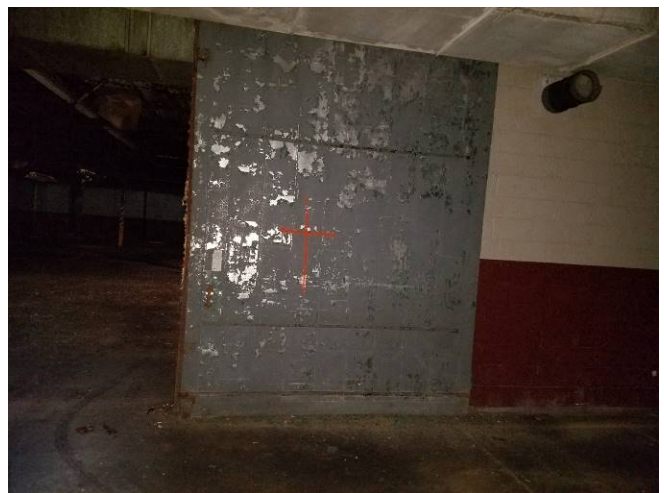
Photo 12) Typical Fire Door

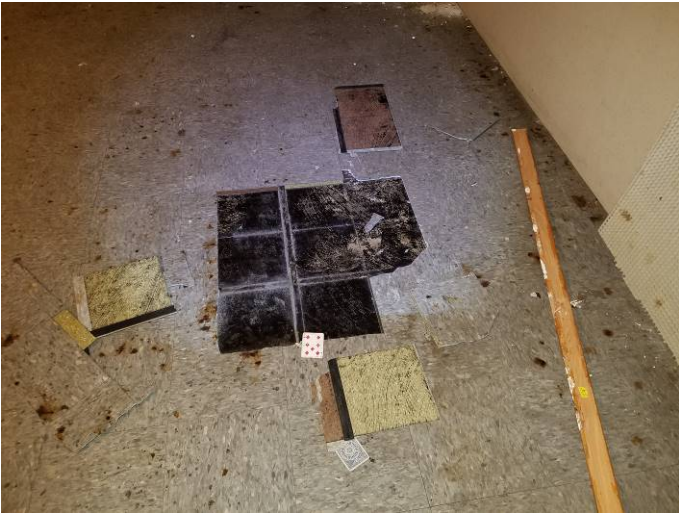
**Photo 13) 9" Tan Floor Tile & Black Adhesive
- Bldg 15 Mezzanine**

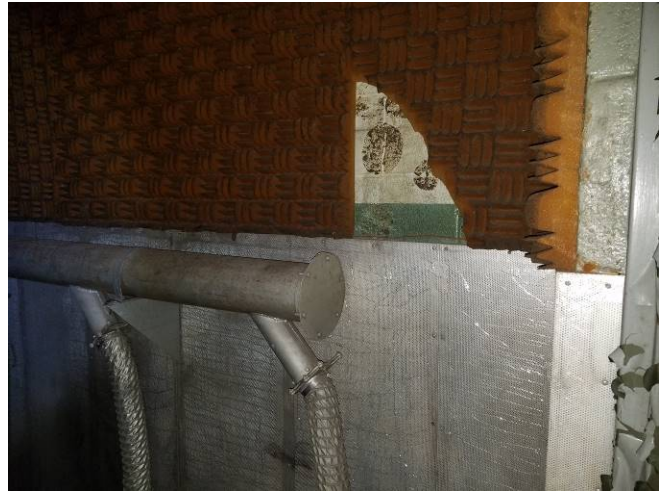
Photo 16) Brown Wall Adhesive – Bldg 12

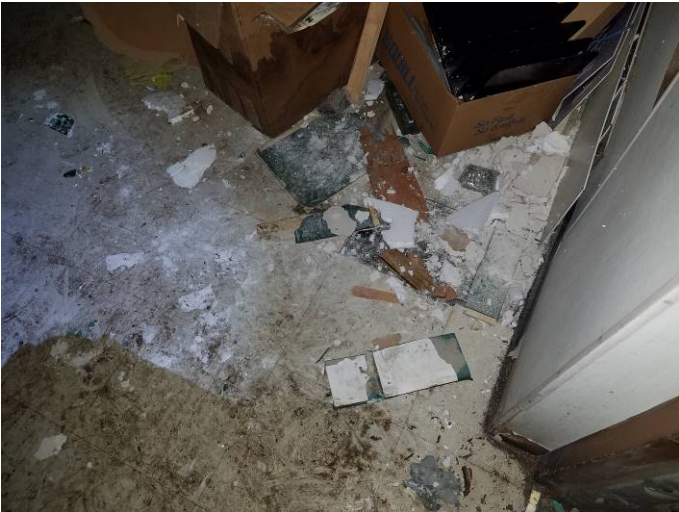
**Photo 14) 9" Green Floor Tile & Black Adhesive
- Bldg 11 Offices**

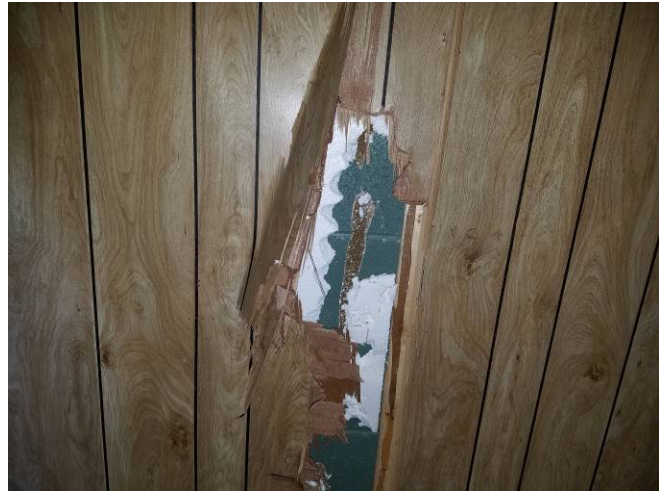
Photo 17) Brown Paneling Adhesive – Bldg 11

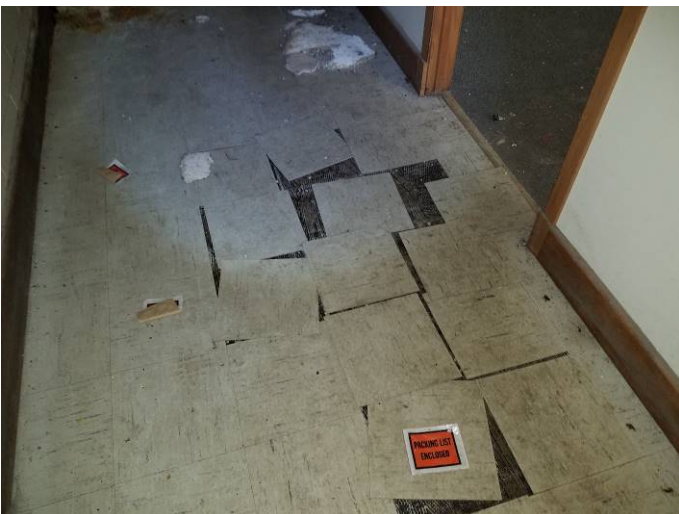
**Photo 15) 12" Tan Floor Tile & Black Adhesive
- Bldg 1 Offices**

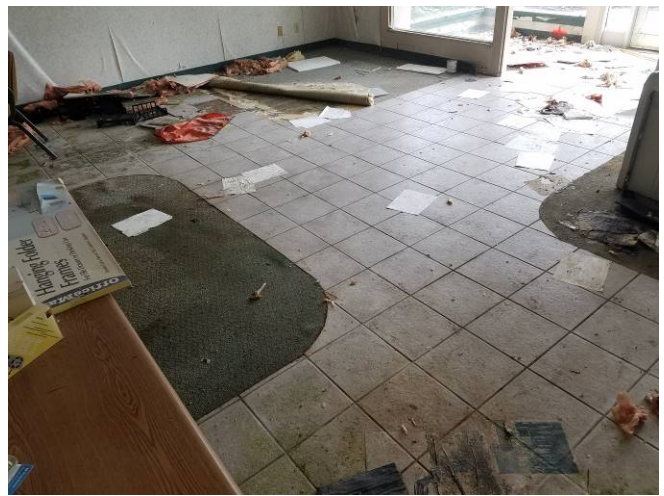
**Photo 18) Black Flooring Adhesive
- Bldg 1 Lobby**

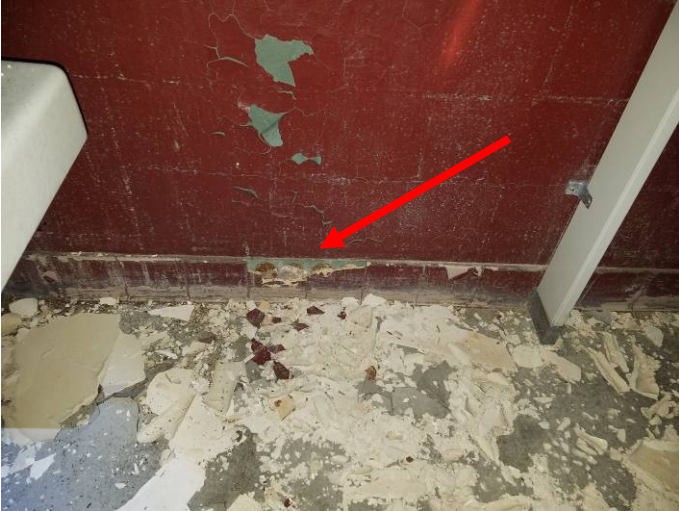
**Photo 19) Brown Ceramic Baseboard Adhesive
- Bldg 9 Bathroom**

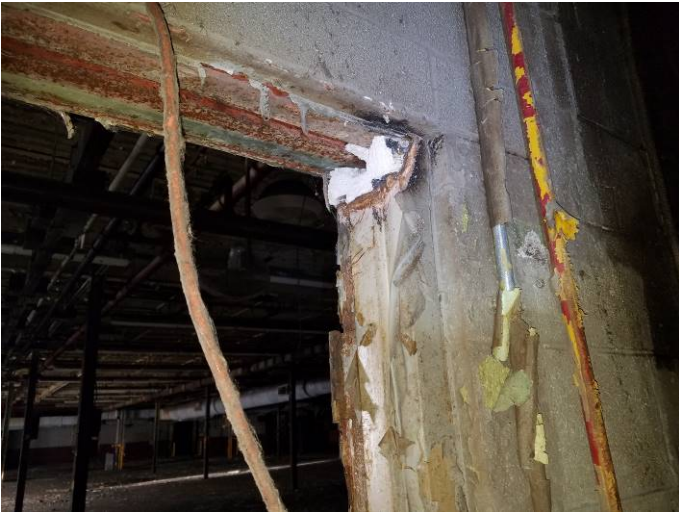
Photo 20) Gray Door Caulk – Bldg 12 West Room

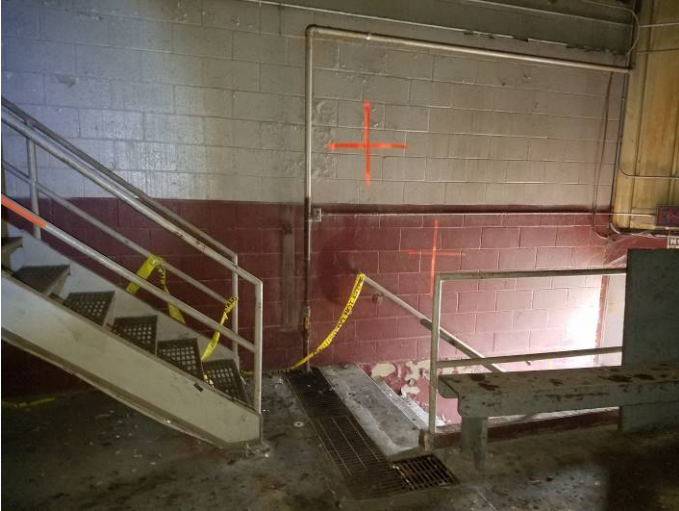
Photo 21) Typical Wall with Lead-Based Paint

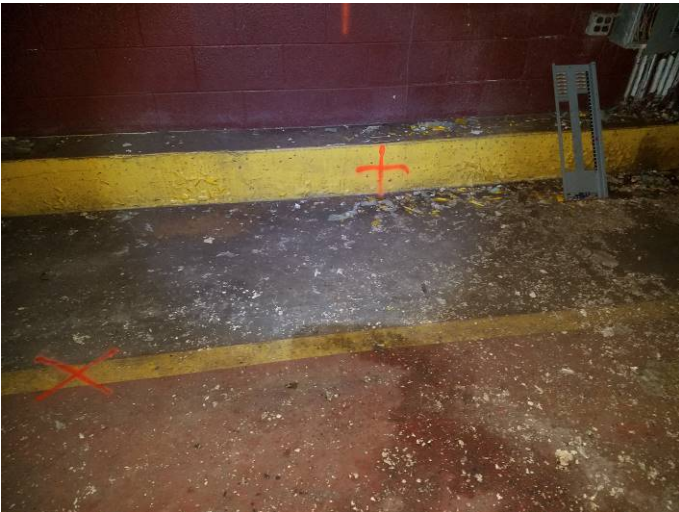
Photo 22) Typical Curb with Lead-Based Paint

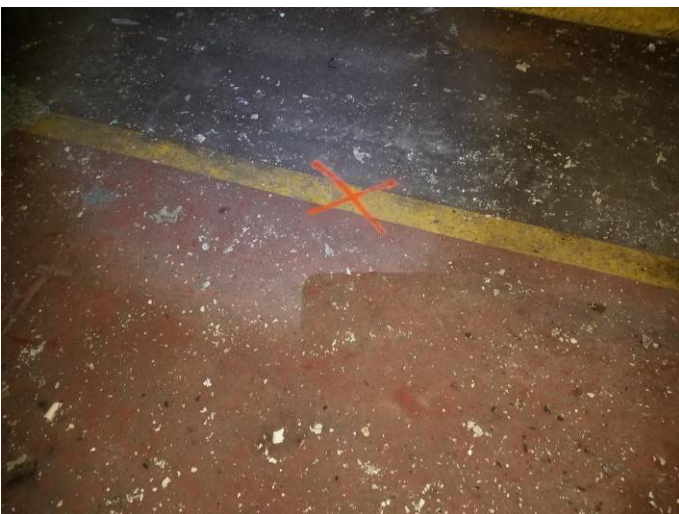
Photo 23) Typical Floor Stripe with Lead-Based Paint
