**BRRTS ID No. 02-13-560426**

Review Date: 07/29/2022

Site Name: Carriage Trade Dry Cleaners Former

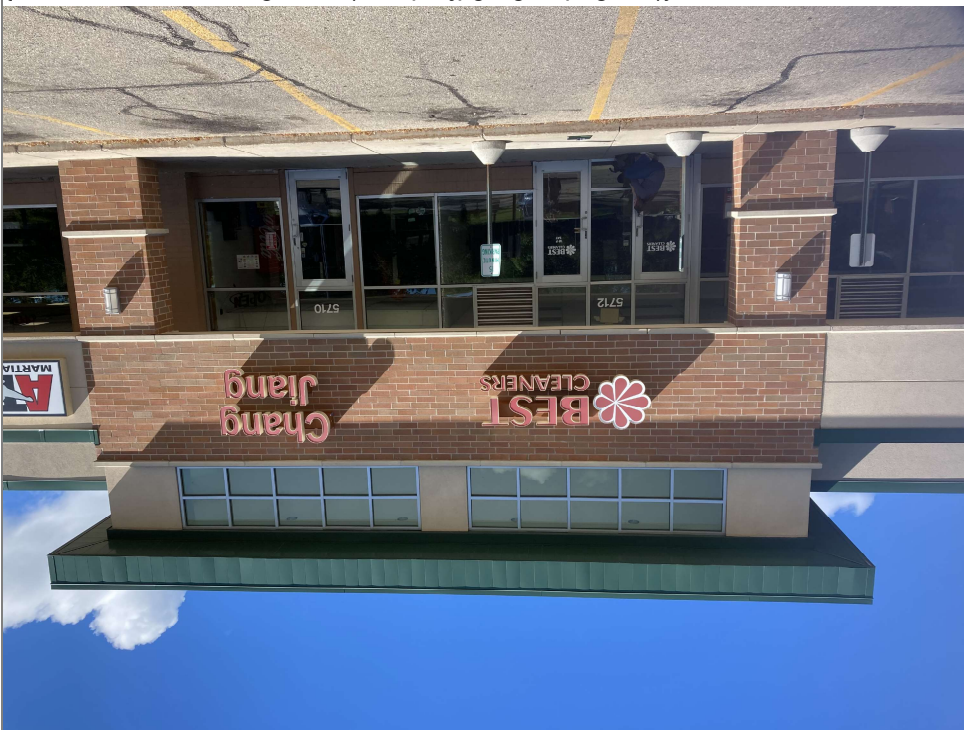
Title: Front of the former Carriage Trade Cleaners a.k.a. Best Cleaners

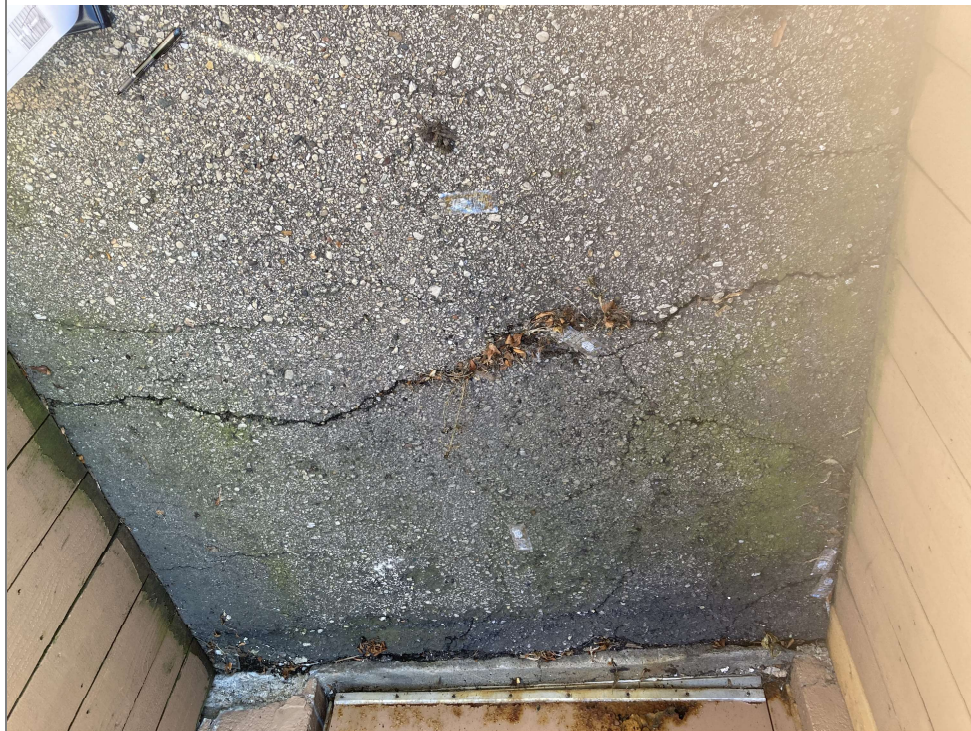
The asphalt cap is in need of maintenance (see log).

Title: Crack in the asphalt cap on the north side of the building near the fencing around the dumpster.

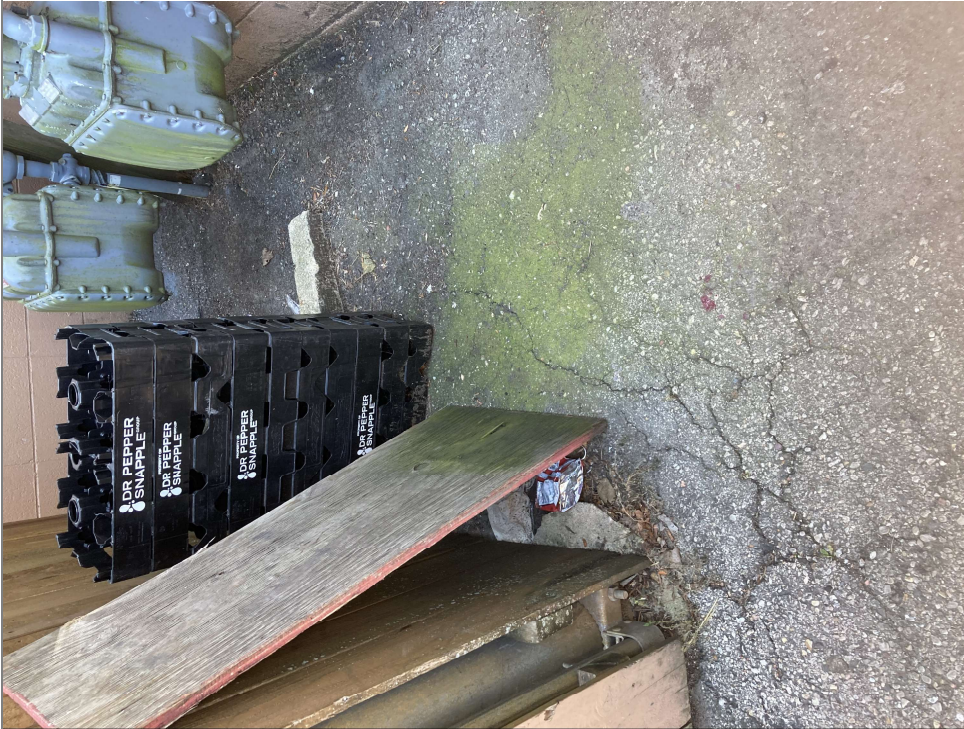
Title: Asphalt cap with some cracks, north side of the building near the back exit.

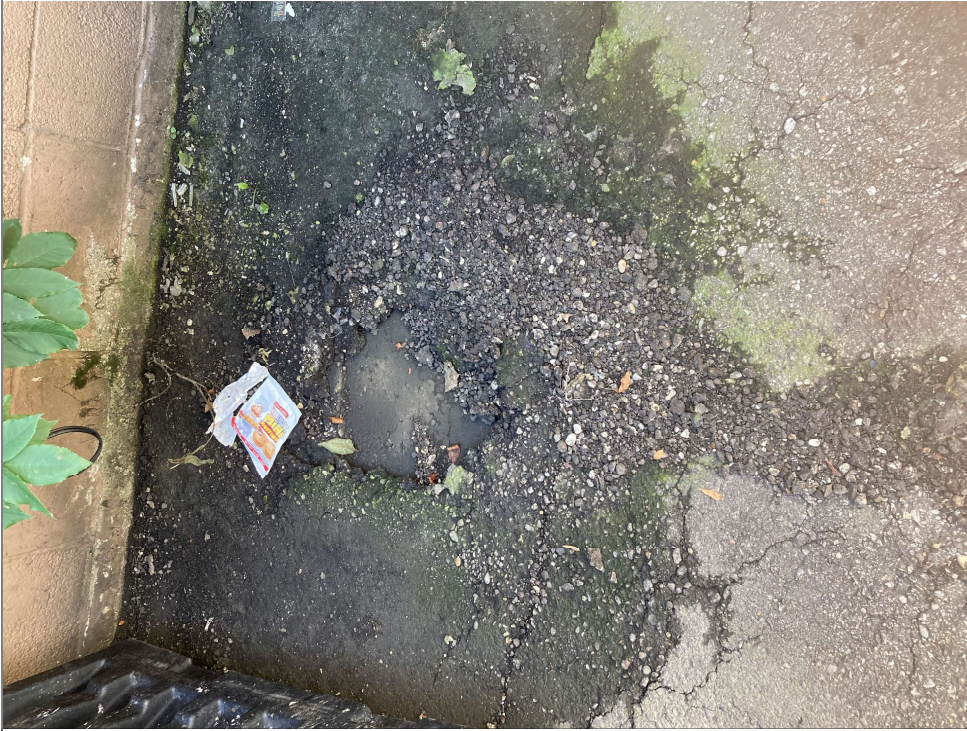
Title: Asphalt cap near the dumpsters on north side of the building. Cap has an area approx. 1" or more in depth deteriorated and needs to be patched.

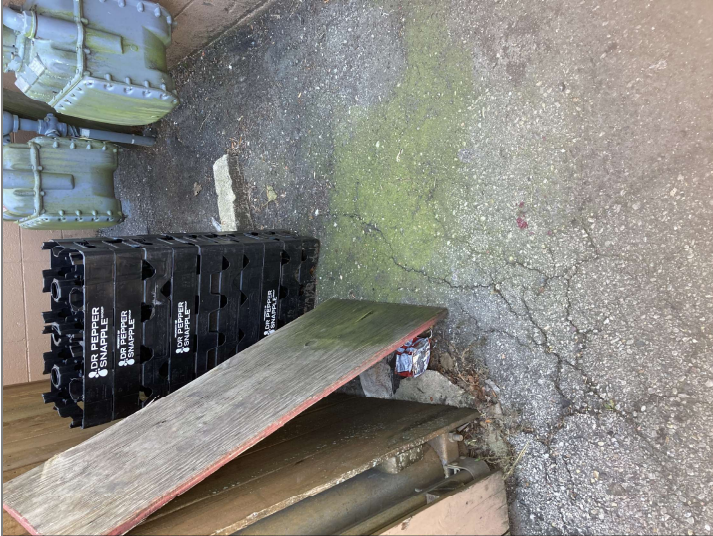
Title: Cracks in the asphalt cap, north side of building near the dumpsters.

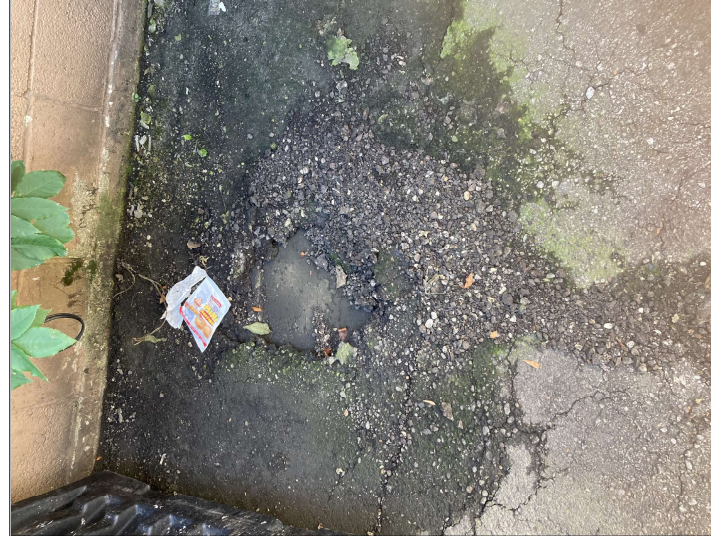
Title: Asphalt degraded cap ~1' x 1' inside of fence near dumpster.
