**From:** DiMaggio, Janet H - DNR  
**Sent:** Tuesday, October 18, 2022 1:38 PM  
**To:** DiMaggio, Janet H - DNR  
**Subject:** FW: Former Carriage Trade, 5710 Raymond Road, Madison, WI - VMS audit documentation

Address Being Inspected (e.g., 123 N. Main St.): 5712 Raymond Rd Madison WI 53711 Date of Inspection: 10/14/2022

Inspection Performed By (Name & Title/Company): Brian Thompson Lifetime Radon Solutions

### Vapor Mitigation System Inspection Log

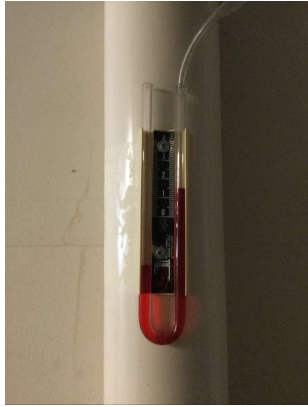
<input type="checkbox"/> Not Applicable	
			liquid is not level with each other and system is running and working properly

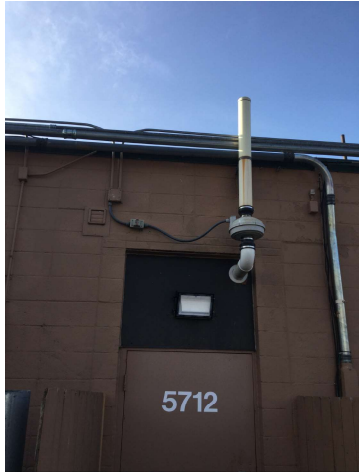
<p><b>NOTES:</b> (Identify specific building and location description:)</p> <p><input type="checkbox"/> Not Applicable</p>
	<p>Fan is on and working properly. Mounted outside and motor is quiet. No problems indicated</p>
