From: [Ryan Nehls](#)
To: [Koepeke, Cynthia L - DNR](#)
Cc: [Bill Buckingham](#); [Brian Flad](#)
Subject: Shorewood Commons BRRS #02-13-560698
Date: Friday, June 24, 2022 11:41:03 AM
Attachments: [HydroGraph.pdf](#)
[Well Screen & Water Levels.pdf](#)
[Site Map.pdf](#)

I wanted to give you an update on the Shorewood Commons site and get you some responses to your email to Bill sent February 18.

GROUNDWATER ELEVATION MAP (5/20/22)
 PHASE II INVESTIGATION
 SHOREWOOD COMMONS
 3330 UNIVERSITY AVENUE
 SHOREWOOD, WI 53705

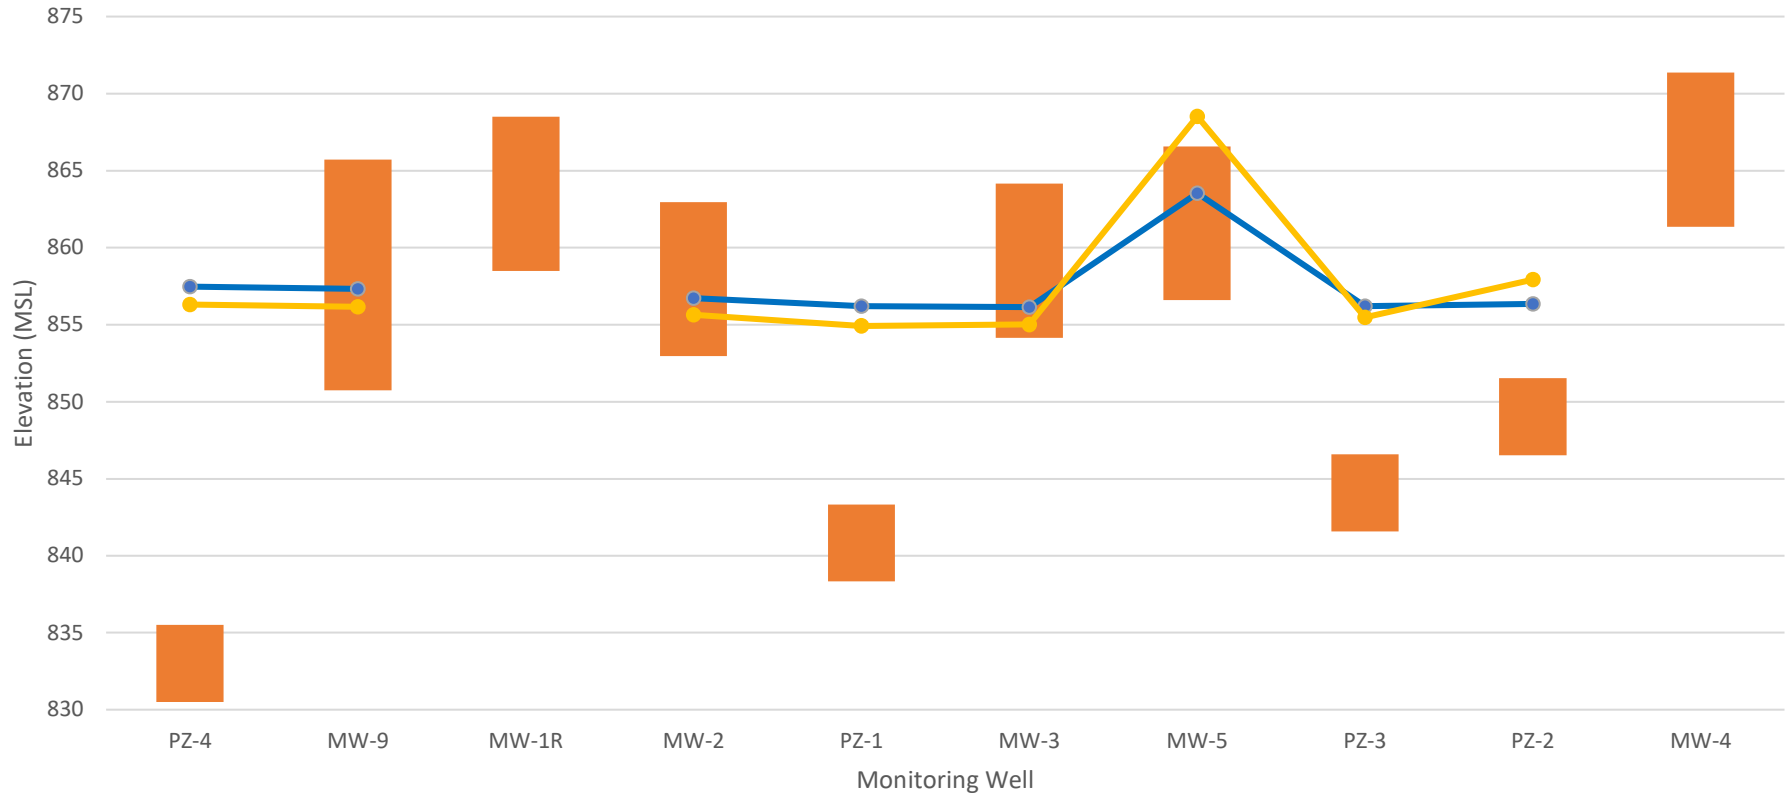
Well Screens & Water Elevation

2. Some cross-sections and a chart showing the well screen depths can help show if the wells might be in different units with different hydraulic conductivities or with the screen submerged etc.
See attached Well Screen & Water Levels. The wells are ordered in what is assumed upgradient to downgradient. We're below the screens on MW-1R and MW-4.

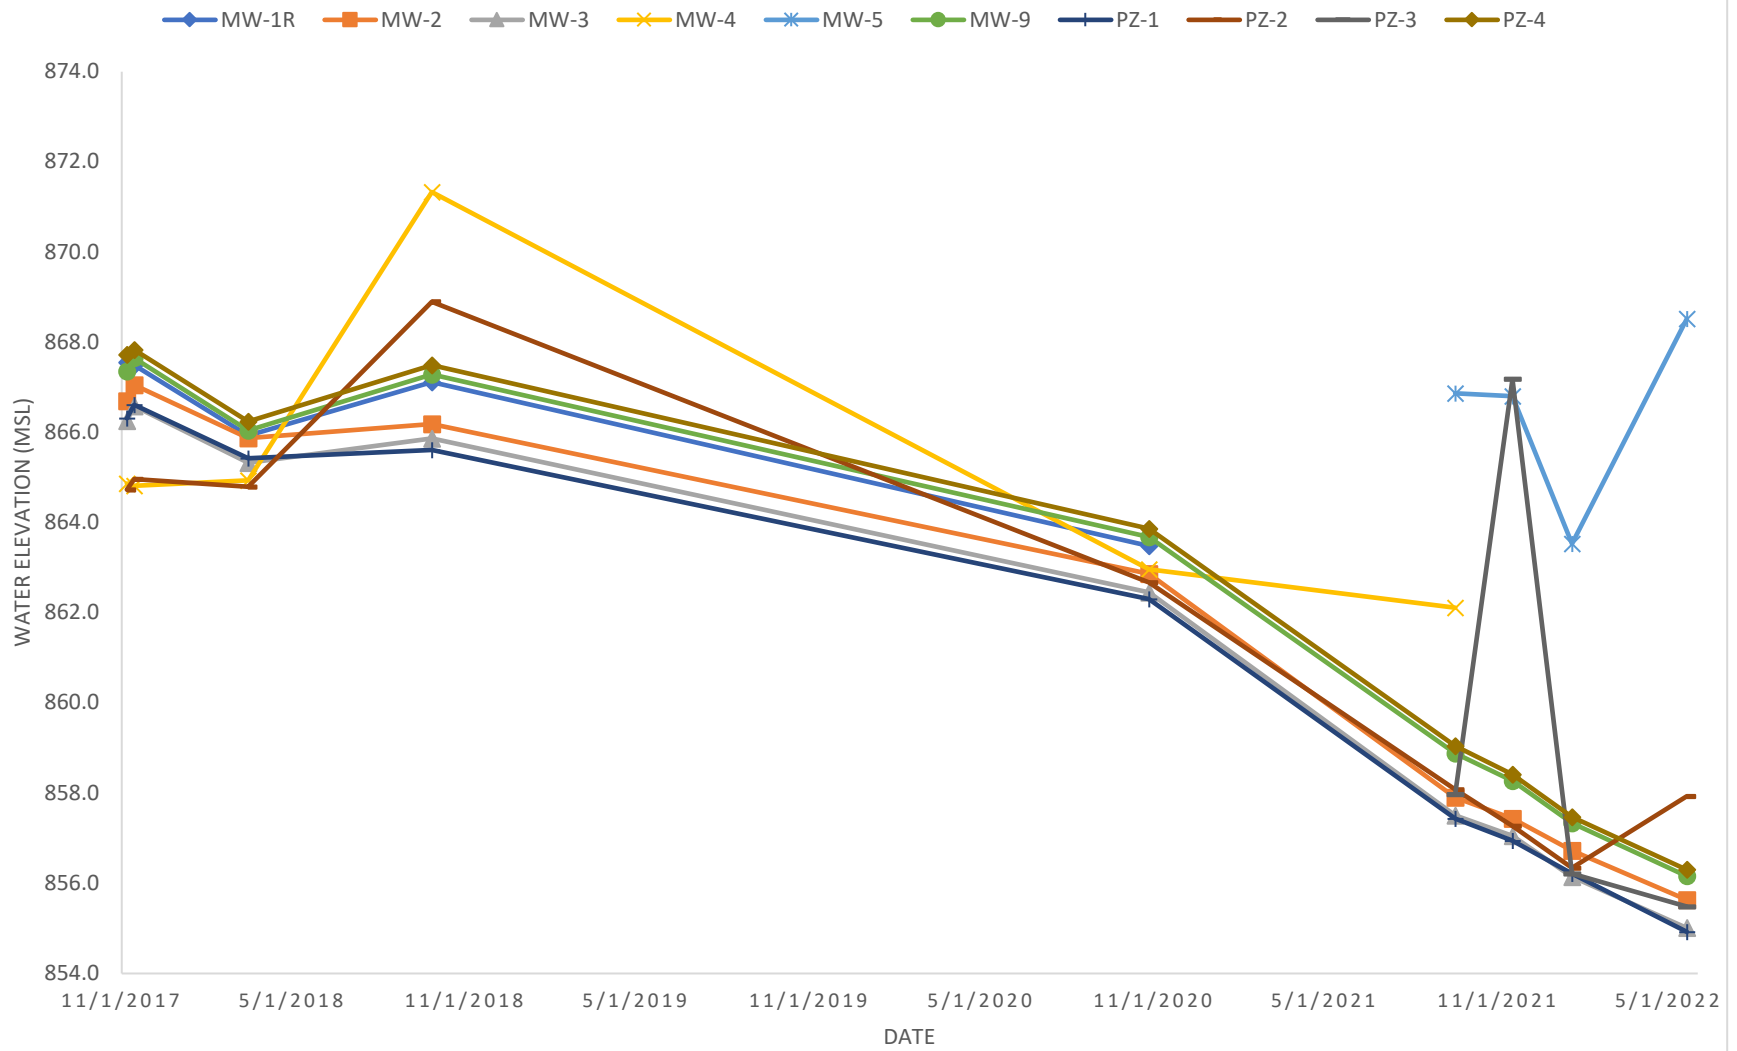
HYDROGRAPH

1. Prepare a hydrograph covering at least the last 5 years and see if the wells are responding in a similar fashion. This is a good way to see if it's only a few wells that are "behaving" differently.
See attached Hydrograph, seems our new PZ-3 is back in line but MW-5 is still out there.

We will keep monitoring the water levels, but MW-5 continues to be an anomaly. I do know that bailing that well, the water level falls quickly and is slow to recover which would be consistent with a low K. Let me know if you have any thoughts.
