Remediation & Redevelopment Continuing Obligation Review

BRRTS I	No. <u>02-1</u>	3-56193	7					
Reviewer:	Trevor 1	Banniste	Region:	SCR	Review Date:	08/08/2019		
Site Name	e: Jims Mo	onroe St	Cleaners Former					
See RR5242 for instructions http://intranet.dnr.state.wi.us/int/aw/rr/guidance/RR5242.pdf . Steps with an * denote DNR follow up; ** denote RP/property owner follow up. If auditing a VPLE site, use the applicable LUST or ERP BRRTS number. Use the NOTES area in each section to add information not otherwise addressed.								
File Revie	:w:

SUBJECT: Audit of a Vapor Mitigation System, Jim's Monroe Street Cleaners, 2530 – 2536 Monroe

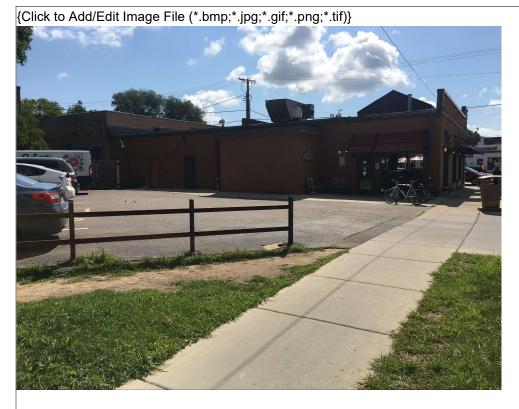
Title: Building, Looking Southeast - August 8, 2019.

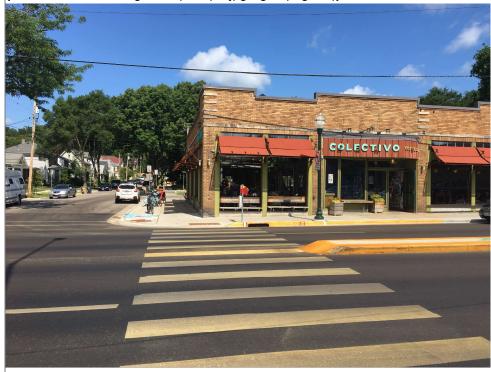
Title: Building, Looking Northwest - August 8, 2019.
