**From:** Kendyl Hoss <khoss@fehrgraham.com>  
**Sent:** Wednesday, October 18, 2023 8:42 AM  
**To:** Rice, Caroline M - DNR  
**Cc:** Sean Phelan; Dillon Plamann; Luke Paterno  
**Subject:** 2530 – 2536 Monroe St - Continuing Obligations Audit  
**Attachments:** 2530-2536 Monroe St - Continuing Obligations Inspections.pdf; Invoice 000000118914 Project 23-1601.pdf

Activity (Site) Name: Jims Monroe St. Cleaners Former BRRTS No. 02-13-561937

# Vapor Mitigation System Photolog

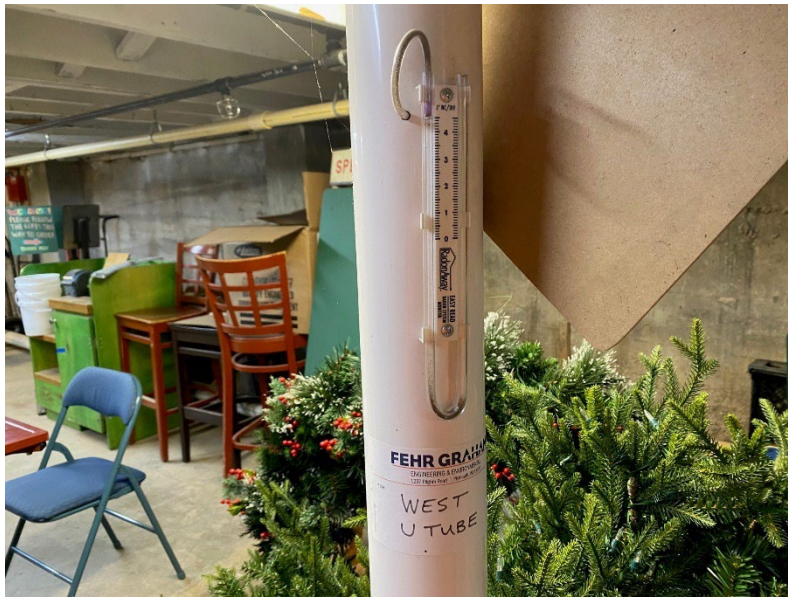
1. Damaged West U-Tube Manometer, facing south.

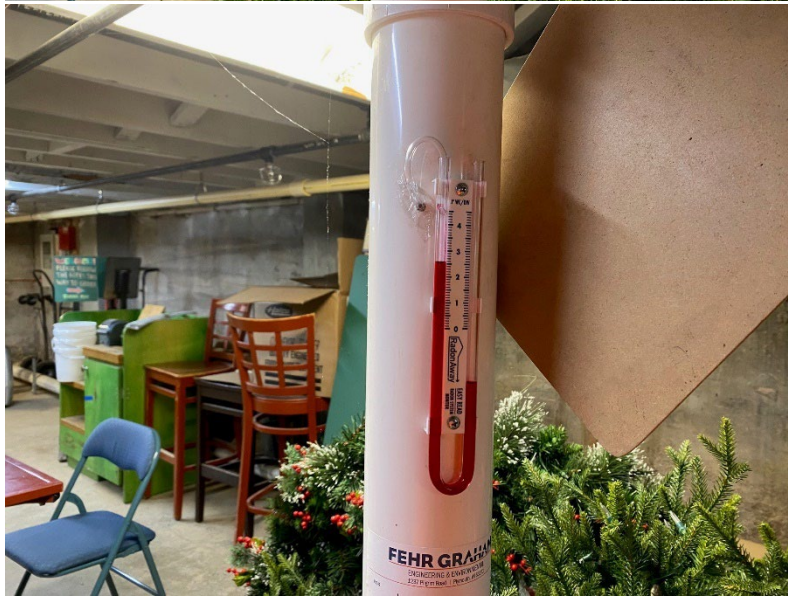
2. Newly installed West U-Tube Manometer, facing south.

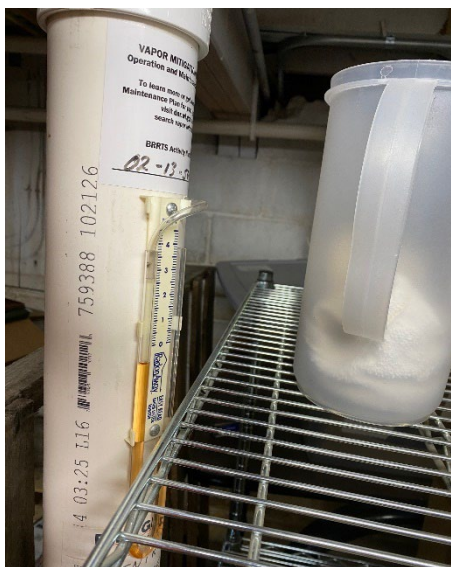
3. Damaged Central U-Tube Manometer, facing north.

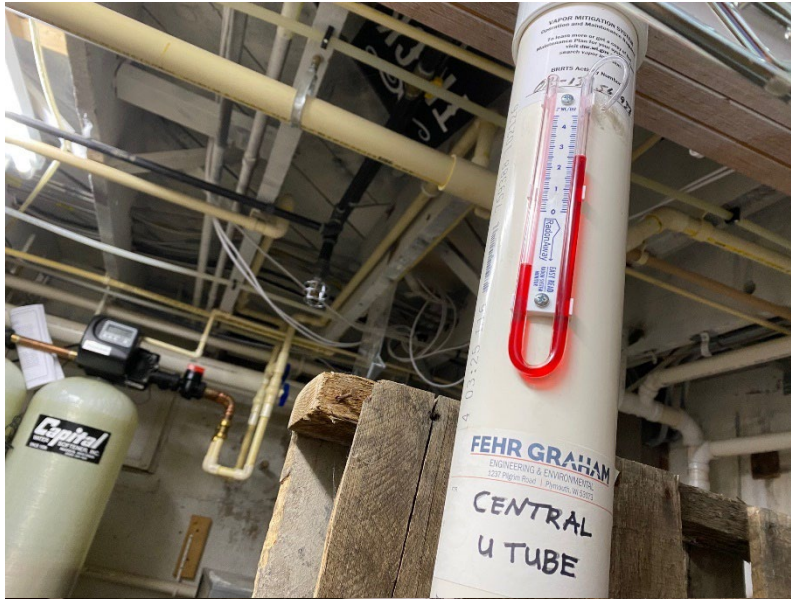
4. Newly installed Central U-Tube Manometer, facing north.

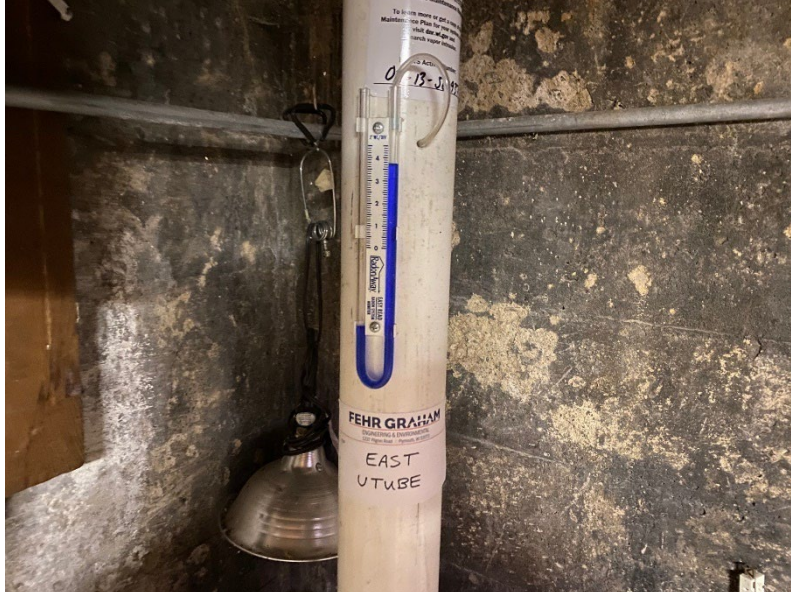
5. Properly working East U-Tube Manometer, facing northwest.

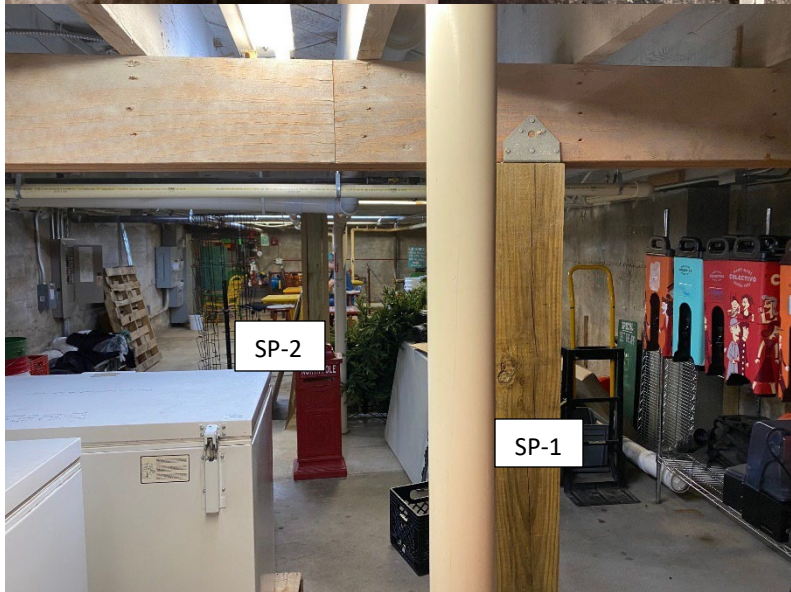
6. Two floor penetrations, SP-1 and SP-2 (West U-Tube location), facing southeast.

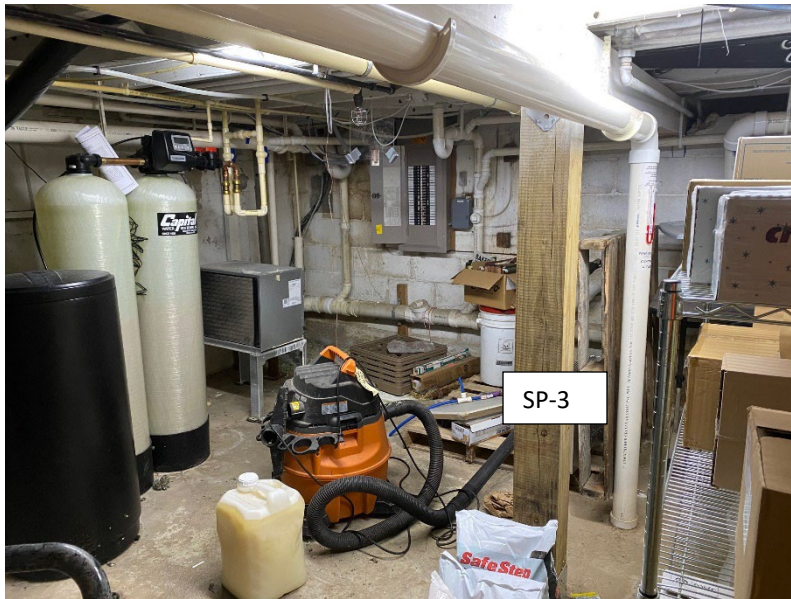
- 7. One floor penetration, SP-3 (Central U-Tube location), facing north.

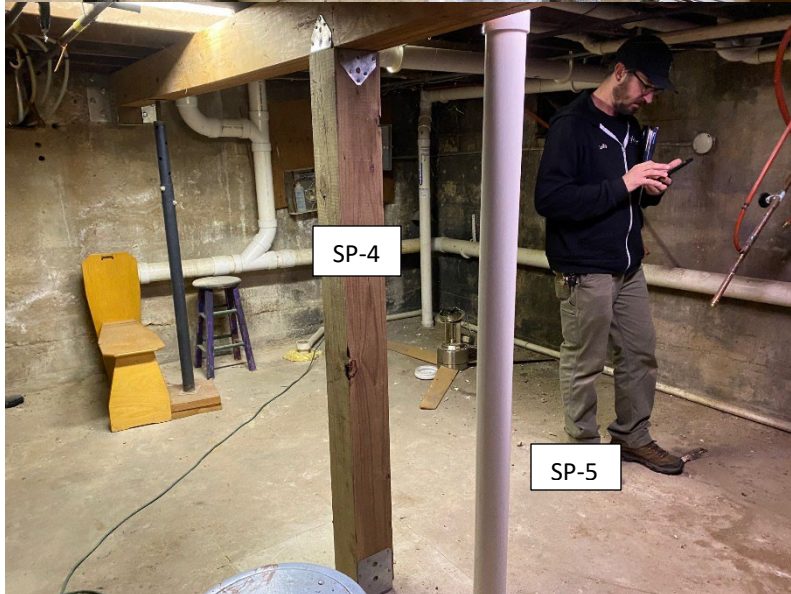
- 8. Two floor penetrations, SP-4 and SP-5 (East U-Tube location), facing west.

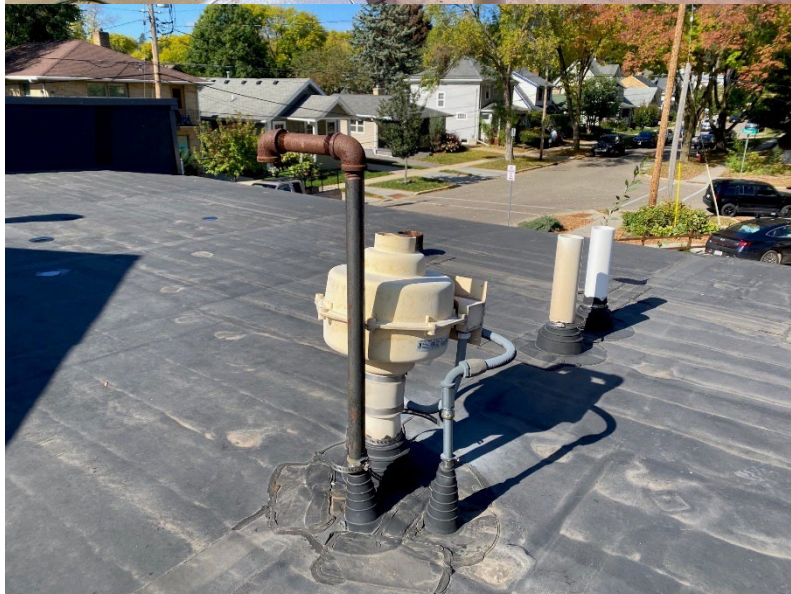
- 9. One of two high vacuum fans (RadonAway GP501), facing northwest.

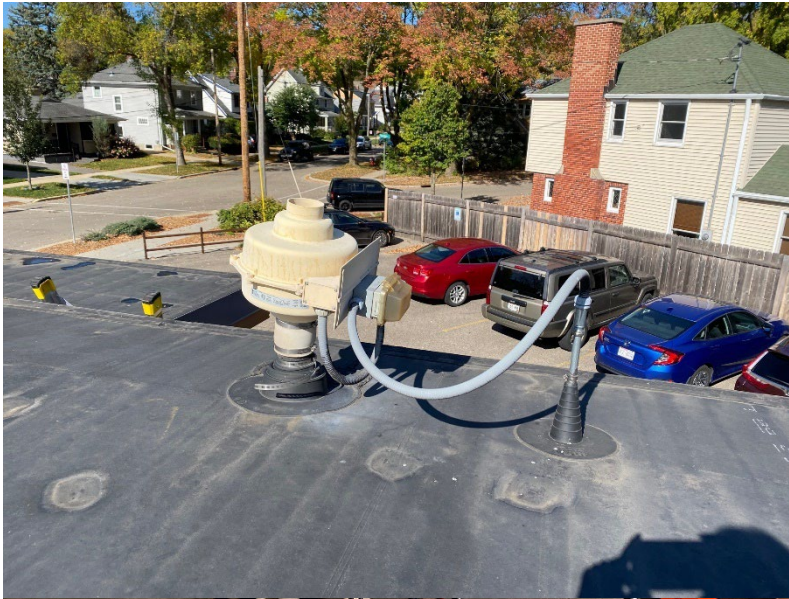
10. Second high vacuum fan (RadonAway GP501), facing northwest.

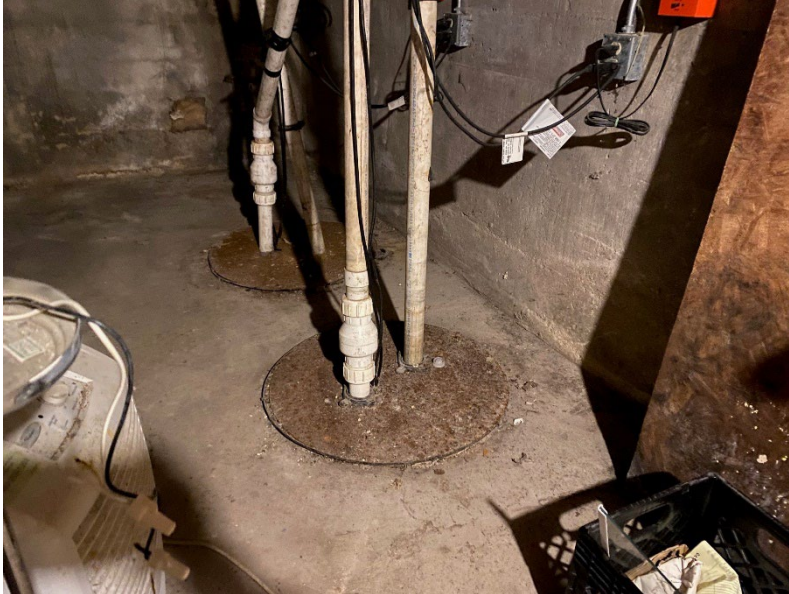
11. Sumps located near East U-Tube location, facing north.

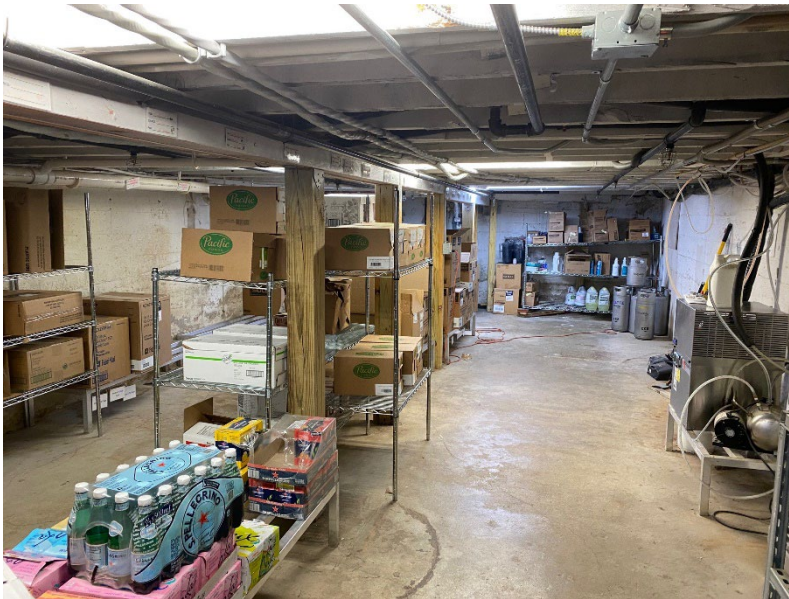
1. Barrier cap in good condition with minor cracks (Central U-Tube location), facing southeast.

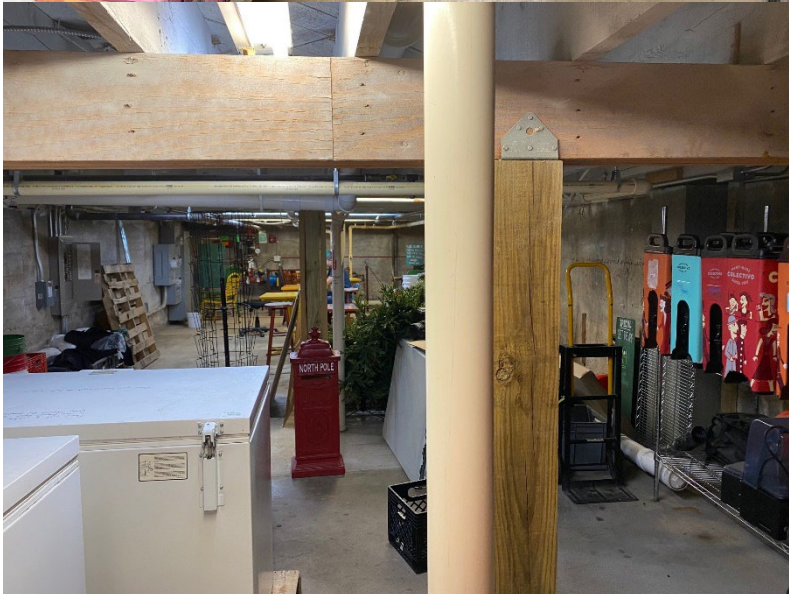
2. Barrier cap in good condition with minor cracks (West U-Tube location), facing southeast.

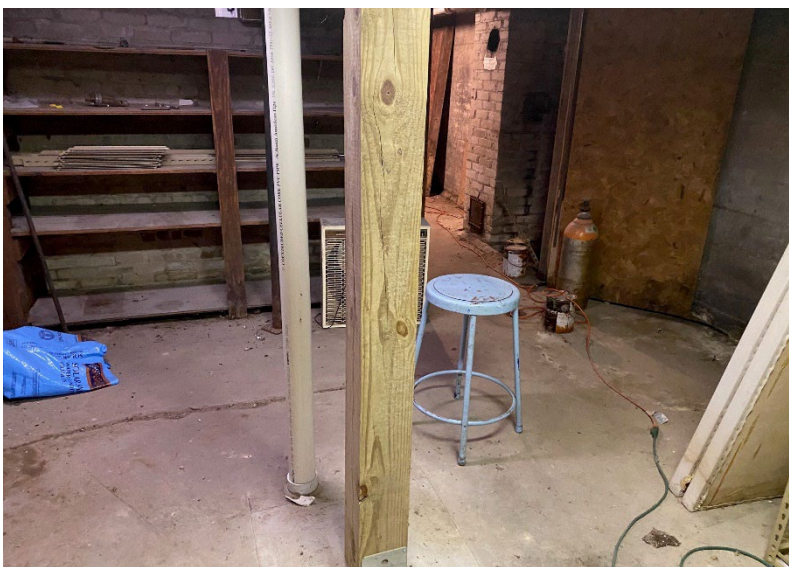
3. Barrier cap in good condition with minor cracks (East U-Tube location), facing east.

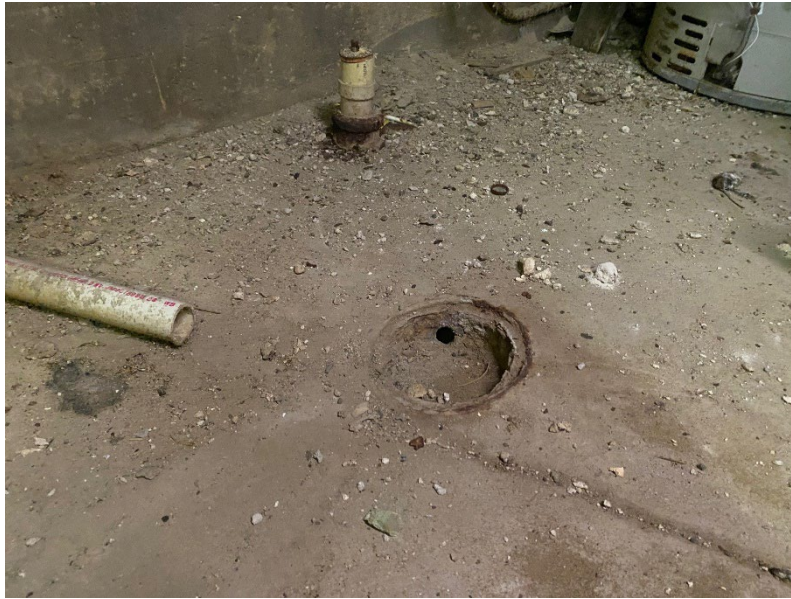
4. Old uncovered drain outlet,  
facing northwest.
