FILE REF: Allyn Property
BRRTS # 02-31-564071

SUBJECT: Indoor Air Sampling at 109 Steele Street, Algoma, WI

SUBJECT: Initial Basement Evaluation at 109 Steele Street, Algoma, WI

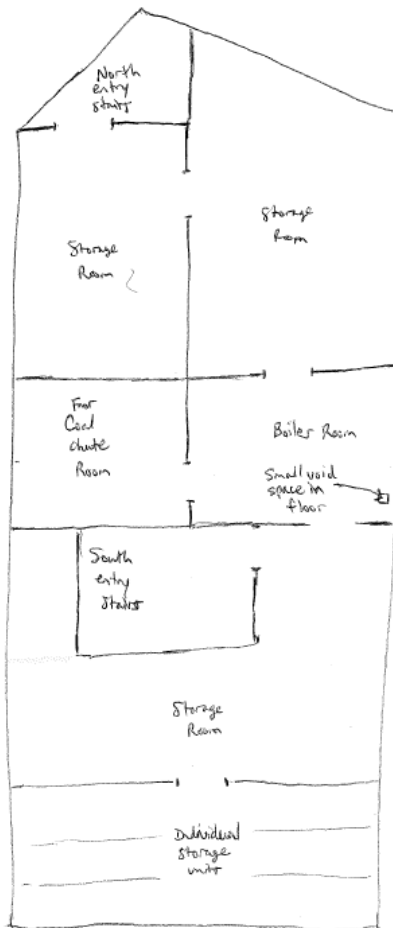
Plan View of Basement
Layout - Not to Scale

While Beggs was on-site to conduct indoor air sampling, Beggs also looked at the basement with Cindy Kinnard – Kewaunee County Health Dept. and Sherry Young - Property Manager to evaluate its condition. There were minimal cracks in the concrete floor throughout the basement. There was some tiling on the north end that was in decent shape, but the rest of the floor throughout the basement was bare concrete. No sumps/sump pits were observed; however, one square void space was seen at the southeast corner of the boiler room. No floor drains were observed on the initial walkthrough of the basement. The boiler room and former coal chute room are located in the middle of the basement, just north of the southern stairway access. See the hand drawn plan view of the basement below. See photos below:

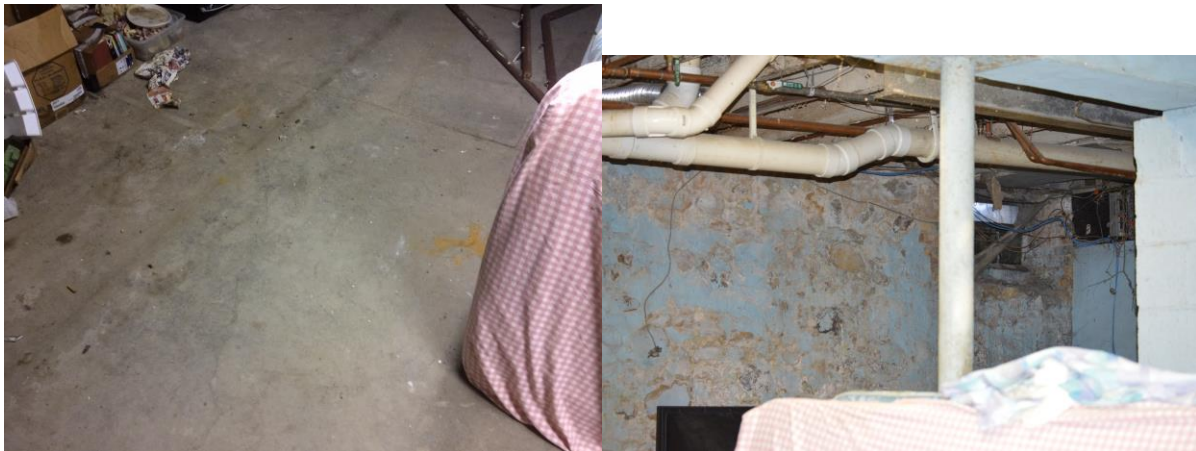
Picture 3 – left: Typical concrete floor condition – minimal cracks
Picture 4 – right: Looking at west wall and window well.

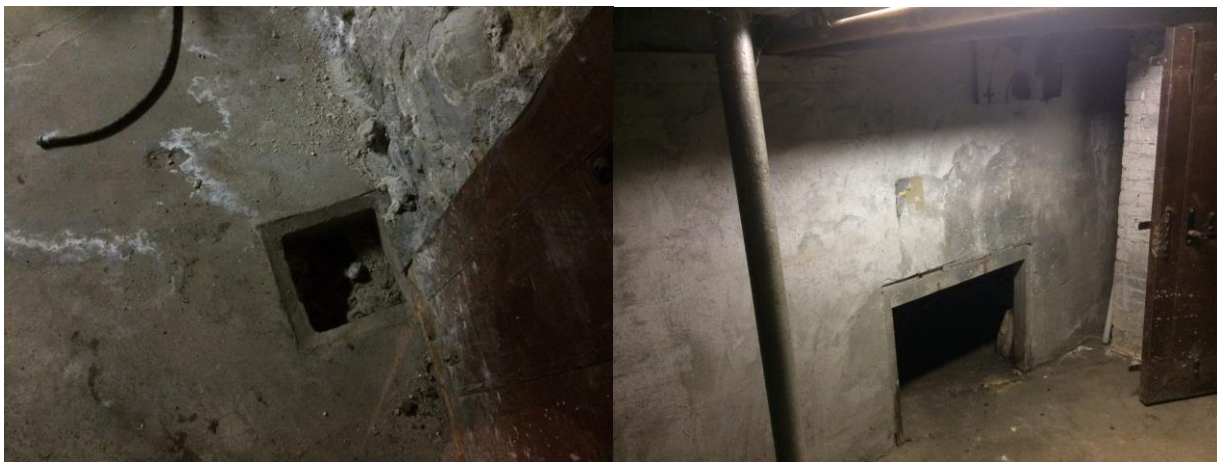
Picture 7 – left: Square void space in concrete floor in the southeast corner of boiler room

Picture 8 – right: Looking west-northwest at the wall between the boiler room and former coal chute room
