Technical Memorandum

To: Alex Smith, Enbridge Energy
From: Ryan Erickson and Chris Goscinak
Subject: Superior Terminal Manifold 225 Release
Date: February 15, 2015
WDNR SERTS ID: 20141203NO16-1
Barr Project: 49161301

This memorandum summarizes the field screening, analytical sampling, and waste management assistance conducted by Barr Engineering (Barr) at the request of Enbridge Energy (Enbridge) in response to the Manifold 225 crude oil release at the Enbridge Superior Terminal in Superior, Wisconsin in December of 2014 (Figure 1).

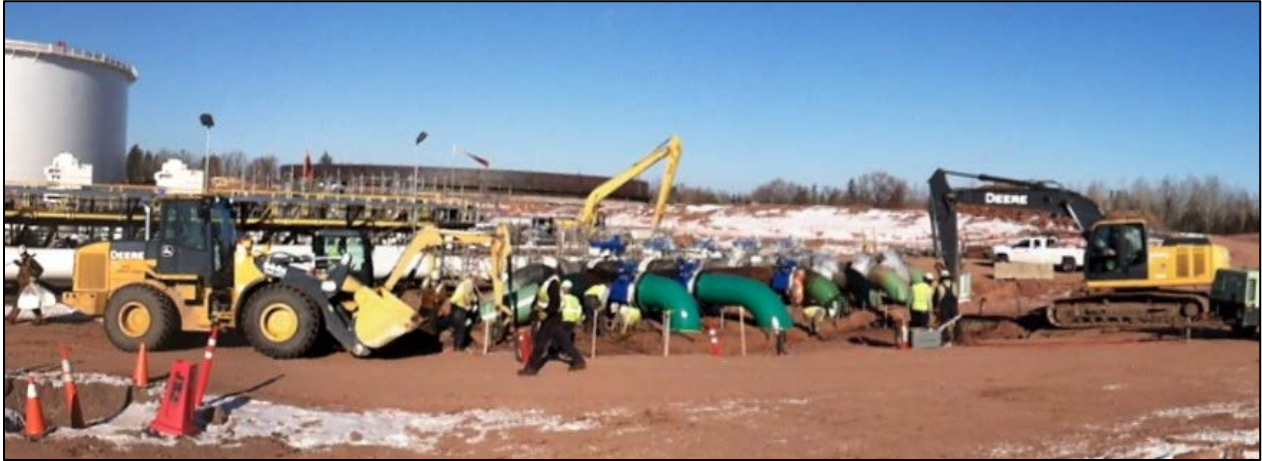
On December 3, 2014 at approximately 8:45 AM, approximately 5.95 barrels of crude oil were released from a vertical 2-inch pipe on Manifold 225 (Figure 2; Photos 1, 2, 3) during pipeline maintenance activities. The crude oil was released onto the ground surface beneath the release point and some product mist sprayed into the air and blew to the east of the release point (Photo 4). The Enbridge Pipe Line Maintenance (PLM) personnel conducting the maintenance immediately responded to the release by replacing the 2-inch pipeline plug to halt the release and initiated remediation activities. Remediation activities included: recovering product with a vacuum truck where possible; removing crude oil from the manifold infrastructure with a biodegradable degreaser; and excavating soil containing crude oil from the release area with hydrovacuum (hydrovac) trucks, excavators, and hand tools. Shortly after the release, PLM personnel notified Enbridge Environment and the Wisconsin Department of Natural Resources (WDNR). The WDNR assigned Substance Release Notification Report (SERTS) number 20141203NO16-1 to the release (Attachment A).

Photo 1: Manifold 225 release area with remedial response personnel and equipment. Photo taken facing north on December 3, 2014.

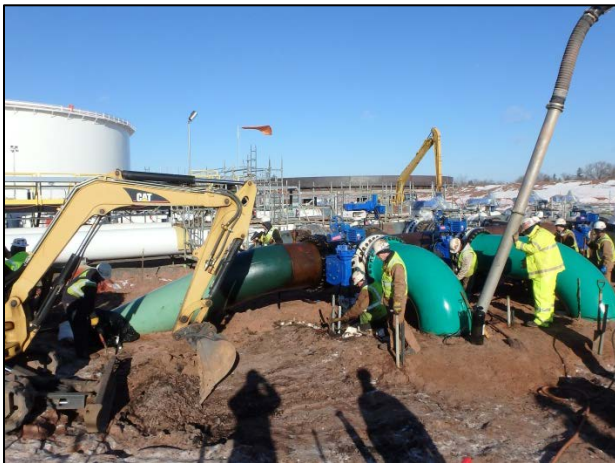
Photo 2

Photo 2: Release location. The 2-inch pipe is located above the section of brown pipeline shown in the center of the photo and in Photo 3. Photo taken facing north on December 3, 2014.

Remedial excavation activity near the release point was conducted on December 3 and December 4, 2014 (Photos 2, 5, 6, 7). Product pooled in this area before it could be removed and the crude oil was able to infiltrate beneath the frost layer along preferential pathways (e.g. pipeline infrastructure, wooden lathe). A surficial scrape of soil was conducted throughout the area to remove soil with crude oil impacts. Small pockets of crude oil were identified in two limited areas where soil impacts were observed at depths up to 7.5 feet bgs. Two remedial excavations were made in these areas, a 7-foot by 7-foot by 7.5-foot deep excavation (Photo 6) and a 5-foot by 5-foot by 4-foot deep excavation (Photo 7), to remove contaminated soil (Figure 3). Most crude oil contaminated soil in the release area was removed during the excavation activities; however, small areas of residual contamination could not be excavated due to the presence of buried pipeline infrastructure.

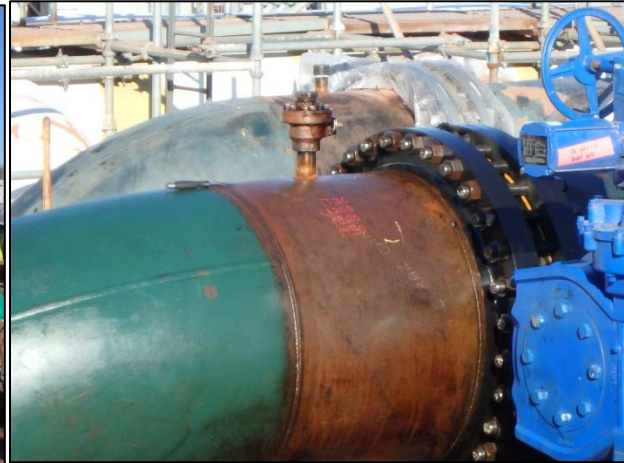
Photo 3

Photo 3: The 2-inch pipe release source. The 2-inch pipe is the short vertical pipe above the section of brown pipeline. Photo taken facing north on December 3, 2014.

Spill Cause:
PLUGGING TOR'S TO REMOVE VALVE'S PLUG IN THE TOR WAS NOT CEDED/ TOR PLUG RELEASED AND LET OIL OUT.

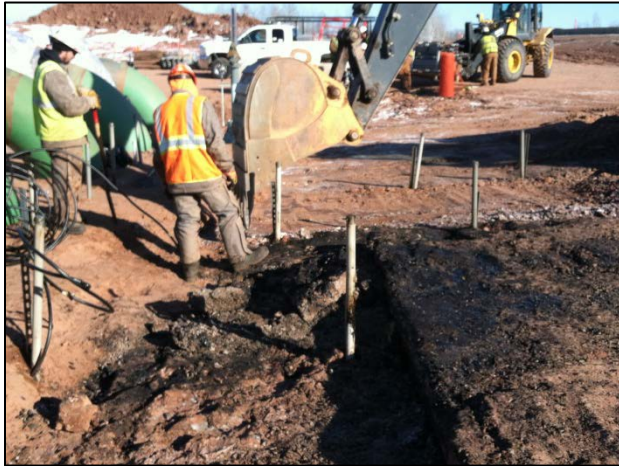
Photo 4

Photo 4: Crude oil contaminated soil and timber mat south of the release point. Photo taken facing east on December 3, 2014.

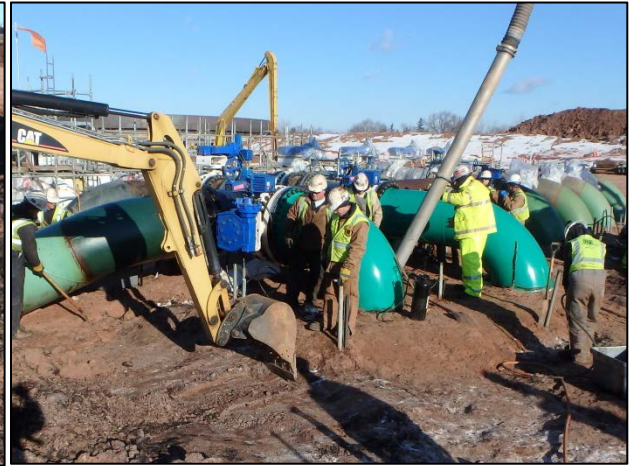
Photo 5

Photo 5: Remedial scrape/excavation activity using an excavator (left) and a hydrovac truck (silver tube on right). Photo taken facing northeast on December 3, 2014.

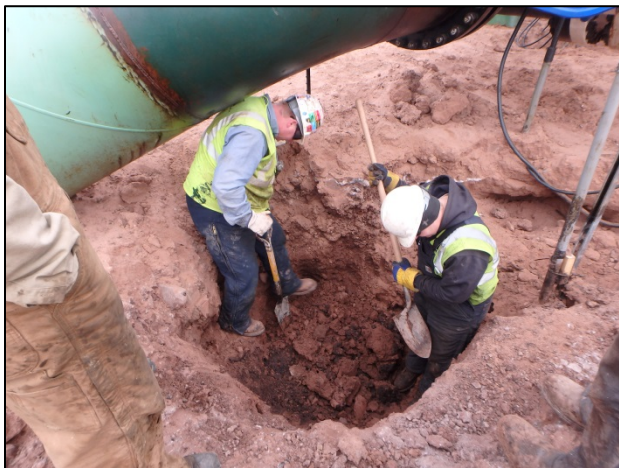
Photo 6

Photo 6: Remedial excavation located beneath the release point. Photo taken on December 4, 2014.

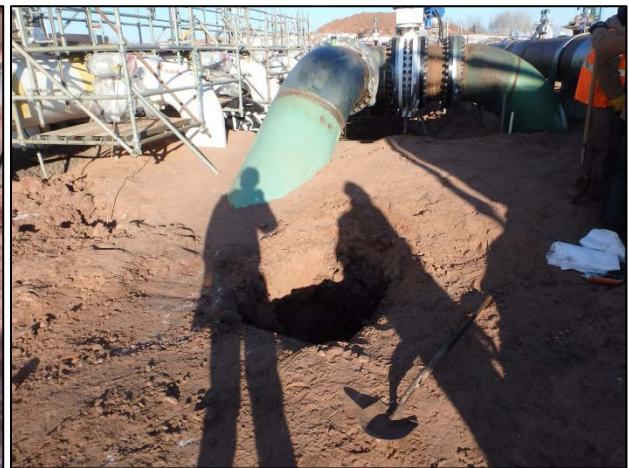
Photo 7

Photo 7: The smaller northern remedial excavation in the release area is shown in the center of the photo. Photo taken facing east on December 4, 2014.

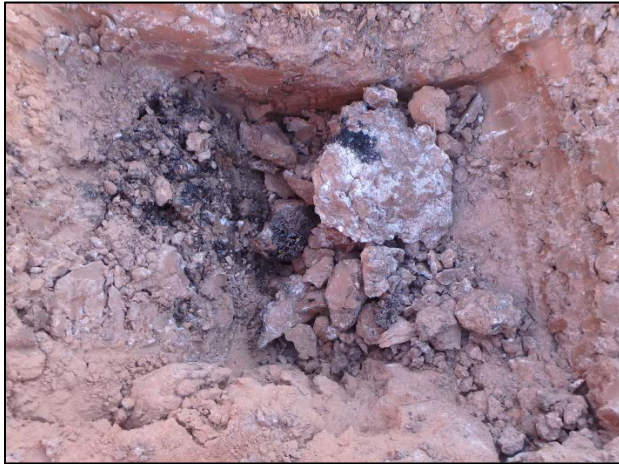
Photo 8

Photo 8: Crude oil contaminated soil encountered in northern remedial excavation. This contaminated soil is representative of the contaminated soil pockets encountered in the immediate release area excavations. Photo taken on December 4, 2014.

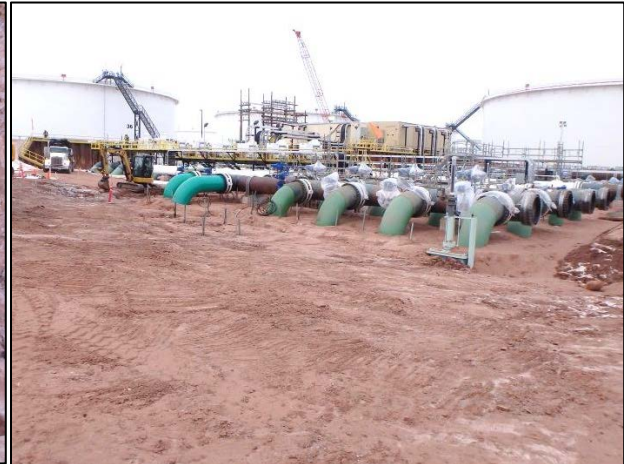
Photo 9

Photo 9: Final spray zone remedial scrape excavation. Photo taken facing west on December 4, 2014.

The eastern 2/3 of the broader release area was impacted by the wind-blown crude oil spray and the impacts were limited to the surficial soil. In this area, a shallow surficial scrape using excavators, hydrovac trucks and hand tools was conducted to remove the contaminated soil (Photo 9). Barr collected 23 field screening soil samples from the spray area and PID headspace readings were all less than 10 ppm with the exception of screening point *B-10* at 0.25 feet bgs which had a headspace of 11.7 ppm (Attachment B). Soil from the *B-10* screening point had no visible crude oil staining and had a citrus odor that was similar to the odor of the degreaser that was used to clean the pipeline infrastructure. The 11.7 ppm headspace detection was attributed to the degreaser. No analytical samples were collected from the spray area after a discussion with the WDNR.

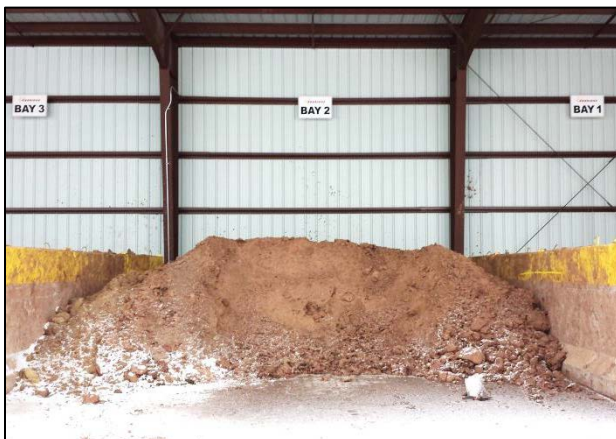
Photo 10: Manifold 225 crude oil release contaminated soil stockpile in the Superior Terminal SMA building on December 19, 2014.

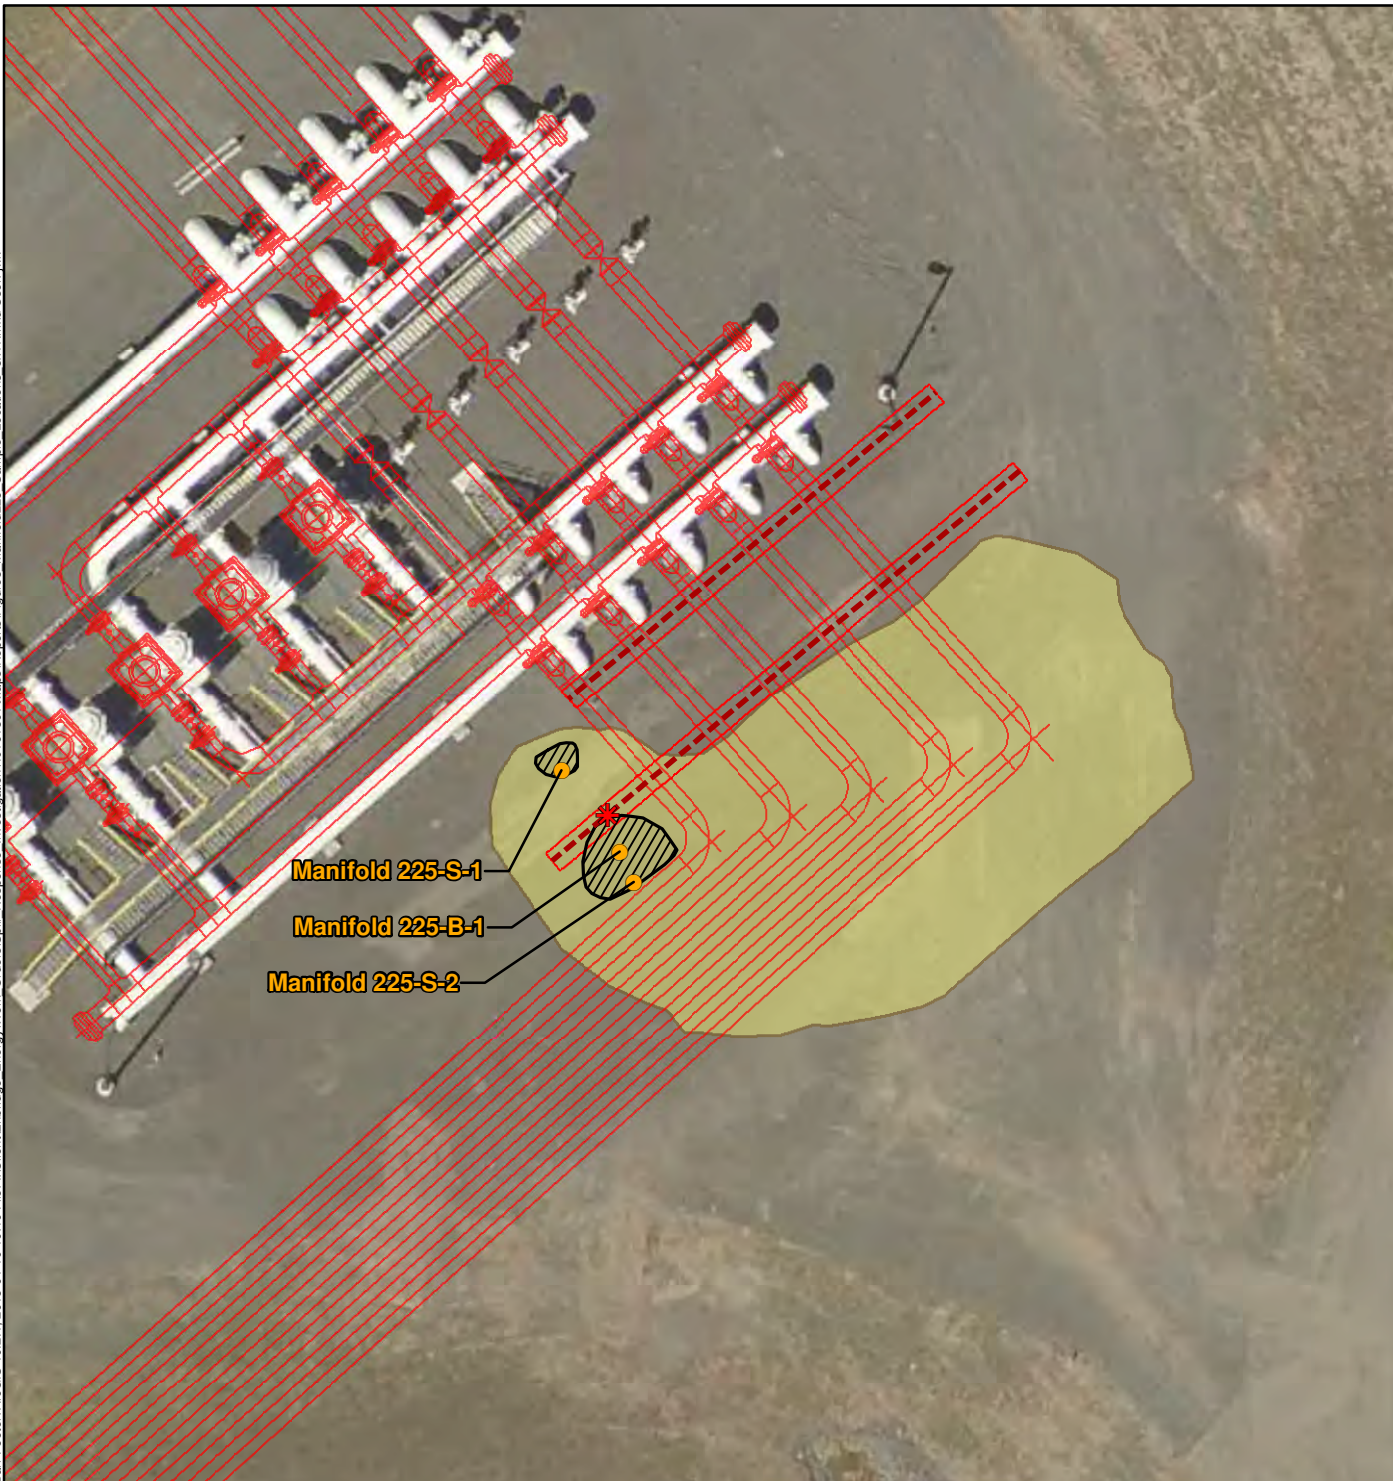
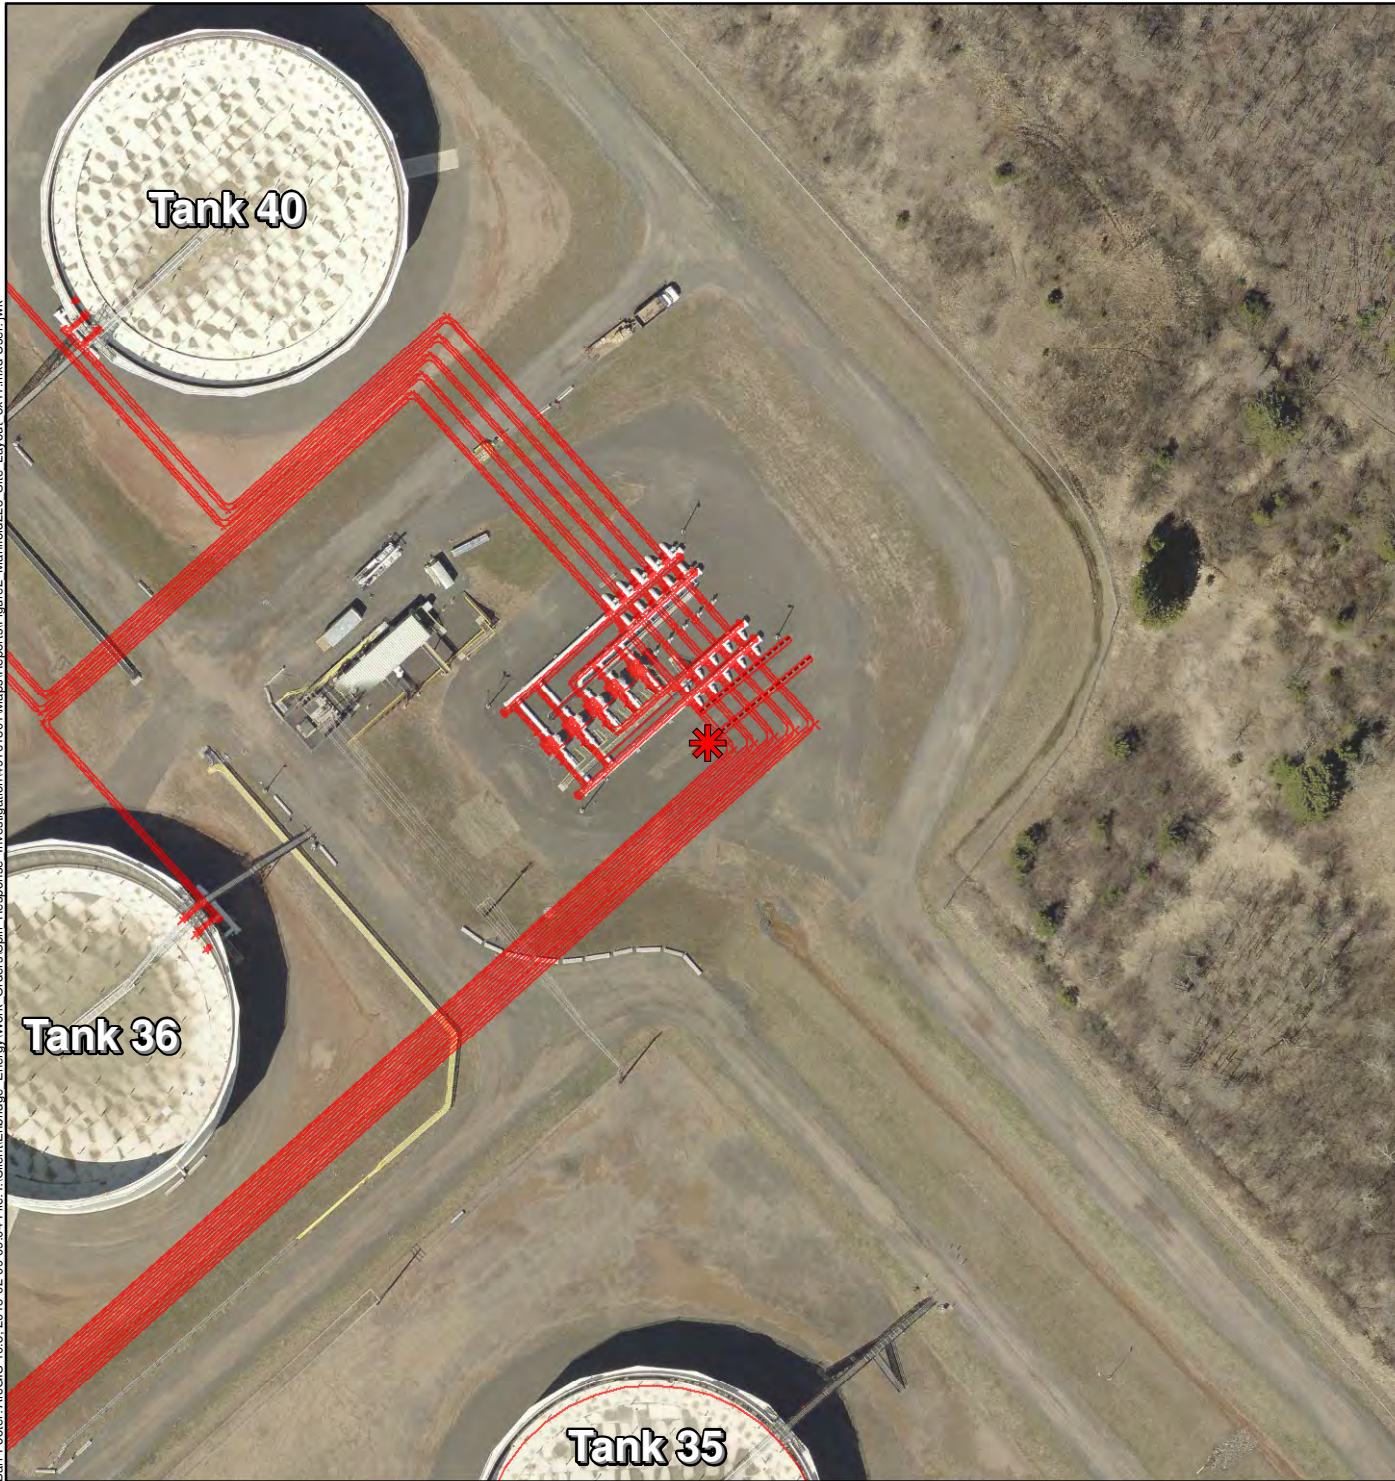
Figure 2

Barr observed that the area impacted by the crude oil release was approximately 65 feet long (east to west) by 25 feet wide (north to south). Soil at the ground surface was primarily sand fill that had been used as backfill around the recently constructed manifold structure. The ground surface was frozen to a depth of approximately 0.5 feet below ground surface (bgs); which prevented significant infiltration of the crude oil into the soil in most areas. The largest volume of product released onto the ground surface was focused in an area within 10 feet of the release point. Crude oil contaminated soil to the east of the release point, up to 60 feet away, was caused by the wind blowing the released crude oil mist.

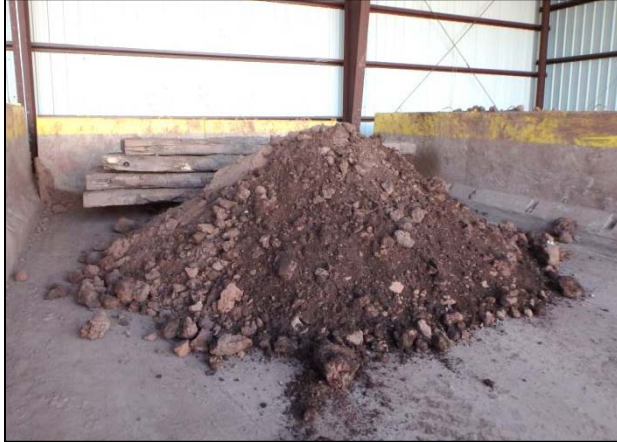
Photo 1

Photo 1: Manifold 225 crude oil release contaminated soil stockpile in the Superior Terminal SMA building on December 12, 2014.

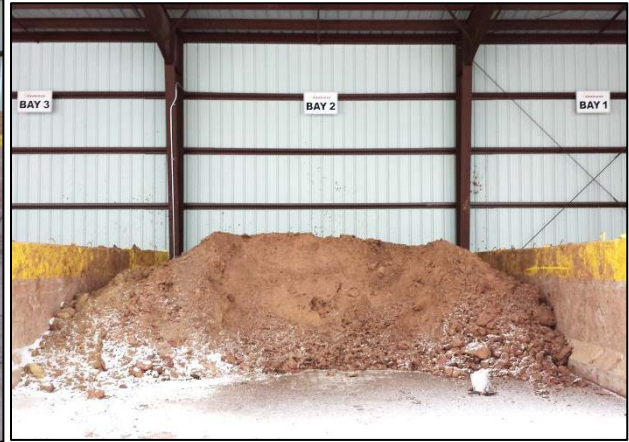
Photo 2

Photo 2: Manifold 225 crude oil release contaminated soil stockpile in the Superior Terminal SMA building on December 19, 2014.

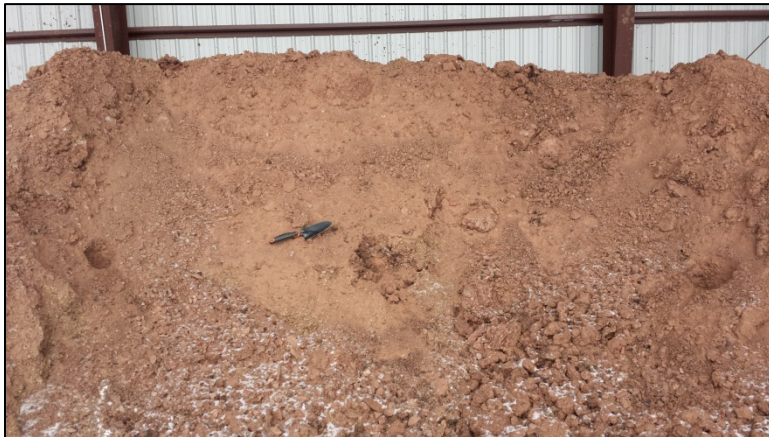
Photo 3: Manifold 225 crude oil release contaminated soil stockpile in the Superior Terminal SMA building on December 19, 2014.
