**Re: *Supplemental Information to
Site Investigation Report Amendment
BRRTS #: 02-41-576336 & 02-41-579429
FID #: 241828620
Sunrise Shopping Center
2410-2424 10th Avenue & 1009 Marquette Avenue
South Milwaukee, Wisconsin 53172***

**FIGURE B.1.b.2
DETAILED SITE MAP SHOWING
SOIL, GROUNDWATER, AND VAPOR
SAMPLING LOCATIONS**

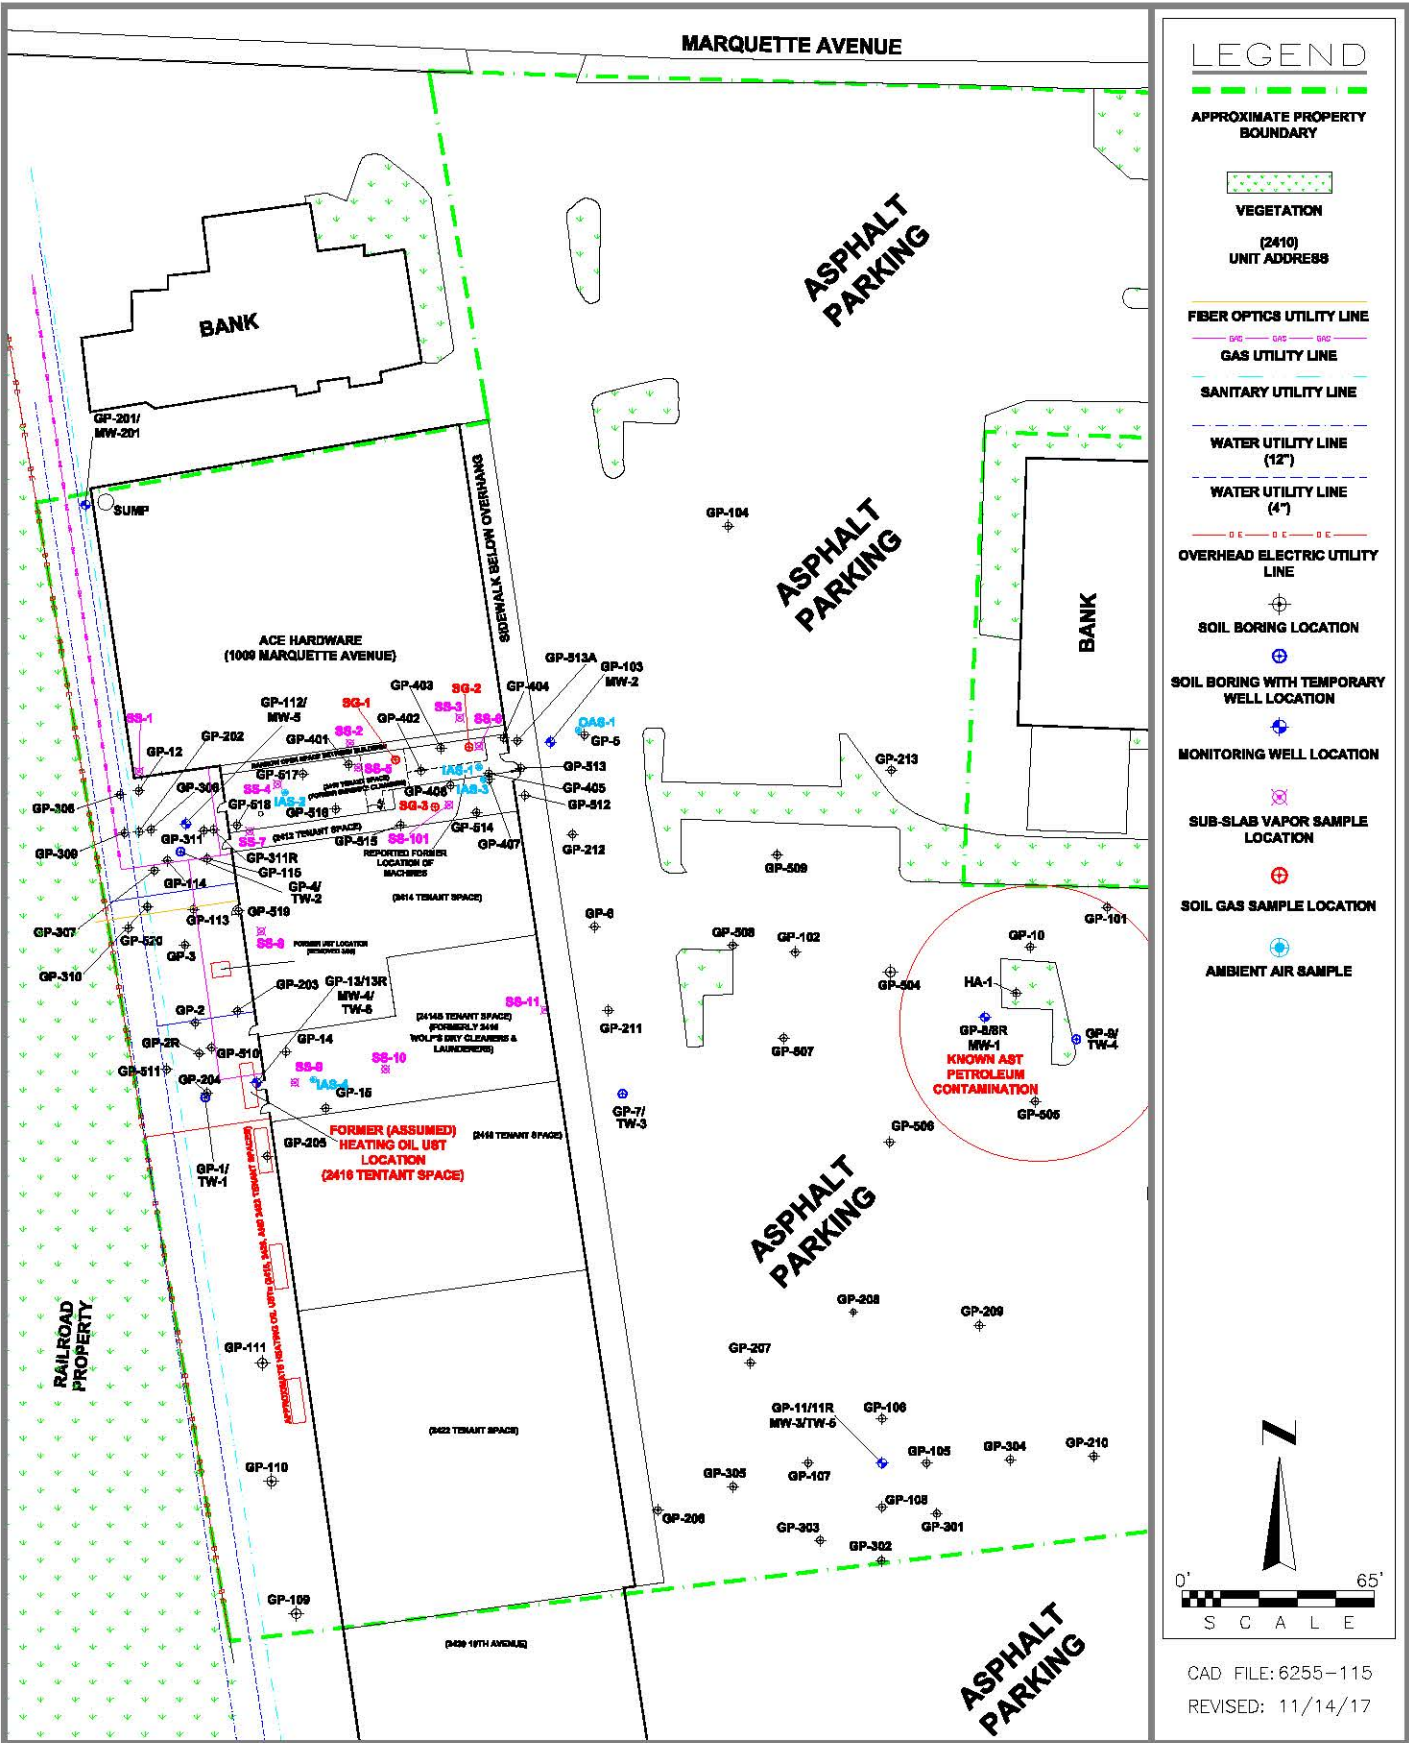
After completing delineation of the Naphthalene contamination identified at GP-13, DAI's opinion is that the source of this contamination is associated with a former heating oil underground storage tank (UST) that was previously located in this area. A UST was registered at the 2416 (now 2414B) tenant space with the State of Wisconsin Department of Agriculture, Trade and Consumer Protection (DATCP). While no records exist indicating that the tank was removed, no signs that the UST remains were noted during the Phase I Environmental Site Assessment (ESA), nor during subsequent subsurface investigation activities. The approximate location of the UST for the 2416 tenant space is shown on Figure B.1.b.2 (provided here as an attachment).

A water sample was collected from the sump located in the northwestern corner of the basement of the Ace Hardware building (see Figure B.1.b.2). The analytical results indicated a Perc concentration in the sump water above the Enforcement Standard. Conversely, the groundwater samples collected from monitoring well MW-201, located outside of the northwestern corner of the Ace Hardware building, have not shown any detectable concentrations of any VOCs in any of the three (3) samples collected during Site Investigation activities, including the May 30, 2017, sample that was collected shortly before the June 4, 2017, sump sample. (Also, no contamination was detected in the soil during the installation of MW-201.) The VOC concentrations from the sump water sample are more consistent with the groundwater concentrations observed in monitoring well MW-5.
