January 31, 1996

WISCONSIN DNR
CEDARBURG GROUNDWATER INVESTIGATION

EXISTING CONDITIONS
REPORT

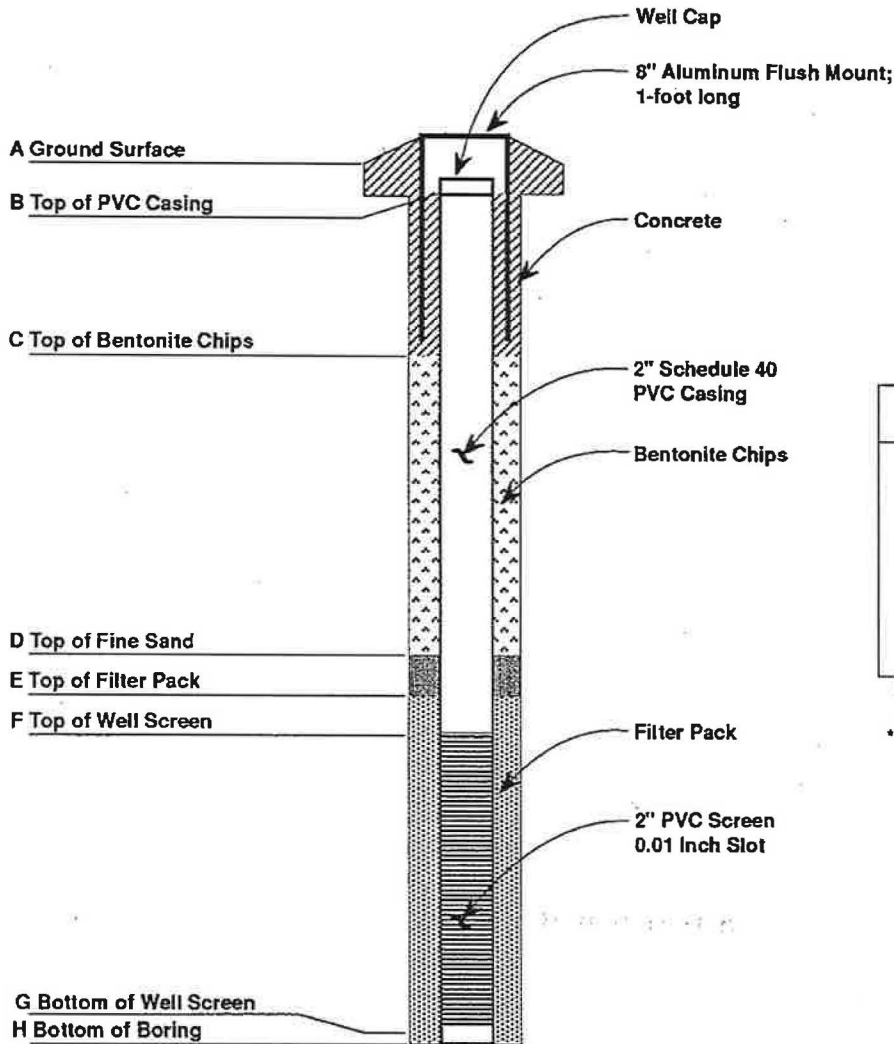
Monitoring well construction details are shown in Figure TM1-1. Monitoring well construction and development forms were completed for each well and submitted to the Wisconsin DNR per Chapter NR 141 of the Wisconsin Administrative Code. Copies of those forms are in Attachment 2.

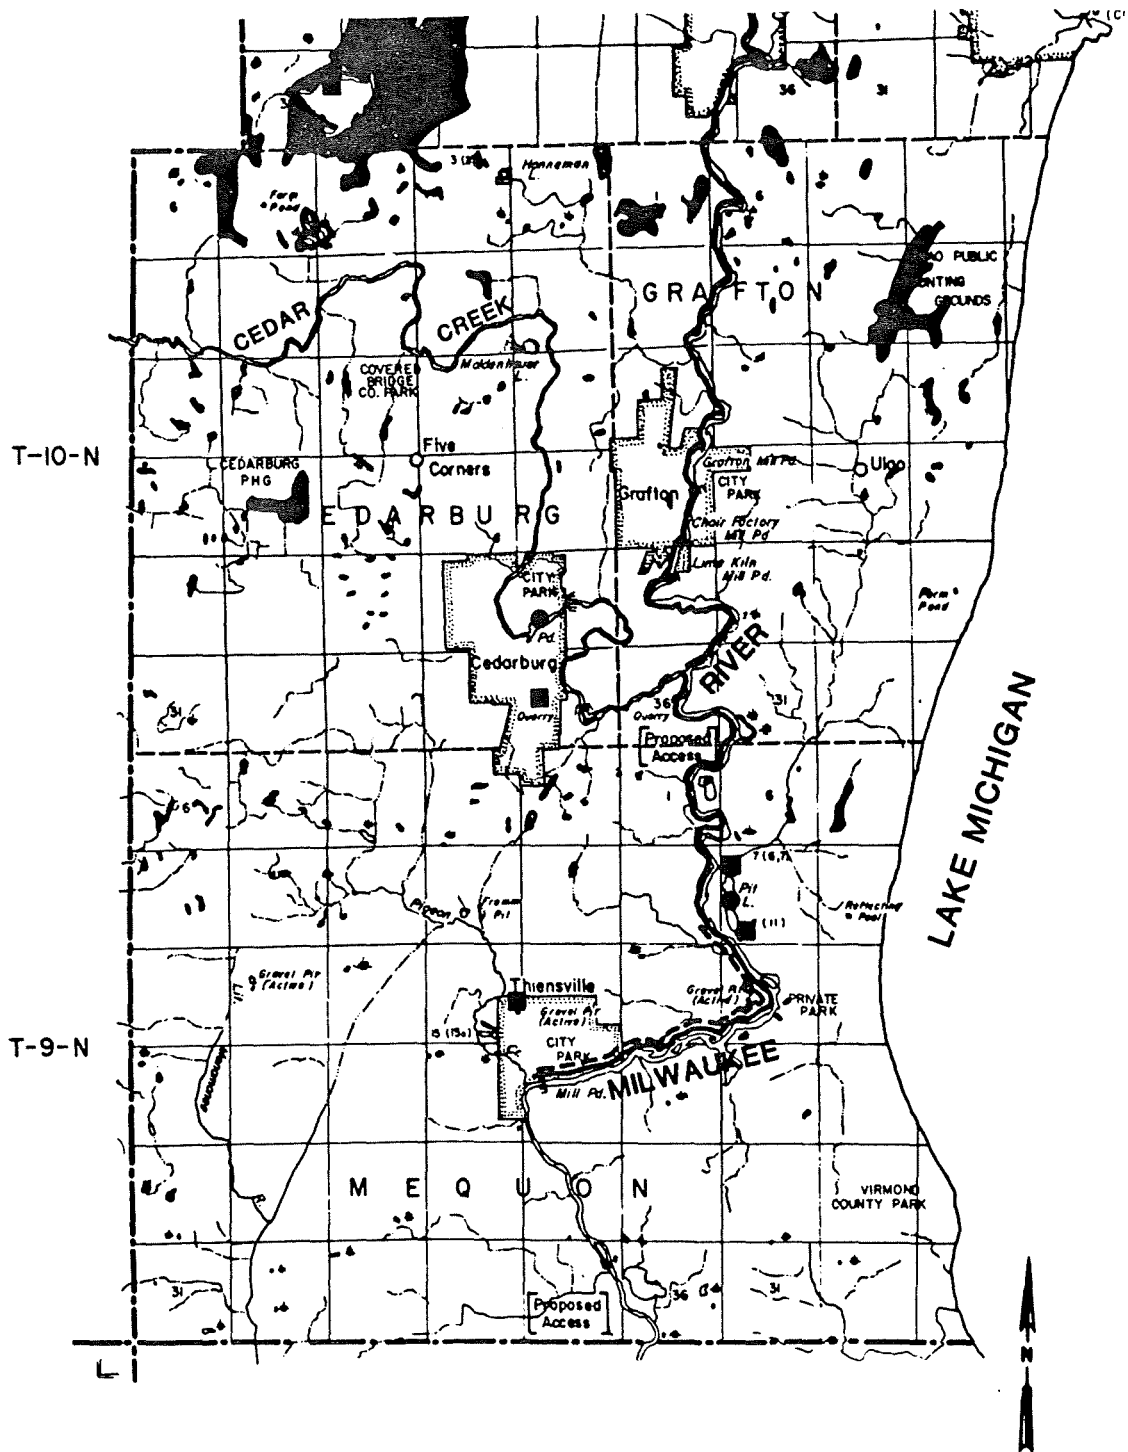
FIGURE
2.04-1

CEDARBURG GROUNDWATER
INVESTIGATION
SURFACE HYDROLOGY

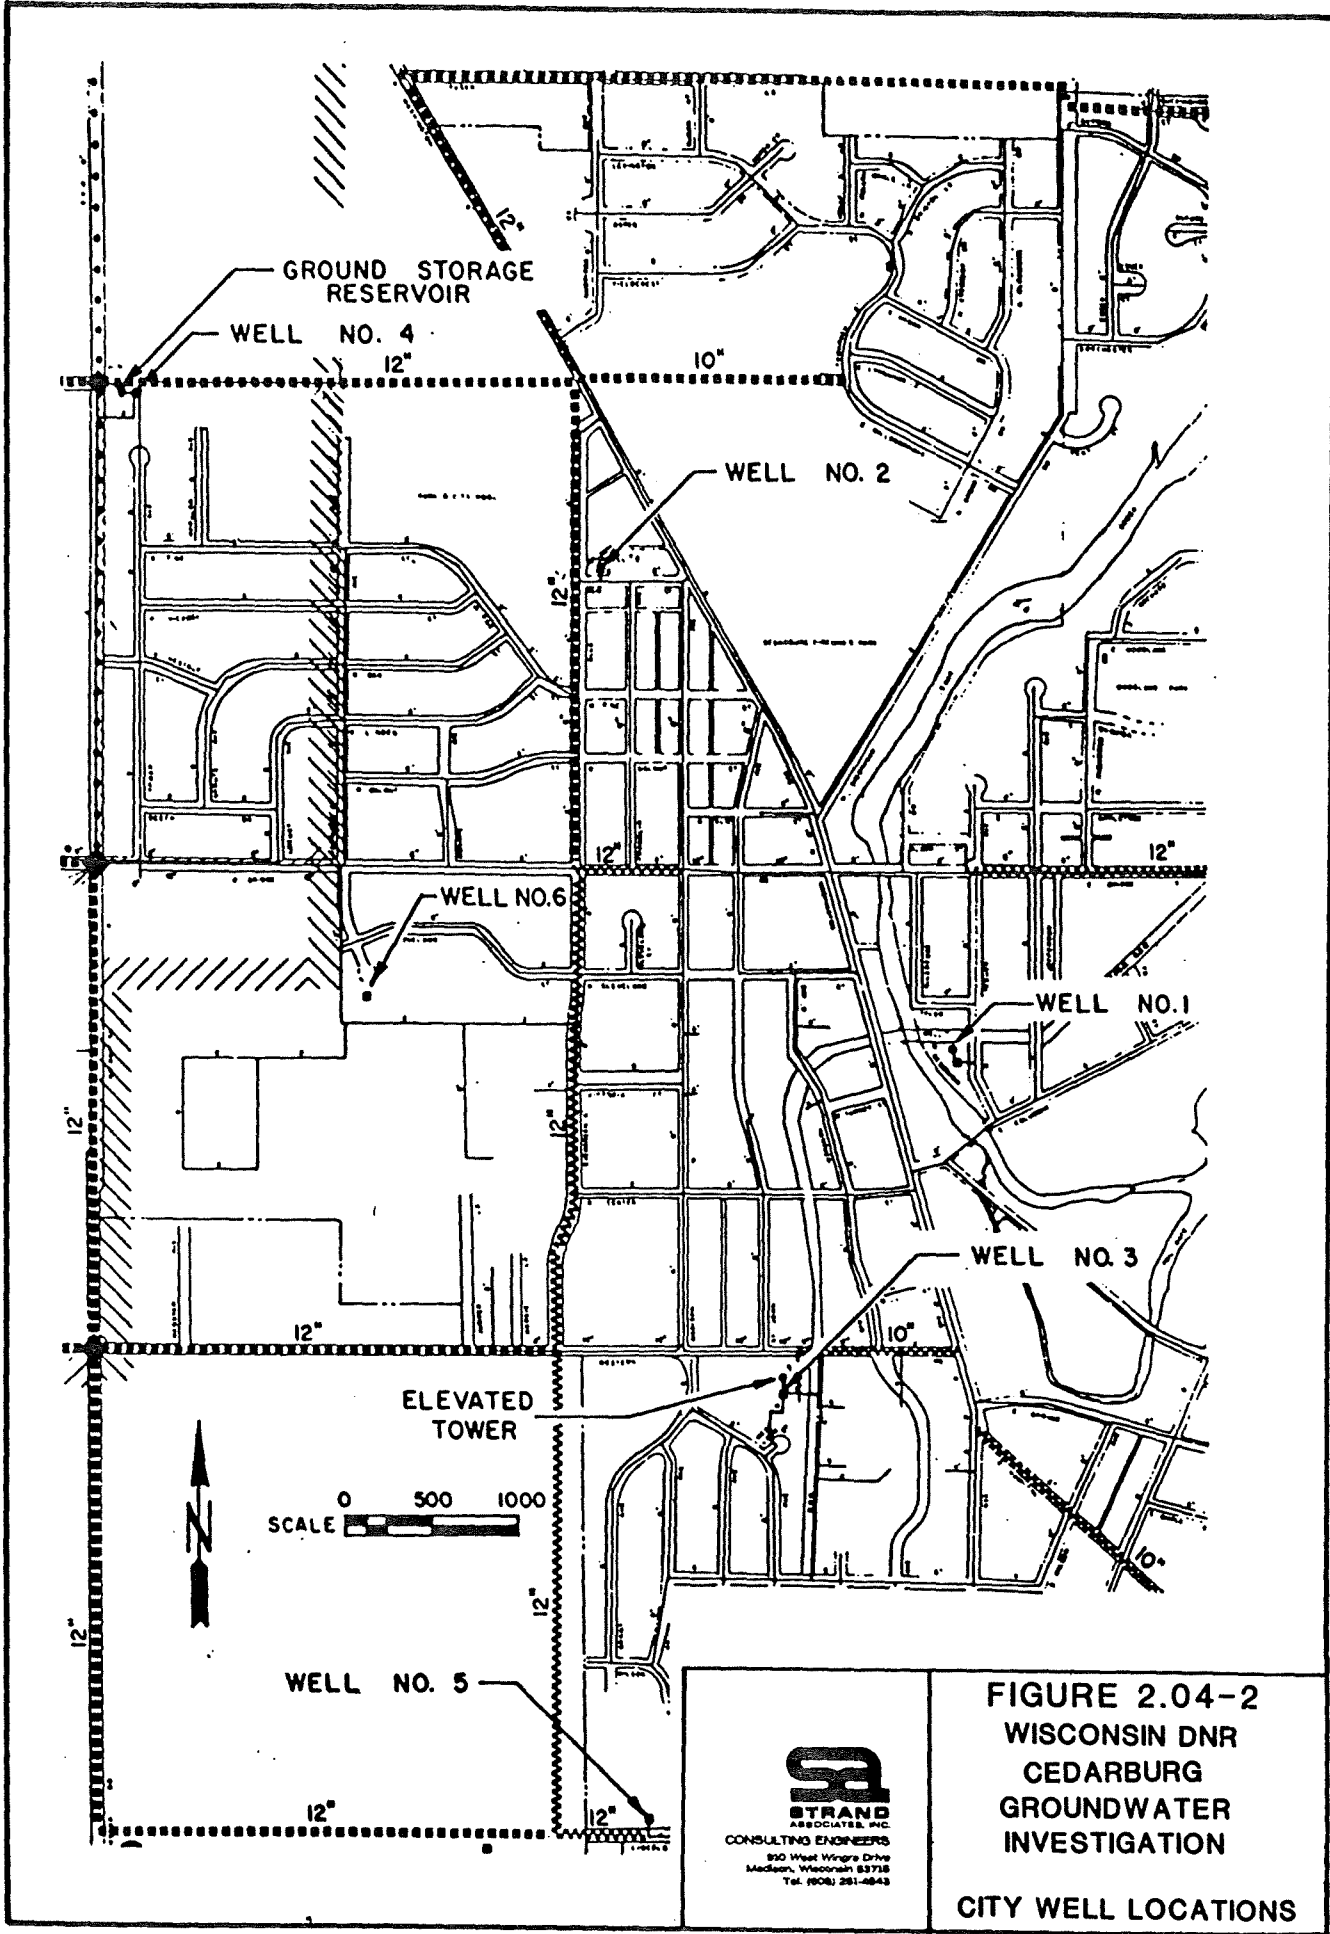
FIGURE 2.04-2
WISCONSIN DNR
CEDARBURG
GROUNDWATER
INVESTIGATION
CITY WELL LOCATIONS

Local hydrogeology was investigated using the well logs of city wells 1,3,4,5 and 6 and USGS publications. The location of these wells are shown on Figure 2.04-2, and the well logs can be found in Appendix C.

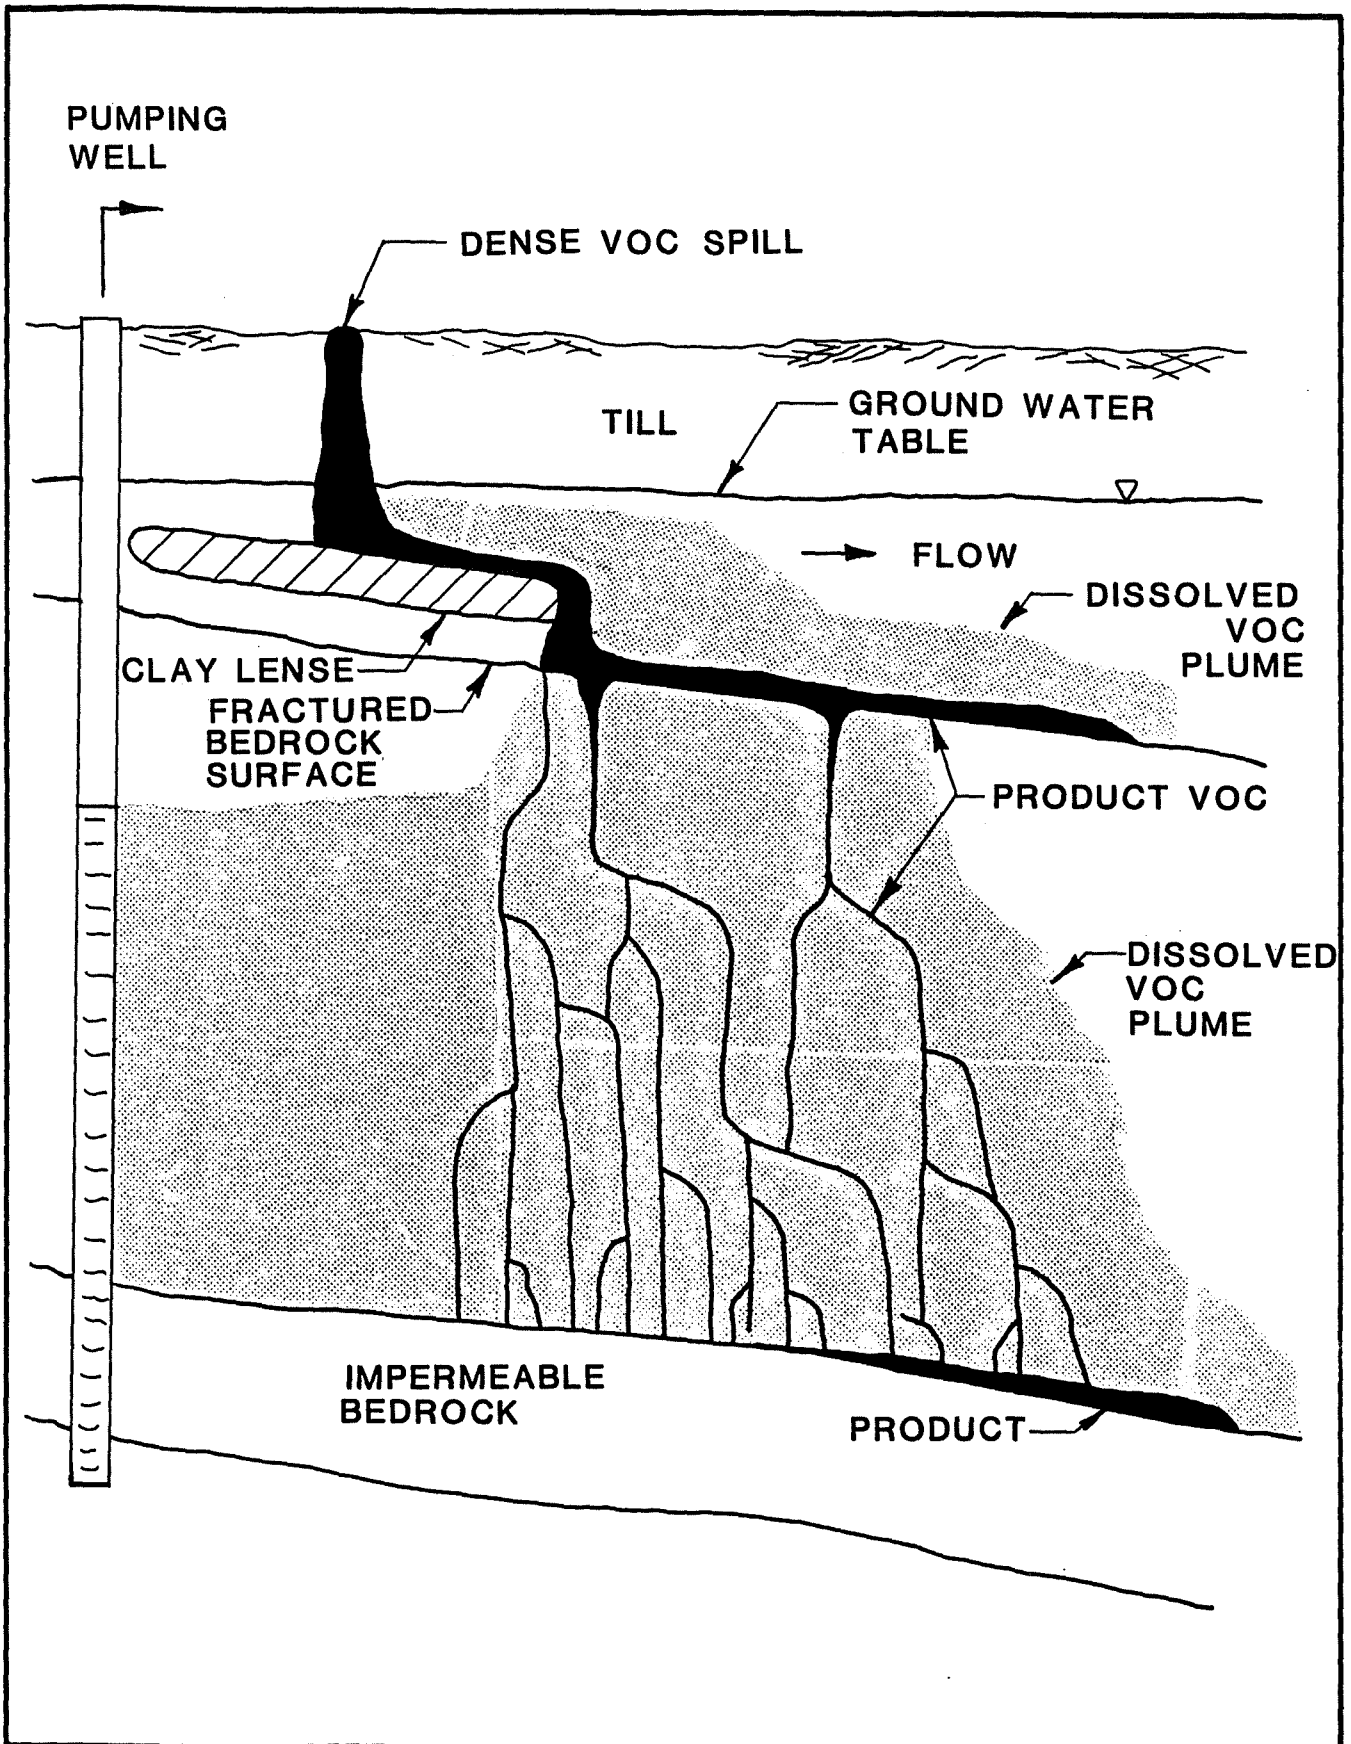
FIGURE 4.04-1

CEDARBURG GROUNDWATER
 INVESTIGATION
 SCHEMATIC OF A DENSE VOC SPILL
