# Immediate Response Action Report

#6 Fuel Oil Release SERTS ID 20180220NO16-1

Prepared By:  
Matt Turner  
Superior Refining Company LLC  
2407 Stinson Avenue  
Superior, WI 54880  
(715) 398-8434

7/25/2018

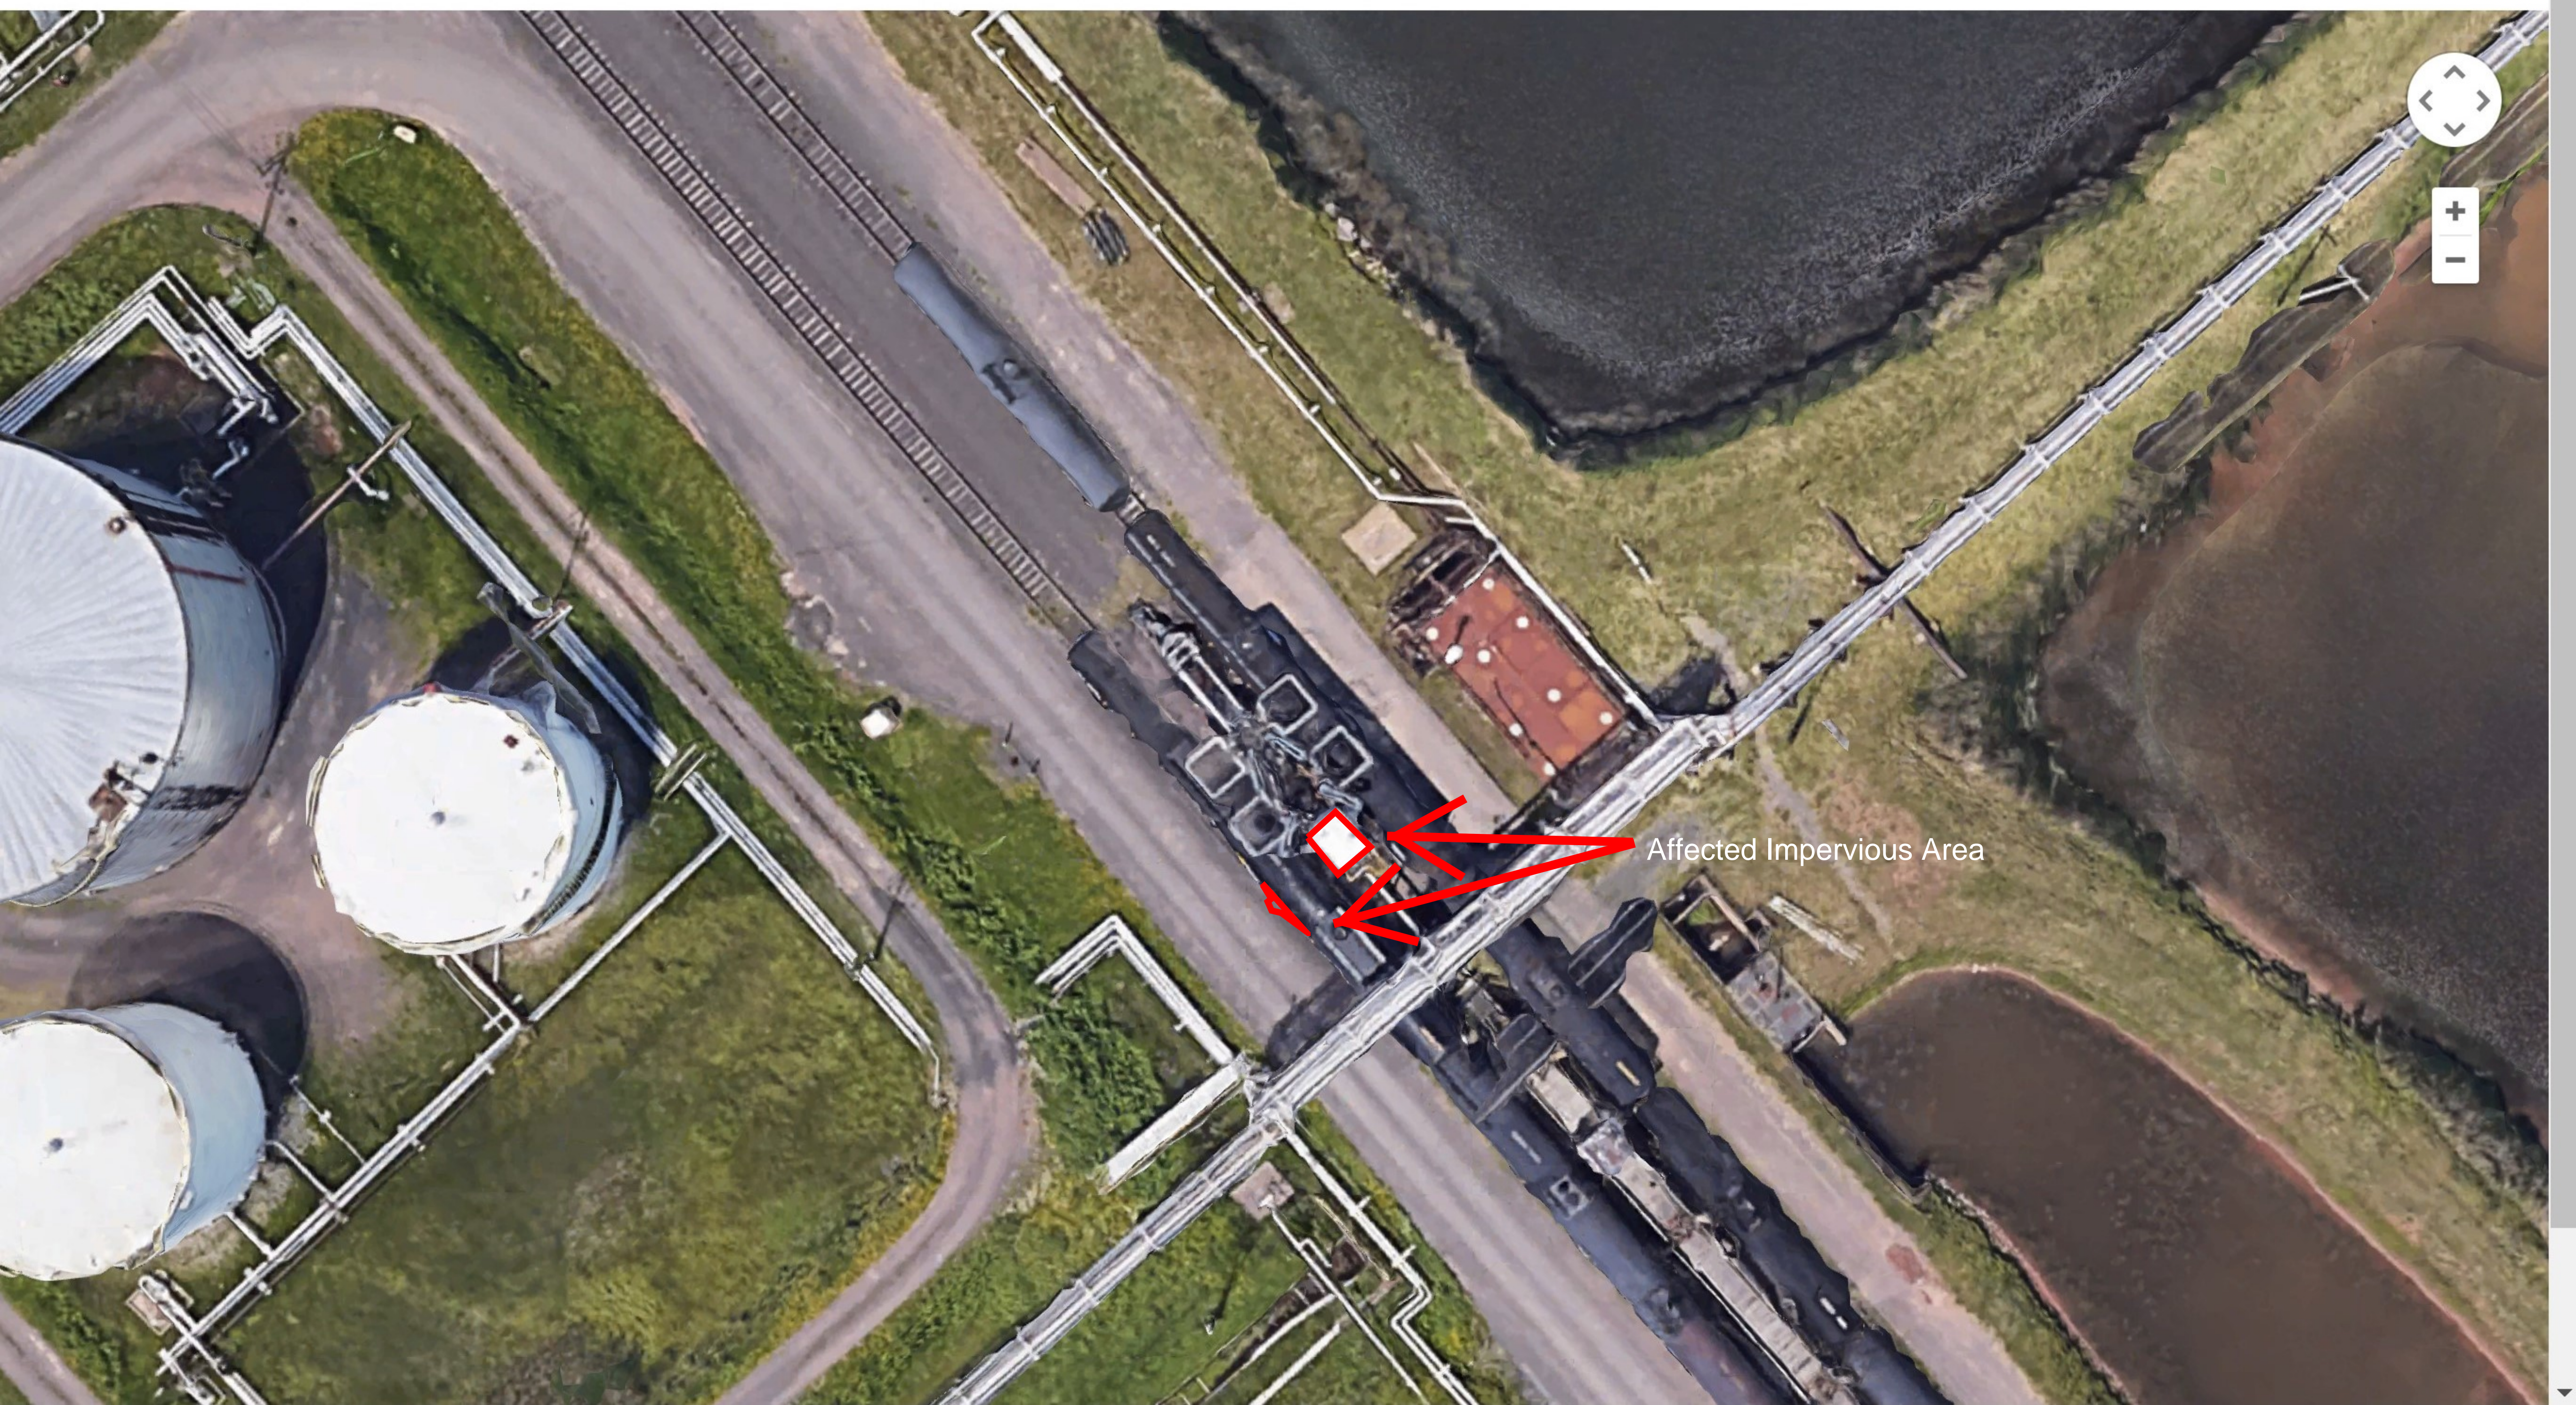
Figure 2                    Site Map

nearby No. 2 API separator. From there, free product can be recovered and any water present can be treated at the onsite waste water treatment plant. On February 20<sup>th</sup>, 2018 hand excavation of the visibly contaminated soil was both commenced and completed. The estimated volume of soil that was removed is 7-10 cubic feet. The excavated soil was brought to our “three sided building” where it was stored before sending it to a proper TSDf for disposal. The excavation took up an area approximately 40 square feet in total and had a few structural impediments present. The area was excavated to a depth between two and three inches as the product did not leech any deeper into the soil. Spill site conditions and remediation efforts are depicted in the photographs which are included in Appendix A. The area of the spill and excavation are depicted in Figure 2.

Affected Impervious Area

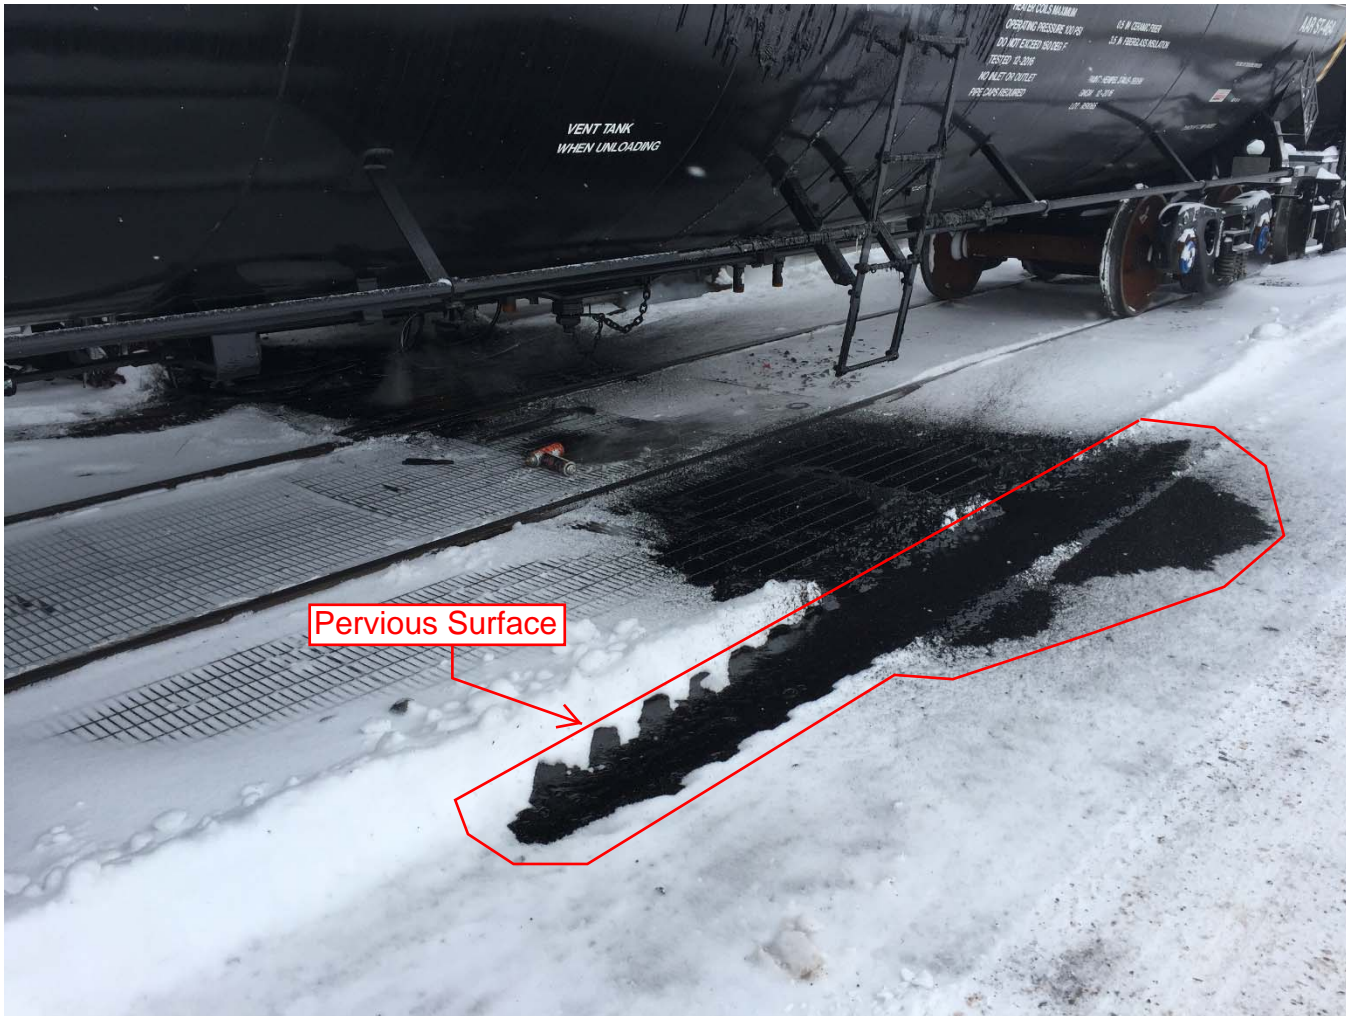
Photo 1: Looking southeast while standing on the west side of Track 3.

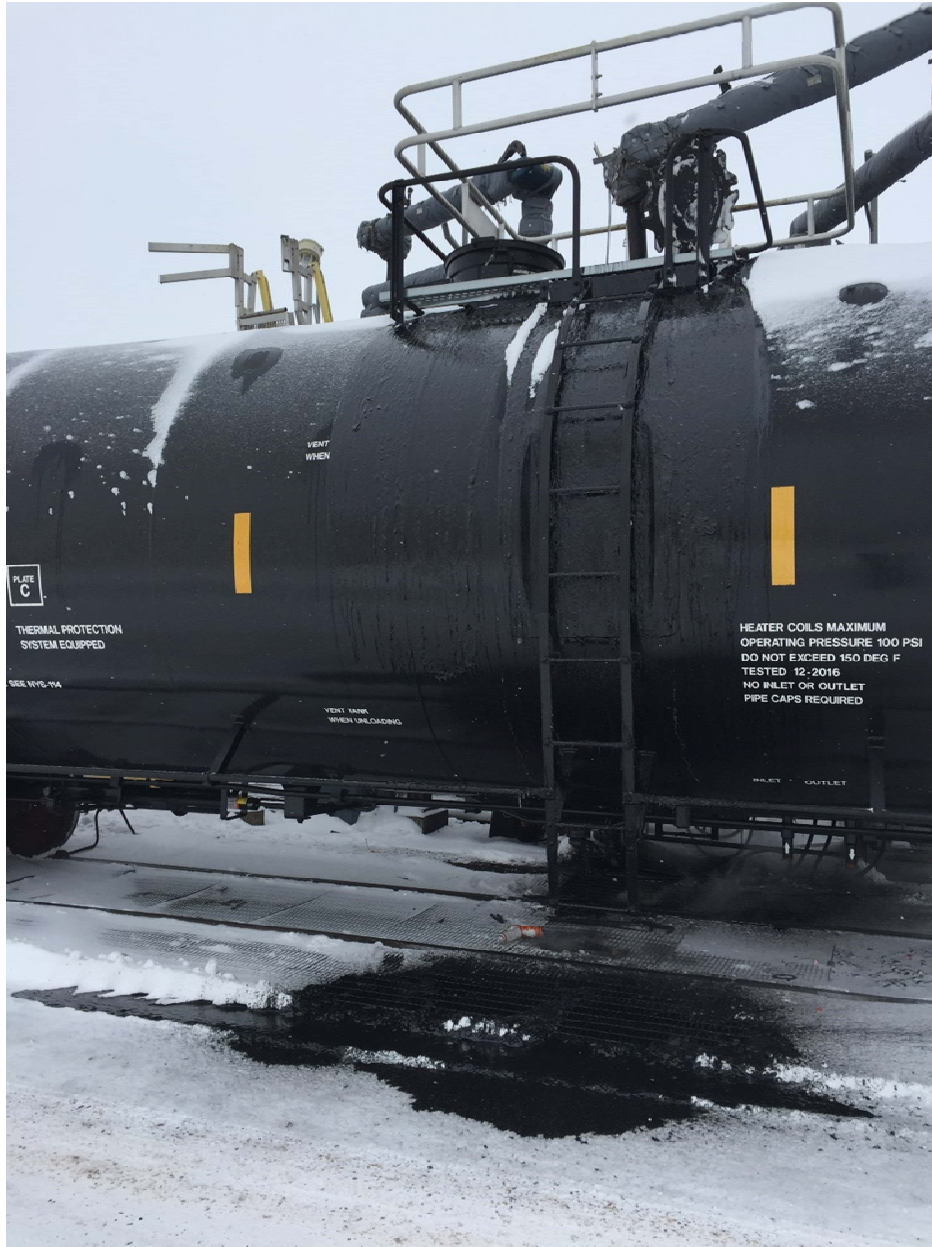
Photo 2: Looking east and standing on the west side of Track 3. The released product rolled down the side of the railcar and mostly dripped into containment.

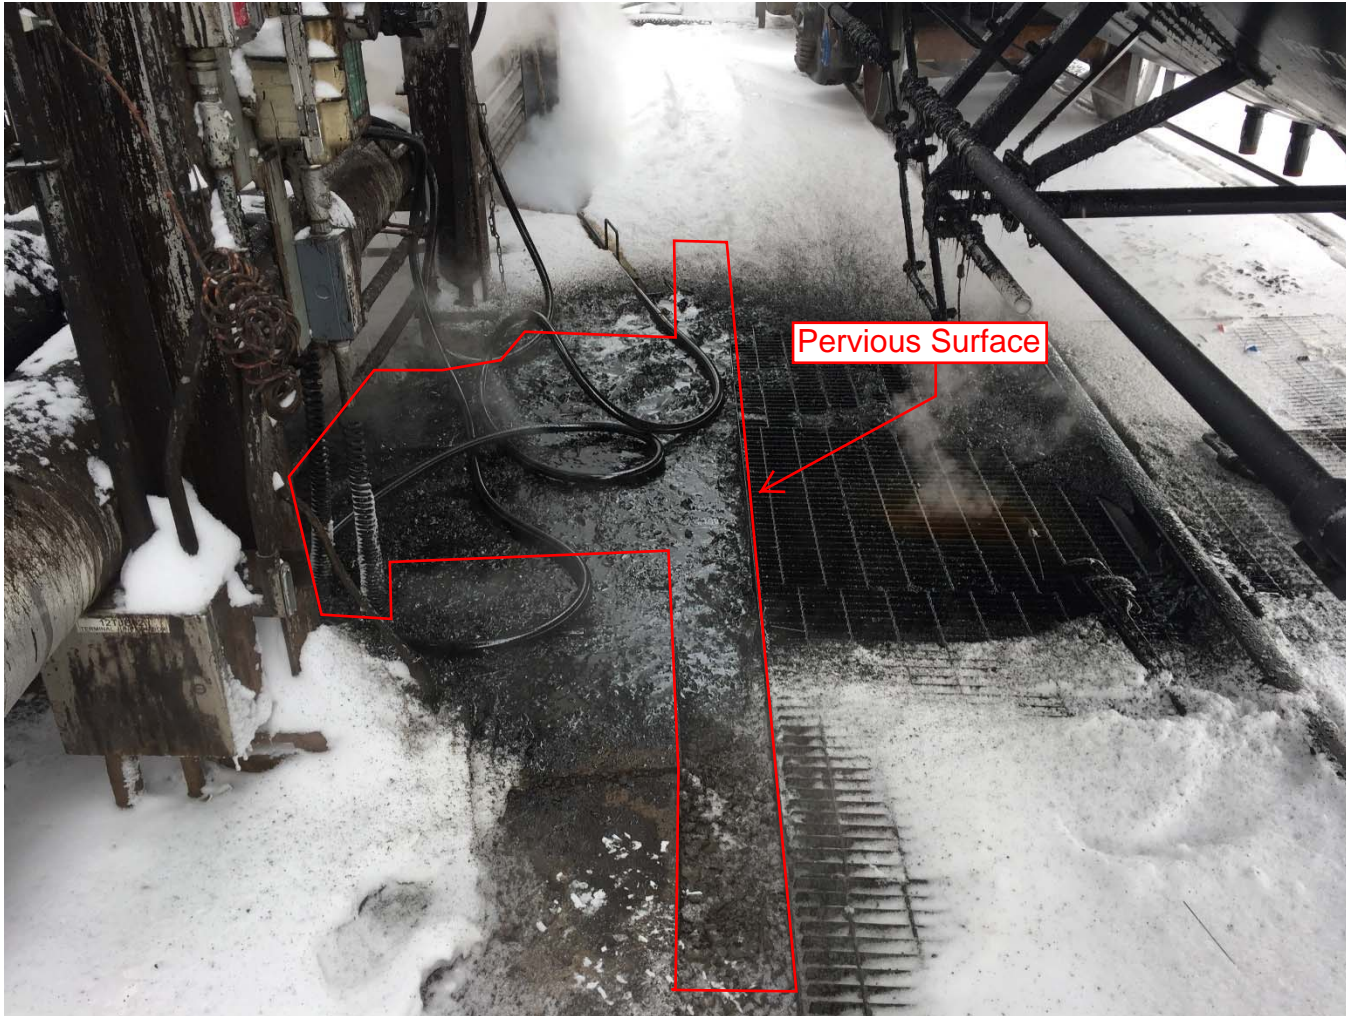
Photo 3: Looking south while standing on the east side of Track 3.

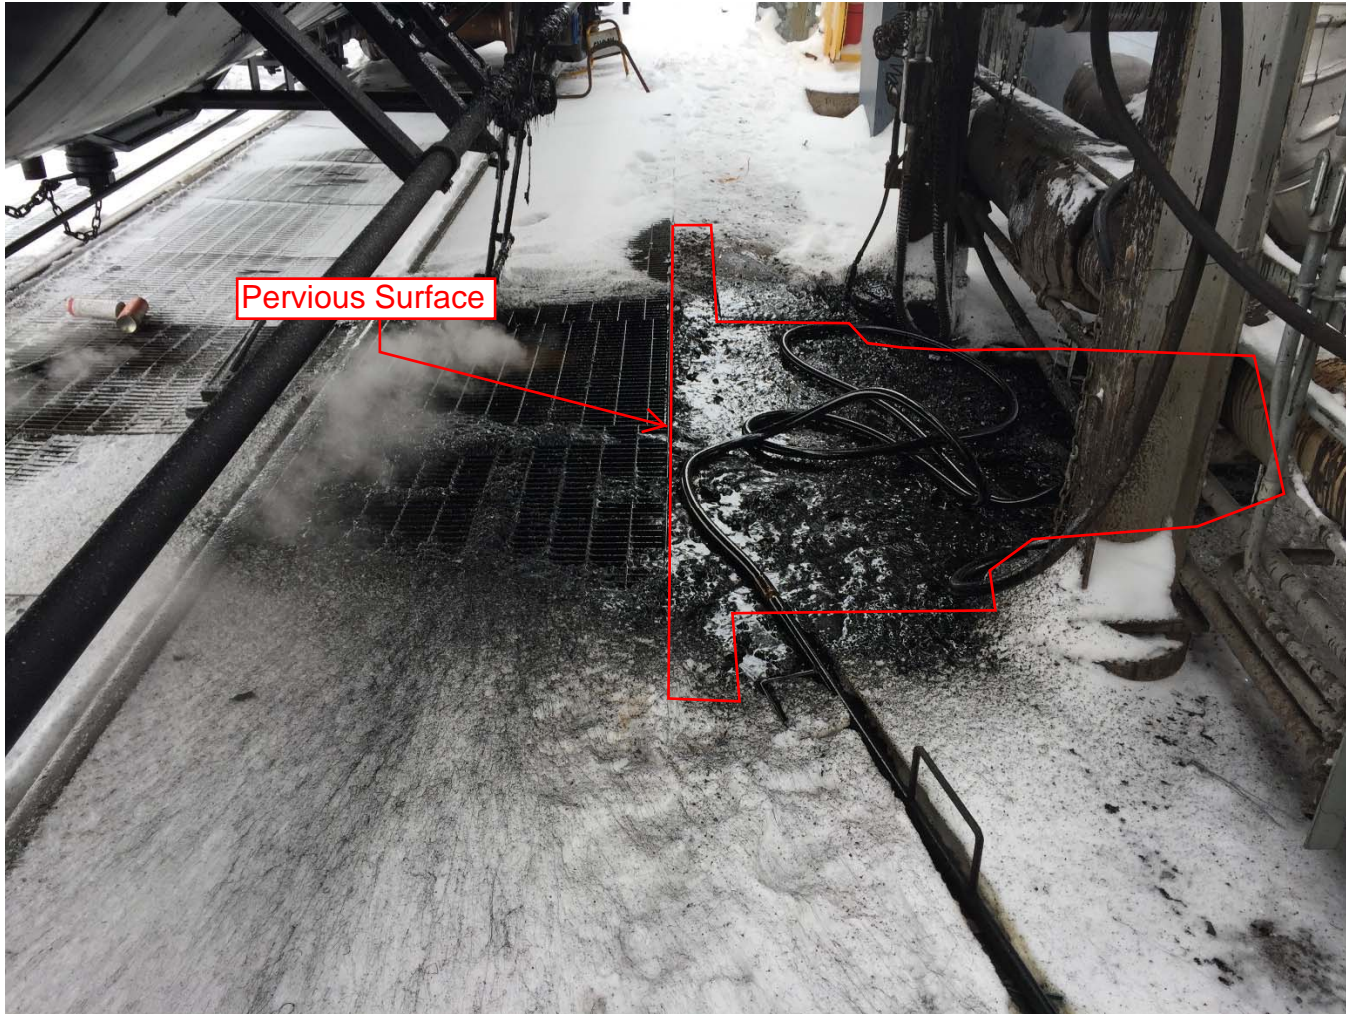
Photo 4: Looking north while standing on the east side of Track 3.

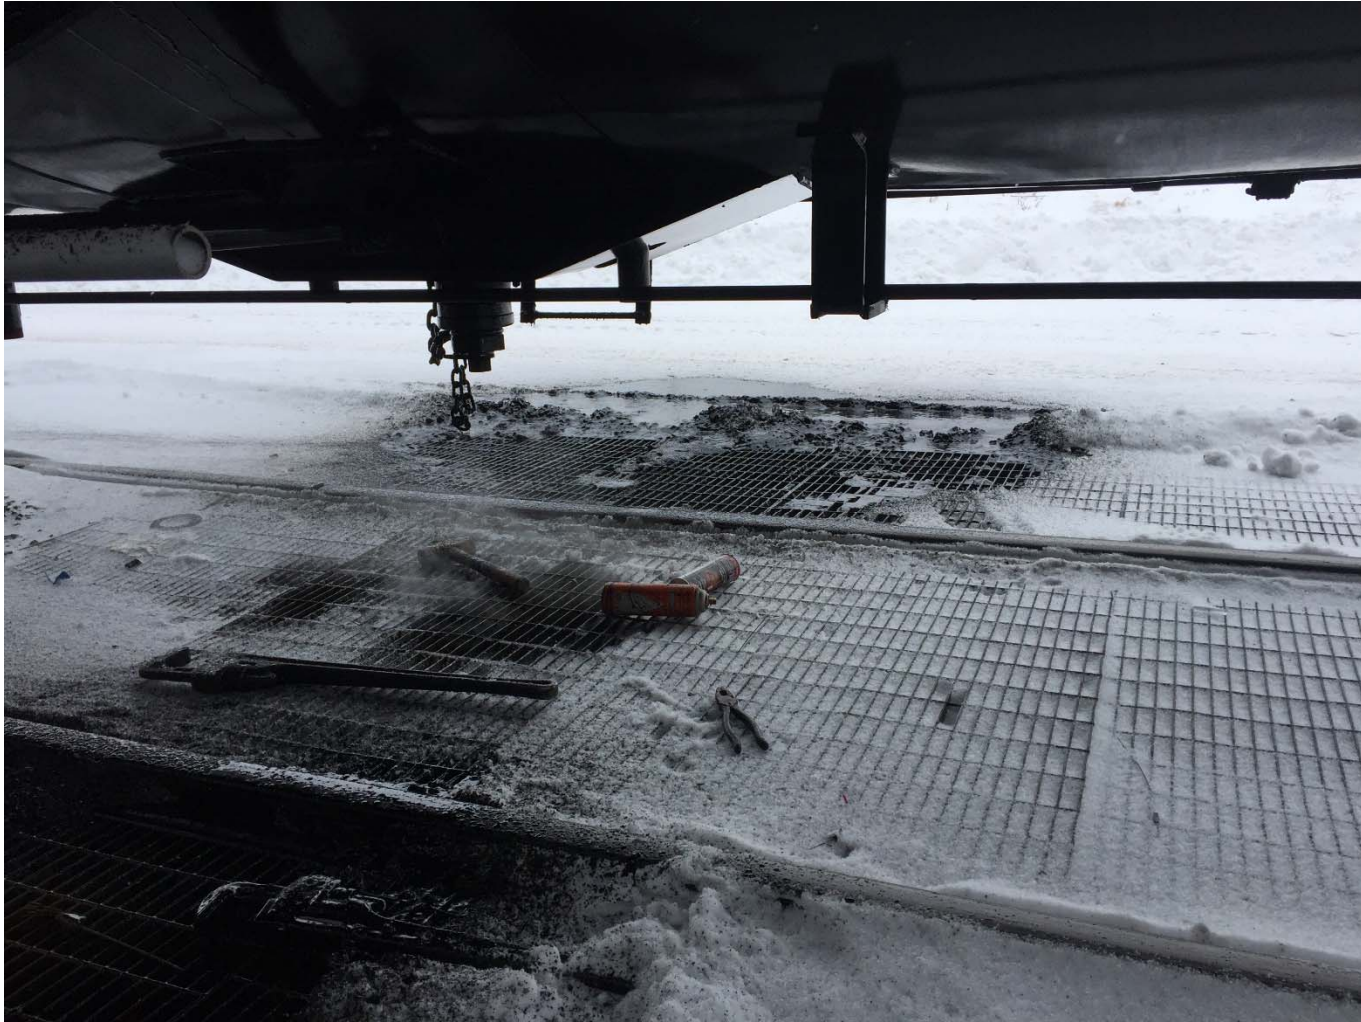
Photo 5: Looking west at the three “track pan” containments underneath the railcar on Track 3.

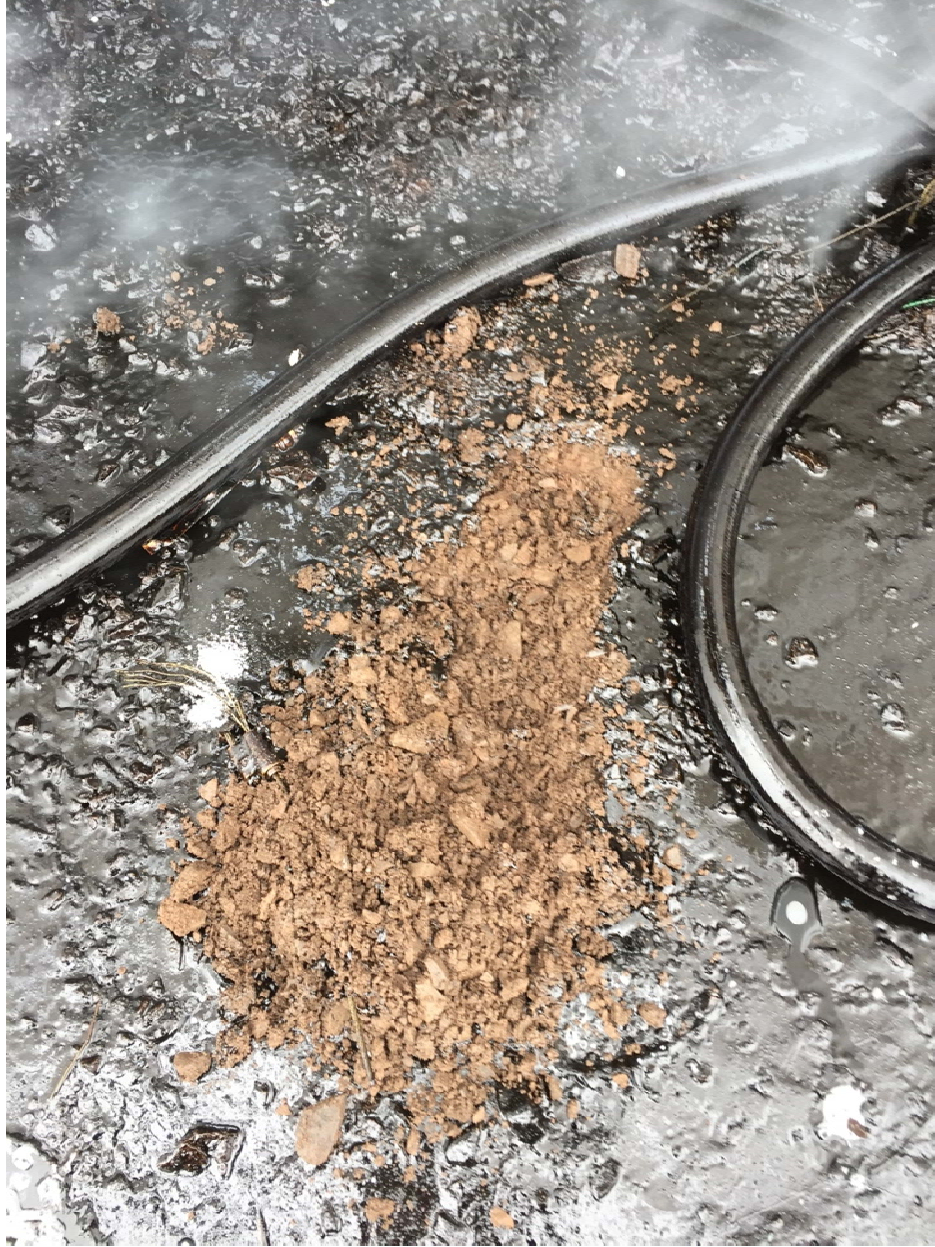
Photo 6: A gentle toe drag was done through the product to gauge its thickness.

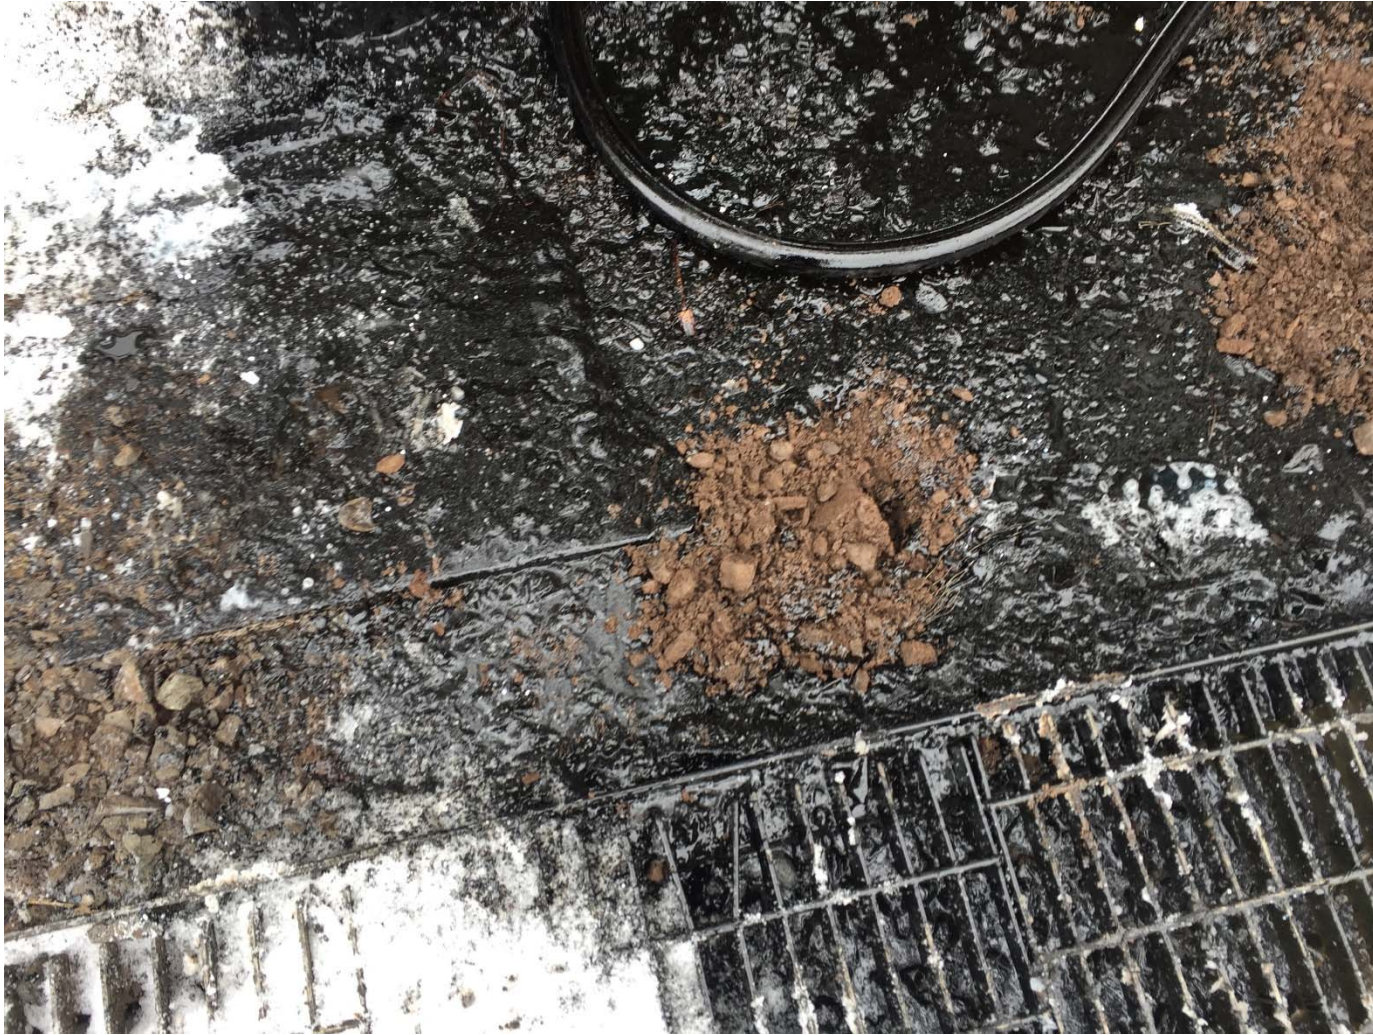
Photo 7: Another surface scrape to estimate product thickness.

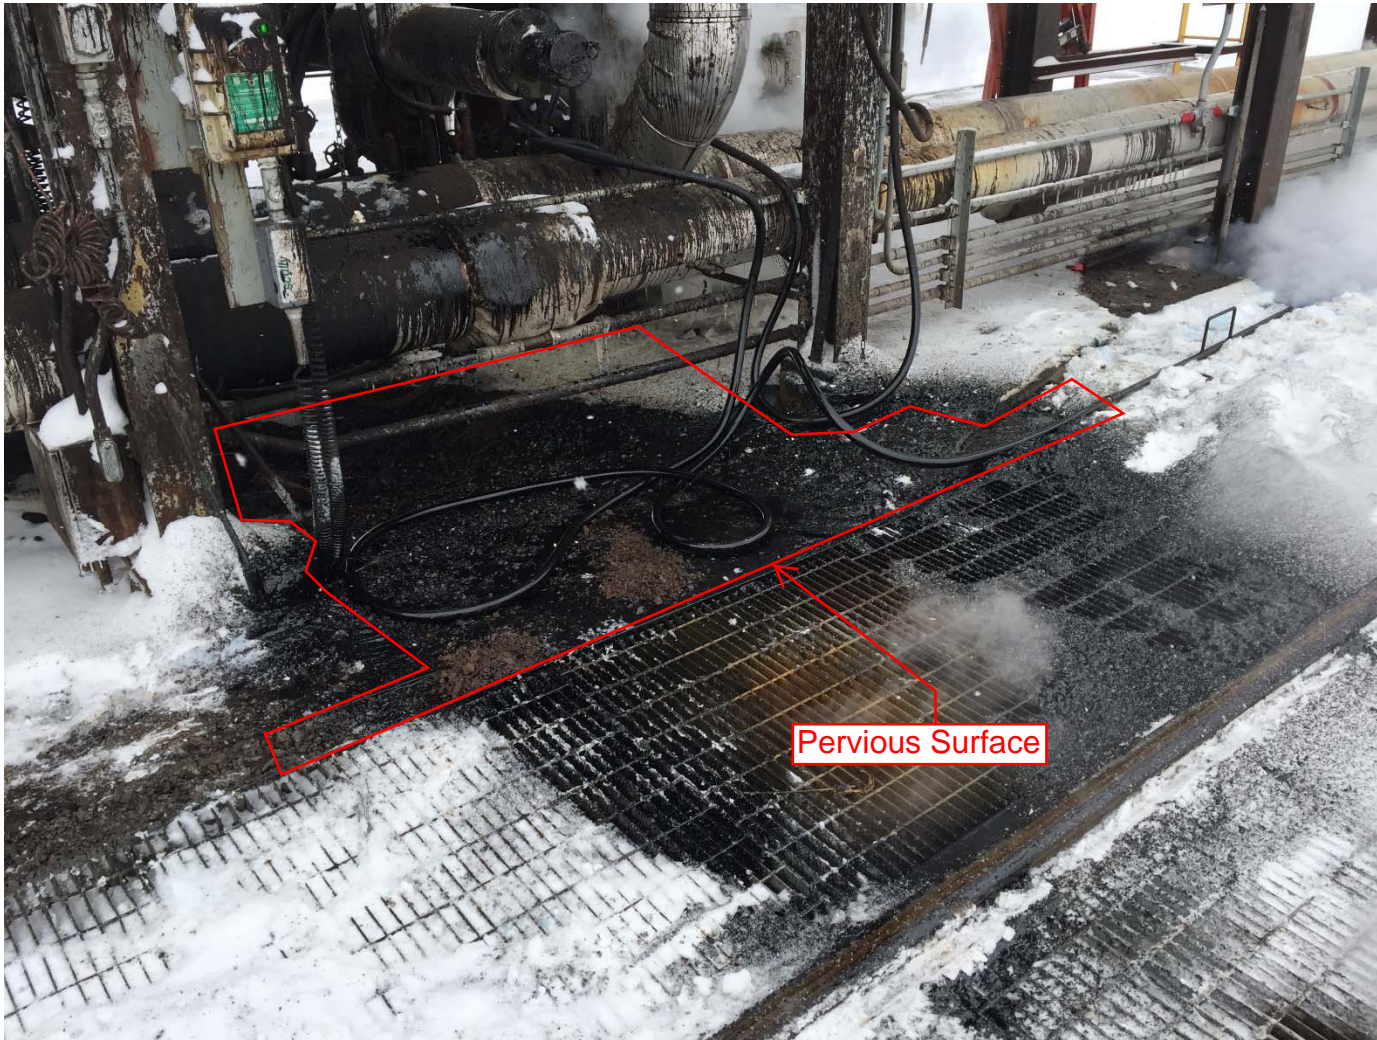
Photo 8: Looking southeast and standing where the railcar on Track 3 was parked.

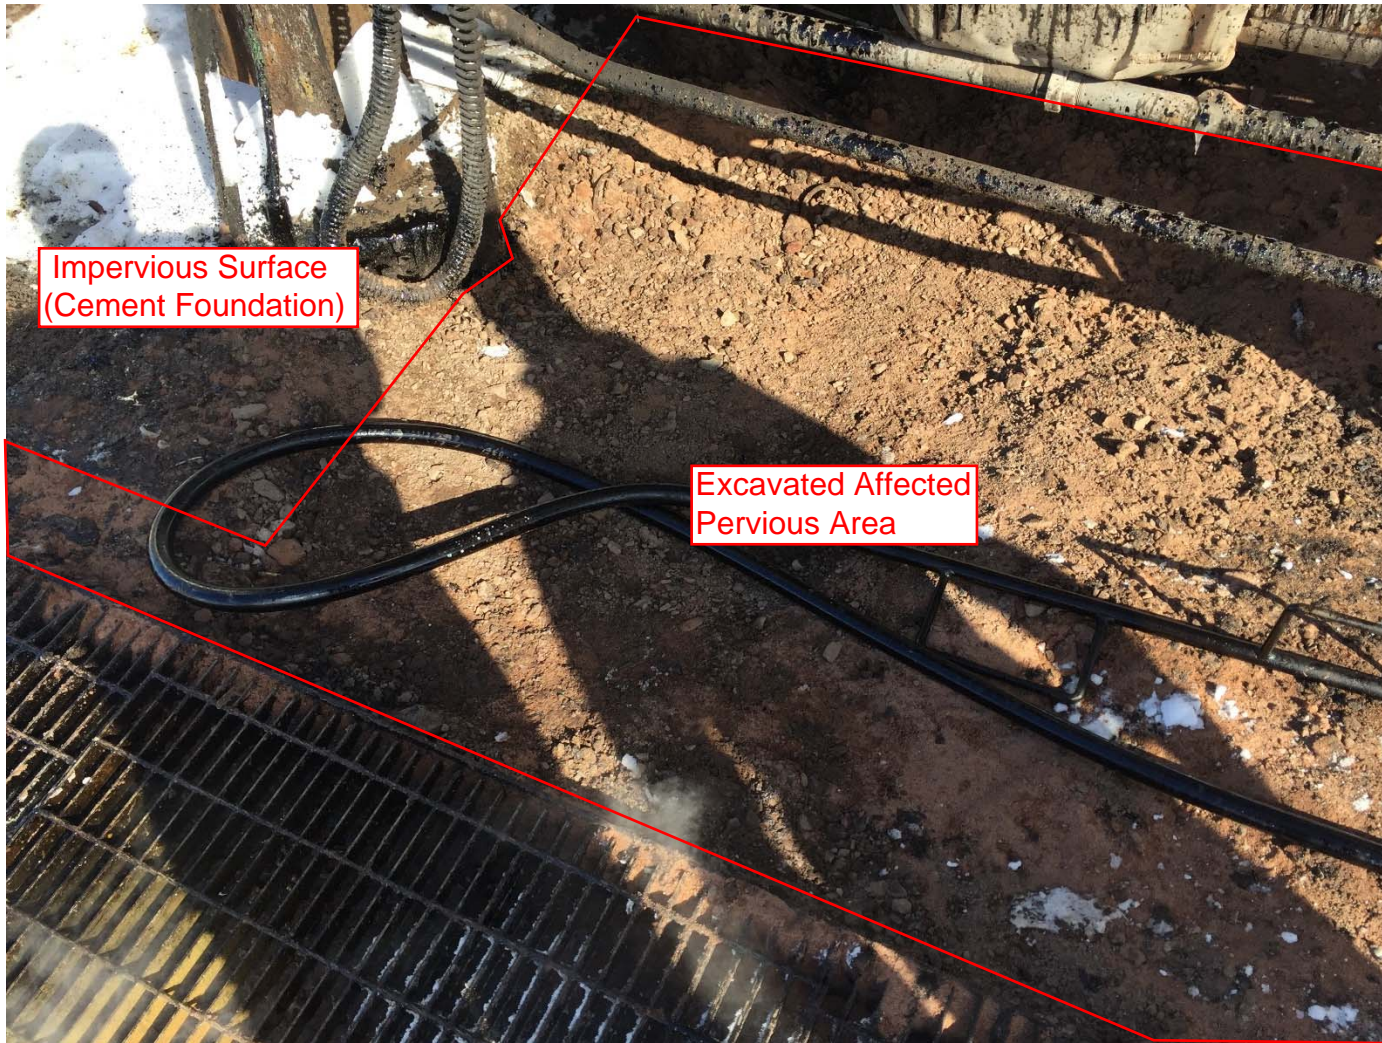
Photo 9: Looking east at the excavated affected area.

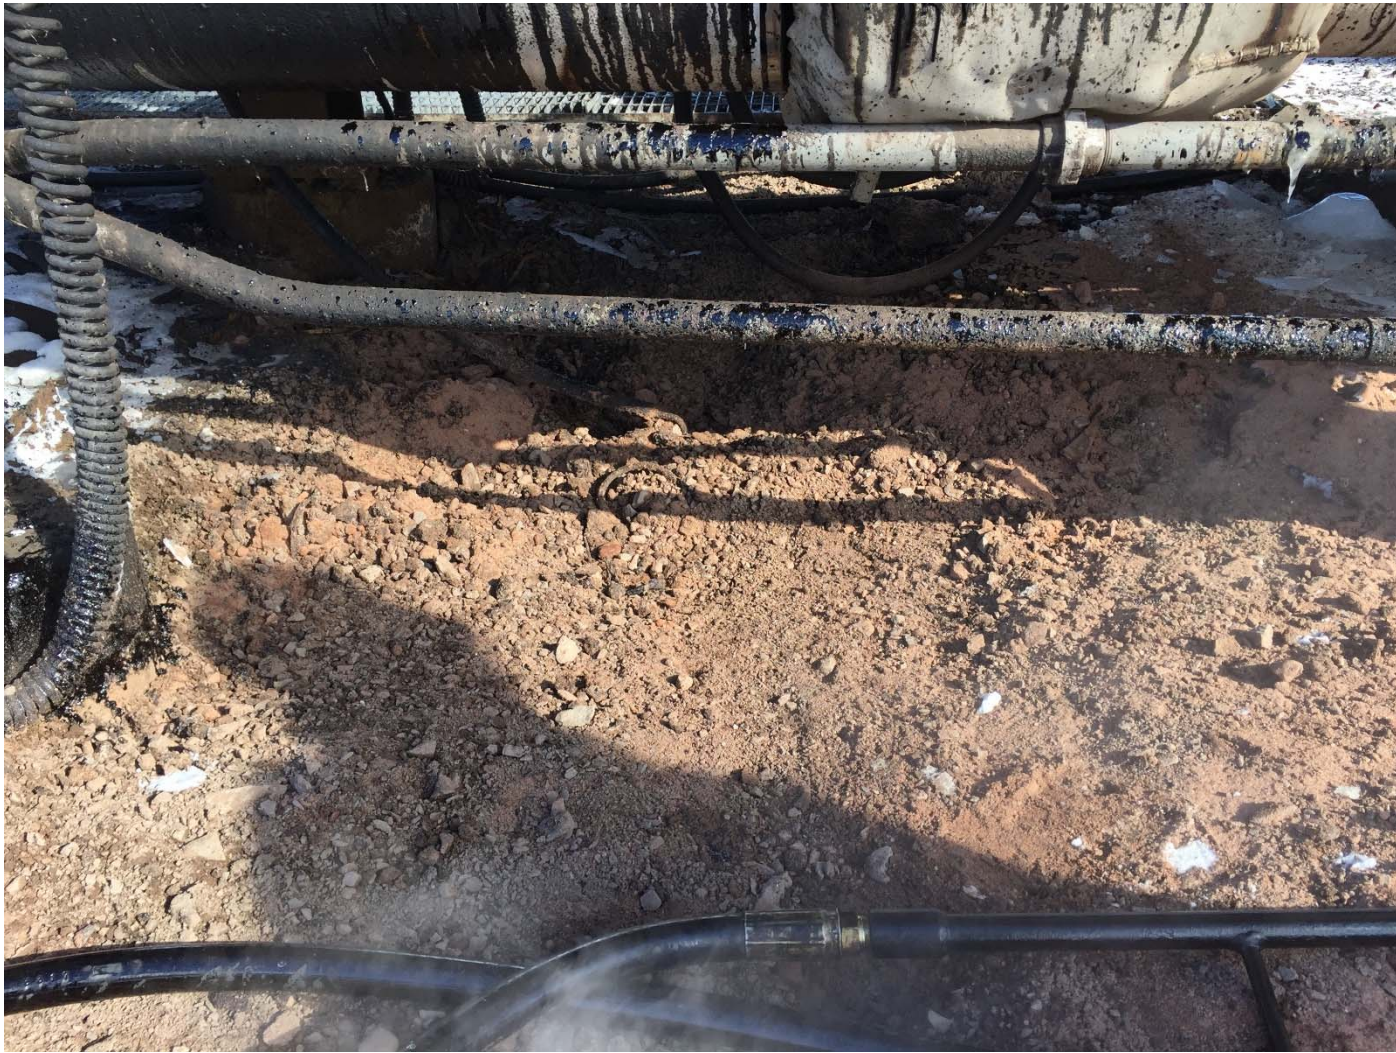
Photo 10: Looking east at the excavated affected area.
