March 27, 2019

**RE: Vapor Mitigation System Documentation and Maintenance Plan
4002 Dental Building, LLC Property
4002 Monona Drive
Madison, Wisconsin
Project #T218047
BRRTS #: 02-13-368525**

Post Mitigation Report

VAPOR MITIGATION SYSTEM MAINTENANCE PLAN
4002 Monona Drive, Madison, Wisconsin

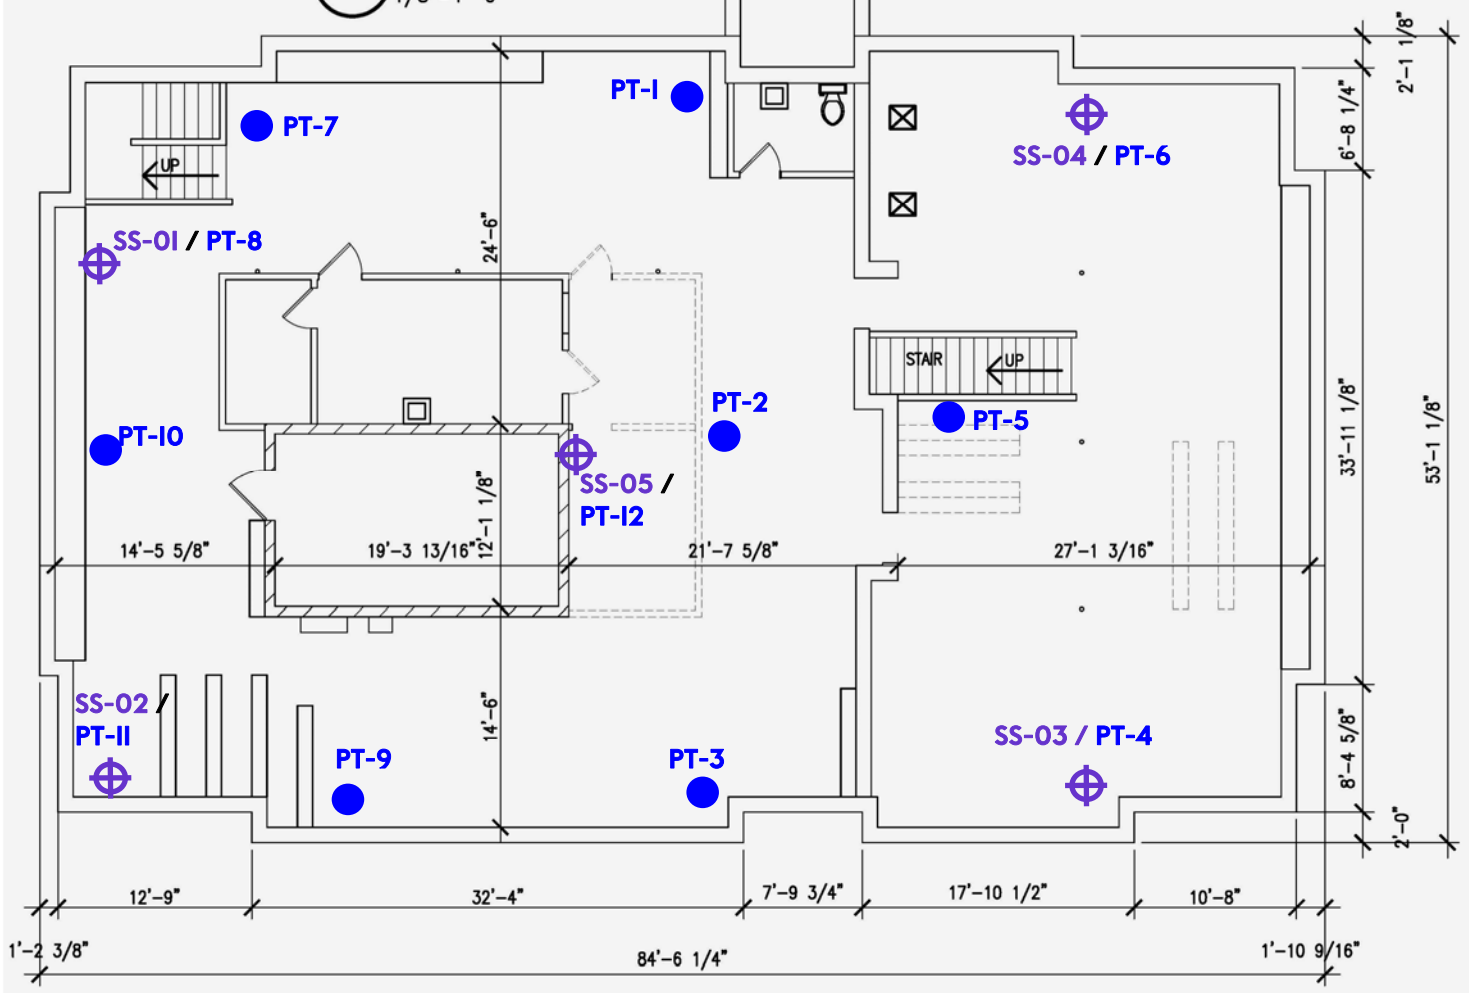
FIGURE
 2

Acura and True North performed communication assessment on March 13, 2019. Seven temporary vacuum observation points (PT-1 through PT-3 and PT-7 through PT-10), which were installed through the building slab, and five vapor sampling points (SS-01 through SS-05) were utilized to evaluate the VMS pressure field extension. The location of the temporary vacuum observation points and vapor sampling points are identified on **Figure 2**.

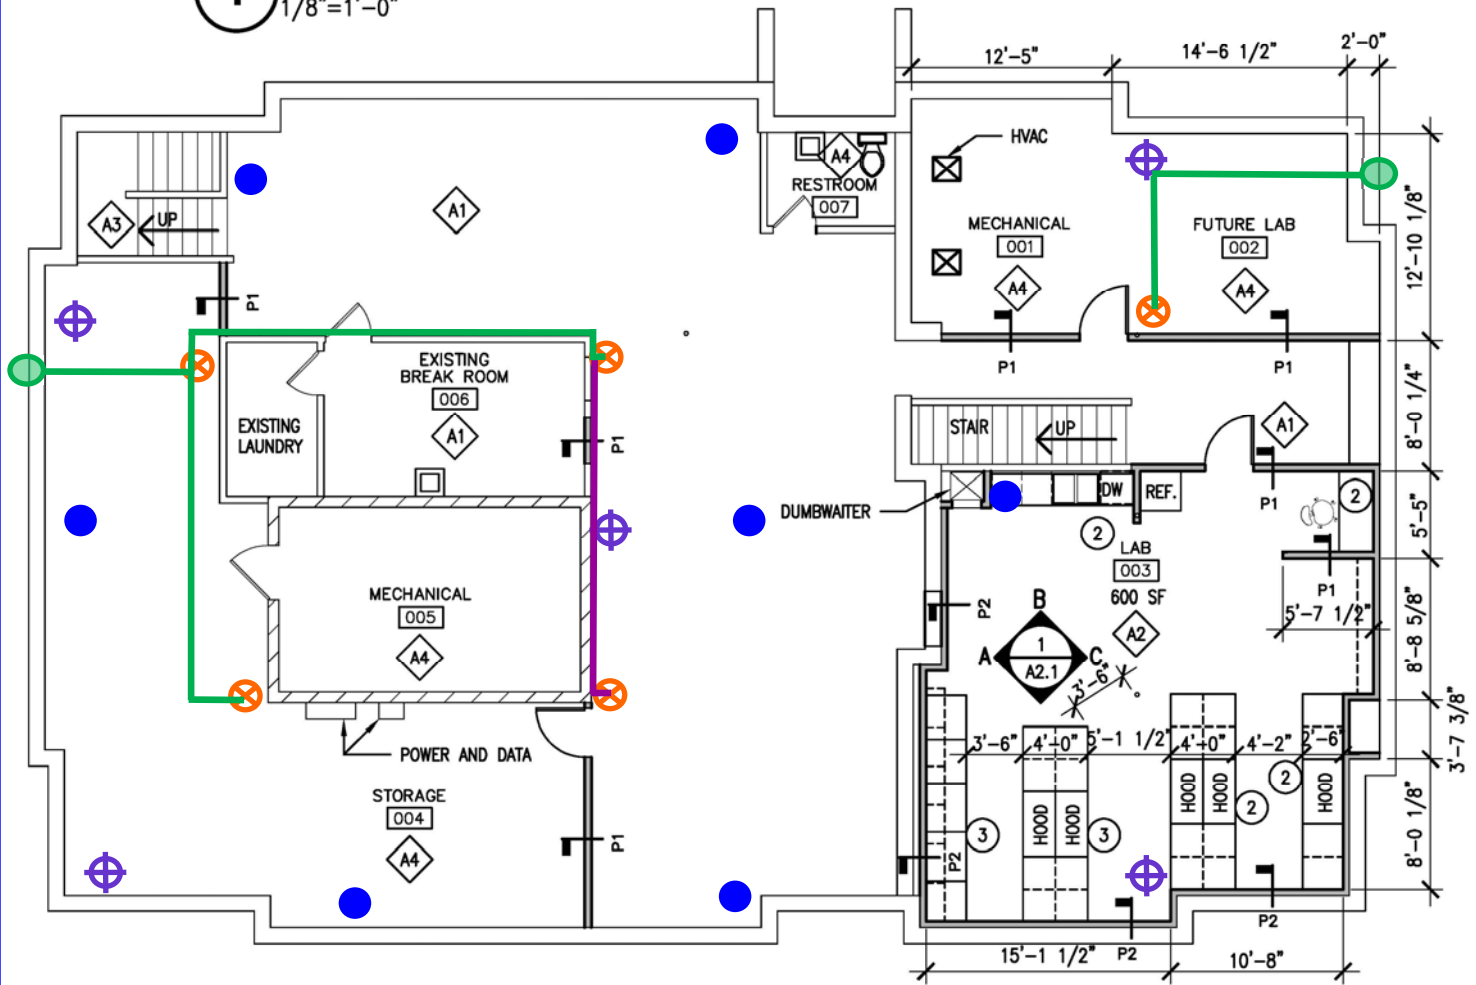
FIGURE
3

A single pick-up point was determined to be sufficient for the southern portion of the building due to the excellent communication of the sub-slab materials. Four pick-up points were determined to be sufficient for the northern portion of the building. The layout of the VMS is provided on **Figure 3**.

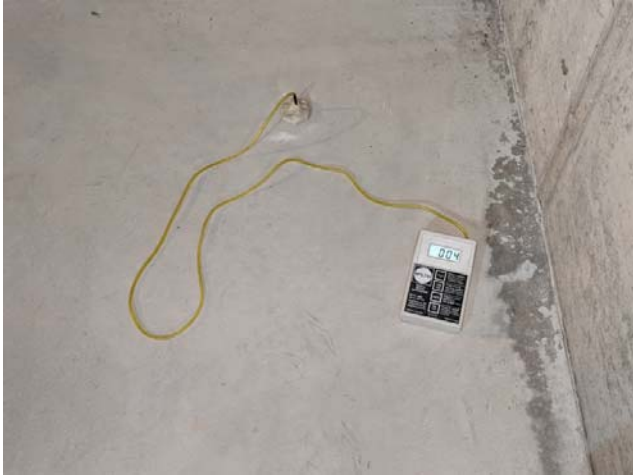
#1: Pre-installation communication testing.

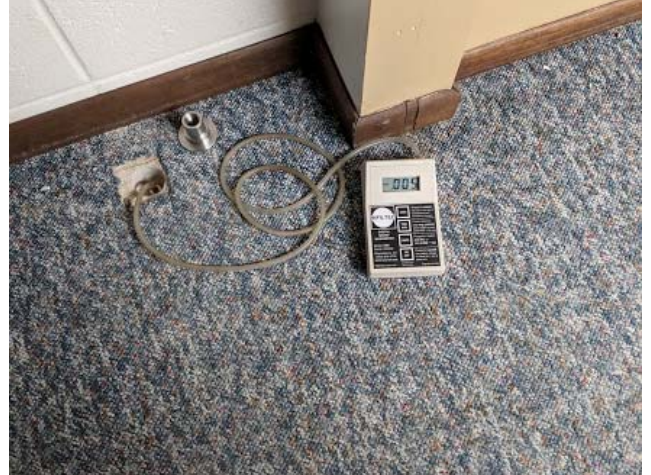
#2: Pre-installation communication testing.

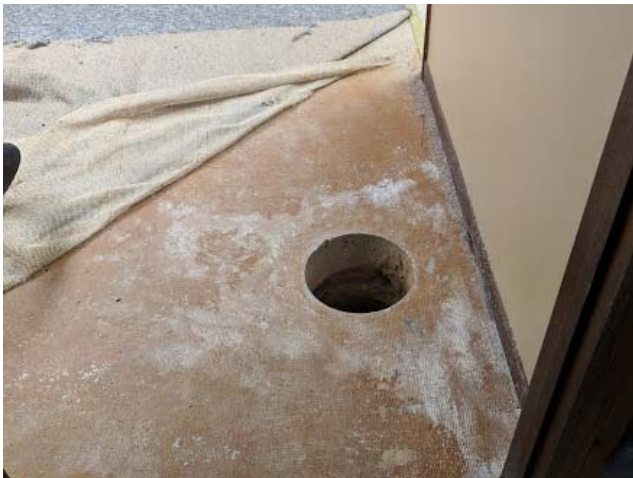
#3: Pick-up point installation through the slab exposing sub-slab materials.

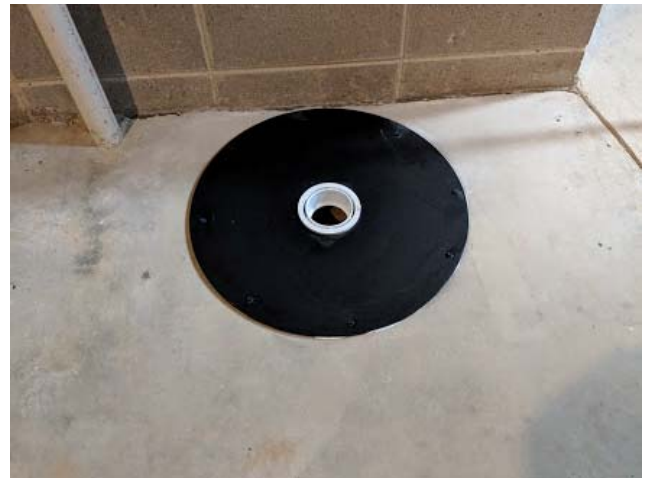
#4: Pick-up point installation sealed to concrete slab.

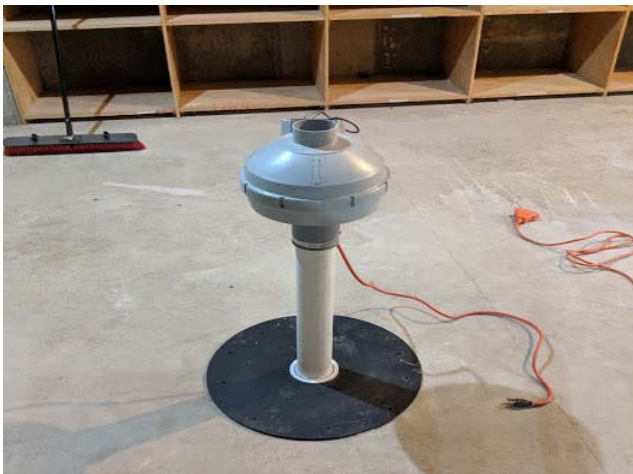
#5: Pick-up point installed and fan temporarily mounted on pick-up point for evaluation of fan requirements.

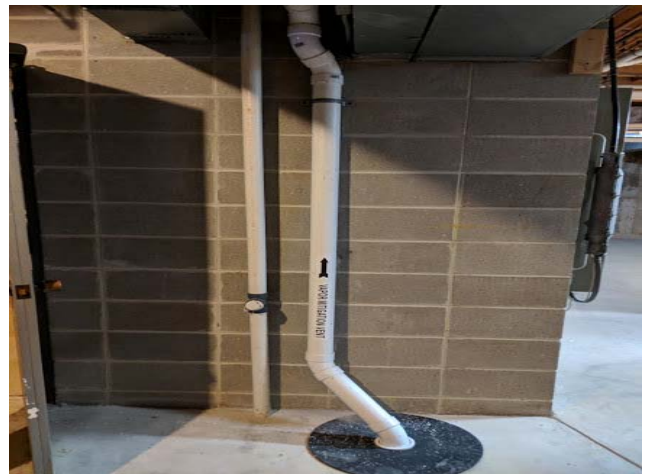
#6: Completed pick-up point in northwest corner of basement.

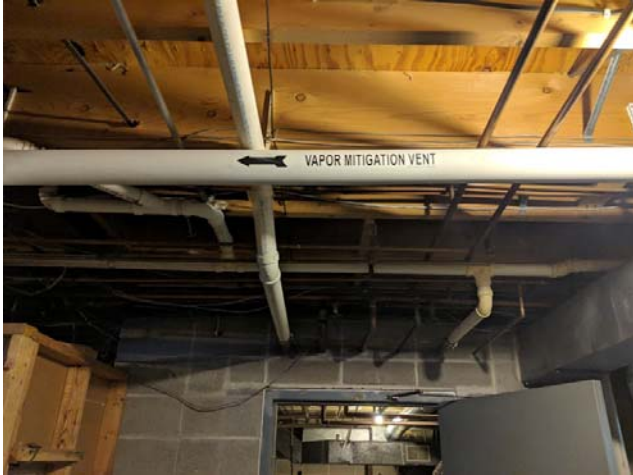
#7: View of VMS piping located on northern portion of basement and labeled.

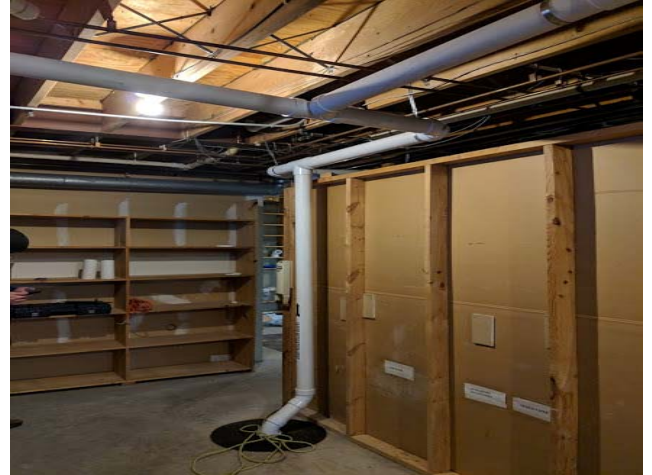
#8: View of completed pick-up point in northeast corner of basement.

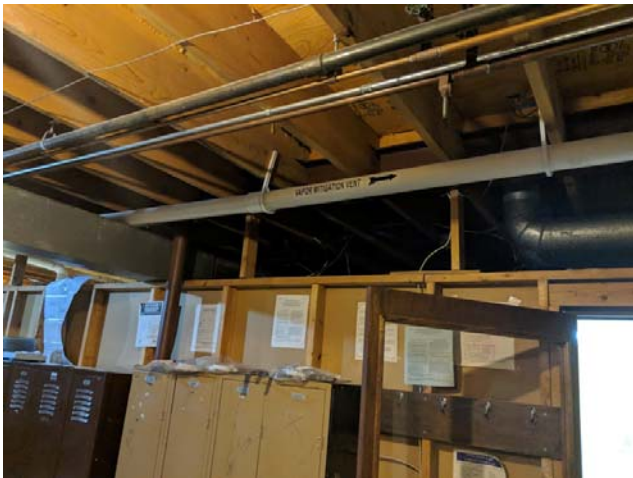
#9: View of VMS piping running along west side of breakroom and labeled.

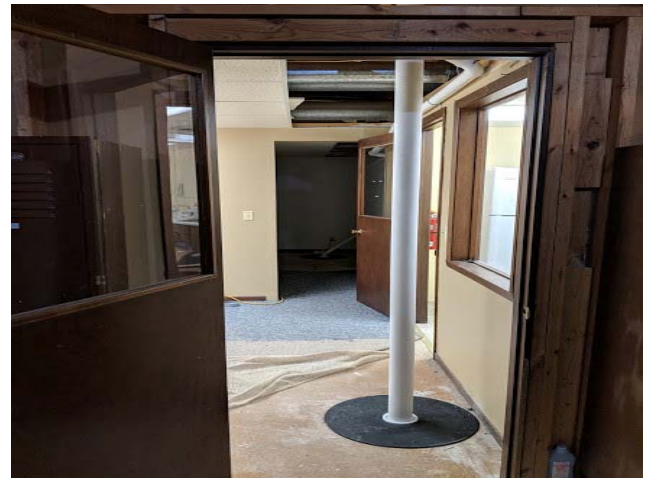
#10: View of completed pickup points. Pick-up point in front is southeast point and pickup point in background is the southwest pick-up point.

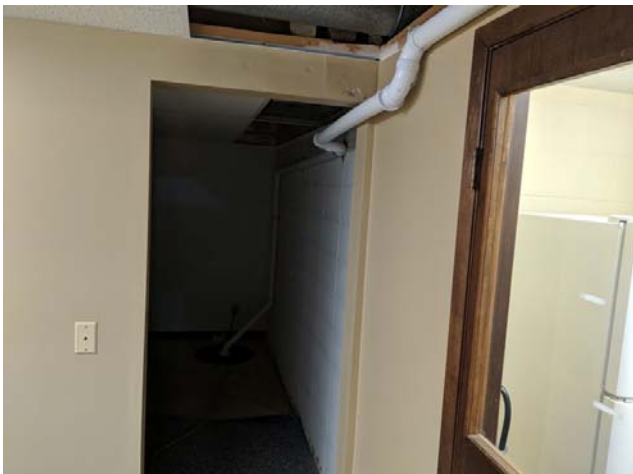
#11: View of southwest pick-up point and associated piping running to the east toward southeast pick-up point.

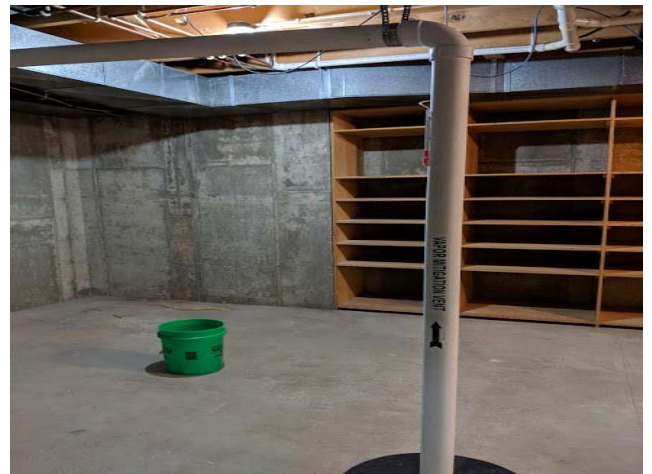
#12: View of completed, southern VMS system pick-up point.

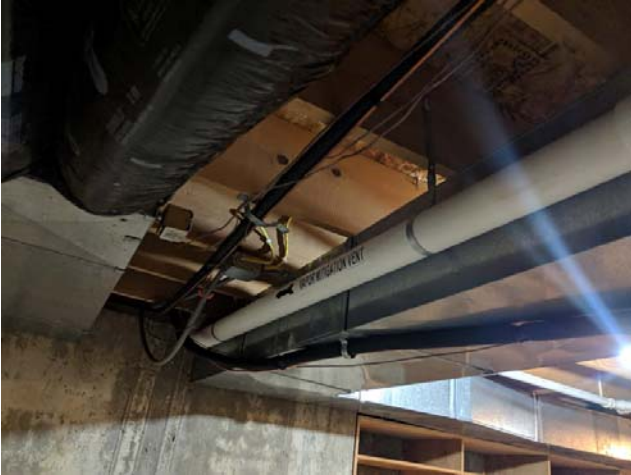
#13: View of southern VMS piping exiting on the south side of the basement.

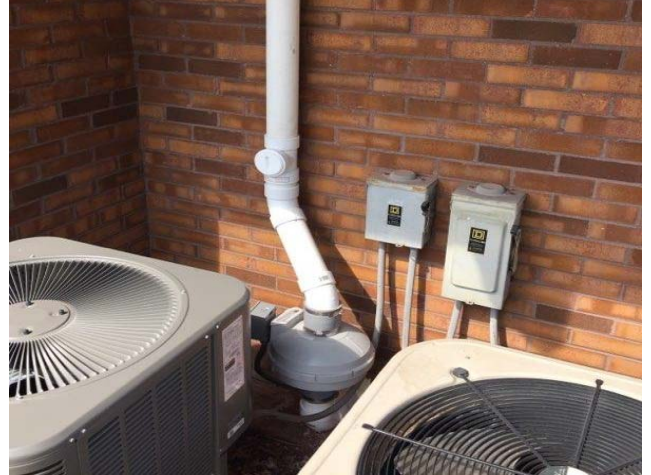
#14: View of exterior southern VMS fan and vent piping.

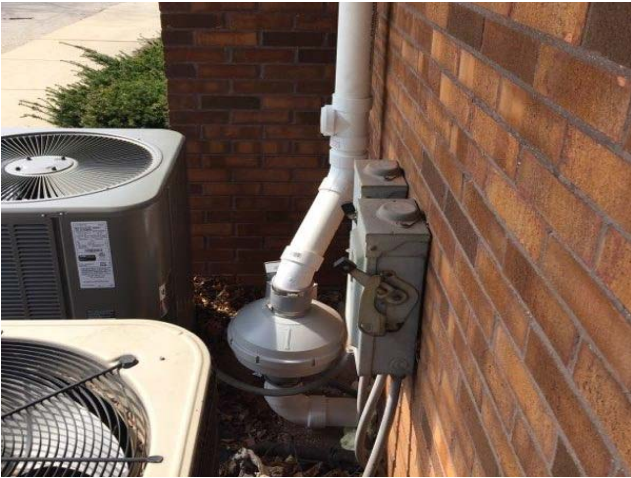
#15: View of exterior southern VMS fan and vent piping.

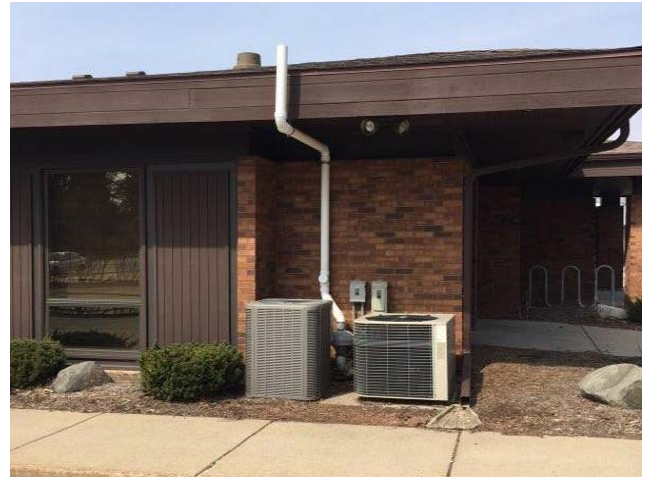
#16: Southern VMS fan and piping on the south side of the building.

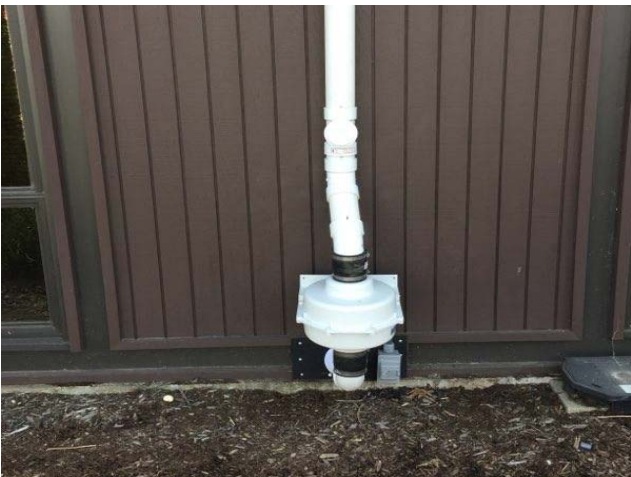
#17: Northern VMS piping exit and fan location.

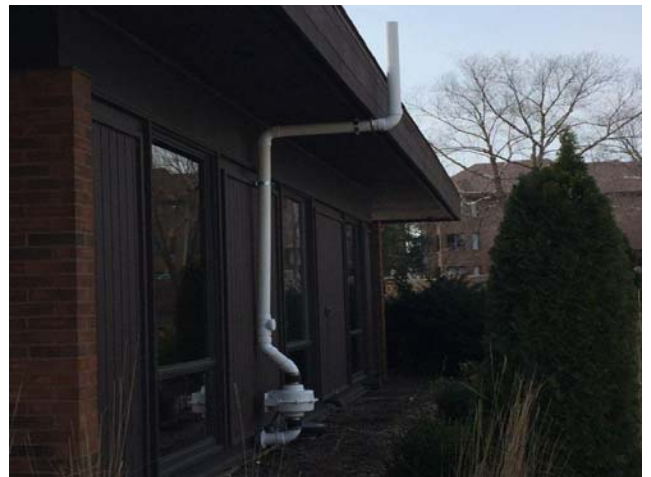
#18: Northern VMS fan and piping on the north side of the building.
