Re: DNR BRRTS Activity #02-33-582970
Landfill Gas Monitoring, Darlington City Historic Landfill
149 Wells Street, Darlington, WI
July 2020 Monitoring Results

Ayres Associates Inc (Ayres), on behalf of the City of Darlington (City), is providing the July 2020 site sampling results of gas probes on the site perimeter at 149 Wells Street. This monitoring event was conducted on July 8, 2020. This is the tenth event conducted under the July/December monitoring events as noted in September 10, 2015, Wisconsin Department of Natural Resources letter detailing revised monitoring frequency.

AS-BUILT GAS PIPING MODIFICATIONS

July 2020 Gas Monitoring Event

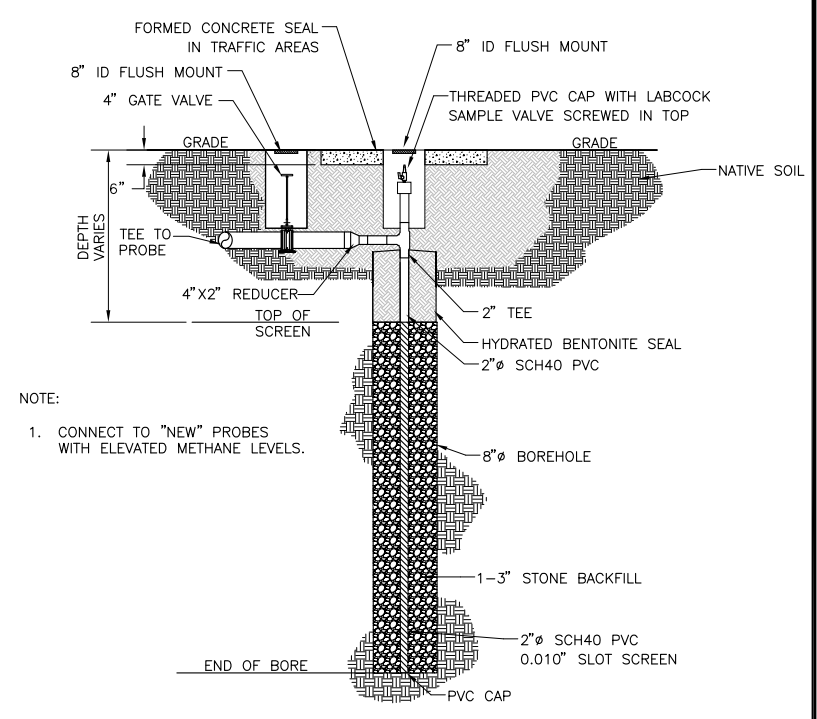
GAS PROBE
DETAIL 1
SCALE: NOT TO SCALE

NOTE:
1. CONNECT TO "NEW" PROBES WITH ELEVATED METHANE LEVELS.
