Immediate Response Action Report

#6 Fuel Oil Release SERTS ID 20190114NO16-1

Prepared By:
Matt Turner
Superior Refining Company LLC
2407 Stinson Avenue
Superior, WI 54880
(715) 398-8434

3/22/2019

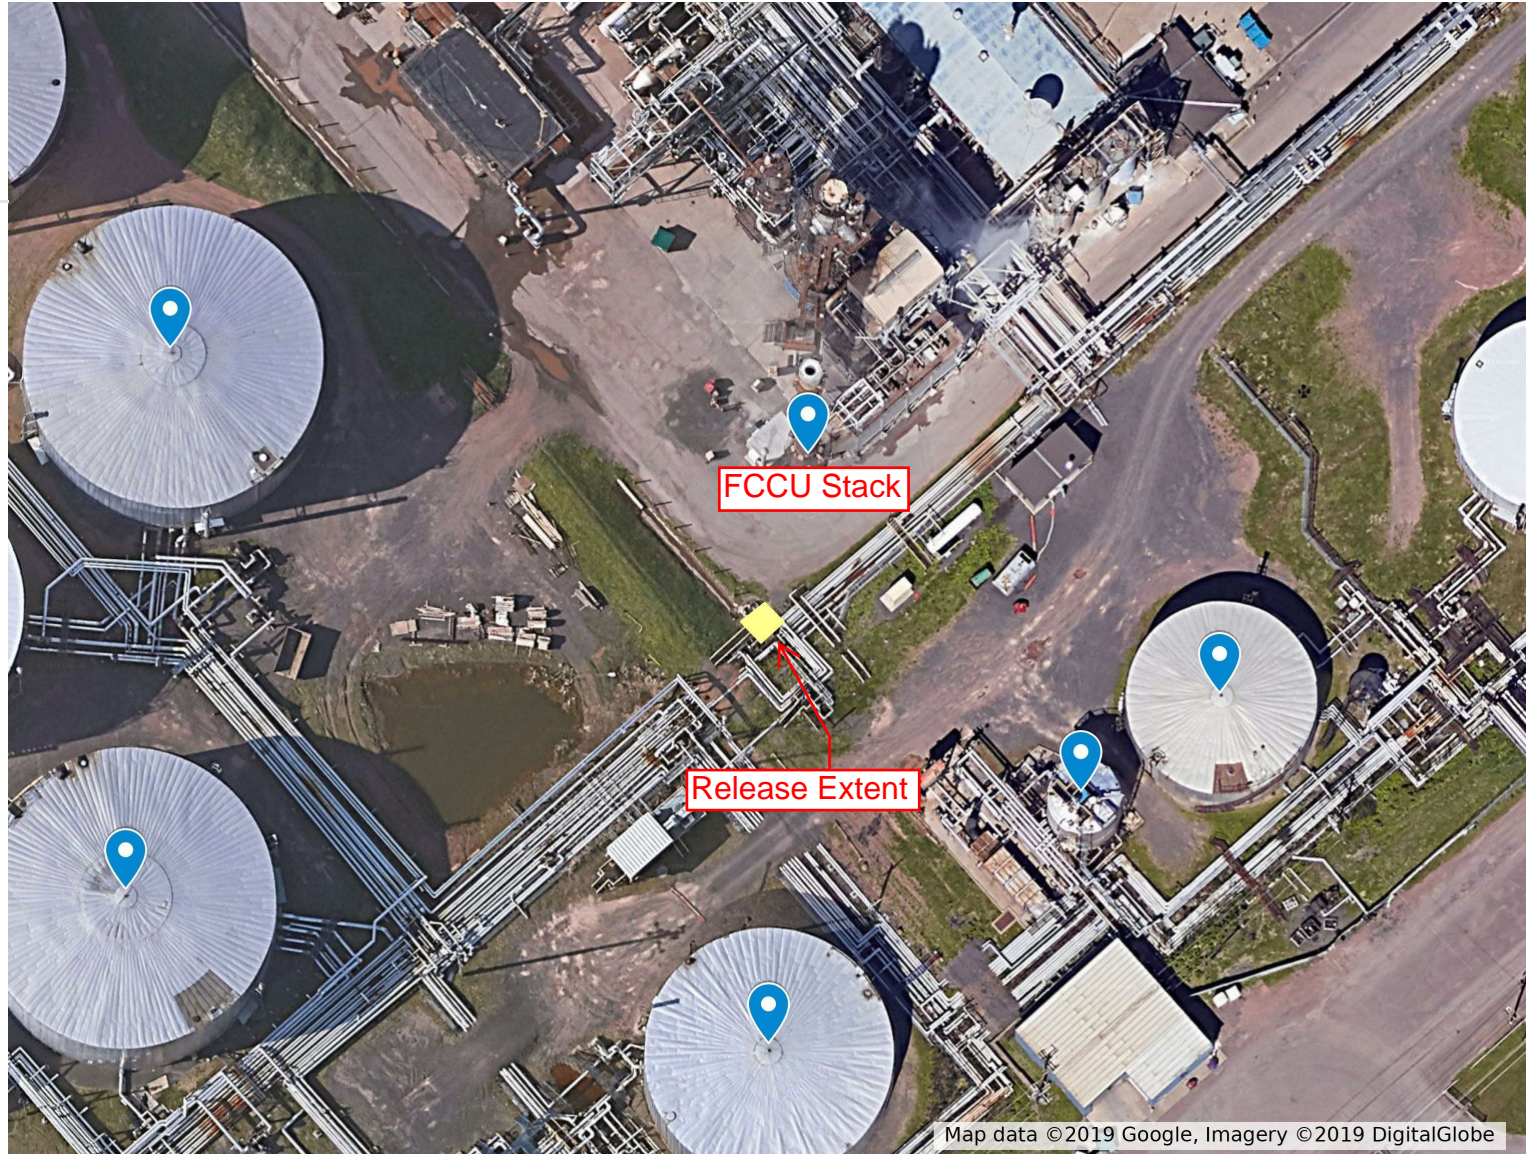
Figure 2 - Site Map

The release occurred as operations staff were steaming cleaning a #6 oil feed line prior to removing it as part of the Refinery's demolition project. Early in the process, it was determined that the line was plugged since steam was not coming out of the downstream end of the pipe. As the operators walked the line to identify where the plug was, the built of pressure of the steam relieved and overtook the poly spill containment present at the downstream end of the pipe meant to catch any residual product that was present. Vacuum truck operators recovered the material that spilled onto a pervious surface immediately and hand excavation of the visibly contaminated soil was both commenced and completed on the day of the release. The estimated volume of soil that was removed is 1-3 cubic feet since most of the released material landed on a thick layer of snow and ice. The excavated soil was brought to our "three-sided building" where it was stored before sending it to a proper TSDF for disposal. The area was excavated to a depth between two and three inches as the product did not leech any deeper into the soil due to it being frozen. Spill site conditions and remediation efforts are depicted in the photographs which are included in Appendix A. The area of the spill and excavation are depicted in Figure 2.

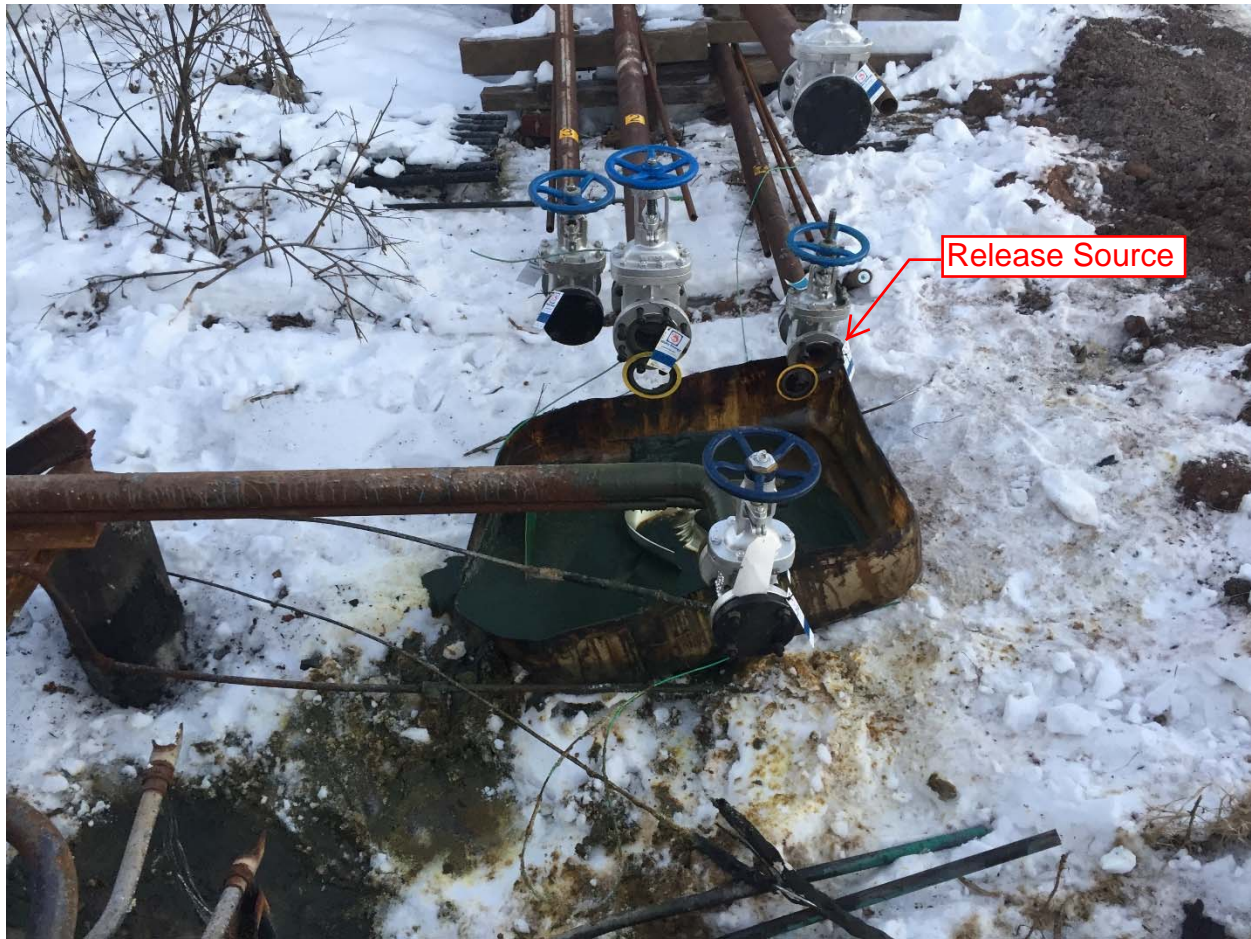
The duration of the discharge to a pervious surface was less than one minute. When the plugged line relieved itself due to steam pressure buildup, the force of the release allowed product to overwhelm the sides of the poly containment structure being used to collect said material and spill onto a pervious surface. After the initial burst, material that left the pipe prior to steam being turned off was captured in a poly containment structure. Discharge to a pervious surface ended when steam flow through the line was turned off.

Photo 1: Looking south at the release source and the poly spill containment. #6 fuel oil was meant to slowly drip into the spill containment and be removed with a vacuum truck.

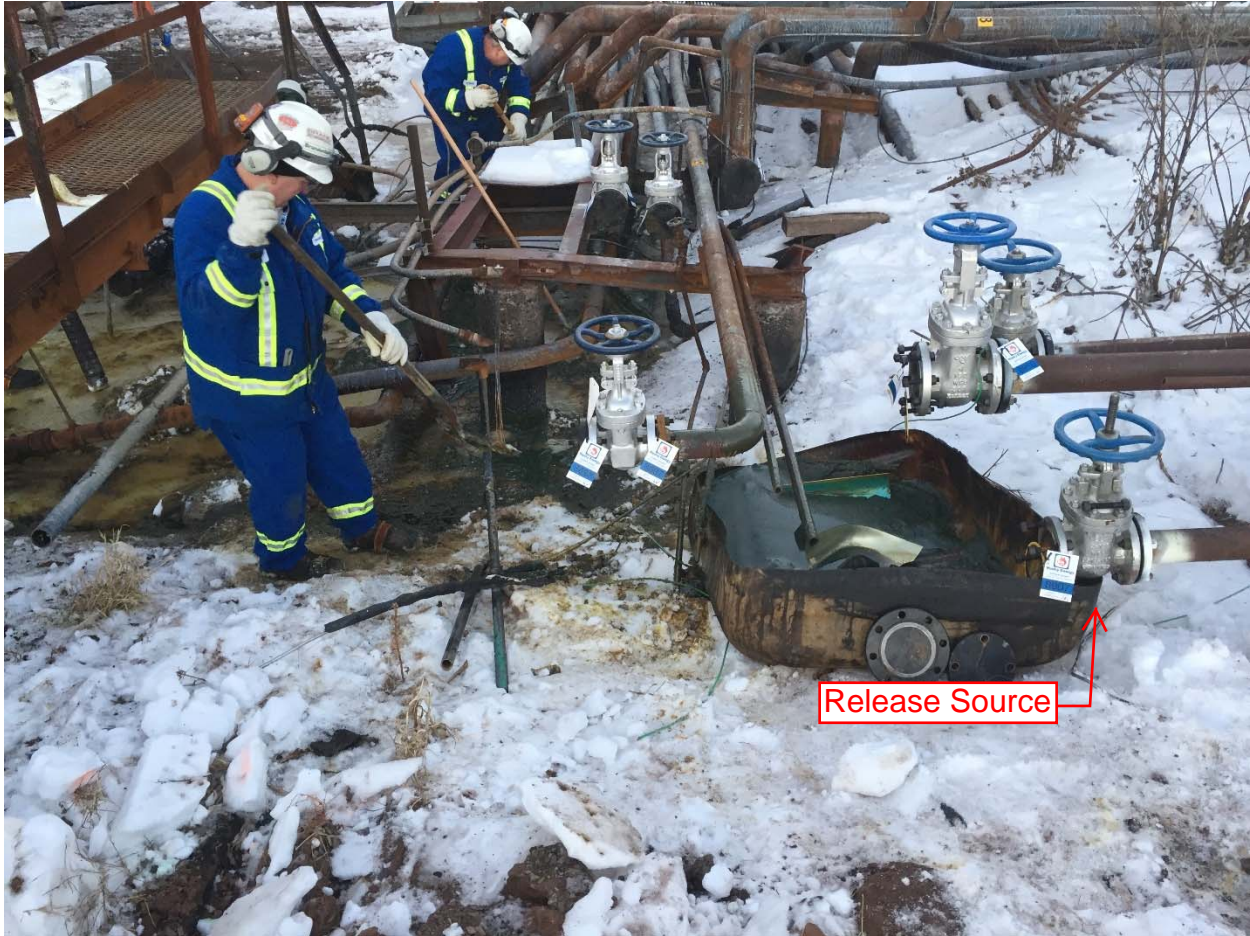
Photo 2: Looking east at the release site while cleanup efforts are ongoing. Operators used shovels and squeegees to move the product to a vacuum truck hose so it could be recovered. The cold air temperatures thickened the product to a pudding-like consistency.

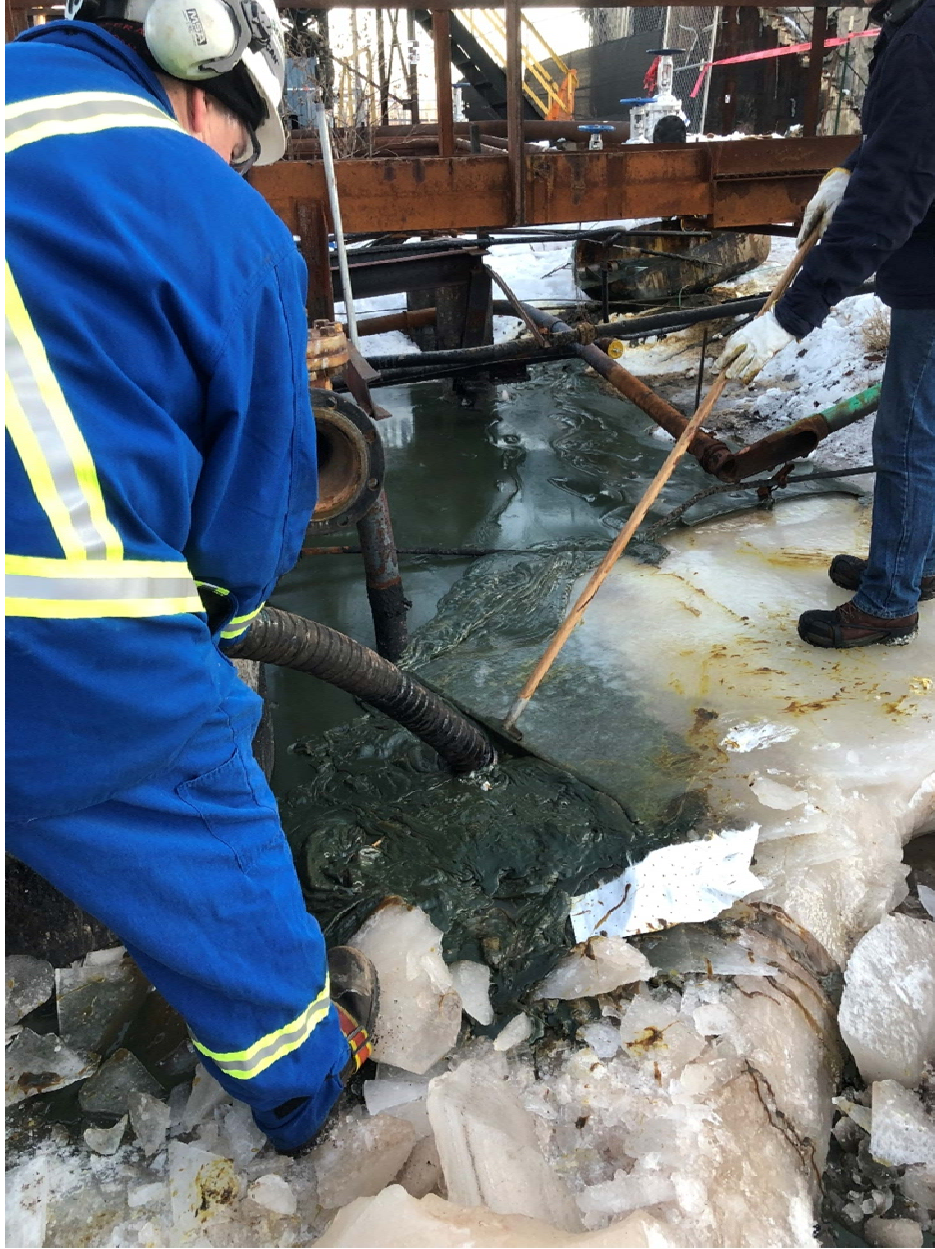
Photo 3: Looking south at the recovery efforts. Note the thick layer of ice present underneath the released #6 fuel oil.

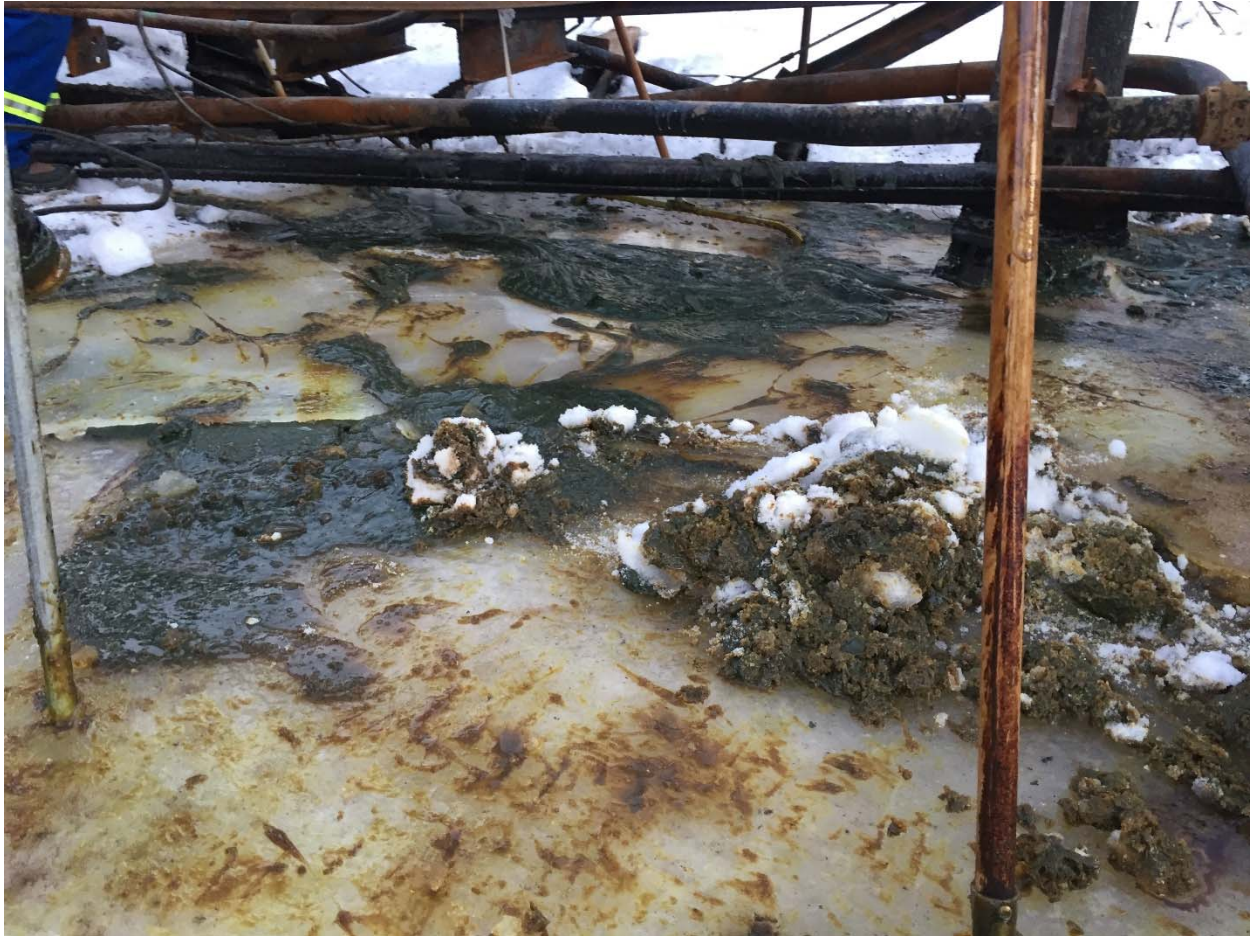
Photo 4: Looking south at the cleanup progression. Piled snow was removed via vacuum trucks. Ice chunks and soil were brought to the contaminated soil storage building.

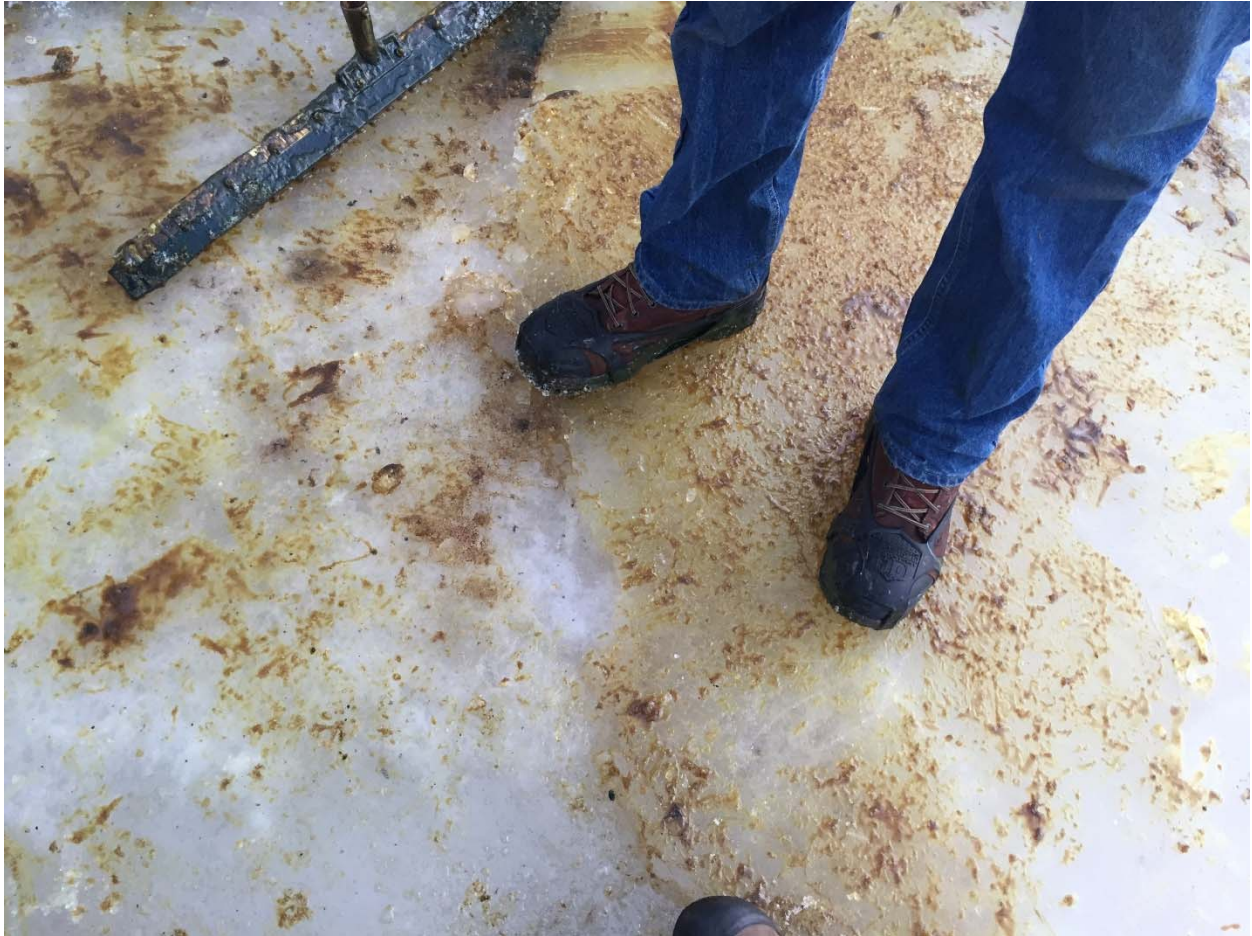
Photo 5: Shovels and squeegees were able to remove the majority of the released #6 fuel oil. The remaining contaminated ice (seen above) was removed with an excavator and shovels before being brought to the contaminated soil storage building.
