Subject: Addendum to Site Investigation Report

BMO Harris Bank Property

900 E. Main Street Merrill, Wisconsin

PSI Project No. 00541993 BRRTS No. 02-35-584409

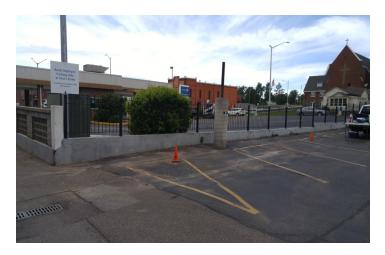
Photograph shows highway cones placed at the locations of SP-1 (left) and SP-2 (right) and the surrounding asphalt pavement and small retaining walls associated with the Subject Property. The photograph is taken facing to the west from the alleyway.

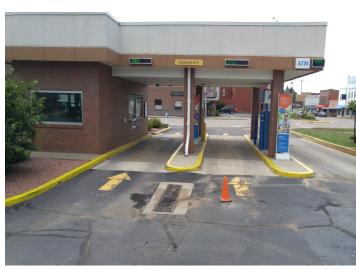
Photograph shows the northern drivethru lines of the service window building associated with the BMO Harris Bank parcel. The highway cone shows the location of SP-4. A stormwater drain is located south of SP-4. SP-11 was placed in the grass area shown on the right side of the photograph. Photograph taken facing to the west.

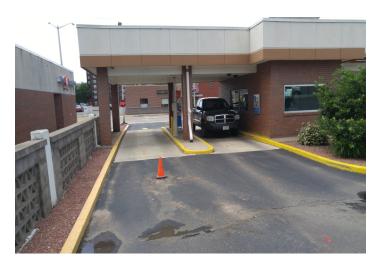
Photograph shows the southern drivethru lines of the service window building and the highway cone is placed over SP-3. The photograph also shows the retaining wall along the alleyway and the asphalt and concrete pavement associated with the bank parcel.

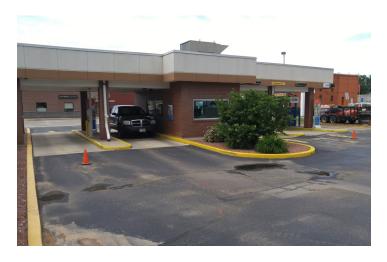
4. Photograph shows the drive-thru window building and SP-3 (left) and SP-4 (right).

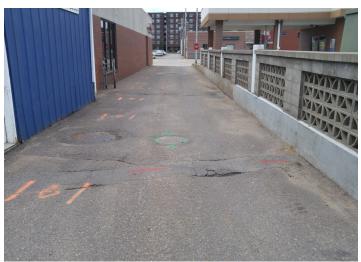
5. Photograph shows the alleyway and is taken facing to the west.

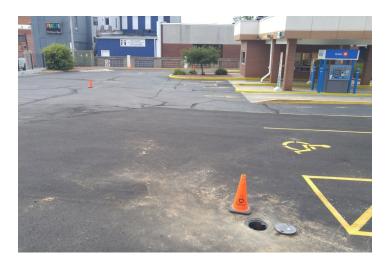
6. Photograph taken for near the northern property line and facing to the south. The photograph shows SP-12/MW-3 (in foreground), SP-10 (in the near background), and SP-9 (background left) and SP-8/MW-2 (background right). The photograph also shows the asphalt and concrete pavement associated with the bank parcel.

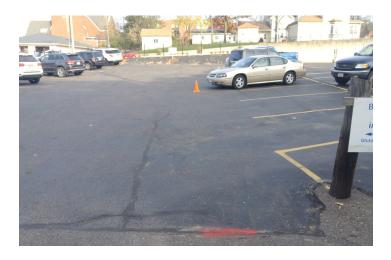
7. Photograph taken from the alleyway and facing to the north and shows the northeastern portion of the asphalt parking lot area. The highway cone is over SP-17 and SP-7 would be to the northwest of SP-17.

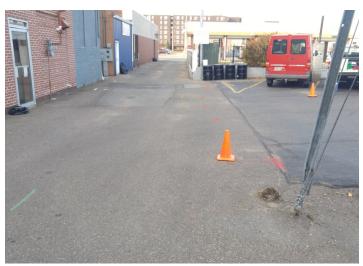
8. Photograph shows the alleyway from east to west. The near highway cone is over SP-16, while the farther cone is near SP-5/MW-1. The drums are associated with the installation and sampling of the wells.

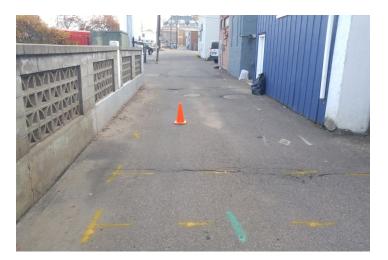
9. Photograph shows the alleyway facing to the east from near the west end and the retaining wall present along the north side of the alley. The highway cone is over SP-9.

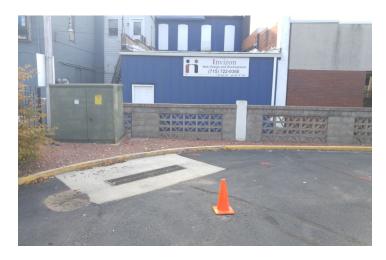
10. Photograph shows a highway cone over SP-14 and a stormwater drain.

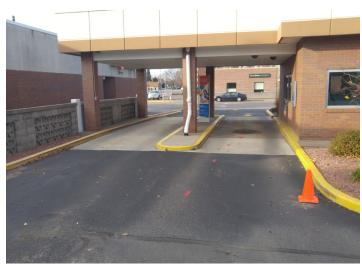
11. Photograph shows a highway cone over SP-13.

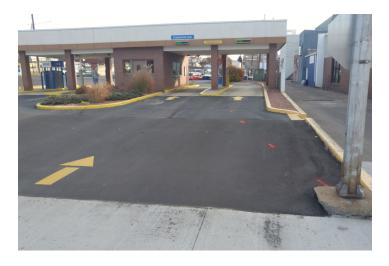
12. Photograph shows the western side of the drive-thru window building and the alleyway (right side of photo). Photograph also shows asphalt and concrete pavement associated with the bank parcel.
