Subject: Site Investigation Report Not Approved
BMO Harris Bank Branch, 117-125 South Chestnut Avenue, Green Bay, WI
BRRTS #: 02-05-585287

Site Investigation Report Not Approved

BMO Harris Bank Branch - BRRTS # 02-05-585287

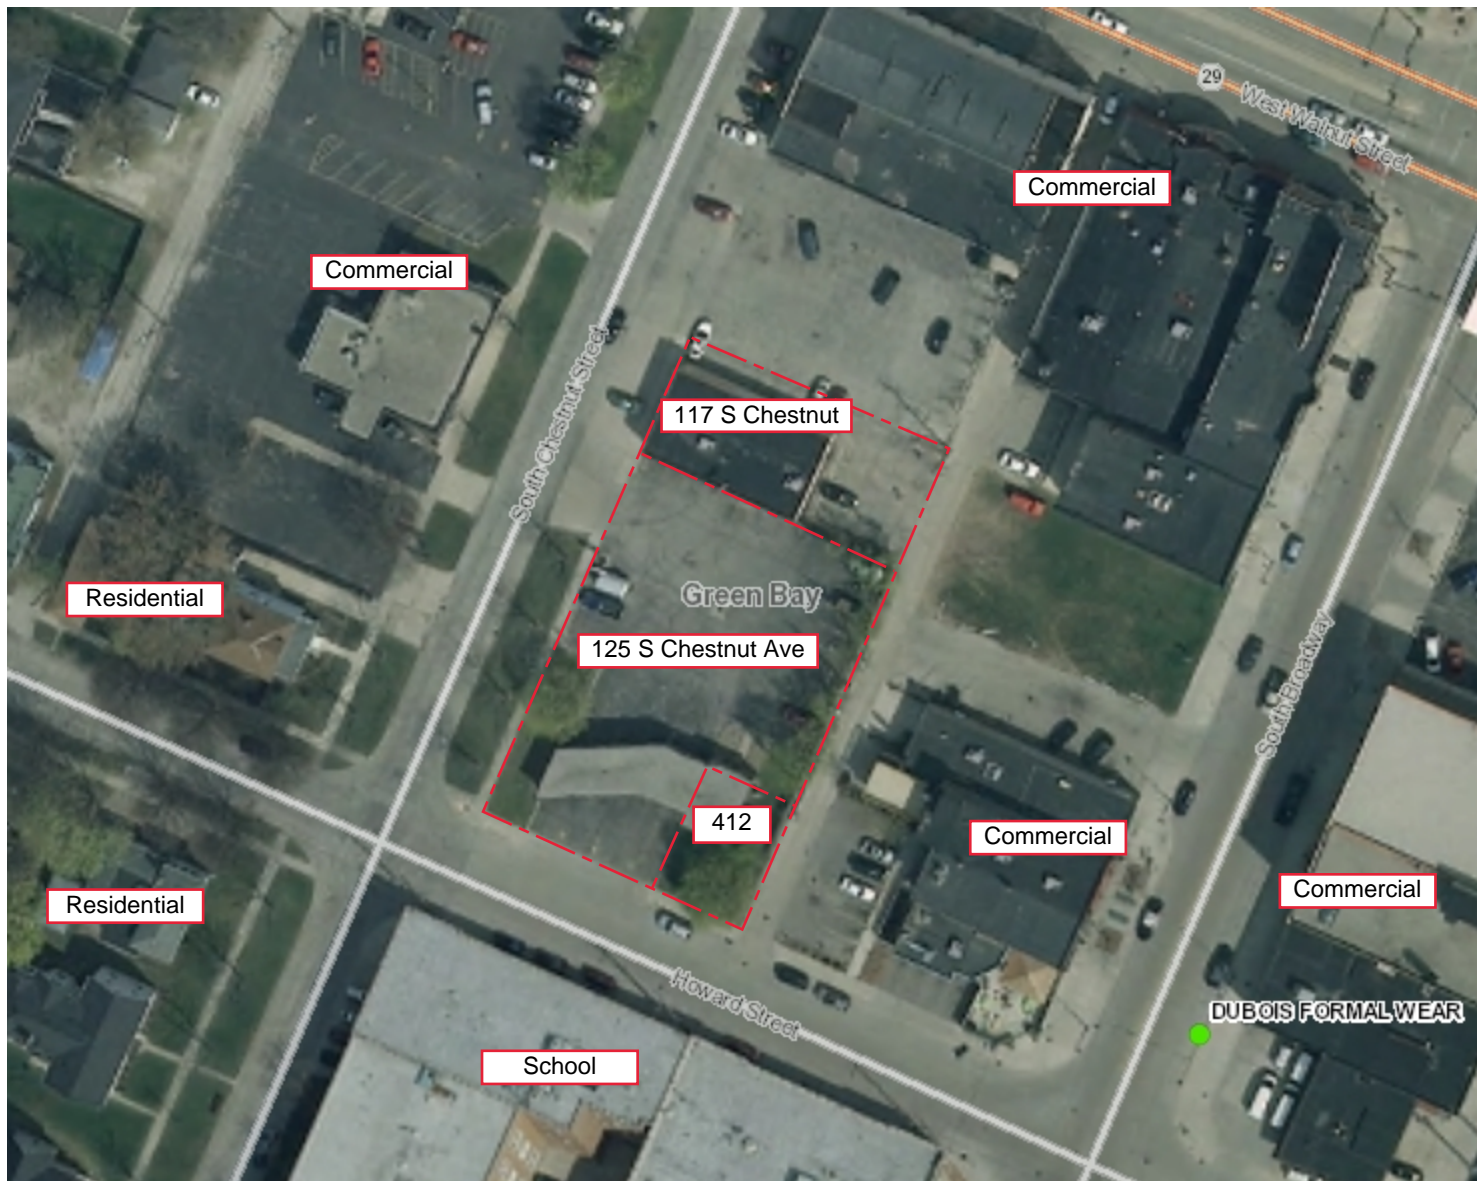
SITE FEATURES DIAGRAM

- Per the screening guidelines in DNR guidance document RR-800, off-site buildings are located within the 100-foot screening distance from the edge of the residual CVOC soil contamination. Further evaluation or assessment will need to be completed for off-site buildings.

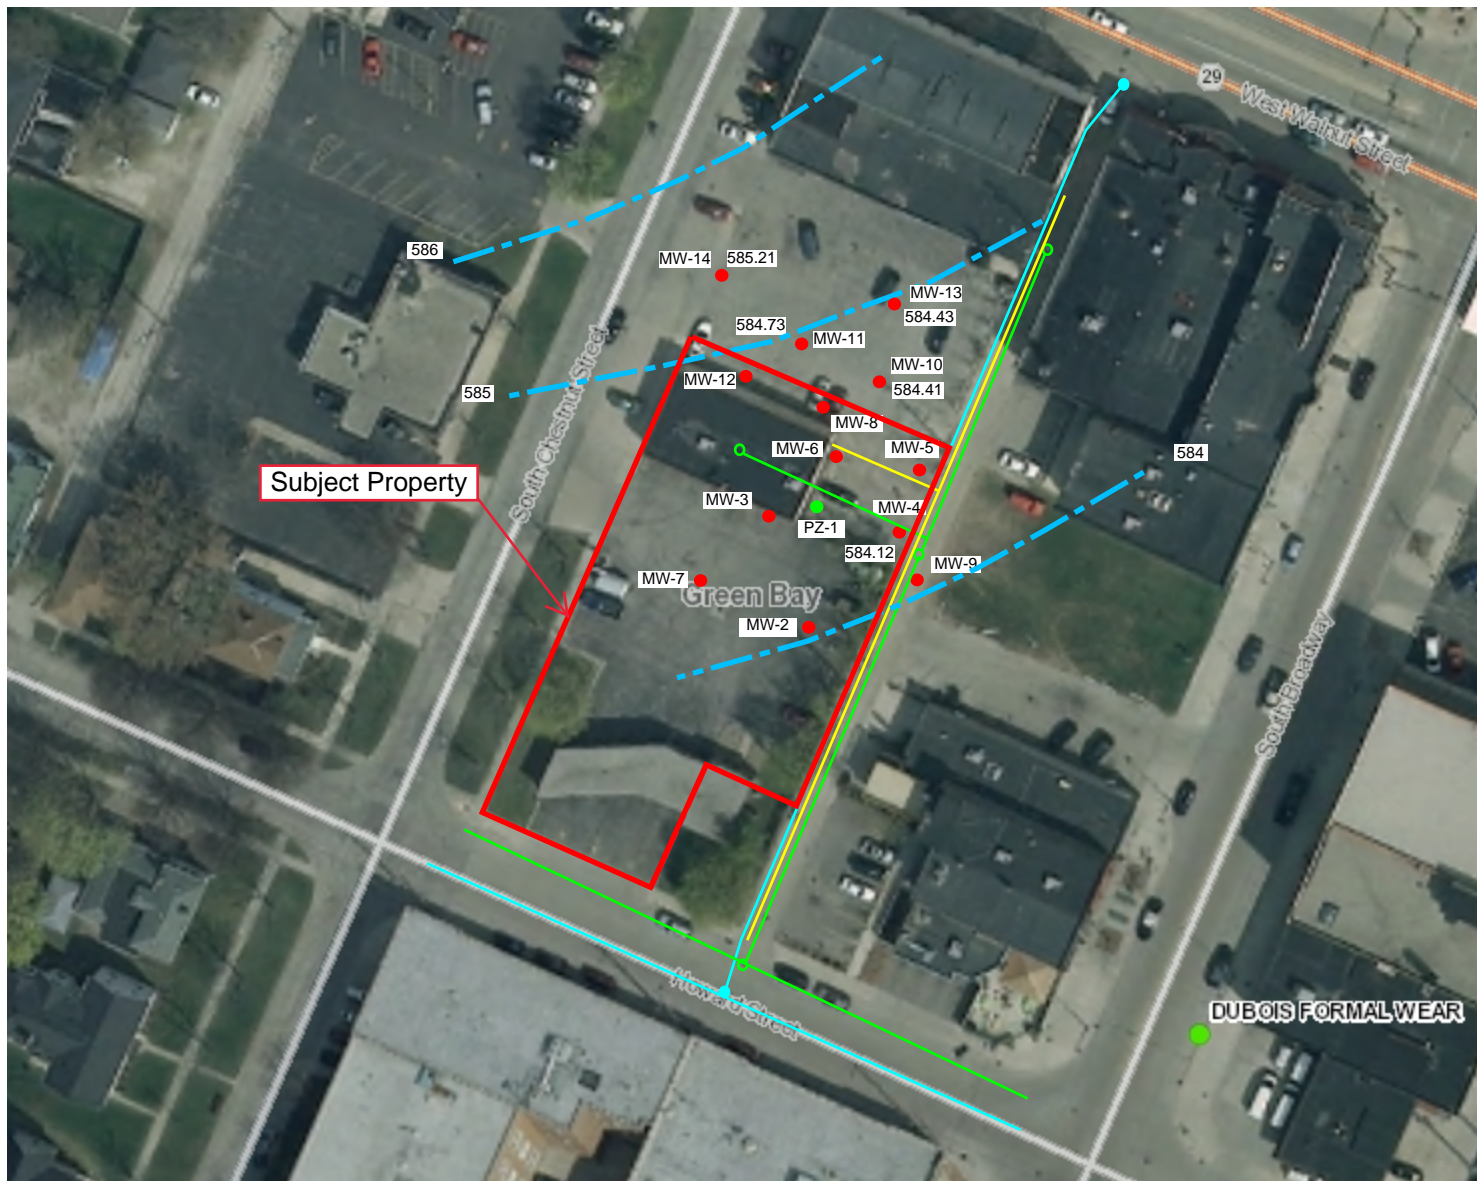
GROUNDWATER ELEVATION CONTOUR DIAGRAM-October 2022
BRRTS No. 02-05-585287

- Include ethene and ethane as sampling parameters in the groundwater monitoring schedule to document that complete breakdown of CVOCs is occurring.
- MW-12 has concentrations of PCE and TCE above their respective enforcement standards (ES), and may require further delineation unless adequate justification can be provided to the DNR. Current well placement is outlined on the attached map (Groundwater Elevation Contour Diagram).

- It is noted that the most downgradient well (MW-9) still exhibits an enforcement standard exceedance for vinyl chloride, and this may also require further delineation unless adequate justification is provided to the DNR.

- It is recommended that a brief work plan for the additional groundwater monitoring be provided for DNR review.
- Depending on future sampling results, additional soil and/or groundwater sampling may be necessary to fully define degree and extent of contamination.
