**Reference: Construction Documentation Report for Demolition and Removal of Structural Impediments, River Point District – Site 1
200 North 10th Street
Manitowoc, Wisconsin 54220
WDNR BRRTS ID: 02-36-585491 (Open ERP)
WDNR BRRTS ID: 07-36-583000 (LGU Exemption)
WDNR BRRTS ID: 02-36-00408 (Closed)**

Reference: Construction Documentation Report for Demolition and Removal of Structural Impediments, River Point District – Site 1

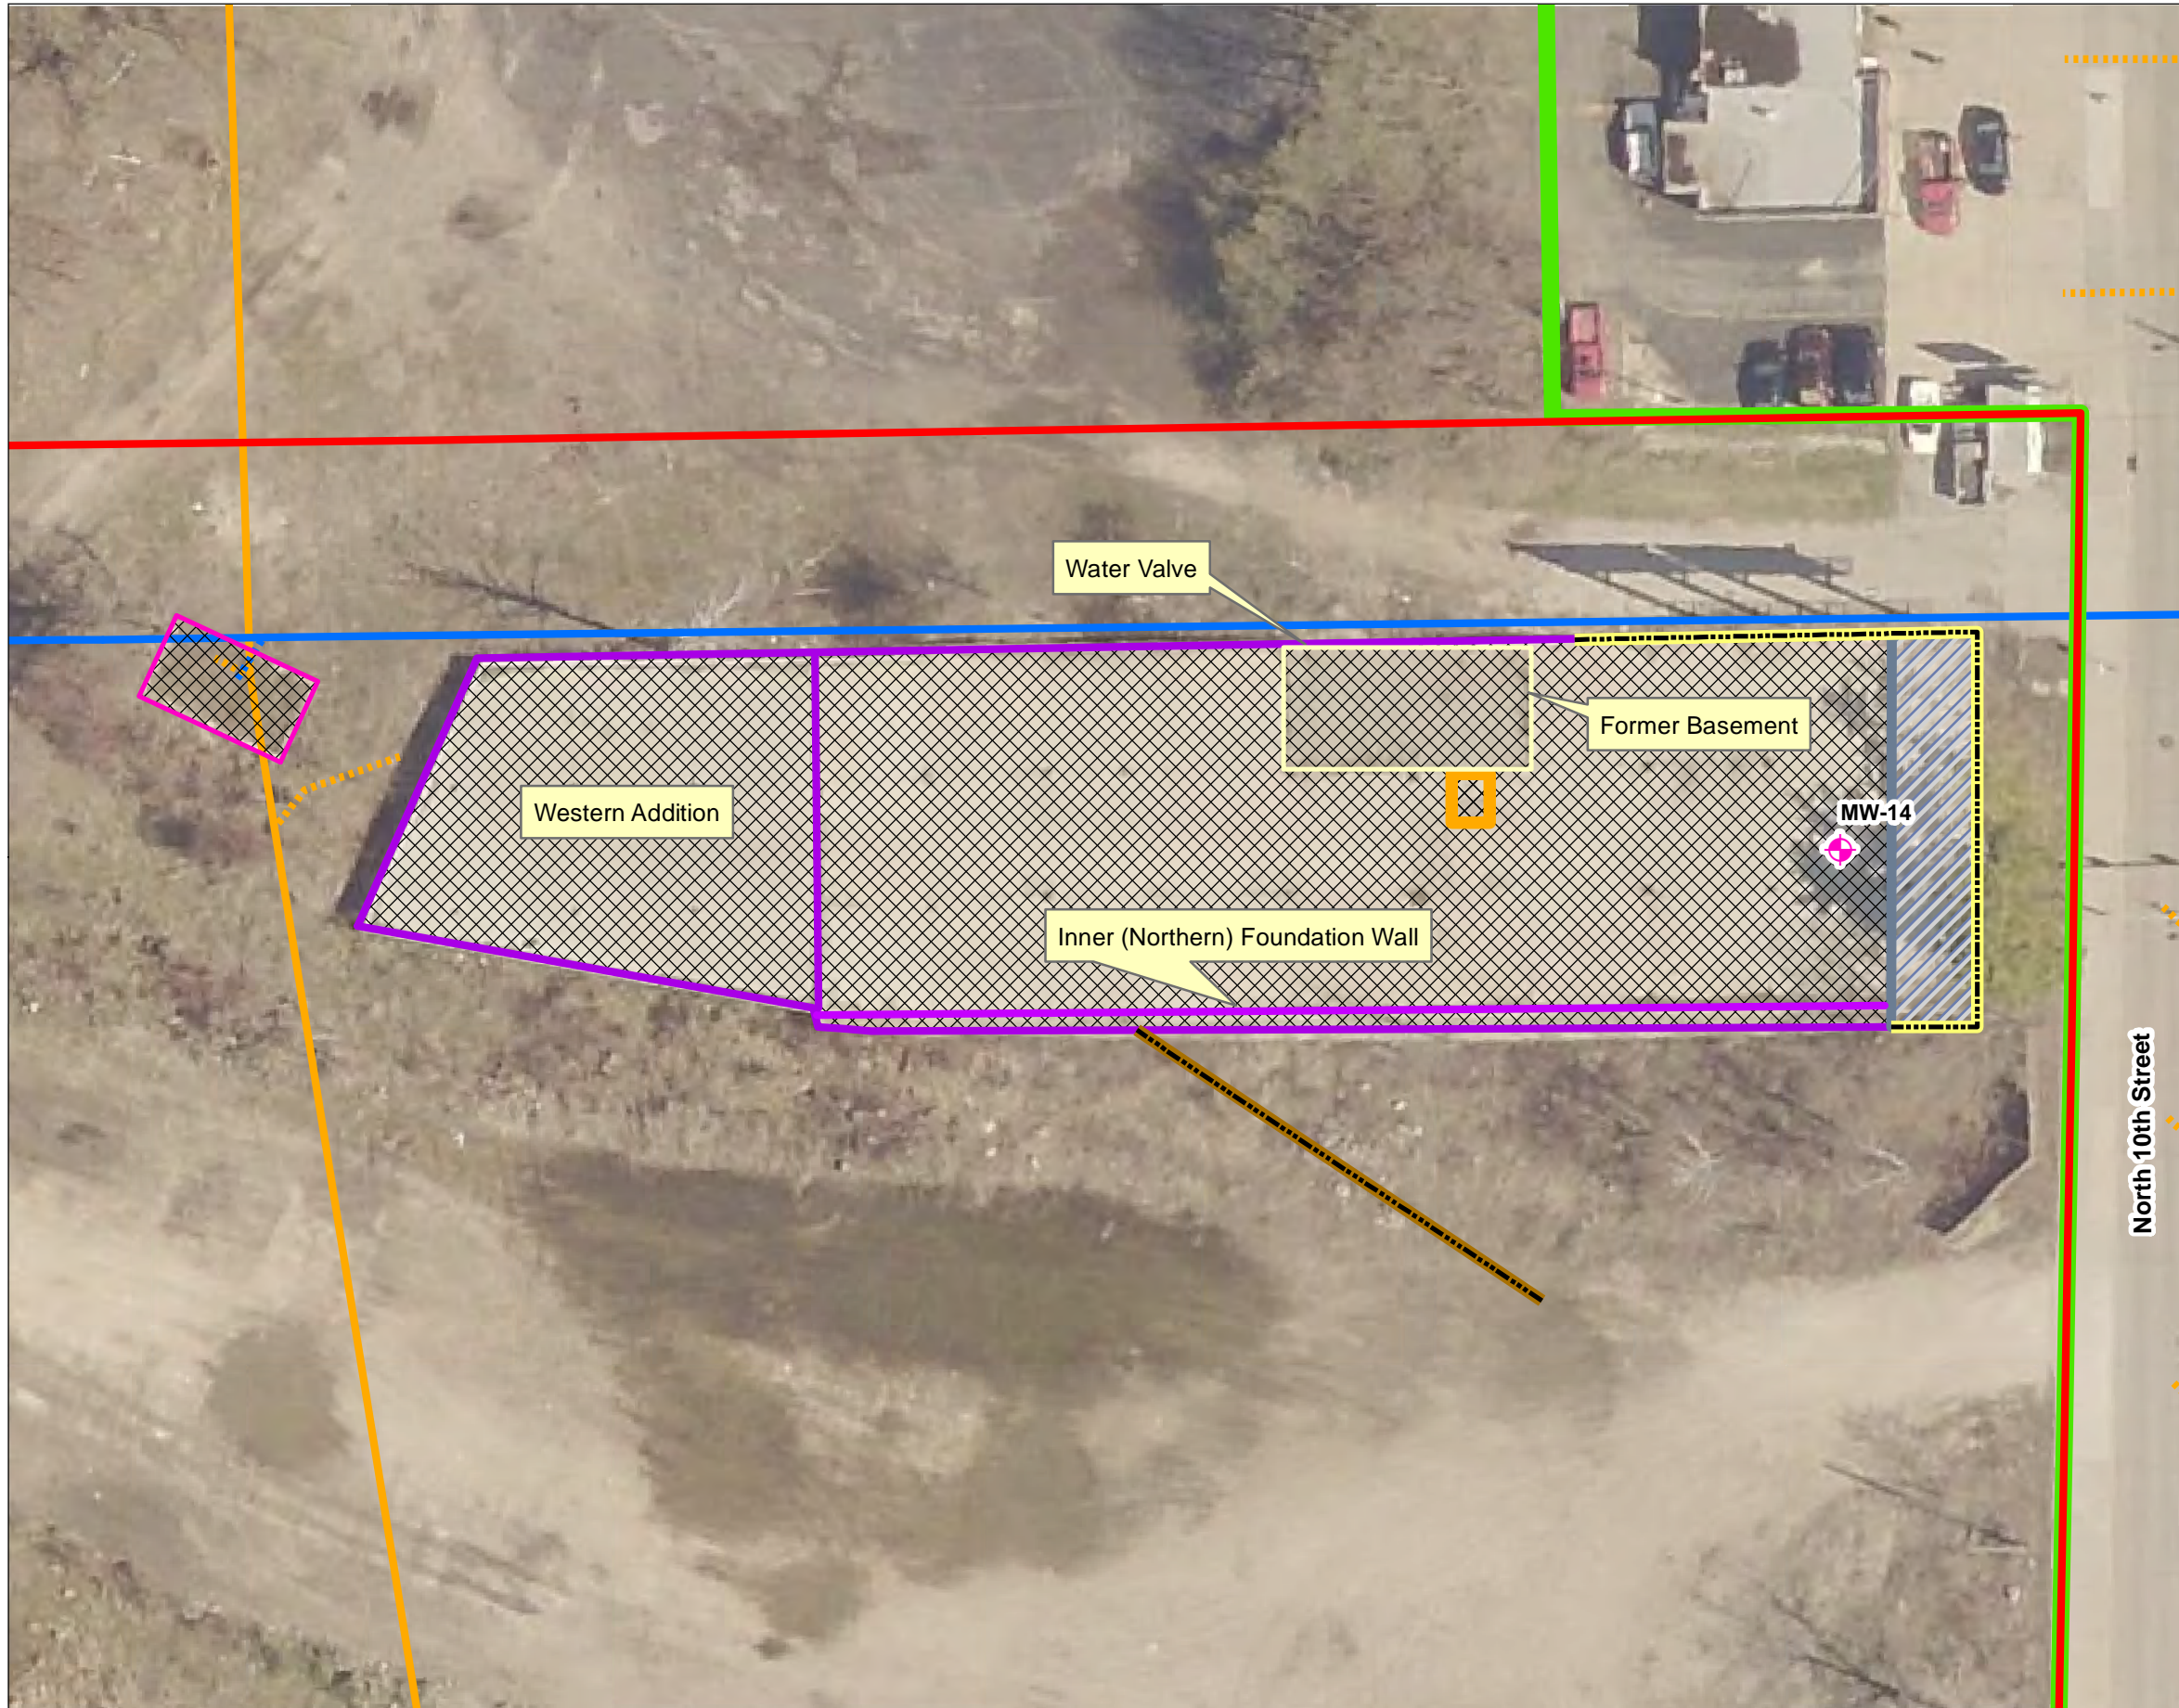
Figure No. **4**
 Title
Removed and Remaining Site Features
 Client/Project
 River Point District, Site 1
 200 North 10th Street
 City of Manitowoc
 0 25 50 Feet
 Prepared by HLB on 9/28/2020

Two pipes were encountered 3.0' below ground surface in test pit TP-3 near the south-central edge of the warehouse slab, appearing to run from the northwest to southeast away from the building (Attachment A, Photograph No. 3). Test pit TP-4 delineated the piping to at least 80 feet from the slab to the active gravel access road (Figure 3). The piping run consisted of two parallel pipes, one 2" and one 4" in diameter, both encased with wooden planks and consistently 3.0' below grade (Attachment A, Photograph Nos. 4 - 8). The piping run remains at the Property and is depicted on Figure 4.

- The northeastern portion of the foundation wall near the existing billboard was not removed so as not to compromise the active and electrified billboard or the north-adjointing asphalt driveway.
- The footings of the foundation walls were not removed as the foundation walls separated naturally from the footings during demolition. In addition, the footings were located below the water table and would have been difficult to remove. The perimeter footing remains at approximately 582.87 ft amsl.

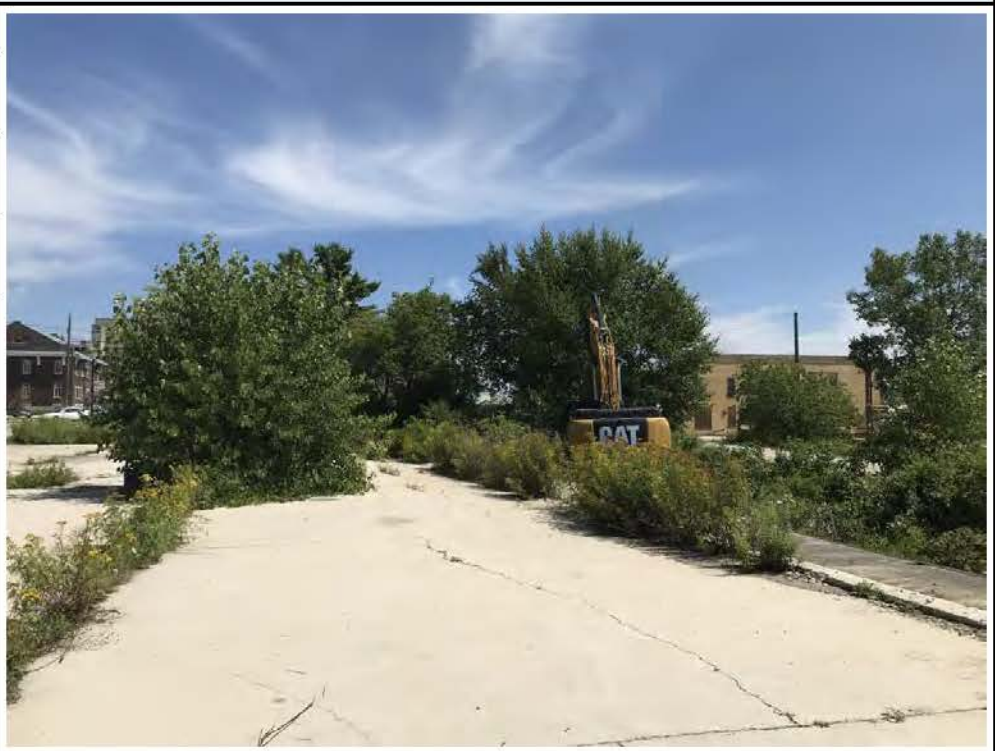
Photograph ID: 1

Photo Location: Warehouse slab - west end	
Direction: Looking east	
Survey Date: 8/13/2020	
Comments: Warehouse slab condition prior to demolition

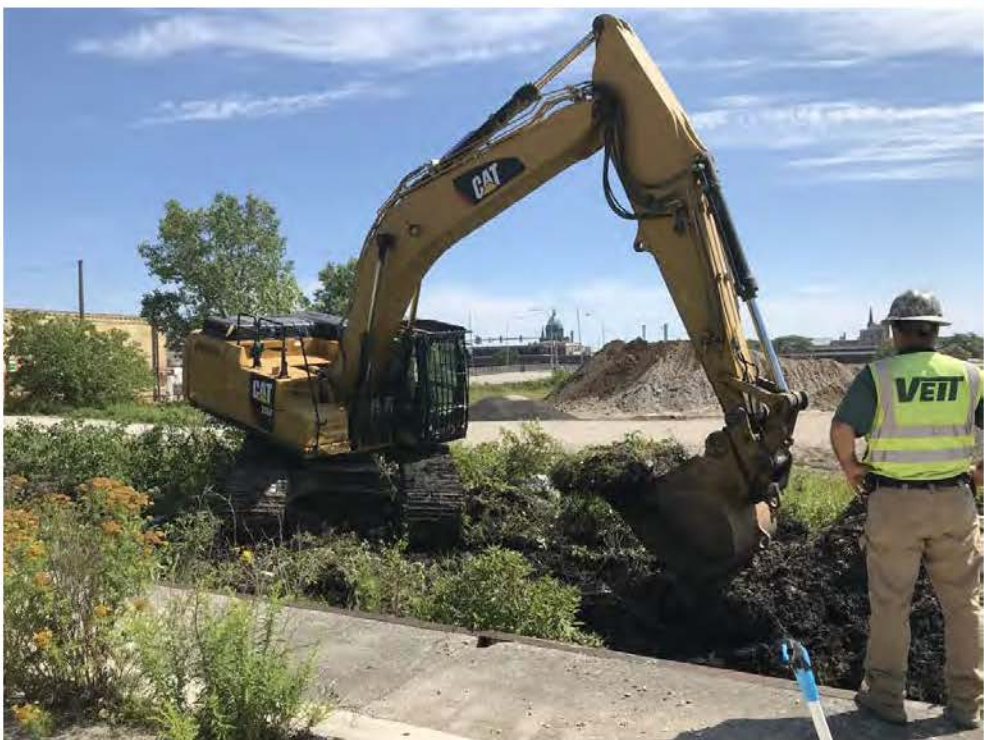
<p>Photograph ID: 4</p> <p>Photo Location: Warehouse slab - south central</p> <p>Direction: Looking south</p> <p>Survey Date: 8/13/2020</p> <p>Comments: Performing test pit TP-4 to follow the piping discovered in TP-3</p>

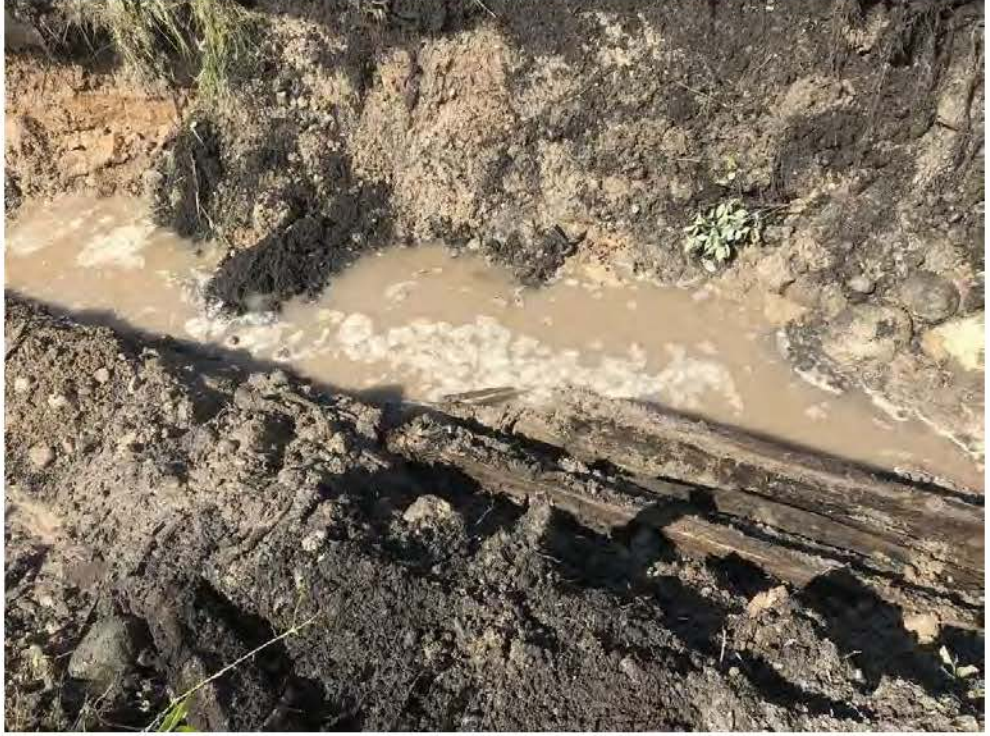
<p>Photograph ID: 6</p> <p>Photo Location: TP-4 - central</p> <p>Direction:</p> <p>Survey Date: 8/13/2020</p> <p>Comments: The piping in TP-4 (one 2" and one 4" pipe, approximately three feet below grade) was encased on all sides with wood planks</p>

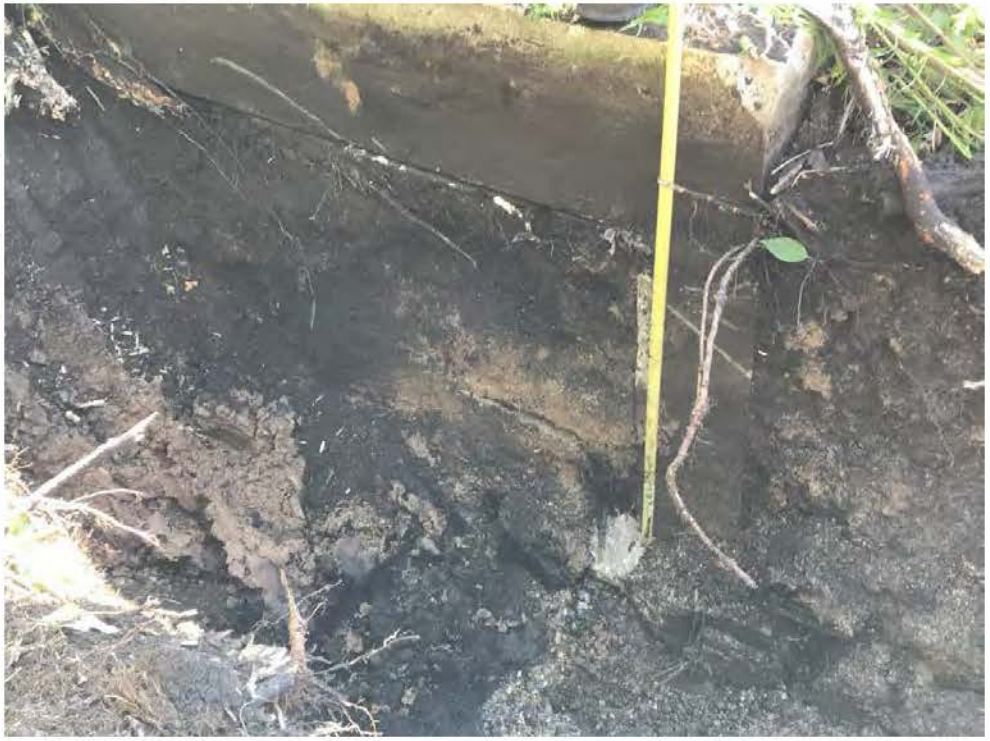
Photograph ID: 13

On August 14th, 2020, the smaller, 500 square foot concrete remnant foundation wall west of the warehouse slab on Site 1 was investigated with test pits TP-8 and TP-9 (refer to Figure 4). The foundation wall remained at grade and was previously supported by concrete piers approximately 1-foot square in width). The piers extended to 5.0' to the top of their footings from the top of ground surface, and to 5.8' to the bottom of the footing from the top of ground surface for each instance. Only the perimeter of the concrete foundation remained in this location at the time of the investigation, comprising of approximately 92 linear feet of concrete with 18" of thickness and reinforced with rebar (Attachment A, Photograph Nos. 11 - 13).

Photo Location: West of small foundation remnant	
Direction: Looking east	
Survey Date: 8/14/2020	
Comments: Measuring the depth of the pier at the west corner of the foundation (visible tape behind the measuring tape)

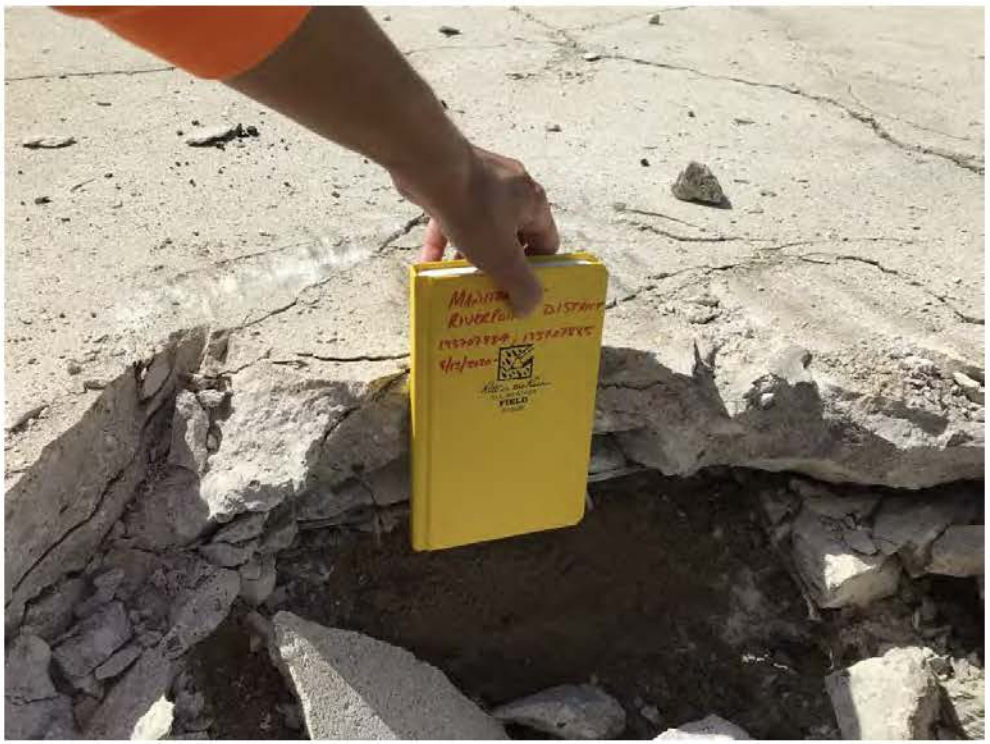
Photograph ID: 14

Photo Location: Warehouse slab - west end	
Direction:	
Survey Date: 8/17/2020	
Comments: The entire warehouse floor slab was 6 - 8" thick, and contained wire mesh. Brown fill sand was present beneath the slab in all areas except for the former basement

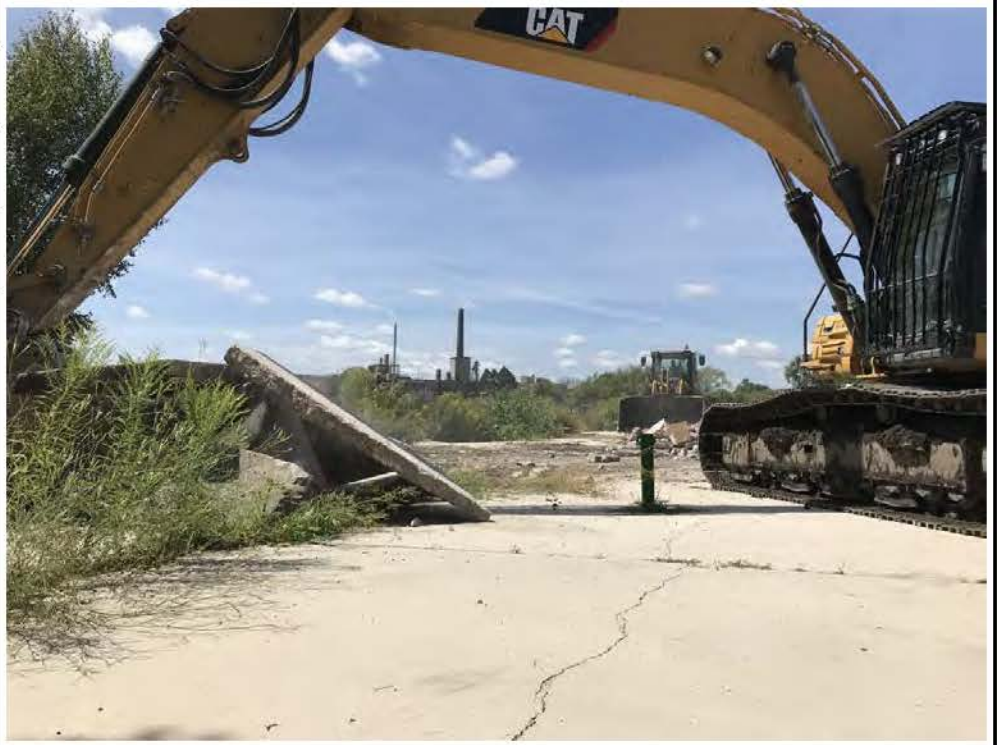
- The eastern 20 feet of the slab and associated foundation walls were not removed to ensure that the foundation for the east-adjointing sidewalk to the Property would not be undermined.

Comments:
Removing the warehouse floor slab. The entire floor was removed except for the eastern-most 20 feet so as not to undermine the east-adjacent sidewalk

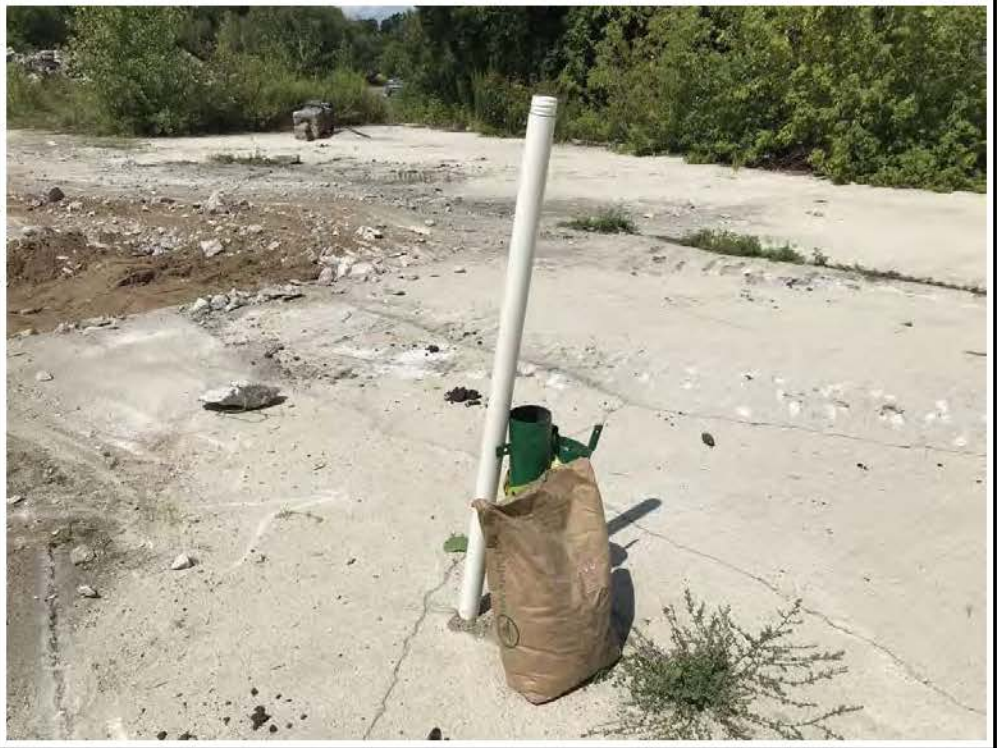
Photograph ID: 16

Comments:
Prior to disturbing the area, monitoring well MW-14 was abandoned by removing the top five feet of riser and filling to the top with bentonite

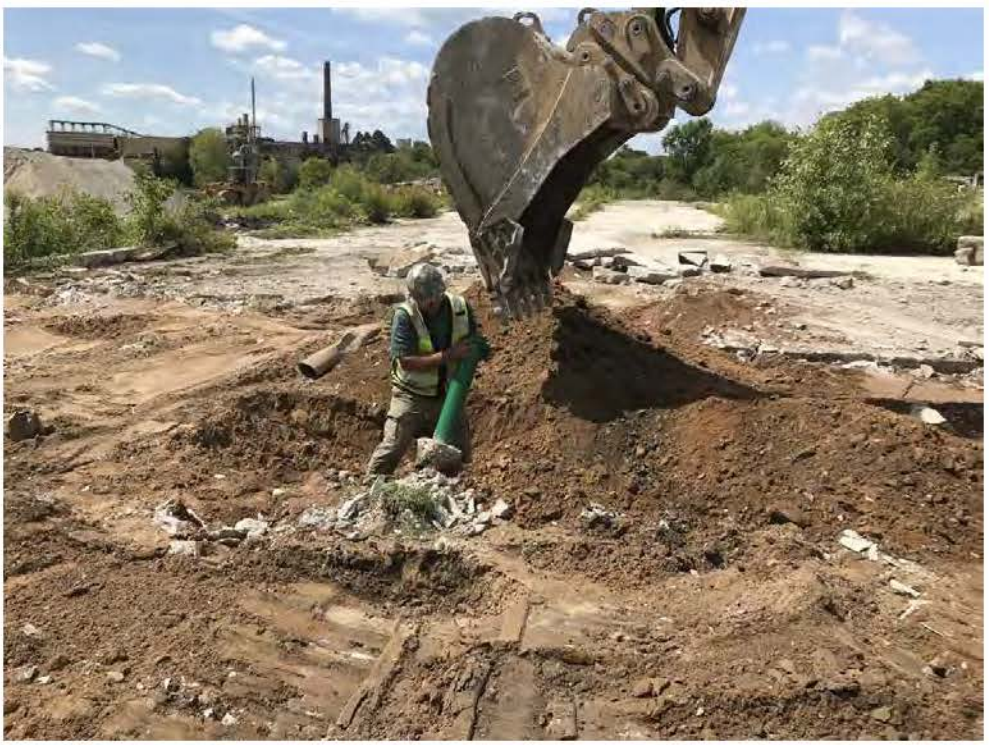
<p>Photograph ID: 17</p> <p>Photo Location: Warehouse slab - east end</p> <p>Direction: Looking west</p> <p>Survey Date: 8/17/2020</p> <p>Comments: After abandoning MW-14, the green protective pipe was removed</p>

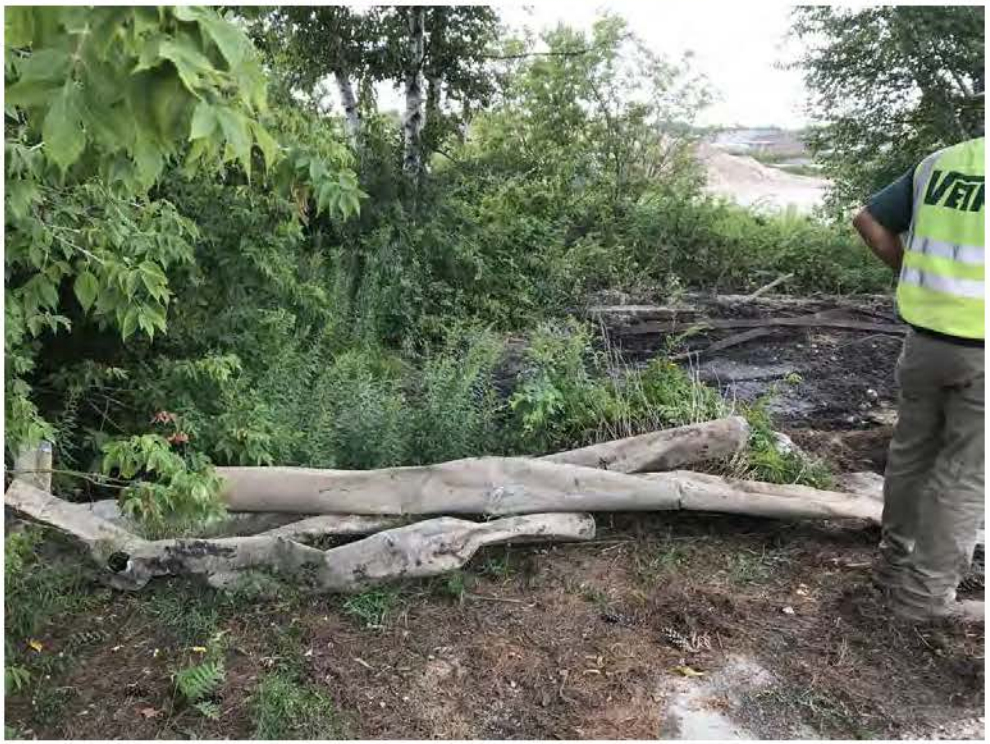
Photograph ID: 22

Photo Location: Warehouse slab - southeast corner	
Direction: Looking south	
Survey Date: 8/17/2020	
Comments: Metal ductwork between 6-8" in diameter was found throughout the slab fill areas, and largely left in place

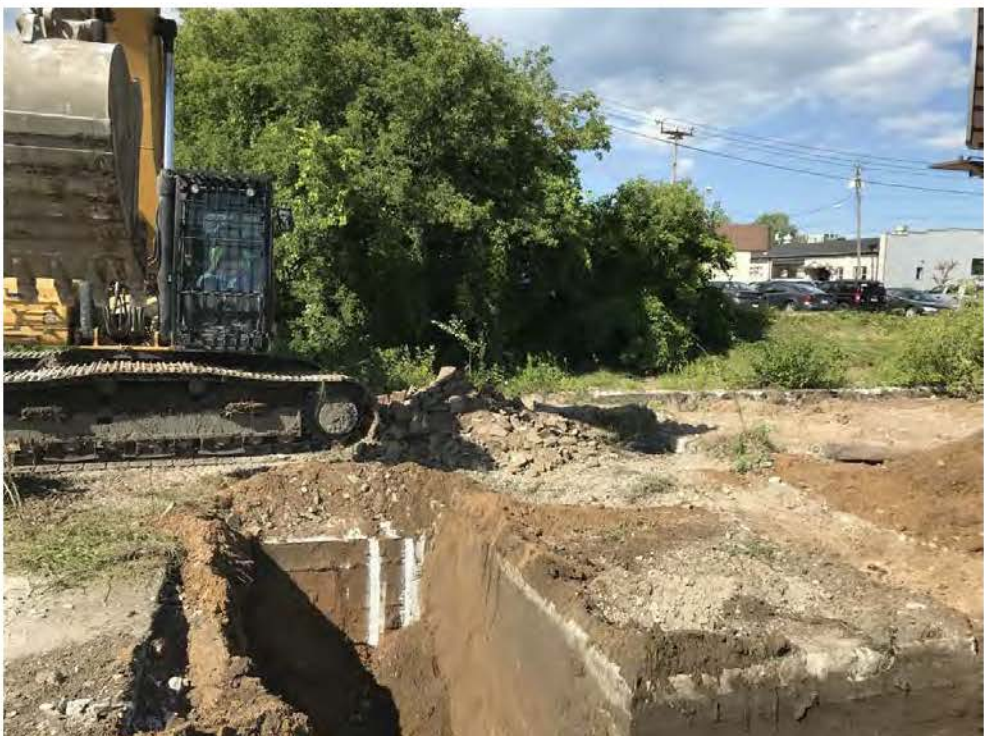
<p>Photograph ID: 24</p>

<p>Photo Location: Warehouse slab - small, south-adjointing room to former basement</p>	
<p>Direction: Looking northeast</p>	
<p>Survey Date: 8/17/2020</p>	
<p>Comments: Revealing the small south-adjointing room to the former basement</p>

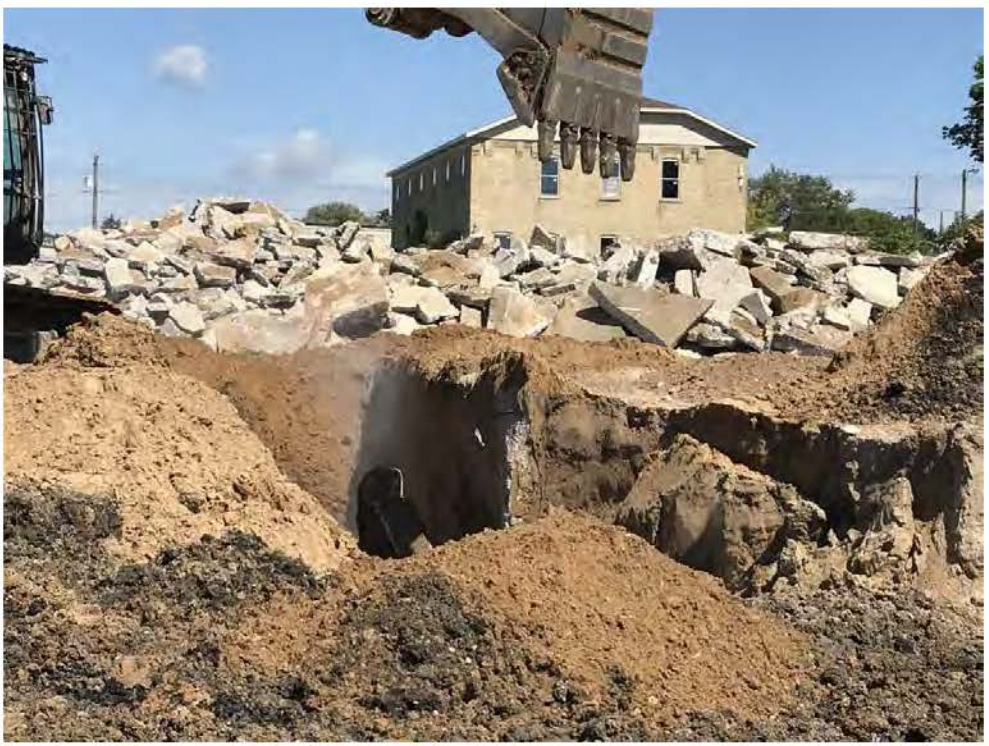
<p>Photograph ID: 35</p> <p>Photo Location: Western addition - southeast corner</p> <p>Direction: Looking north</p> <p>Survey Date: 8/19/2020</p> <p>Comments: The eastern foundation wall of the western addition (running north-south through the warehouse slab building) was also revealed and removed, leaving only the footing behind</p>

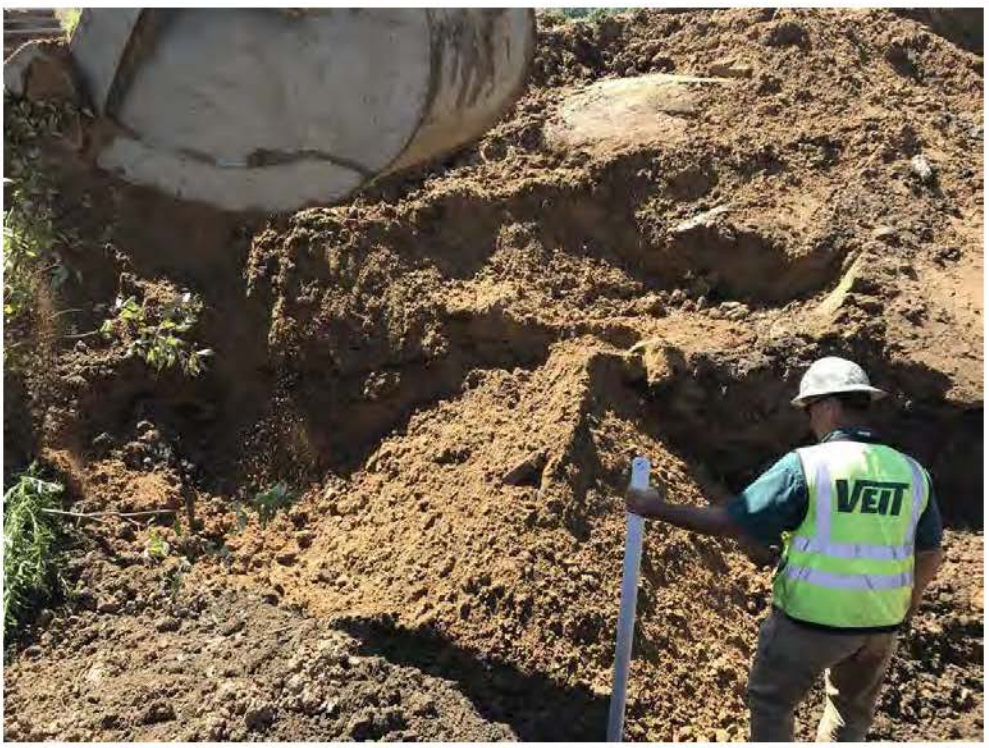
<p>Photograph ID: 37</p> <p>Photo Location: Western addition - northwest corner</p> <p>Direction: Looking south</p> <p>Survey Date: 8/19/2020</p> <p>Comments: Marking the top of the footing left in place with a PVC pipe, so that it could be captured by a professional land surveyor</p>
