December 11, 2020

Executive Director  
Community Development Authority of the City of Manitowoc  
City of Manitowoc  
900 Quay Street  
Manitowoc, Wisconsin 54220

**Reference: Construction Documentation Report for Demolition and Removal of Structural Impediments, River Point District – Site 3  
1110 Buffalo Street  
Manitowoc, Wisconsin 54220  
WDNR BRRTS ID: 07-36-583000 (LGU Exemption)  
WDNR BRRTS ID: 03-36-001962 (Closed LUST)  
WDNR BRRTS ID: 02-36-585491 (Open ERP)**

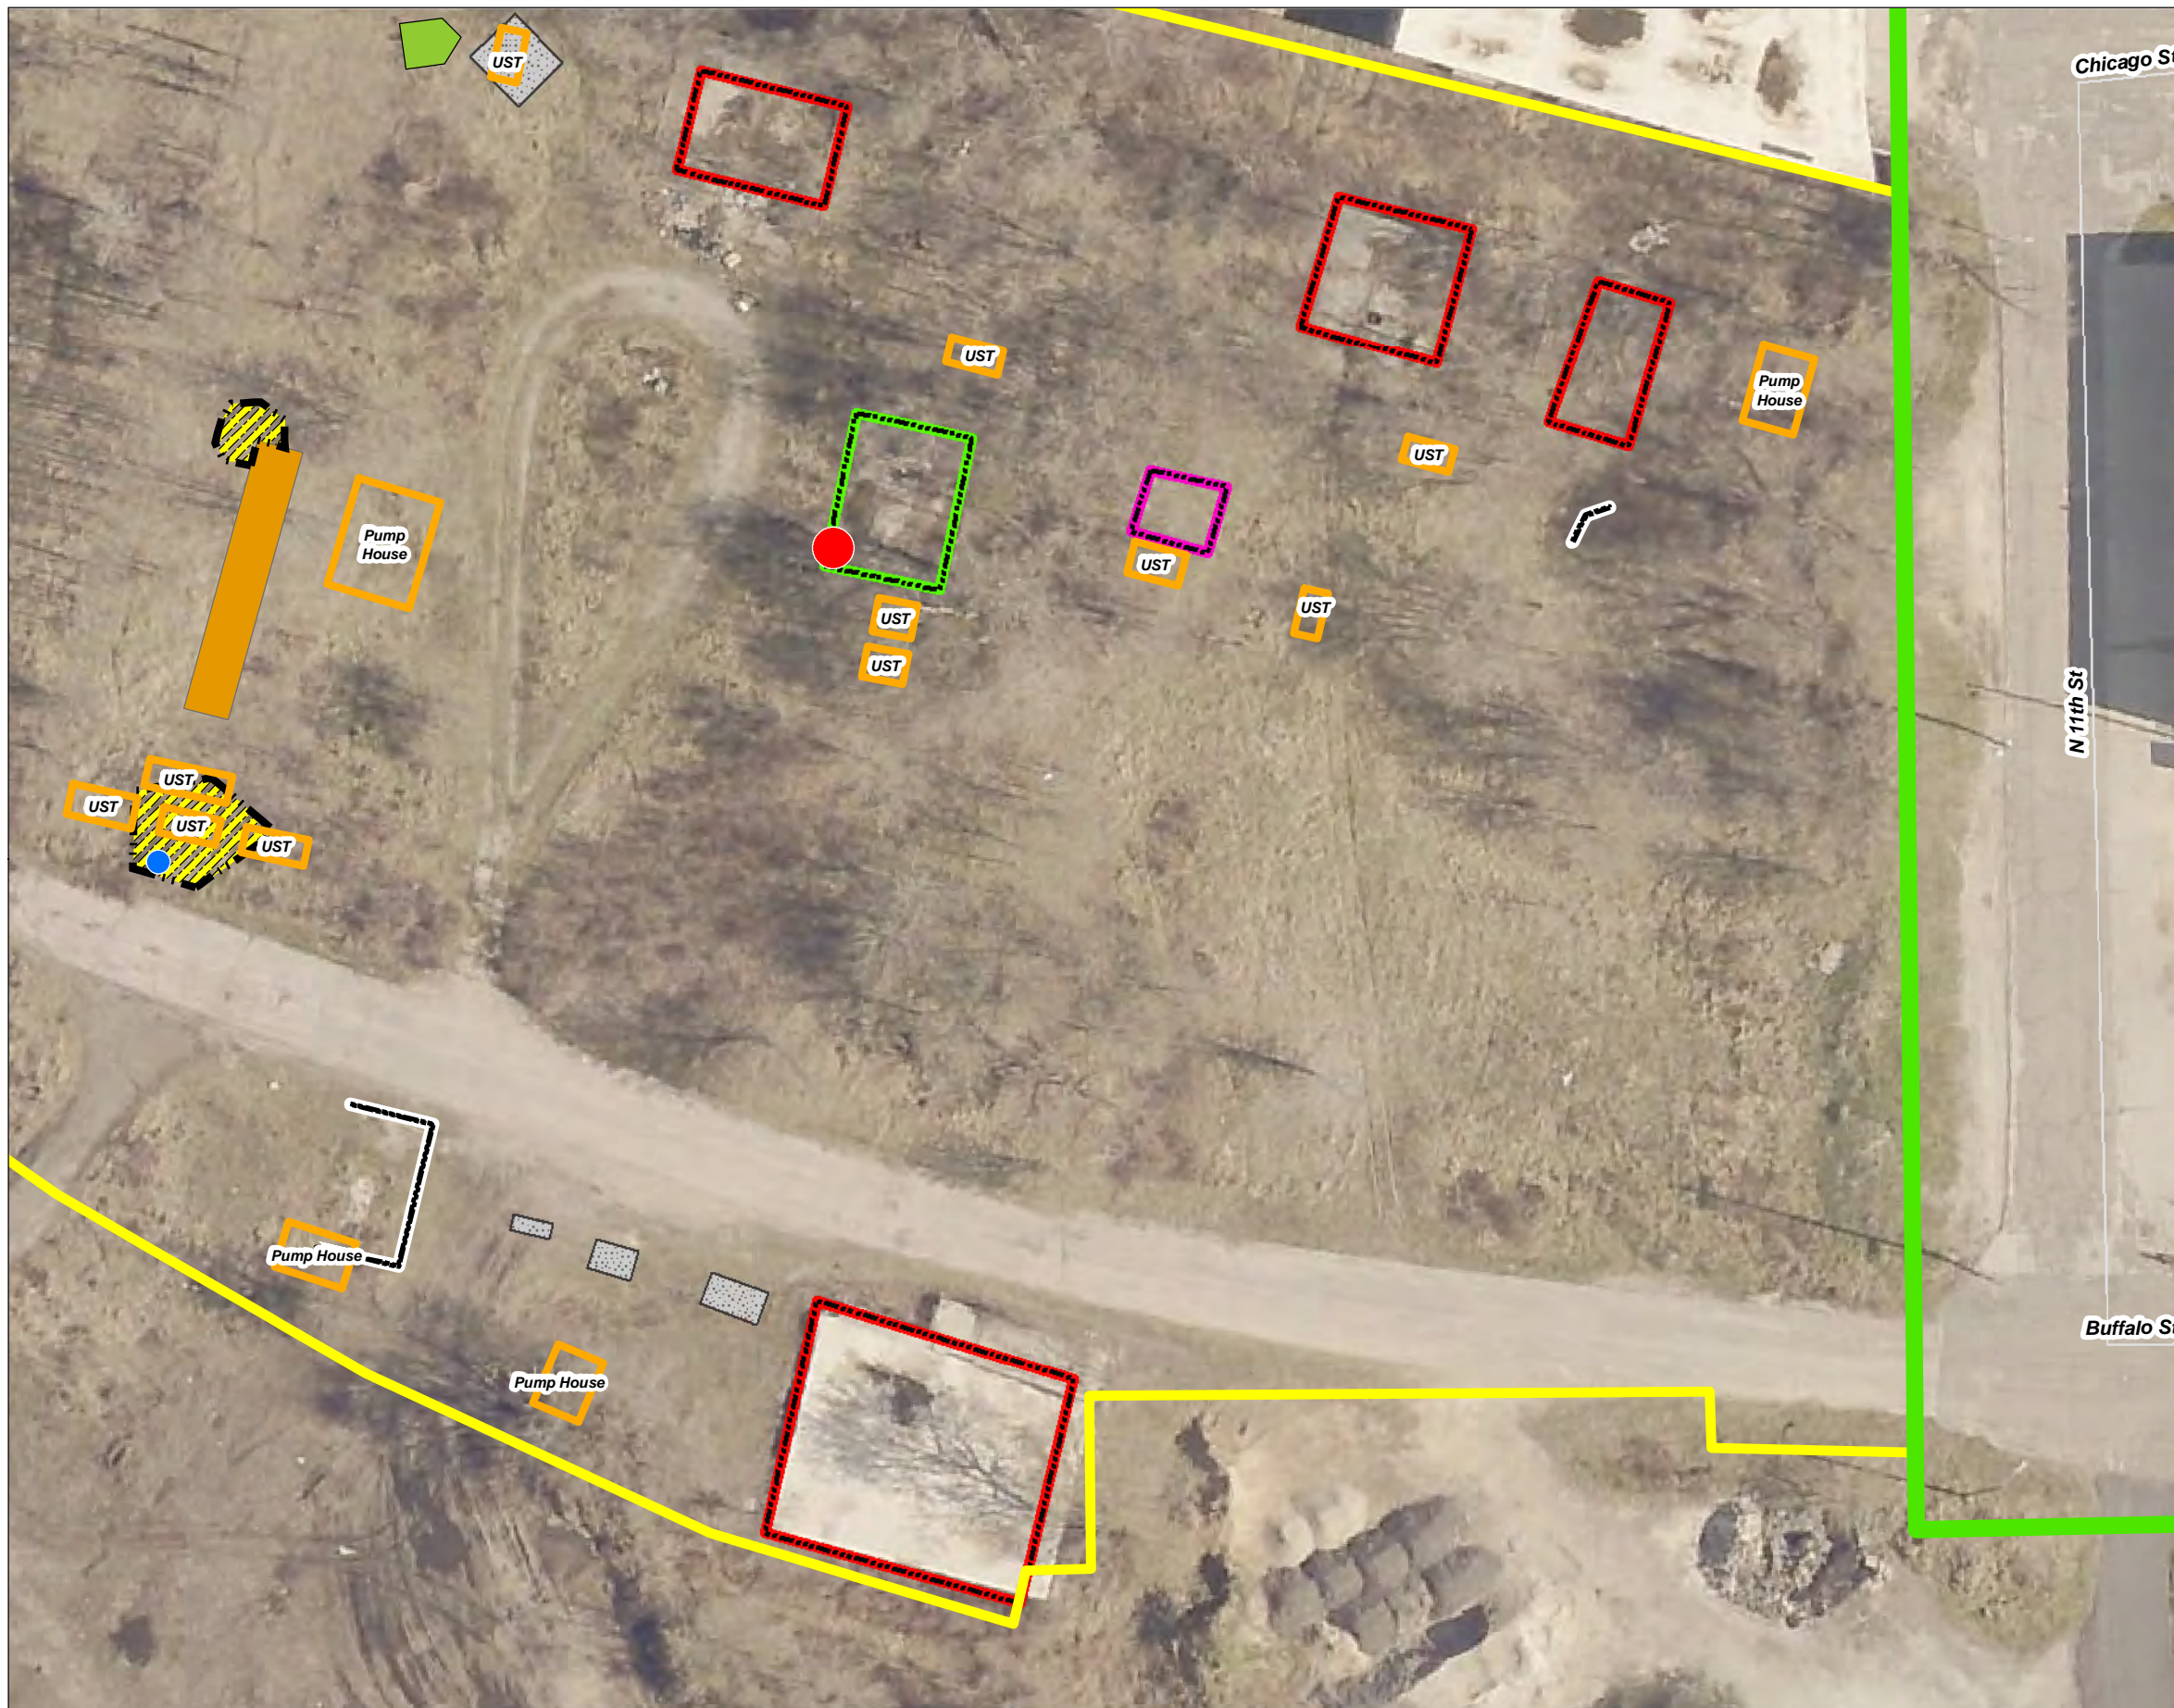
Figure No. **6**  
 Title **Removed and Remaining Features at Site 3**  
 Client/Project Riverpoint District Site 3  
 1110 Buffalo Street  
 City of Manitowoc  
 0 30 60 Feet  
 Prepared by HLB on 3/25/2020

Most of the foundation features present on Site 3 (including floor slabs, footings and footing walls) have been removed. The only foundation features on Site 3 assessed as part of this scope of work that remain in place, as illustrated on Figure 6, are:

- The large concrete slab (approximately 72' x 13' in dimension) in the area of a former AST farm remains on the western end of Site 3 (as assessed by TP-20 and *exploratory test pit #10*).
- The northern, eastern, and southern foundation walls of the gravel pad encountered just east of *exploratory test pit #15* remain.
- A semi-circular concrete remnant containing rebar remains in the northeast corner of Site 3, just northwest of *exploratory test pit #4*.

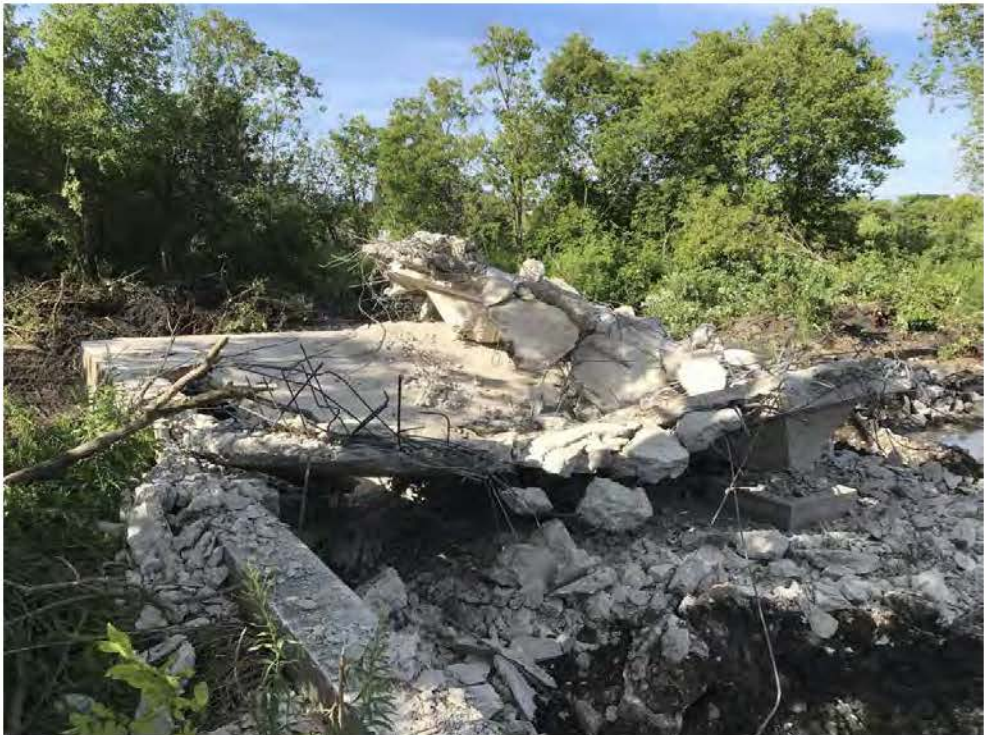
- A series of large concrete piers were found supporting the center of the large oil house slab. These piers were removed as part of slab demolition (Attachment A, Photograph No. 19).

<p><b>Photograph ID:</b> 19</p> <p><b>Photo Location:</b> Large oil house slab - eastern end</p> <p><b>Direction:</b> Looking south</p> <p><b>Survey Date:</b> 8/17/2020</p> <p><b>Comments:</b> Large concrete piers and rebar were present in the center of the large oil house slab, and were removed as part of demolition</p>

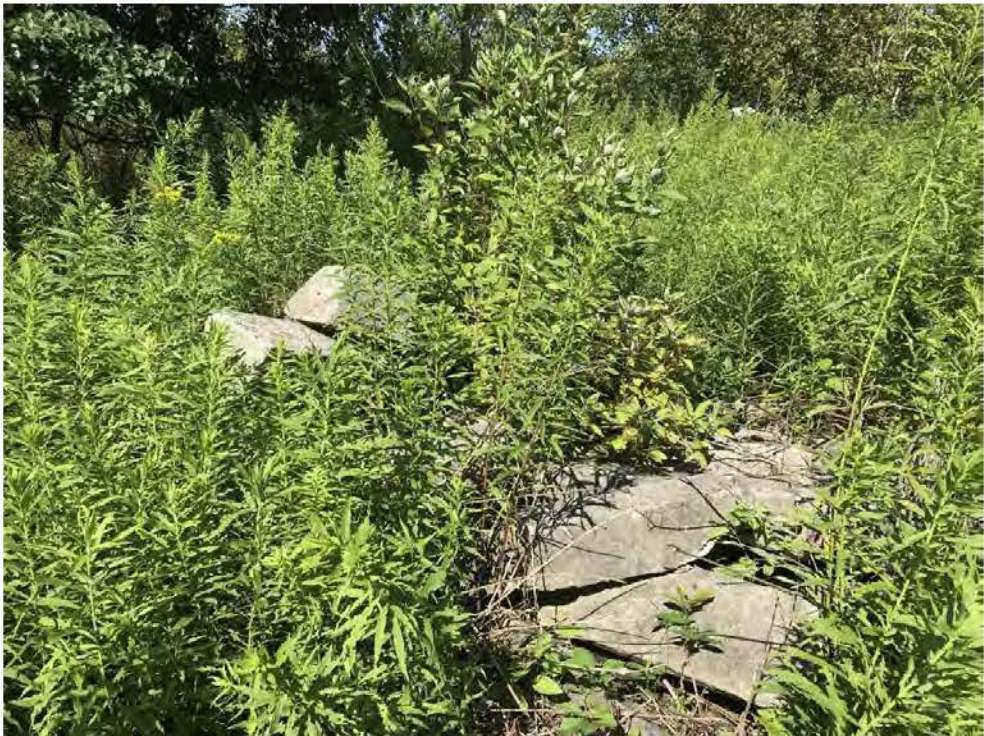
- While performing *exploratory test pit #8*, a small pile containing miscellaneous concrete curb-stop debris was discovered just west of the test pit excavation (Attachment A, Photograph No. 20).

<p><b>Photograph ID:</b> 20</p> <p><b>Photo Location:</b> Concrete debris pile - west of exploratory test pit #8</p> <p><b>Direction:</b> Looking north</p> <p><b>Survey Date:</b> 8/14/2020</p> <p><b>Comments:</b> A pile of concrete curb stops was observed west of exploratory test pit #8, and remains onsite</p>

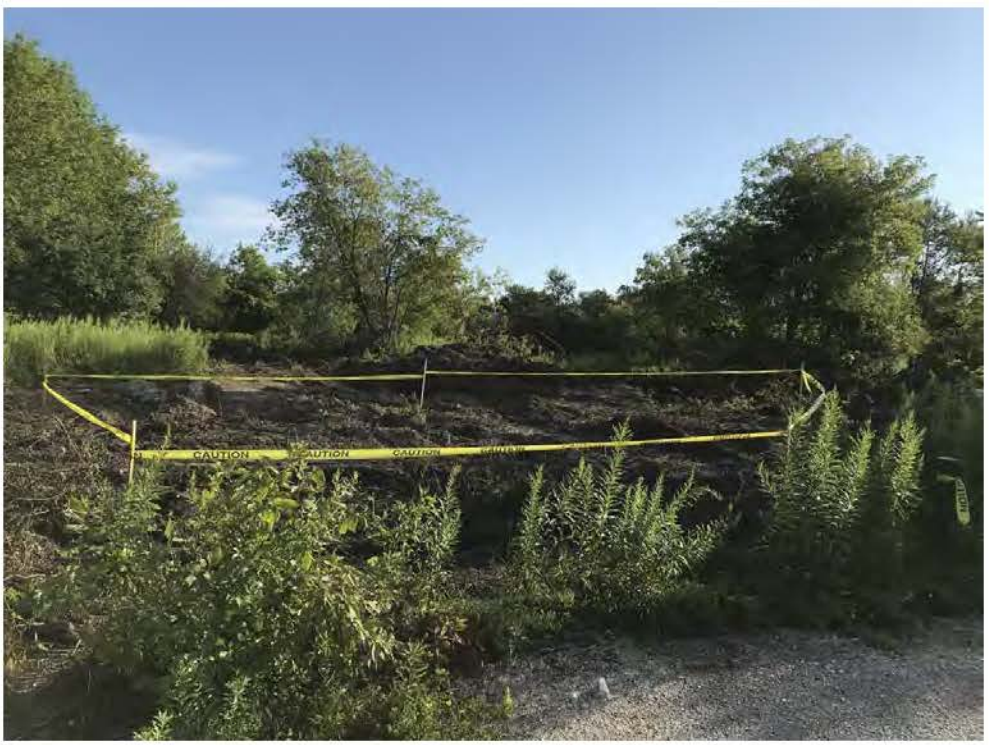
<b>Photograph ID:</b> 21

<b>Photo Location:</b> Oxide box waste area	
<b>Direction:</b> Looking north	
<b>Survey Date:</b> 8/17/2020	
<b>Comments:</b> The area where evidence of oxide box waste (blue) was encountered was roped off to prevent direct contact with the area

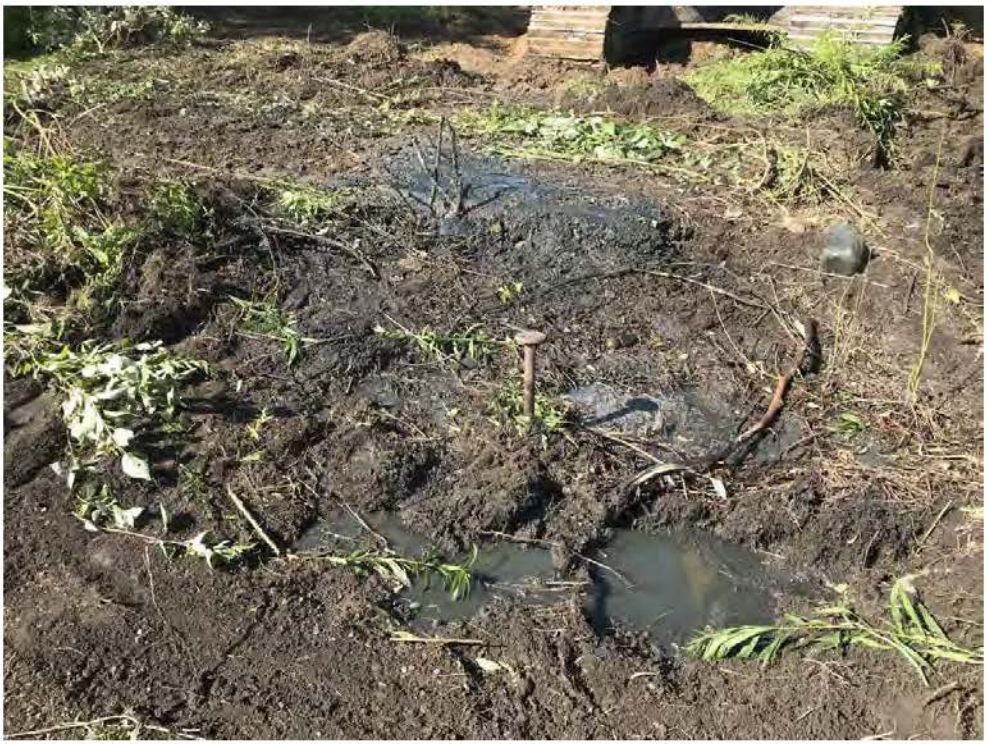
<b>Photograph ID:</b> 22

- Fill material with Prussian blue coloration, which appeared to be consistent with ferrocyanide salts in oxide box waste was encountered approximately 2.5 feet below ground surface in *exploratory test pit #11*, and shallow groundwater encountered approximately three feet below ground surface was the same blue color (Attachment A, Photograph No. 14). The excavation was immediately backfilled, and the area was staked and roped off using “CAUTION” tape for site safety (Attachment A, Photograph No. 21).
- An unmarked water shut-off valve was encountered on the south end of *exploratory test pit #12*. The valve was exposed and marked so that its location could be documented for future work at Site 3 (Attachment A, Photograph No. 22).

<b>Photo Location:</b> Water shut-off valve, oxide box waste area	
<b>Direction:</b> Looking east	
<b>Survey Date:</b> 8/14/2020	
<b>Comments:</b> An unmarked water shut-off valve was discovered while performing exploratory test pit #12 in the oxide box waste area; blue staining to soil is visible behind the valve

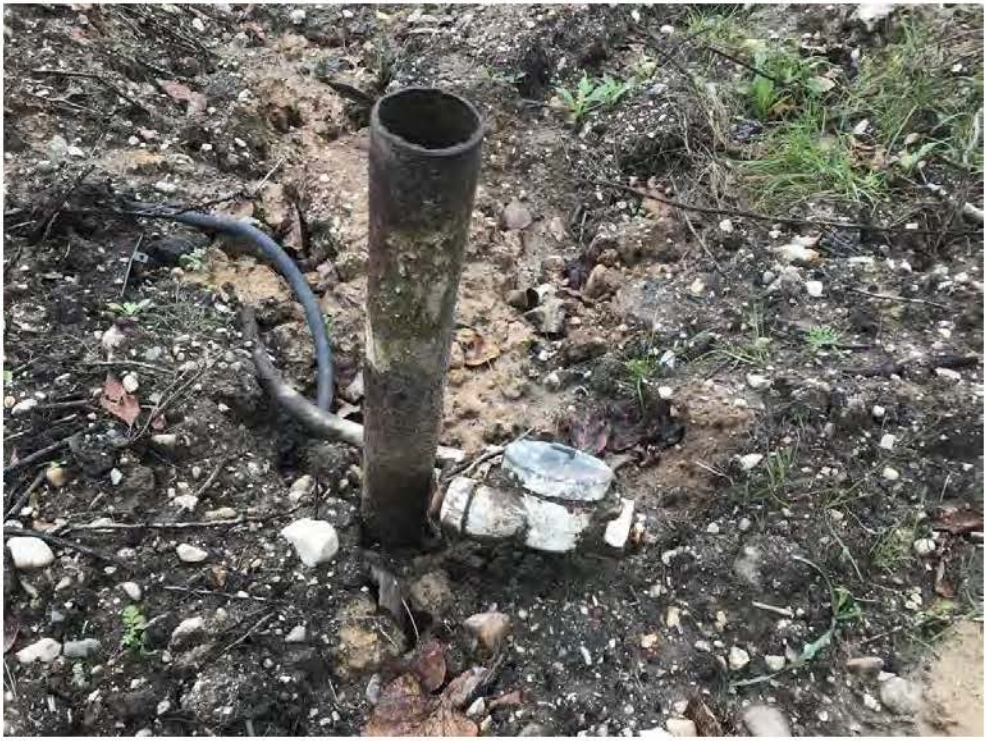
<p><b>Photograph ID:</b> 23</p> <p><b>Photo Location:</b> Unknown pipe, southwest corner of the former storage slab</p> <p><b>Direction:</b> Looking east</p> <p><b>Survey Date:</b> 9/29/2020</p> <p><b>Comments:</b> A vertical pipe (unknown nature) was observed in the southwest corner of the field-identified former storage slab and remains onsite</p>

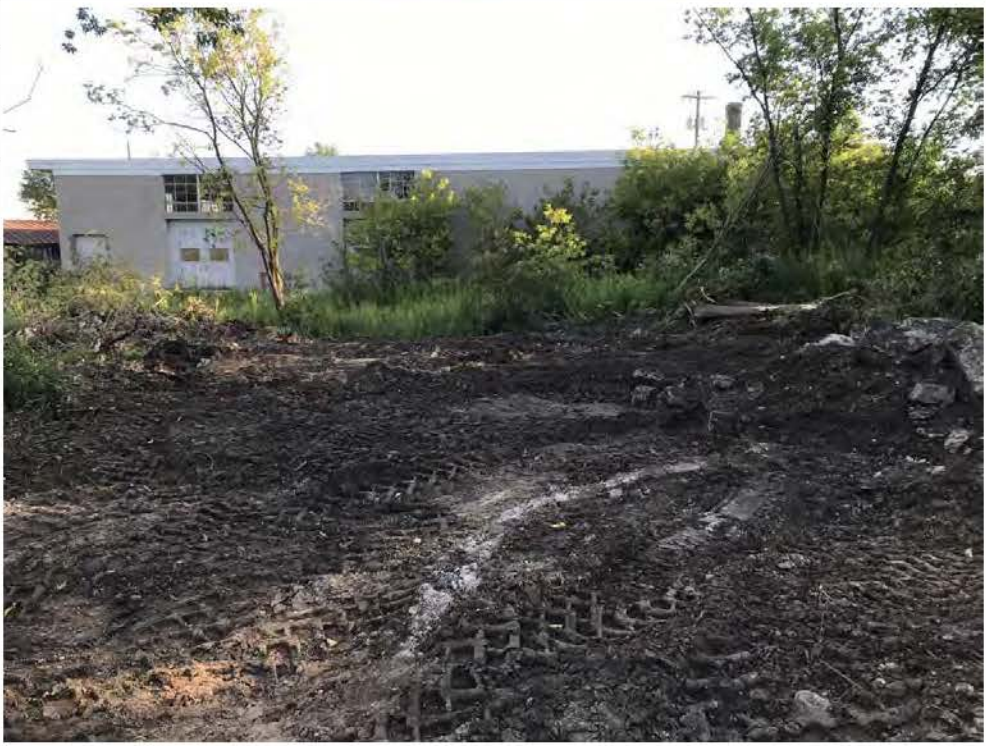
- A semi-circular concrete remnant previously obscured by vegetation at the ground surface was discovered by Veit during the removal of foundation features in the northeast corner of Site 3 (Attachment A, Photograph No. 24). The concrete remnant contained rebar and is located just northwest of a former AST farm and *exploratory test pit #4*. It remains in place (coordinates: 302027.116 feet, 232478.601 feet) and its location is depicted on Figure 6.
- A vertical pipe approximately 2" in diameter was encountered in the southwest corner of the former storage building on Site 3 (Attachment A, Photograph No. 23). Electrical conduit was also present and connected to the outside of the pipe. The nature of the pipe is unknown; it remains in place (coordinates: 302028.599 feet, 232303.809 feet) and its location is depicted on Figure 6.

<p><b>Photograph ID:</b> 24</p> <p><b>Photo Location:</b> Semi-circular concrete remnant</p> <p><b>Direction:</b> Looking north</p> <p><b>Survey Date:</b> 8/17/2020</p> <p><b>Comments:</b> A semi-circular concrete remnant located just northwest of a former AST farm and exploratory test pit #4 remains onsite</p>

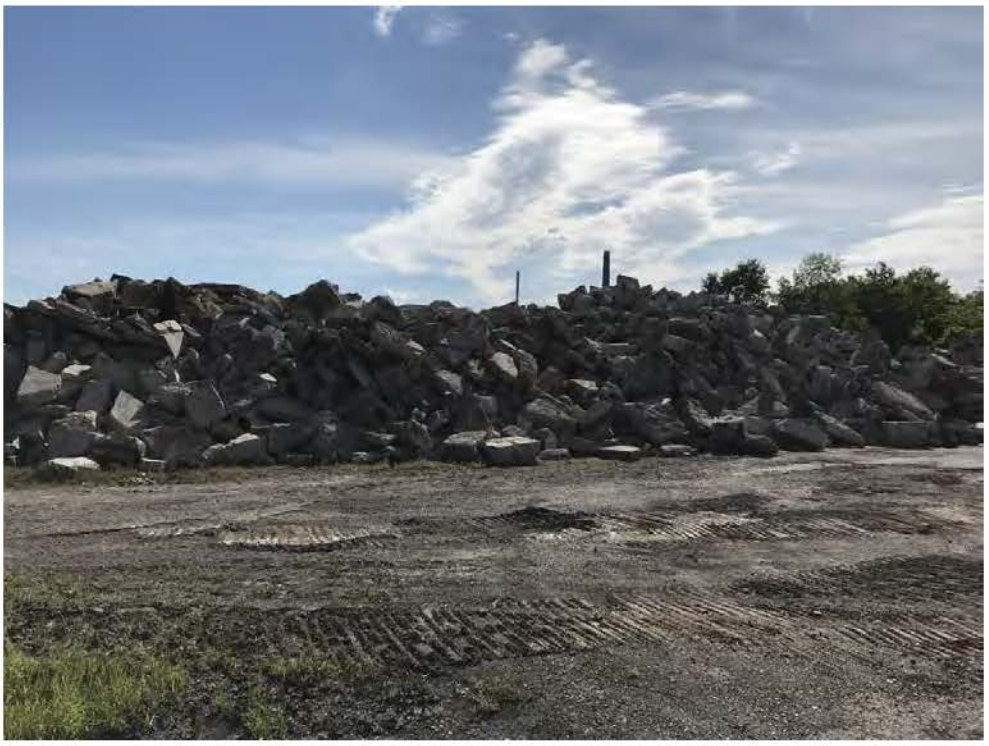
<p><b>Photograph ID:</b> 26</p> <p><b>Photo Location:</b> Northwest corner of Site 1</p> <p><b>Direction:</b> Looking south</p> <p><b>Survey Date:</b> 8/20/2020</p> <p><b>Comments:</b> The stockpile of concrete staged to be crushed onsite by Vinton</p>

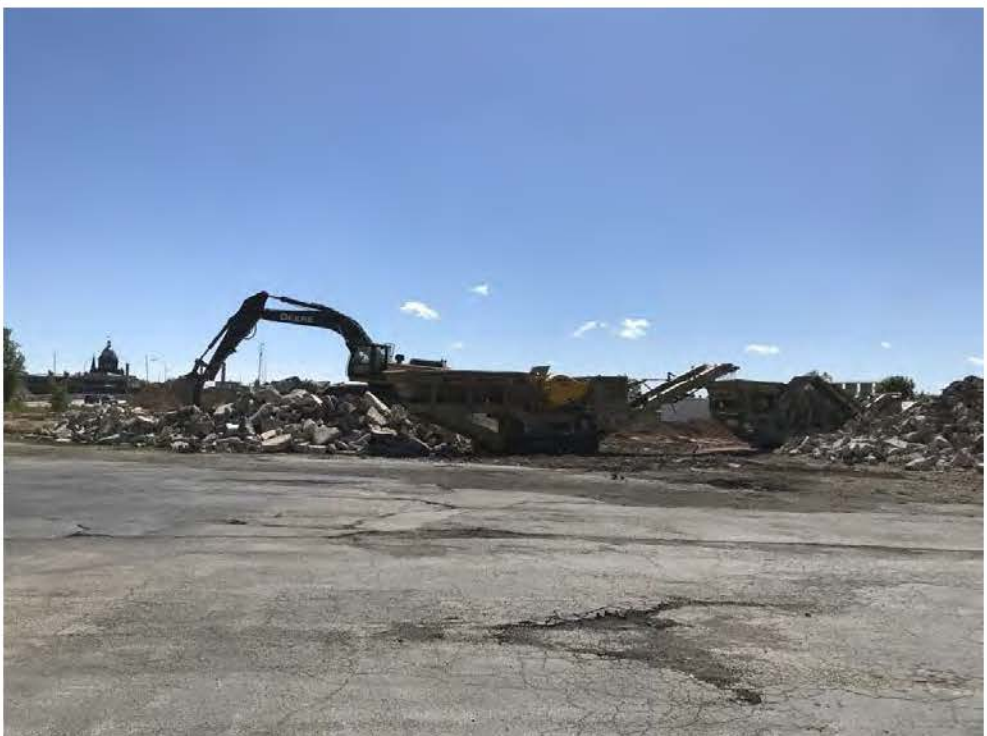
<b>Photograph ID:</b> 28

<b>Photo Location:</b> Northwest corner of Site 1	
<b>Direction:</b> Looking south	
<b>Survey Date:</b> 9/2/2020	
<b>Comments:</b> The stockpile of concrete being crushed onsite by Vinton
