Spill Notification for WRR Environmental Services Co., Inc.

EPA ID# WID990829475 FID# 618026530 WI SPILL# 15057

ID 20200310WC18-1 – Hazardous waste from solvent recovery process

Spill Notification for WRR Environmental Services Co - Residue Tanker Overfilled 03102020

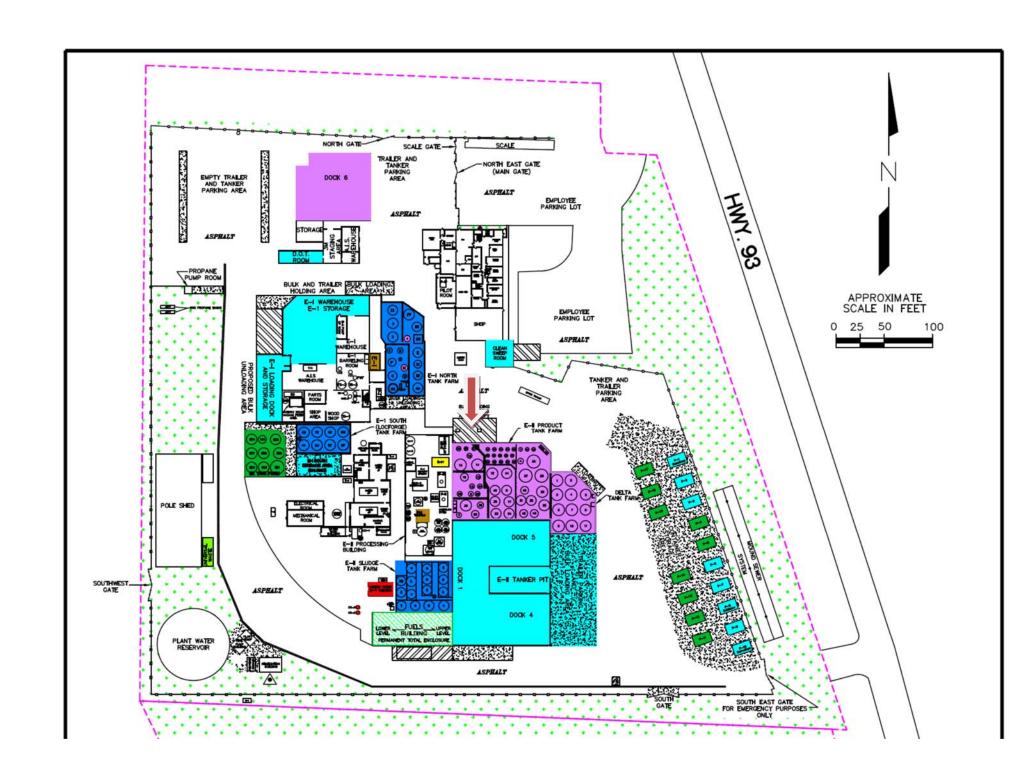
20200310WC18-1 WRR Environmental Services

Included with this report is a facility map with the release location marked with a red arrow.
