Subject: [02-13-587341] RockGen Energy Center 2024 Annual Cover System Maintenance
Inspection Report

On behalf of the site responsible party, RockGen Energy, LLC, TRC Environmental Corporation (TRC) conducted an inspection of the cover system on June 19, 2024. The cover system was installed in the spring/summer of 2022 in three cover areas at the Site and consists of two types of covers: a 5" asphalt cap and a geosynthetic cover system. A detailed description of the cover system and maintenance requirements exists in the cover system maintenance plan submitted to the WDNR in March of 2023.

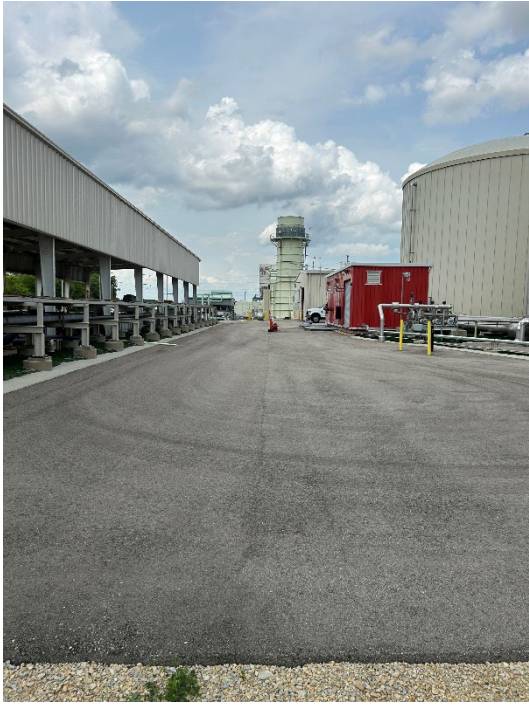
Client Name: RockGen		Site Location: 2346 Clear View Rd. Cambridge, WI	Project No.: 457746.0000
Photo No. 1	Date 6/19/2024

Description Edge of asphalt cover from the south end facing north.

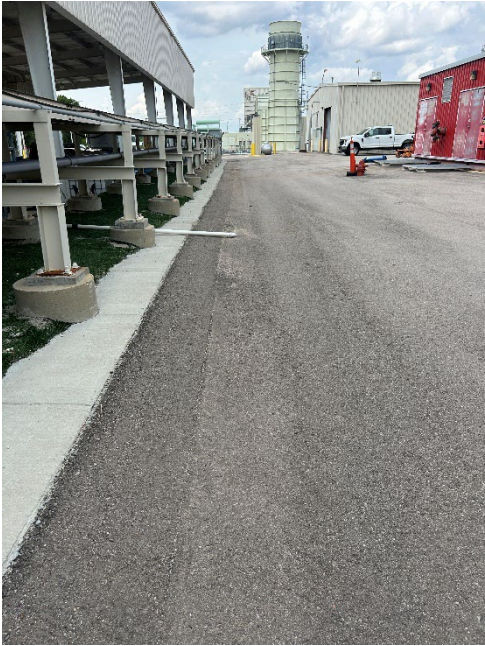
Photo No. 2	Date 6/19/2024

Description Asphalt cover and geosynthetic cover around fuel unloading building facing north.

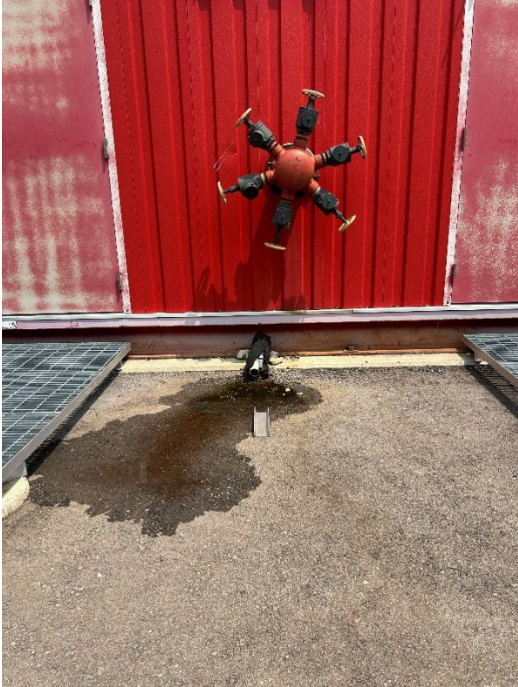
Client Name: RockGen		Site Location: 2346 Clear View Rd. Cambridge, WI	Project No.: 457746.0000
Photo No. 3	Date 6/19/2024

Description Water and some staining from the fire suppression system. Standing on asphalt facing east.

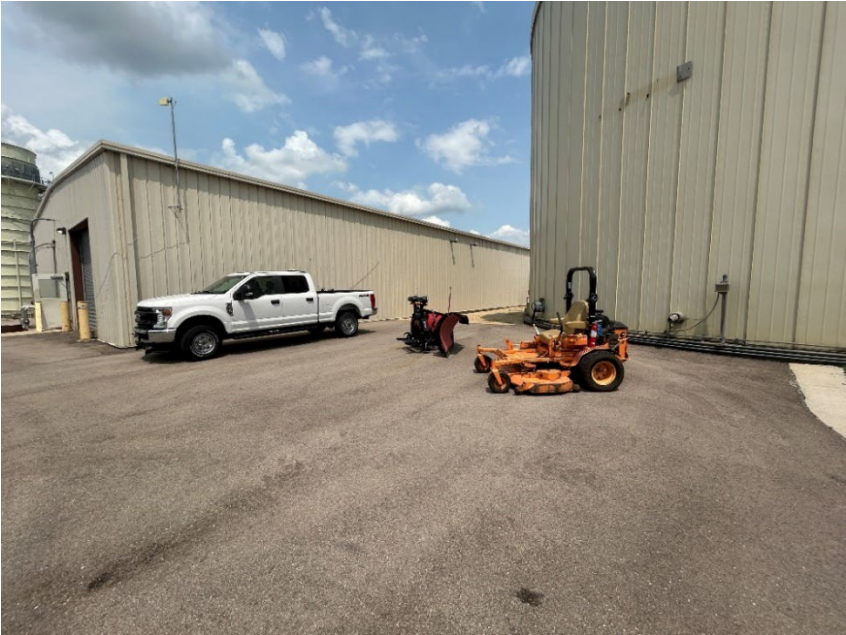
Photo No. 4	Date 6/19/2024

Description Eastern edge of asphalt. Photo facing northeast.

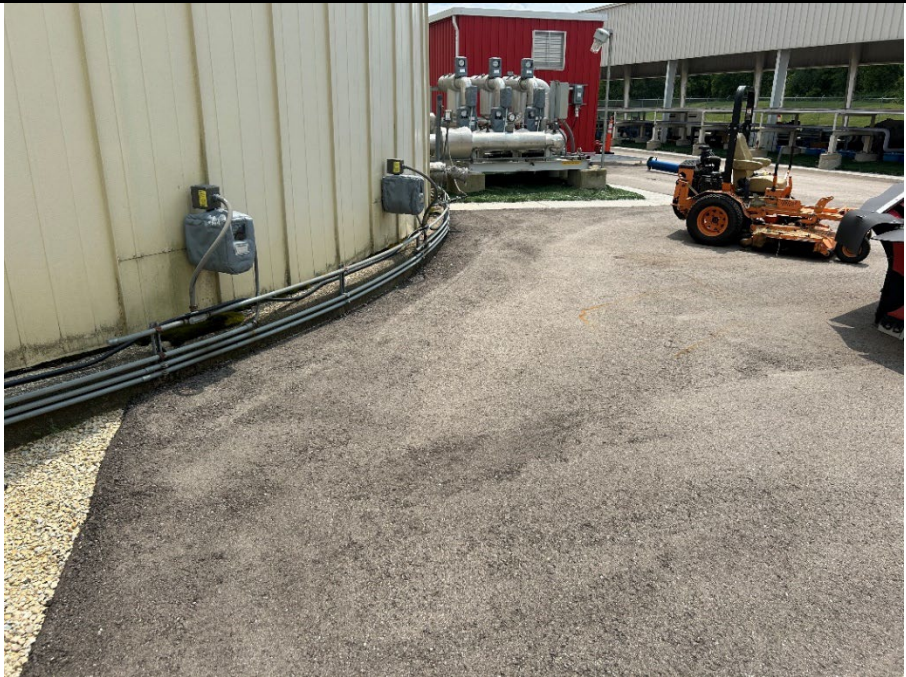
Client Name: RockGen		Site Location: 2346 Clear View Rd. Cambridge, WI	Project No.: 457746.0000
Photo No. 5	Date 6/19/2024

Description Eastern edge of asphalt cover facing south towards fire suppression building.

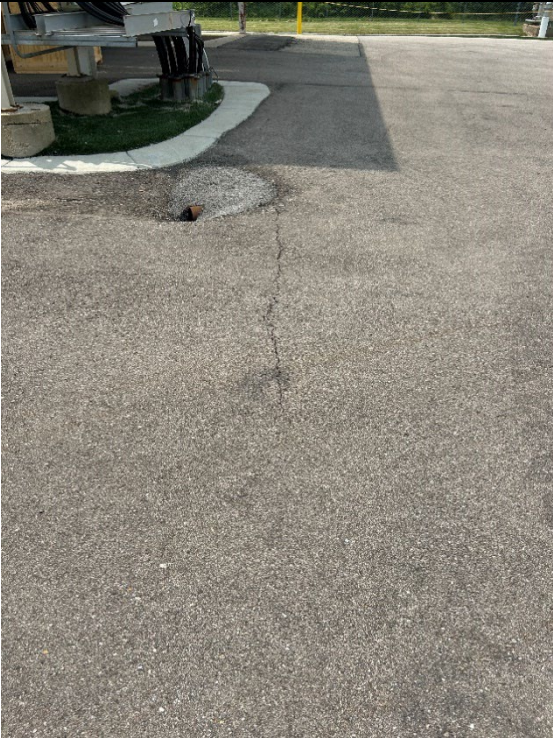
Client Name: RockGen		Site Location: 2346 Clear View Rd. Cambridge, WI	Project No.: 457746.0000
Photo No. 7	Date 6/19/2024

The participants in the 2024 annual inspection were Jeff Ramey and Luca Cecere of TRC. The observed condition of the cover system was satisfactory and the cover system is operating as designed. Both the asphalt cover and geosynthetic membrane have retained their structural integrity. A few Hairline cracks (<1/16th inch) were observed in the asphalt cover in the previous inspection and a few of those cracks appeared to have grown slightly wider (>1/16th inch). Additional hairline cracks in the asphalt cover were also noted during this inspection. The depth of all cracks were <1/2 inch. The cracks are documented in the accompanying photolog. No recommendations for maintenance or repair to the cover system resulted from the inspection due to the insignificance of each hairline depth relative to the cap thickness.

Description Hairline (~1/16 th inch, some portions slightly >1/16 th inch) crack of approximately five feet in asphalt cover near the northeastern corner of the fuel unloading building facing west.

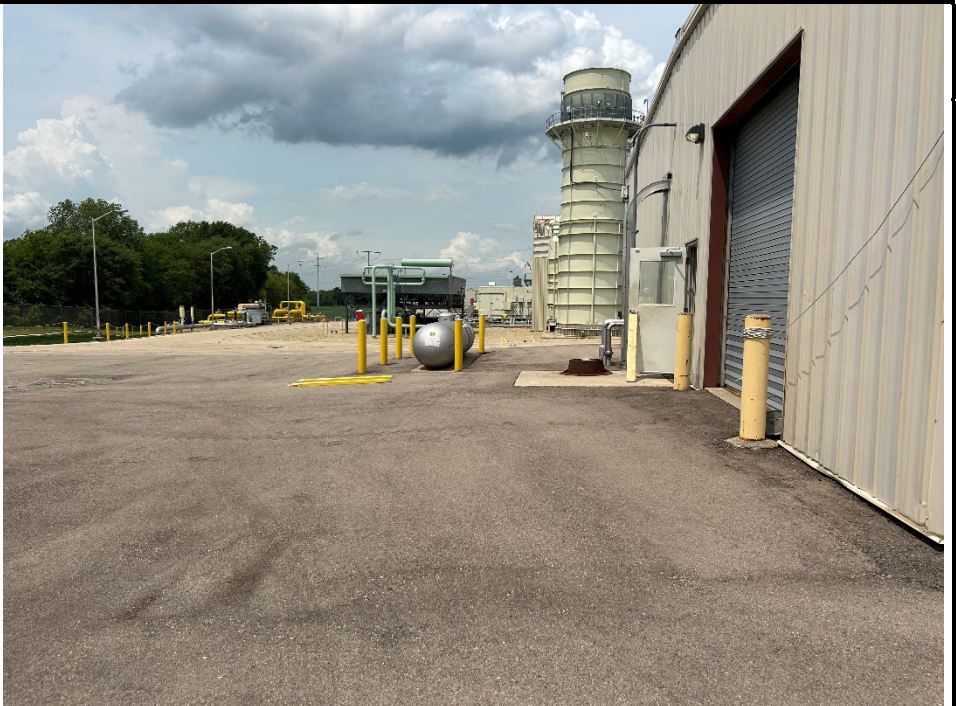
Photo No. 8	Date 6/19/2024

Description Propane tank and northern edge asphalt cover facing north.

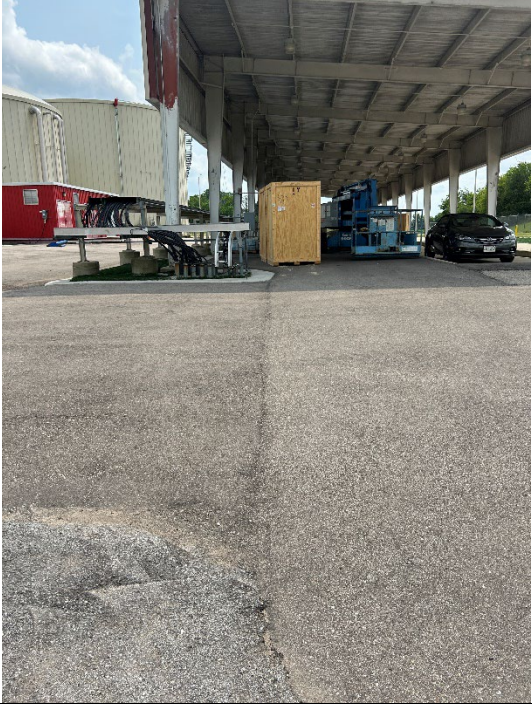
Client Name: RockGen		Site Location: 2346 Clear View Rd. Cambridge, WI	Project No.: 457746.0000
Photo No. 9	Date 6/19/2024

Description Hairline (<1/16 th inch) crack of approximately 12 feet in asphalt cover stretching north from the northeast side of the fuel unloading building to drain cover. Photo facing south.

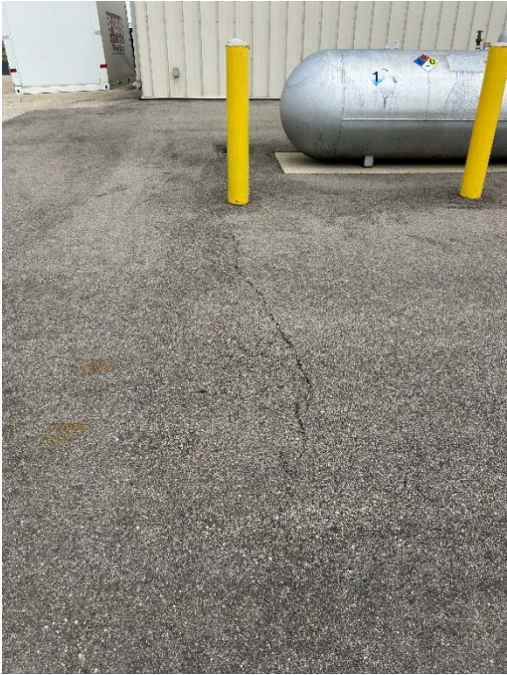
Client Name: RockGen		Site Location: 2346 Clear View Rd. Cambridge, WI	Project No.: 457746.0000
Photo No. 11	Date 6/19/2024

Description Hairline (<1/16 th inch) crack of approximately 7 feet stretching west from fuel tank bollard. Photo facing east.

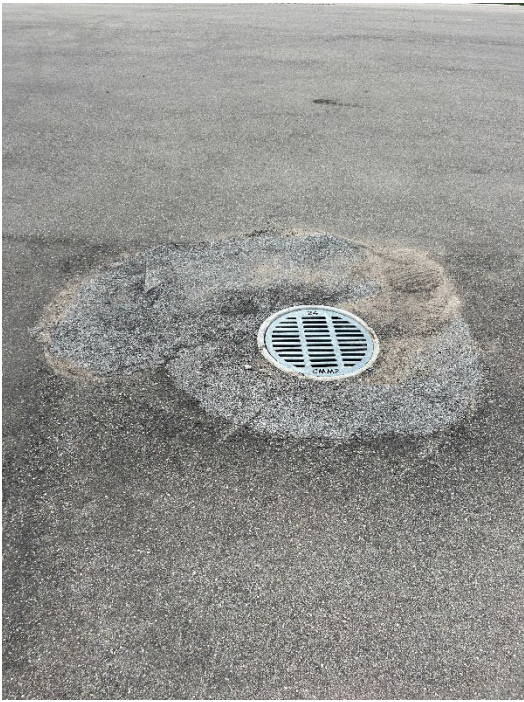
Photo No. 12	Date 6/19/2024

Description Drain cover and layered asphalt fill at the stormwater inlet facing west.

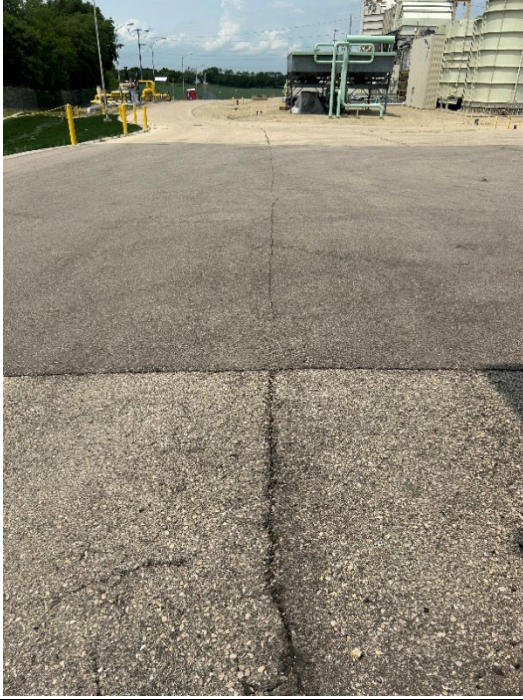
Client Name: RockGen		Site Location: 2346 Clear View Rd. Cambridge, WI	Project No.: 457746.0000
Photo No. 13	Date 6/19/2024

Description Hairline (<1/16 th inch) crack of approximately 12 feet in asphalt cover near the northwestern corner of the fuel unloading building facing north. Concrete crack pictured is not part of the cover system.

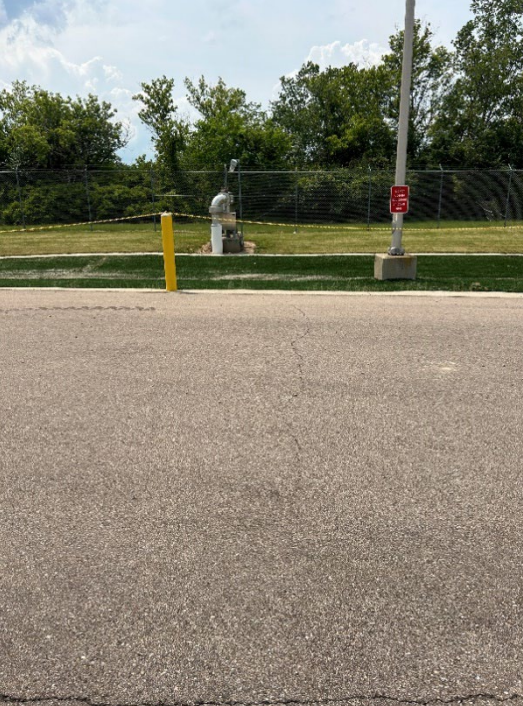
Photo No. 14	Date 6/19/2024

Description Hairline (~1/16 th inch, some >1/16 th inch) crack of approximately eight feet in asphalt cover near the industrial well and geosynthetic membrane cover system facing west.

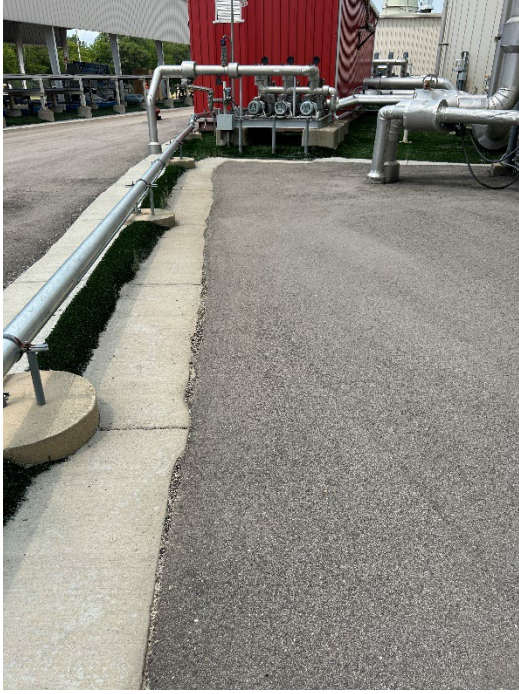
Client Name: RockGen		Site Location: 2346 Clear View Rd. Cambridge, WI	Project No.: 457746.0000
Photo No. 15	Date 6/19/2024

Description Piping from diesel storage tank to fire suppression building facing northwest (~20° from north).

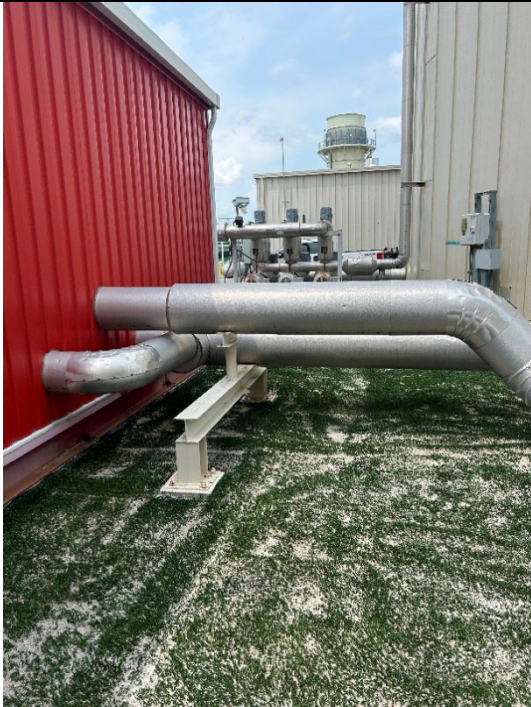
Client Name: RockGen		Site Location: 2346 Clear View Rd. Cambridge, WI	Project No.: 457746.0000
Photo No. 17	Date 6/19/2024

Description Geosynthetic membrane cover system in the piping infrastructure area behind fire suppression system facing north.

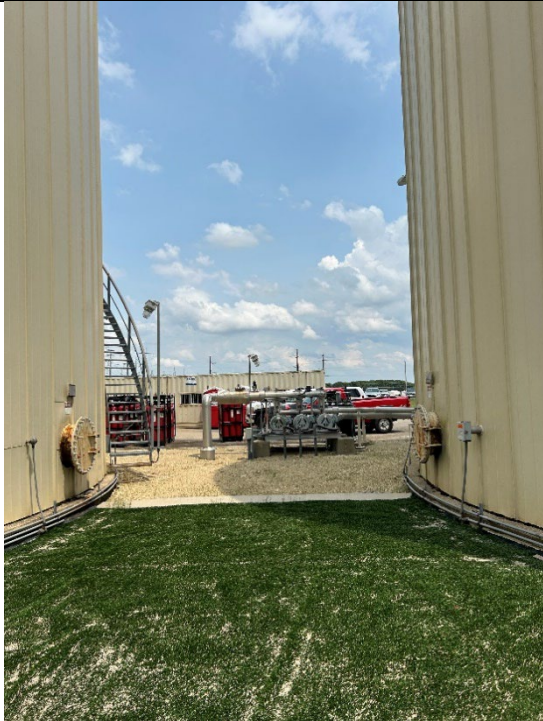
Photo No. 18	Date 6/19/2024

Description Geosynthetic membrane cover system eastern edge near piping infrastructure area facing east.

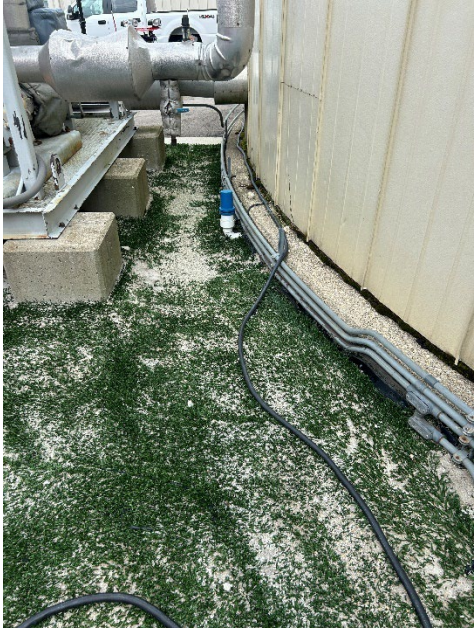
Client Name: RockGen		Site Location: 2346 Clear View Rd. Cambridge, WI	Project No.: 457746.0000
Photo No. 19	Date 6/19/2024

Description Eastern edge of geosynthetic membrane cover system along northern water storage tank in the piping infrastructure area facing north.

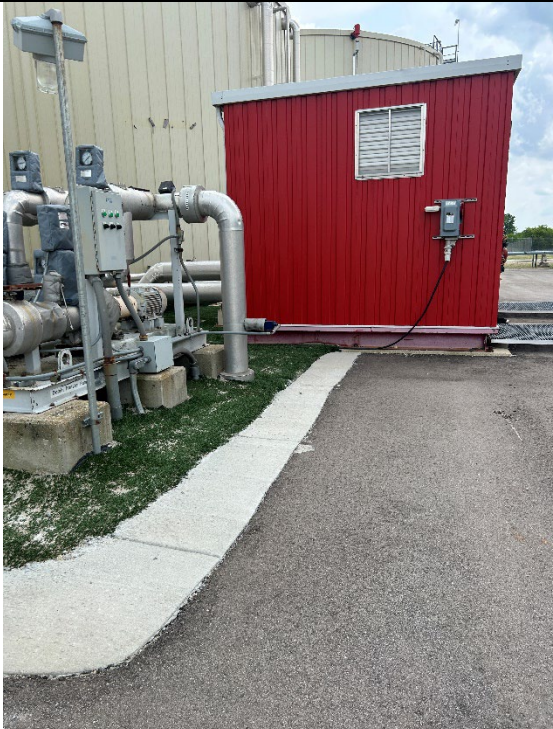
Photo No. 20	Date 6/19/2024

Description Western edge of geosynthetic membrane cover system along north end of the fire suppression building and piping infrastructure area facing south.

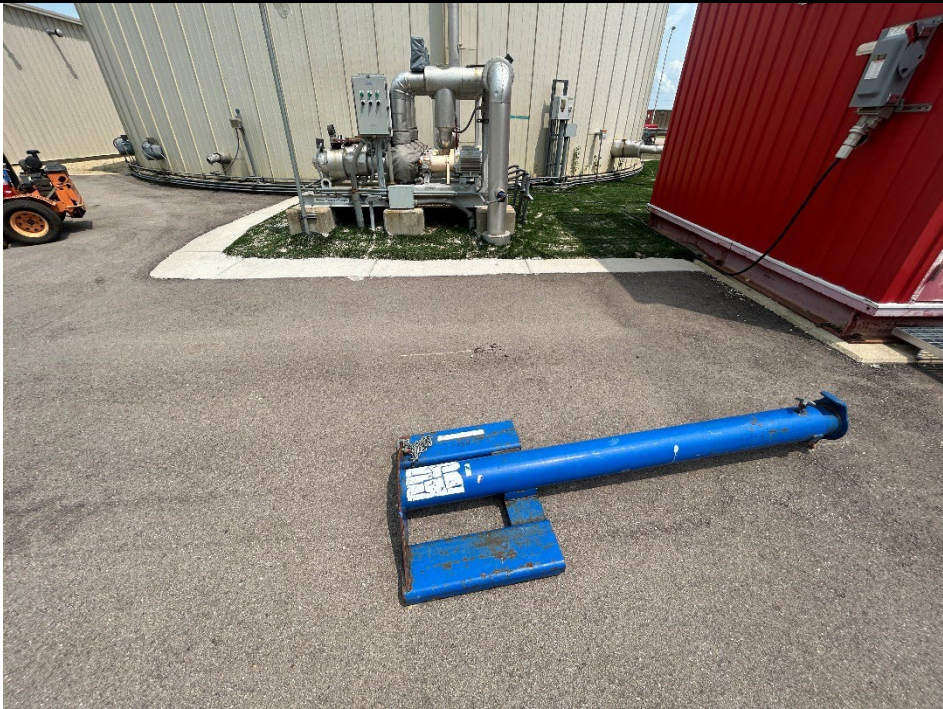
Client Name: RockGen		Site Location: 2346 Clear View Rd. Cambridge, WI	Project No.: 457746.0000
Photo No. 21	Date 6/19/2024

Description Geosynthetic membrane cover system transition near northern water storage tank facing east.

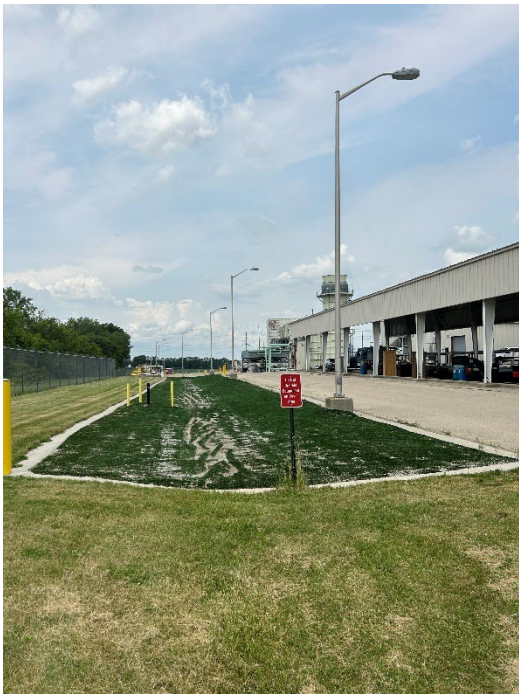
Photo No. 22	Date 6/19/2024

Description Edge of geosynthetic membrane cover system in the western swale facing north.

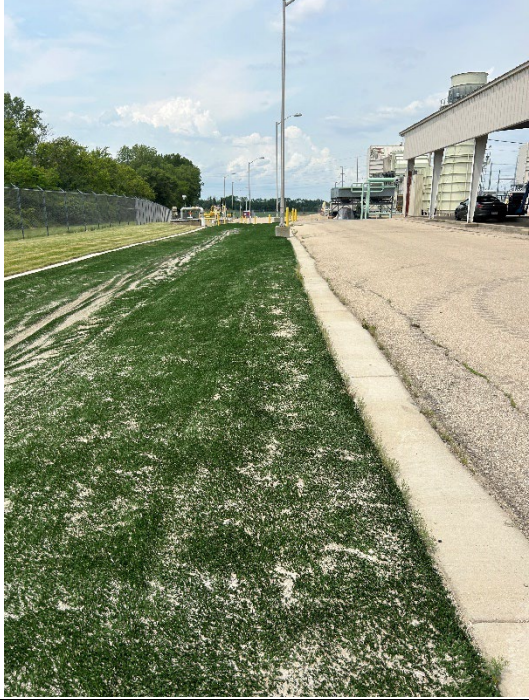
Client Name: RockGen		Site Location: 2346 Clear View Rd. Cambridge, WI	Project No.: 457746.0000
Photo No. 23	Date 6/19/2024

Description Geosynthetic membrane cover system in the western swale facing north.

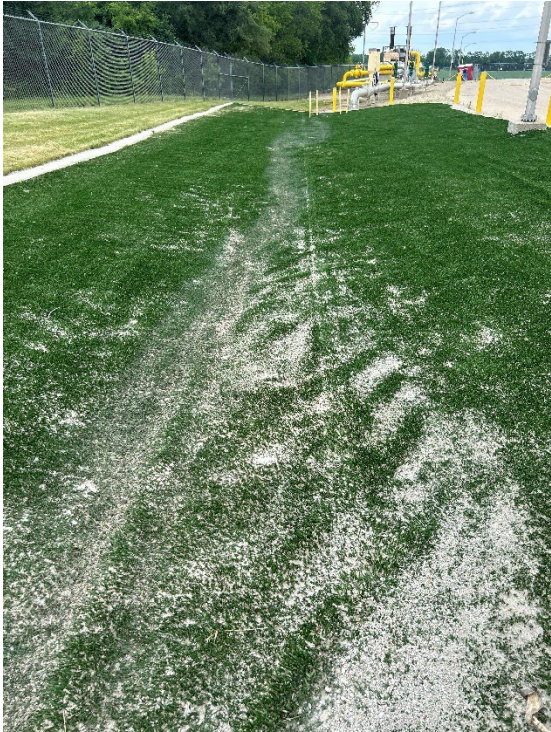
Client Name: RockGen		Site Location: 2346 Clear View Rd. Cambridge, WI	Project No.: 457746.0000
Photo No. 25	Date 6/19/2024

Description Geosynthetic membrane cover system in the western swale as it angles westward. Photo facing northwest (~20° from north).

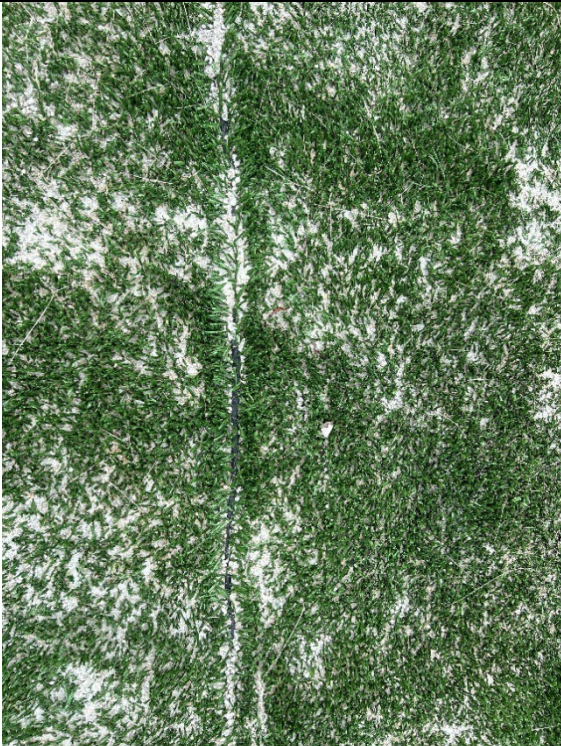
Photo No. 26	Date 6/19/2024

Description Seam developed for water flow within the center of the geosynthetic membrane cover system in the western swale facing east.

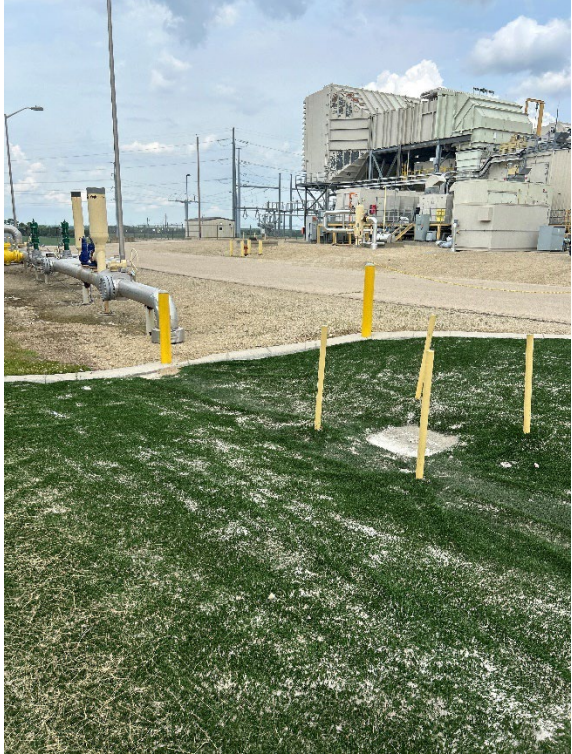
Client Name: RockGen		Site Location: 2346 Clear View Rd. Cambridge, WI	Project No.: 457746.0000
Photo No. 27	Date 6/19/2024

Description Northern edge of geosynthetic membrane cover system in the western swale facing northeast.

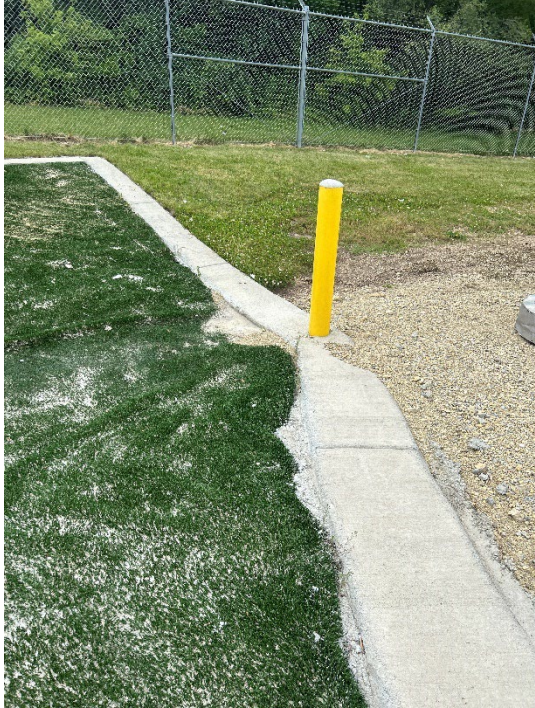
Client Name: RockGen		Site Location: 2346 Clear View Rd. Cambridge, WI	Project No.: 457746.0000
Photo No. 28	Date 6/19/2024

Description Bollard along northern edge of geosynthetic membrane cover system in the western swale facing west.
