April 20, 2023  
Project Number: 193708725

**Reference: Construction Documentation Report – Installation of the Sub-Slab  
Depressurization System  
River North, LLC Project Area  
1000 River Point Drive Manitowoc, Wisconsin  
BRRTS ID: 02-36-588366 (Open ERP)  
Stantec Project No. 193708725**

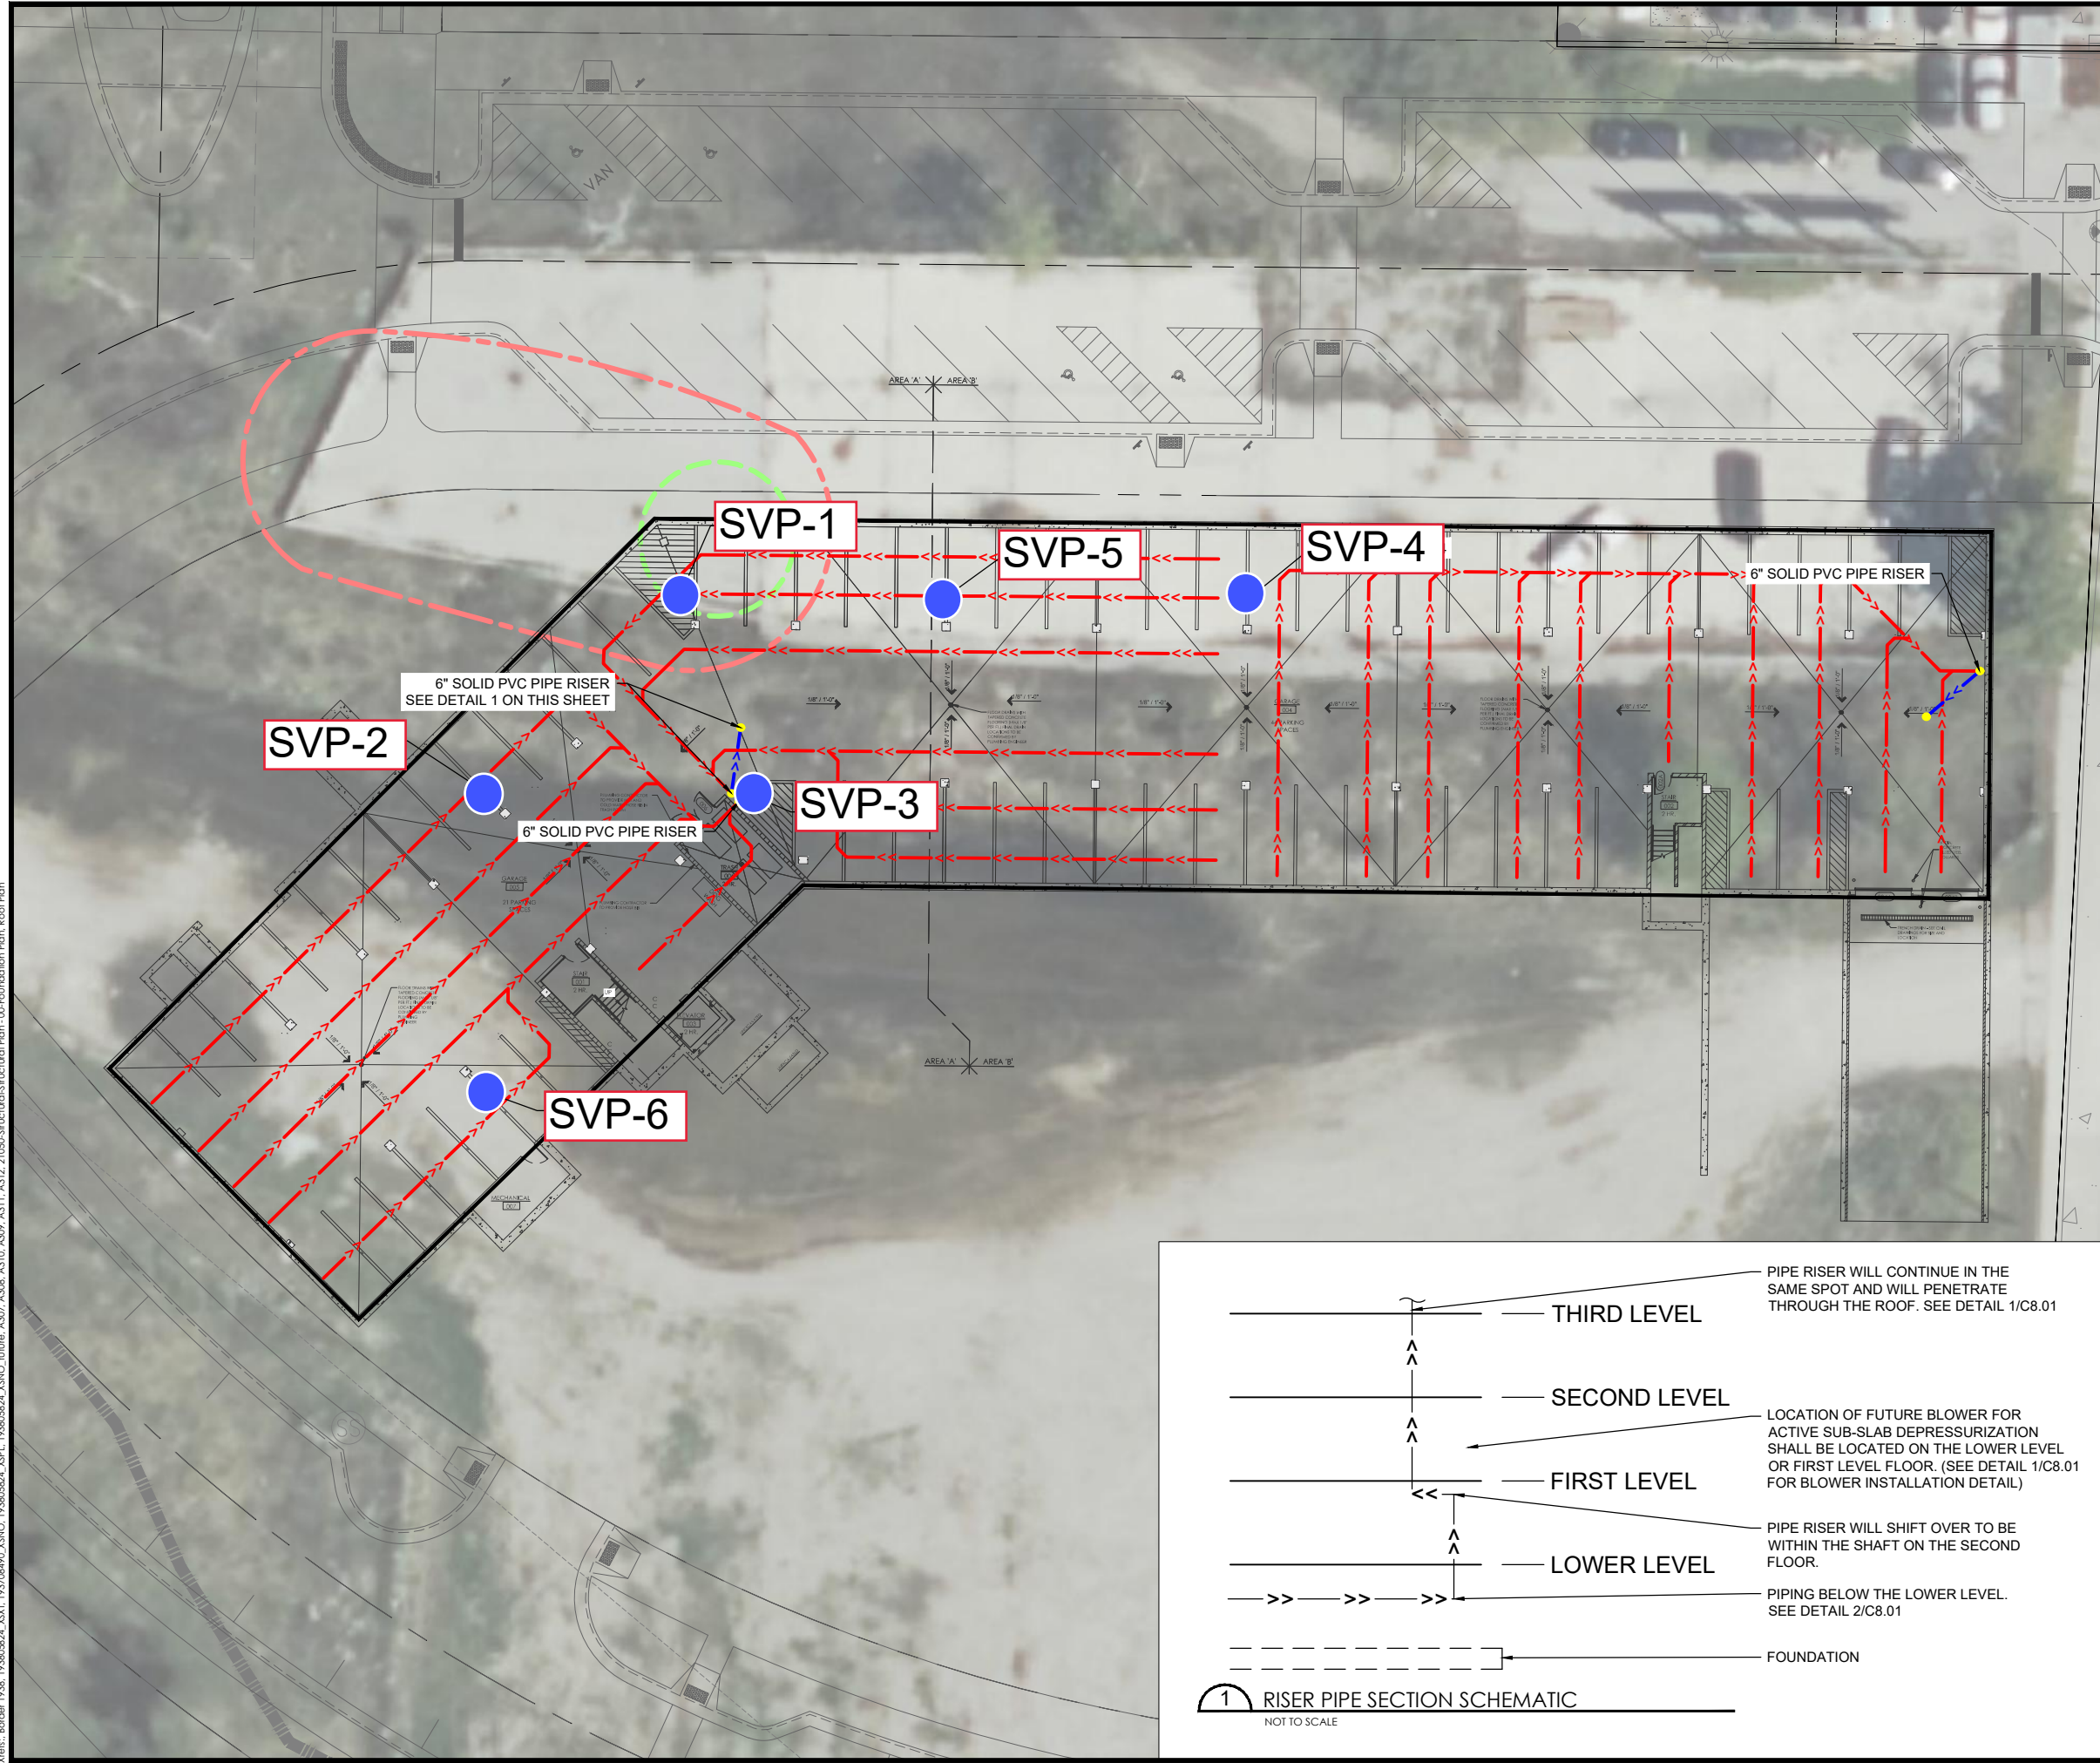
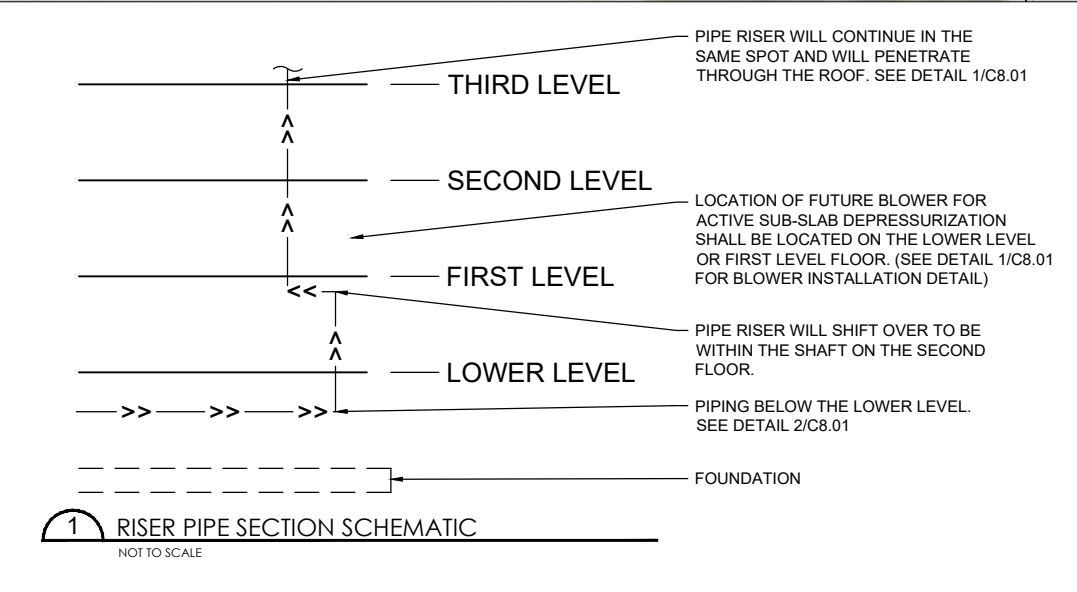
**SUB-SLAB VAPOR SAMPLING POINTS**  
RIVER NORTH APARTMENTS  
PIERCE ENGINEERS, INC.  
MANITOWOC, WISCONSIN

The sub-slab piping was connected to PVC risers during construction, which terminate 1-foot above the roofline. The locations of the risers are illustrated on **Figure 2** as yellow circles. The pipe riser section schematic is provided as an inset image on **Figure 2**.

The installed SSDS currently operates as a passive system. To confirm if the system needs to be made active to mitigate the risk for vapor intrusion, the Stantec (2021b) RAP/MMP, recommends conducting seasonal sub-slab vapor samples. The first round of sampling (heating season) was completed in March 2023, with future sampling scheduled for June and September 2024. Sample locations are illustrated as blue circles on **Figure 2**.

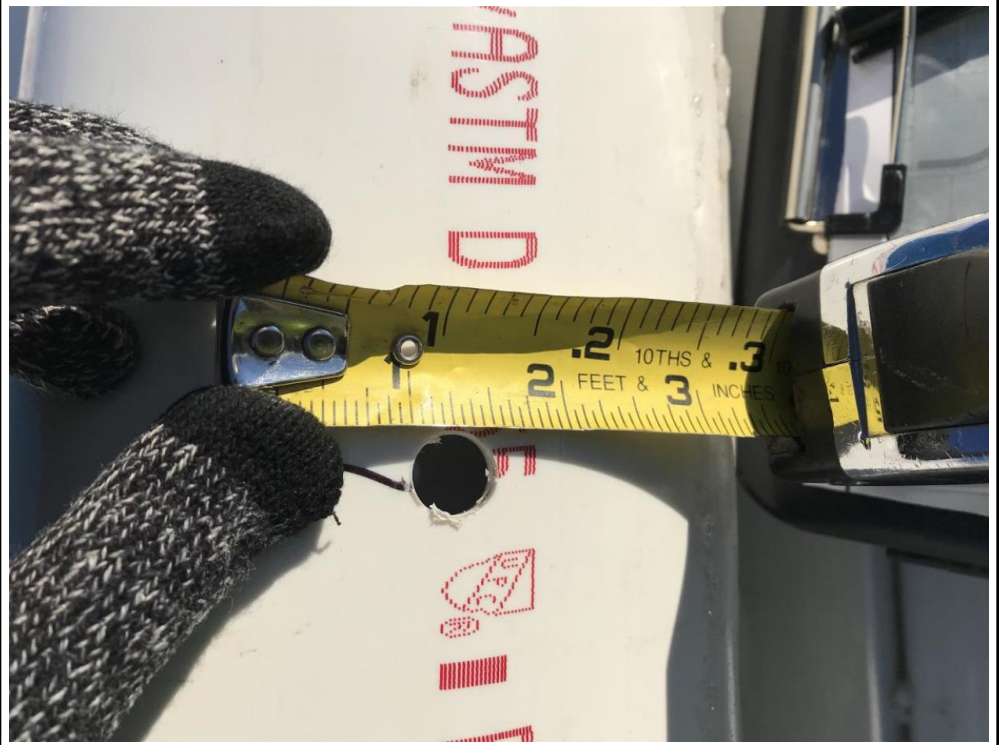
In summary, horizontal collection piping consisting of 6-inch diameter schedule (40) polyvinyl chloride (PVC) was prepared onsite by drilling ½-inch diameter holes every 20 linear inches with holes placed every 90-degrees around the circumference of the pipe (Attachment A, Photo Nos. 1, 2, 4, 5, and 9).

**Photograph ID:** 5  
**Photo Location:**  
**Direction:**  
**Survey Date:**  
11/22/2021  
**Comments:**  
Hole diameter (typical)

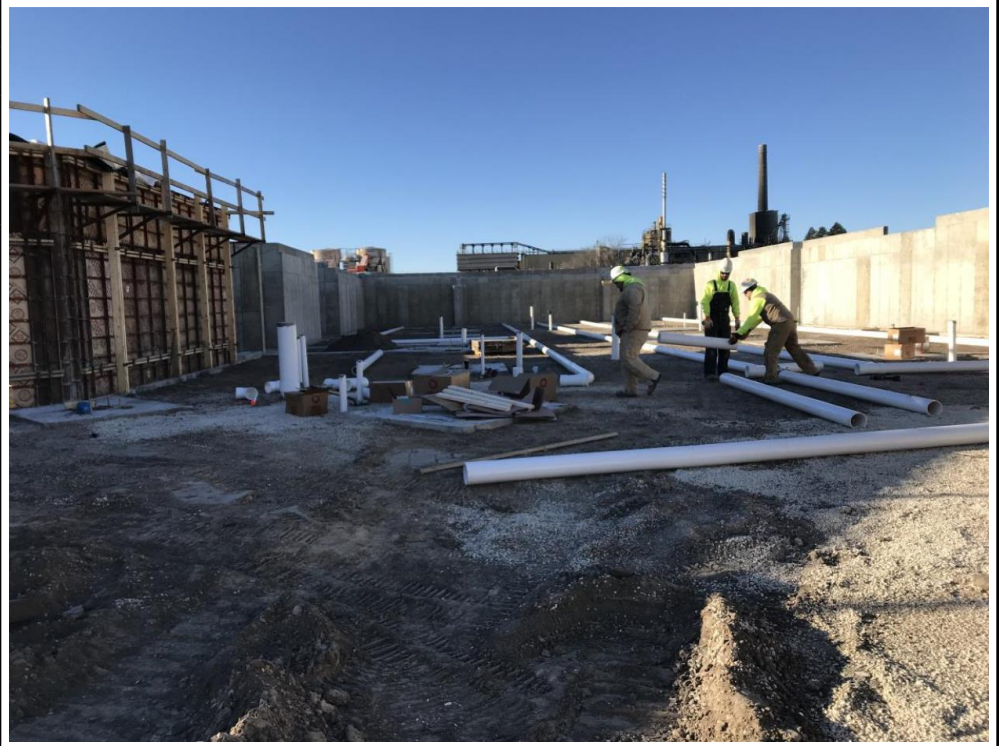
The piping for the SSDS was cut and dry fitted (Attachment A, Photo Nos. 6-8). After which, trenches (approximately 18-inches wide and 7-inches deep) were dug (Attachment A, Photo No. 11-15), the PVC pipes cemented together (Attachment A, Photo No. 10), and the horizontal pipe network bedded in rounded ¾-inch river stone in the trenches per the Stantec (2021c) plan (Attachment A, Photo Nos. 3 and 16-18). Please note the plenum was secured with an L-bracket to avoid shifting/vibration during final slab construction. The locations of the horizontal pipes are illustrated on **Figure 2** as red lines relative to the recently constructed apartment building (outlined as a thick black line on **Figure 2**).

**Photograph ID:** 6  
**Photo Location:**  
**Direction:**  
**Survey Date:**  
11/22/2021  
**Comments:**  
Dry fitting horizontal piping

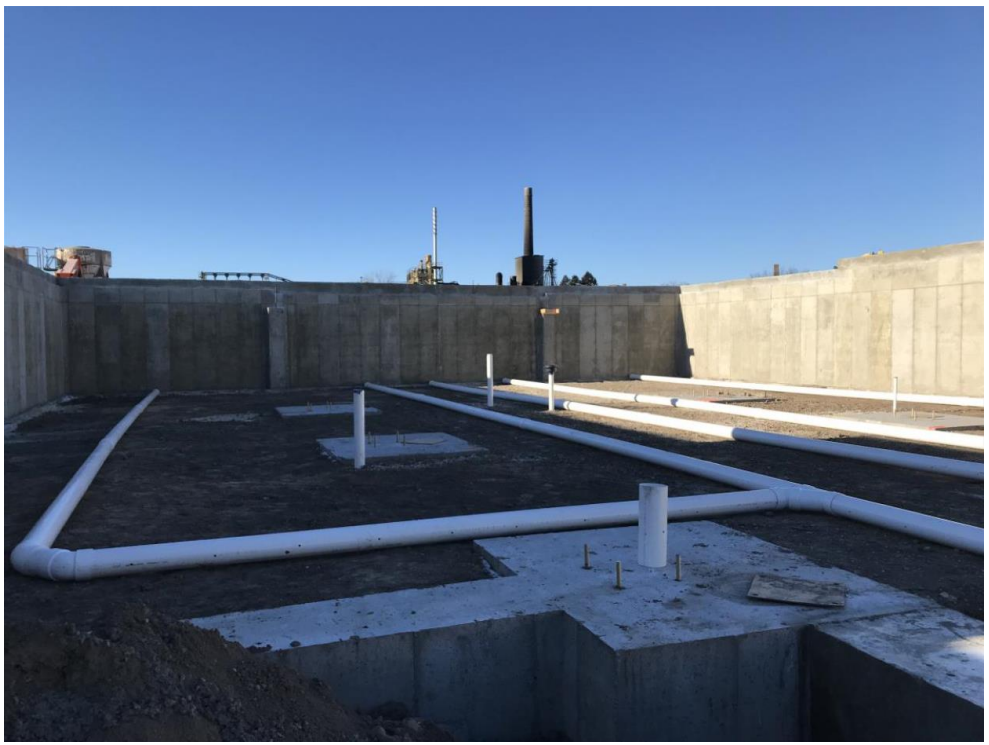
<b>Photograph ID:</b> 7

<b>Photo Location:</b>	
<b>Direction:</b>	
<b>Survey Date:</b> 11/22/2021	
<b>Comments:</b> Dry fitting horizontal piping (typical)

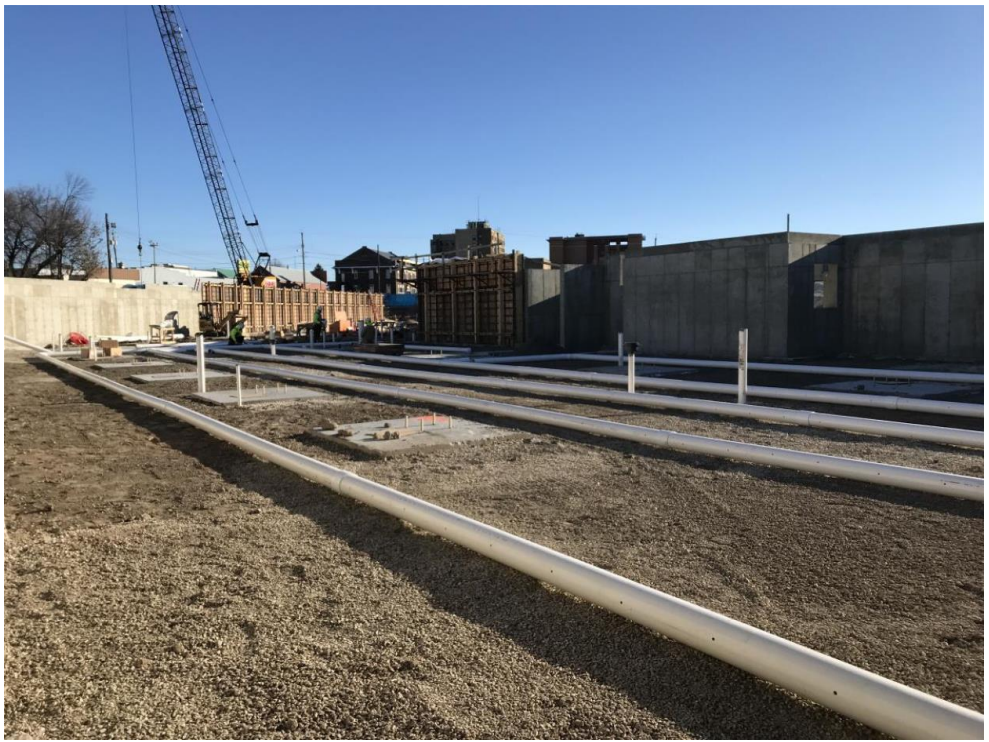
<b>Photograph ID:</b> 8

<b>Photo Location:</b>	
<b>Direction:</b>	
<b>Survey Date:</b> 11/22/2021	
<b>Comments:</b> Dry fitting horizontal piping (typical)

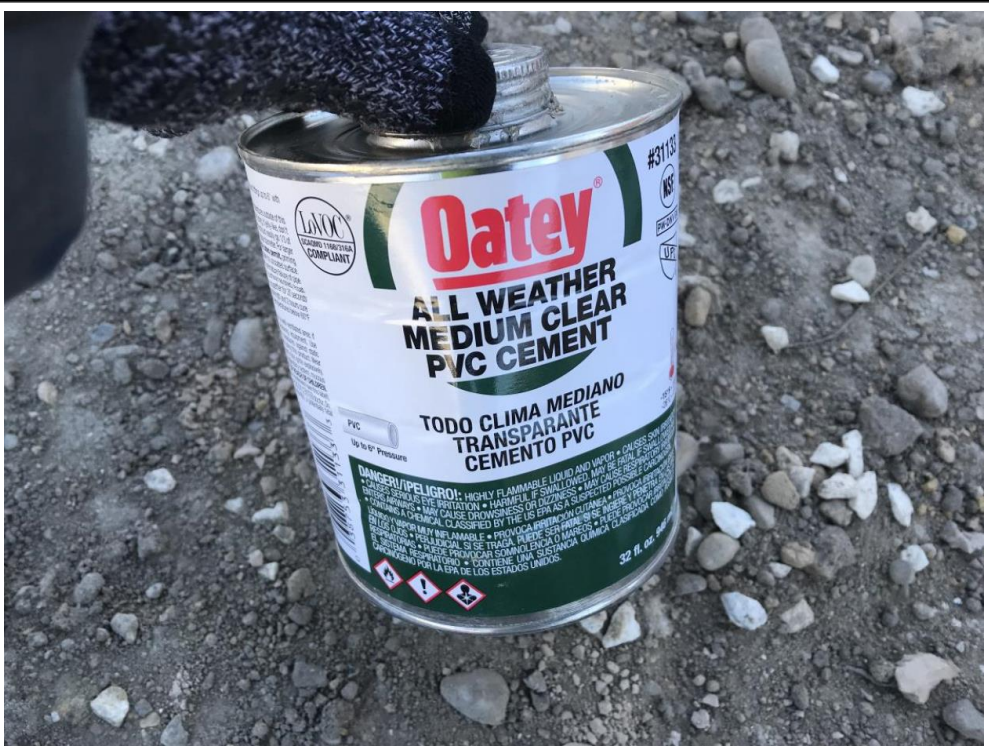
<b>Photograph ID:</b> 10

<b>Photo Location:</b>	
<b>Direction:</b>	
<b>Survey Date:</b> 11/22/2021	
<b>Comments:</b> Cement used to connect PVC piping

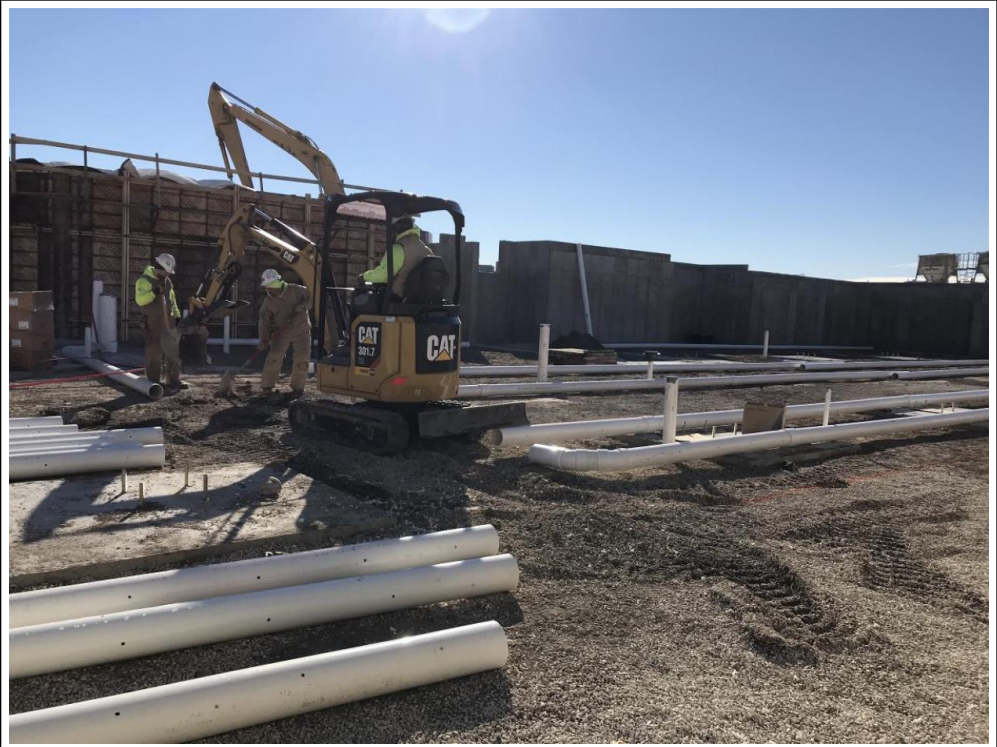
**Photograph ID:** 11

**Comments:**  
Trenching to install PVC piping

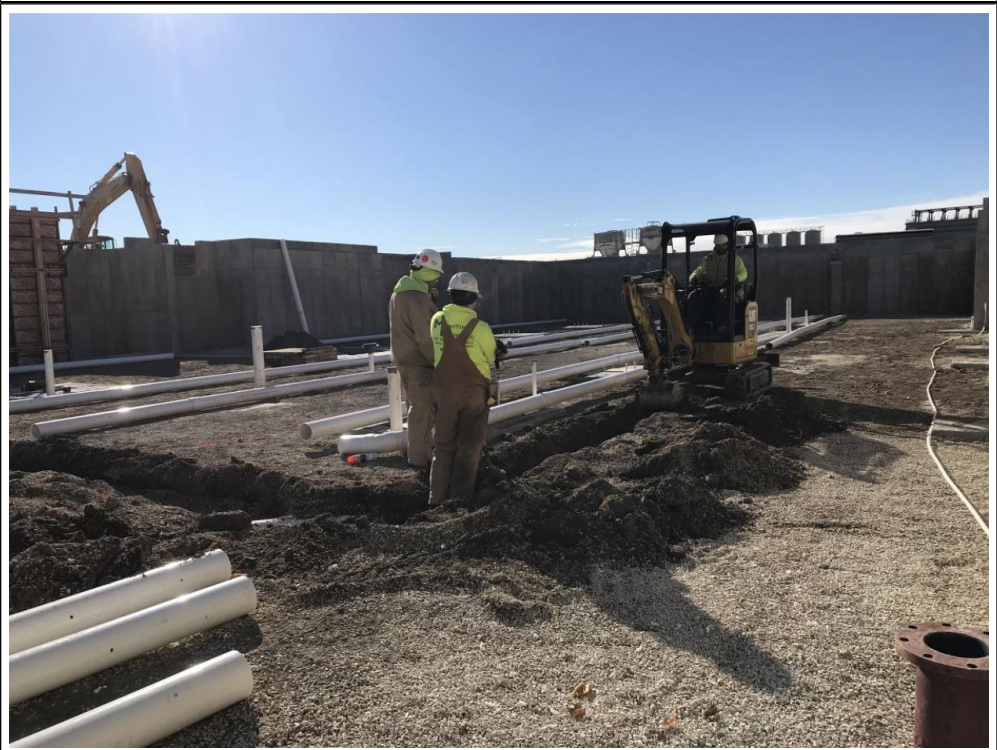
**Photograph ID:** 12

**Comments:**  
Trenching to install PVC piping

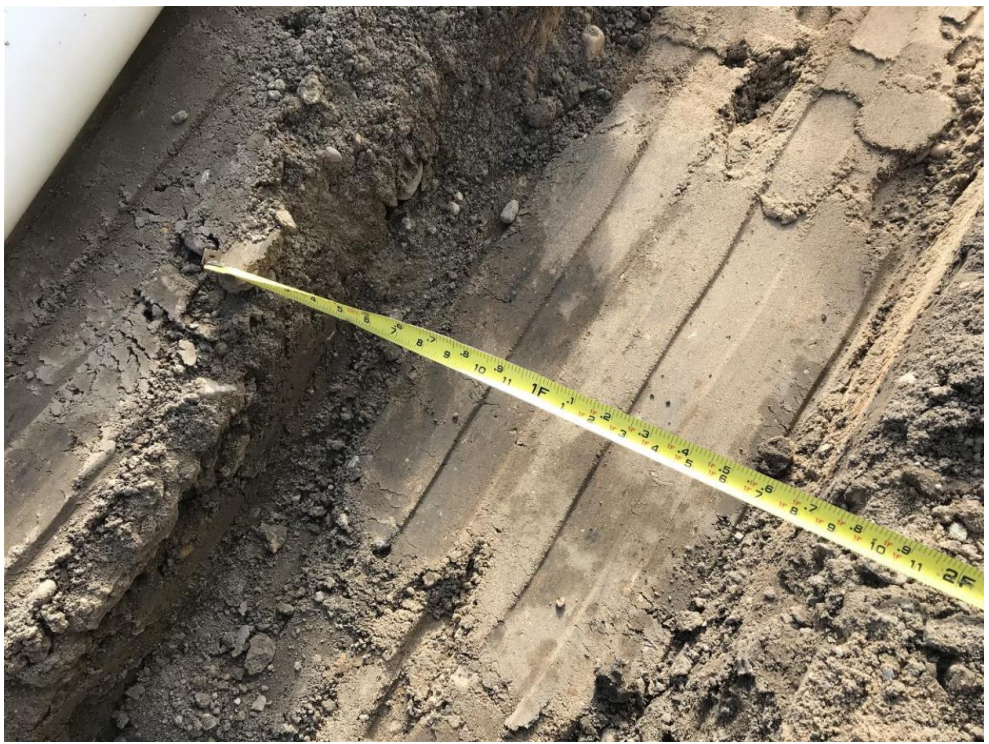
<b>Photo Location:</b>			
<b>Direction:</b>			
<b>Survey Date:</b> 11/22/2021			
<b>Comments:</b> Trench width (typical)			
<b>Photograph ID:</b> 16

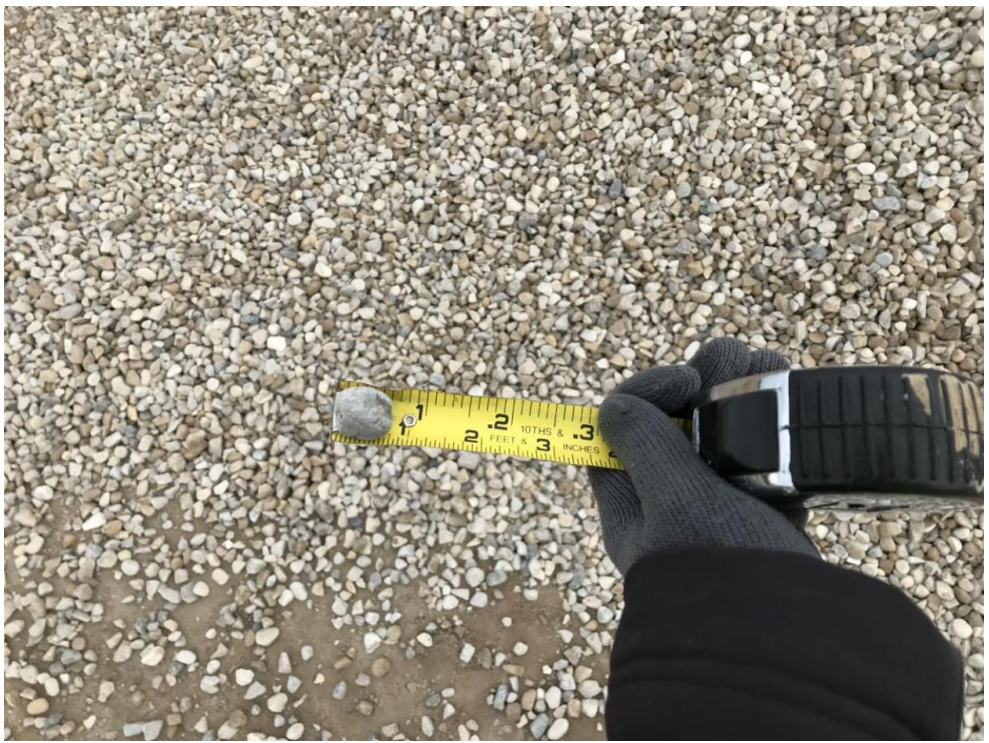
<b>Photo Location:</b>			
<b>Direction:</b>			
<b>Survey Date:</b> 11/24/2021			
<b>Comments:</b> Stockpiled river stone used to backfill the trenches with horizontal piping (typical)

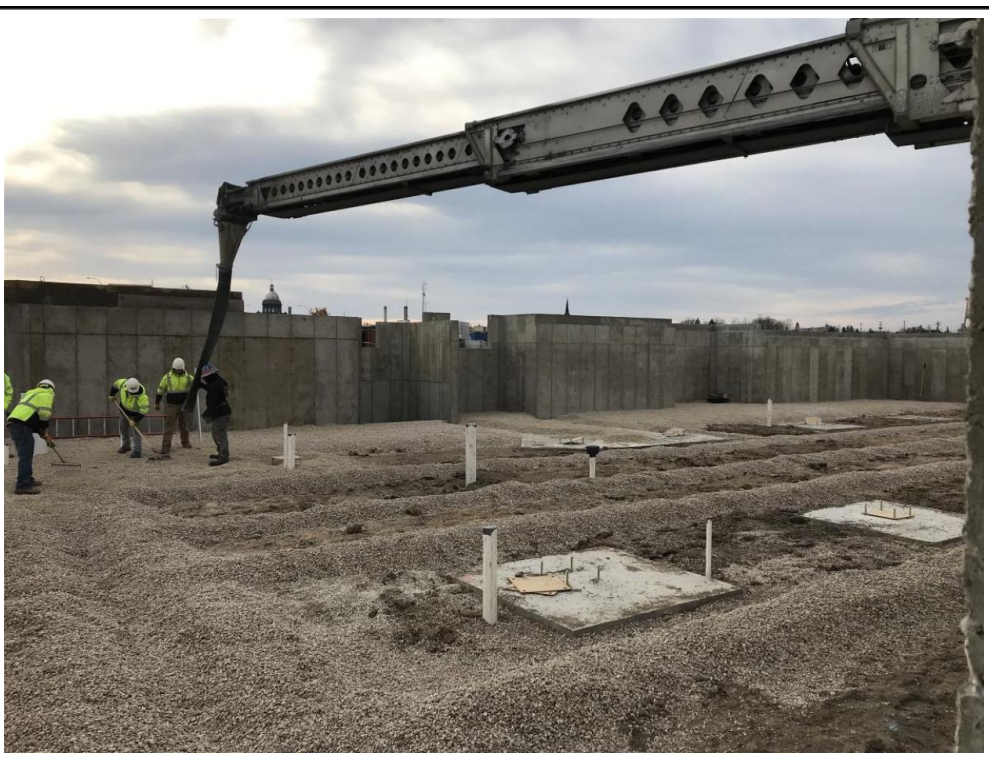
<b>Photograph ID:</b> 18

<b>Photo Location:</b>	
<b>Direction:</b>	
<b>Survey Date:</b> 11/24/2021	
<b>Comments:</b> Bedded PVC piping as remaining sub-base is added

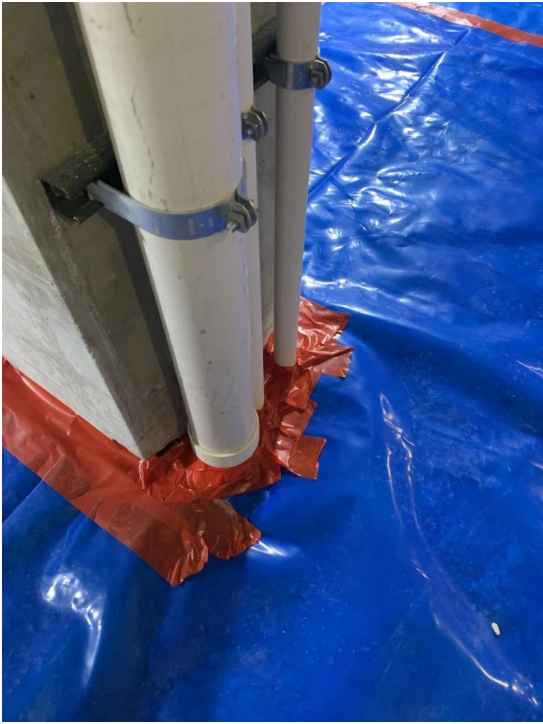
<b>Photograph ID:</b> 21

The remaining slab subbase (¾-inch clear angular stone without fines) was added/graded (Attachment A, Photo Nos. 19 and 20) and the vapor barrier installed (Attachment A, Photo Nos. 21-24). Following, the concrete slab was poured, and the area finished to serve as a parking garage.

<b>Photo Location:</b>	
<b>Direction:</b>	
<b>Survey Date:</b> 3/16/2022	
<b>Comments:</b> Vapor barrier (blue) and sealing penetrations (typical)

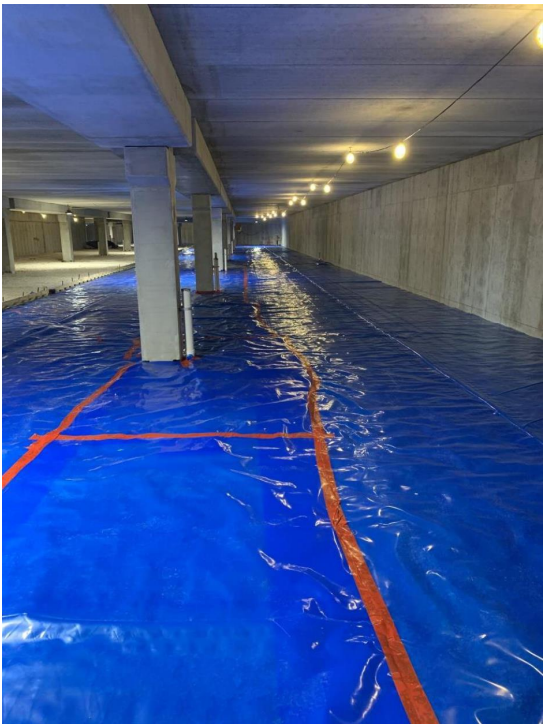
<b>Photograph ID:</b> 22

<b>Photo Location:</b>	
<b>Direction:</b>	
<b>Survey Date:</b> 3/16/2022	
<b>Comments:</b> Vapor barrier (blue) and sealing penetrations (typical)

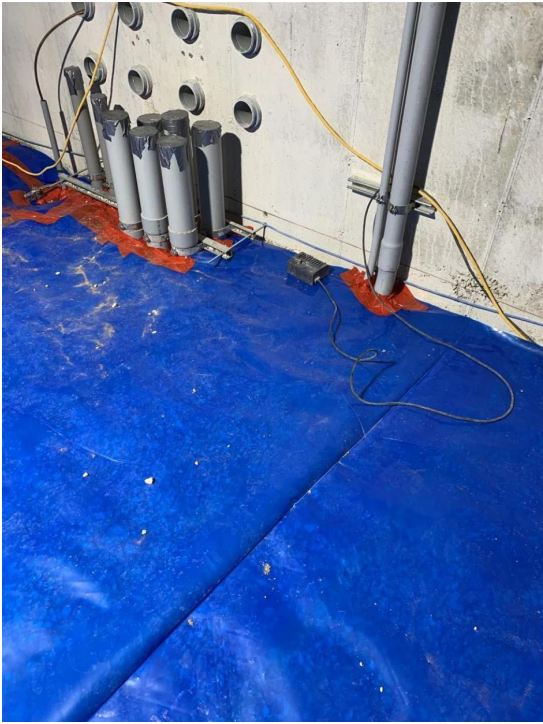
<b>Photograph ID:</b> 23

<b>Photo Location:</b>	
<b>Direction:</b>	
<b>Survey Date:</b> 3/18/2022	
<b>Comments:</b> Vapor barrier (blue) and sealing penetrations (typical)

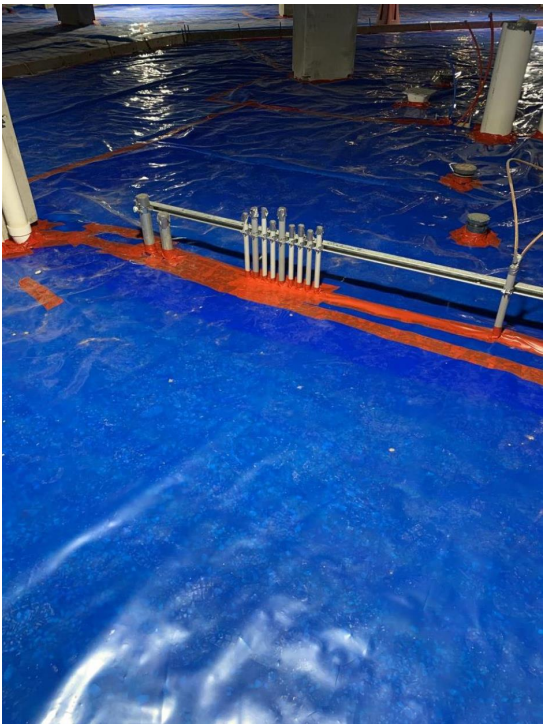
<b>Photograph ID:</b> 24

<b>Photo Location:</b>	
<b>Direction:</b>	
<b>Survey Date:</b> 3/18/2022	
<b>Comments:</b> Vapor barrier (blue) and sealing penetrations (typical)

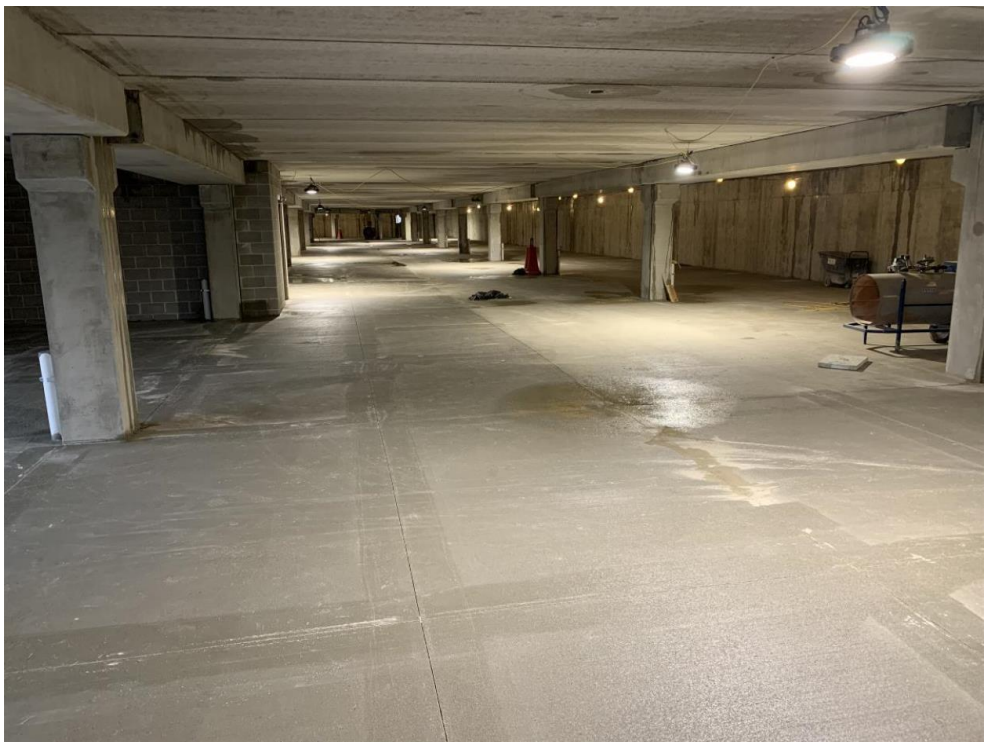
<b>Photograph ID:</b> 25

<b>Photo Location:</b>	
<b>Direction:</b>	
<b>Survey Date:</b> 3/30/2022	
<b>Comments:</b> Finished concrete slab

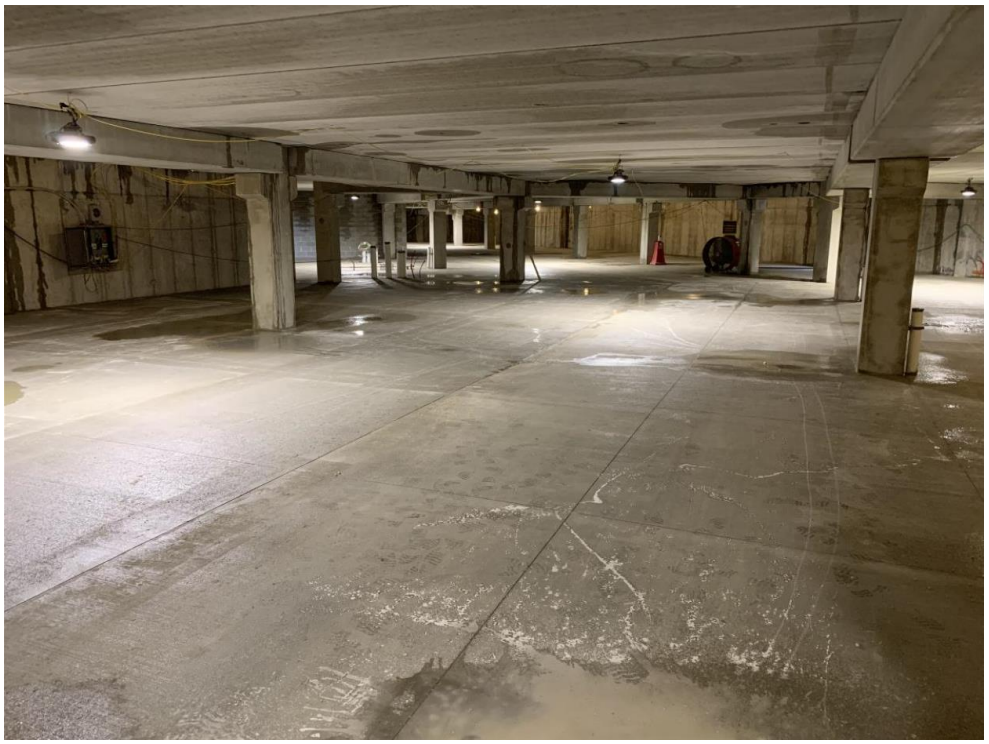
<b>Photograph ID:</b> 26

<b>Photo Location:</b>	
<b>Direction:</b>	
<b>Survey Date:</b> 3/30/2022	
<b>Comments:</b> Finished concrete slab
