January 18, 2023
File No. 25222269.00

Subject: Inspection of Vapor Mitigation System
Golden Flame Restaurant (Former WI DOT Susie's Restaurant – LGU-SL)
WDNR BRRTS No. 02-36-000516
2604 Custer St, Manitowoc, WI 54220

VAPOR MITIGATION SYSTEM INSPECTION

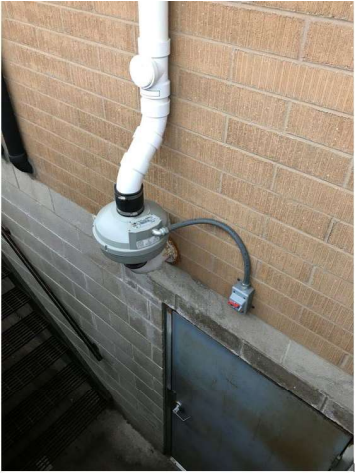
<p>NOTES: (Identify specific building and location description:)</p> <p><input type="checkbox"/> Not Applicable</p> <p>Fan is operating as intended. No damage or excessive motor noise observed.</p>
---	--

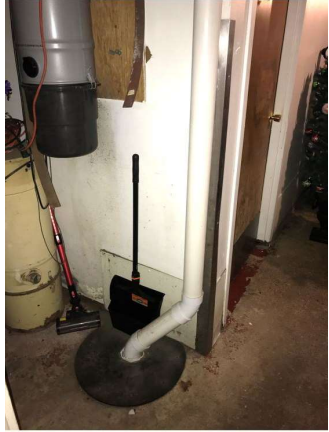
<p>Pickup Point No. 2. Vent piping is secure and connected to the fan. No damage to piping observed. Used smoke pen to test pickup point floor seal and found no leakage.</p>

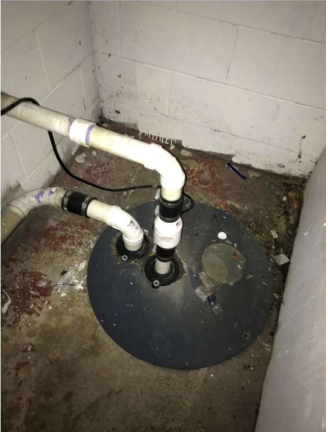
<p>NOTES: (Identify specific building and location description:)</p> <p><input type="checkbox"/> Not Applicable</p> <p>Used smoke pen to test sump lid fittings and floor seal and found no leakage. No damage to piping observed. Sump pump did not appear to cycle while present, but restaurant owner indicated it was operating properly.</p>

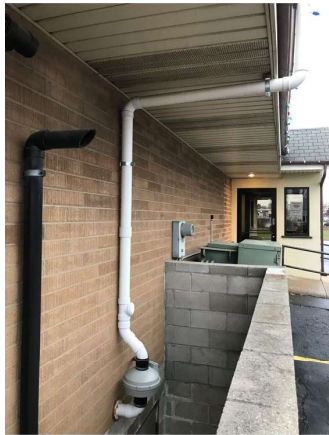
SYSTEM COMPONENT				Date of Inspection:	11/29/2022
NAME	WHAT DOES IT DO?	WHAT DO I CHECK?	WHAT SHOULD I SEE?	WHAT TO FIX?	
Outdoor Vent Pipe	Pipe transports the soil gas from beneath the foundation for discharge to the atmosphere.	Vent Pipe Condition Vent Pipe Location	Vent pipe remains connected to fan. End of pipe free from obstructions. The exhaust is more than 15 feet from windows or air intakes.	Vent pipe may require replacement, or cleaning to remove ice or debris. If any piping or sealing of the system is altered or replaced, the system should be evaluated by a mitigation professional to verify effectiveness, which includes pressure readings.	
PHOTO			NOTES: (Identify specific building and location description:) <input type="checkbox"/> Not Applicable Vent pipe appears solid and connected to fan, no damage observed. Checked exhaust end for obstructions. No obstructions observed. The exhaust appears to be more than 15 feet from windows or air intakes.

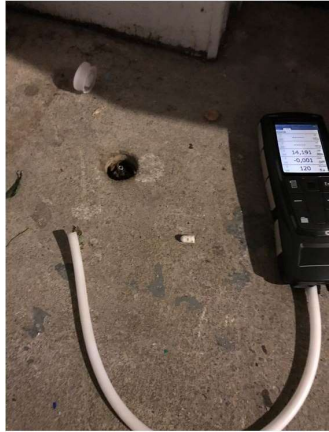
<p>Sub-slab Vacuum Observation Point 1 was missing plastic cover, but port cap was still in place. Installed new cover and measured vacuum using digital manometer at 0.278 inches water. No damage to port observed.</p>

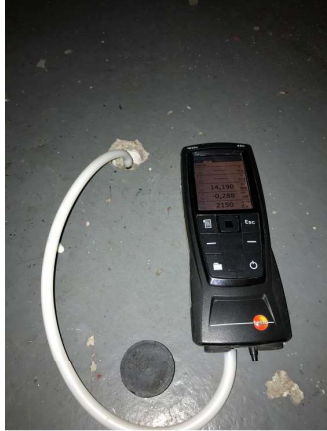
<p>Sub-slab Vacuum Observation Point 3 vacuum measured using digital manometer at 0.281 inches water. No missing components or damage to point observed.</p>
