December 7, 2023
File No. 25222269.00

Subject: Inspection of Vapor Mitigation System at Off-Site Commercial Property
Golden Flame Restaurant, 2604 Custer St, Manitowoc, WI 54220
Re: Former WI DOT Susies Restaurant – LGU-SL, WDNR BRRTS #02-36-000516

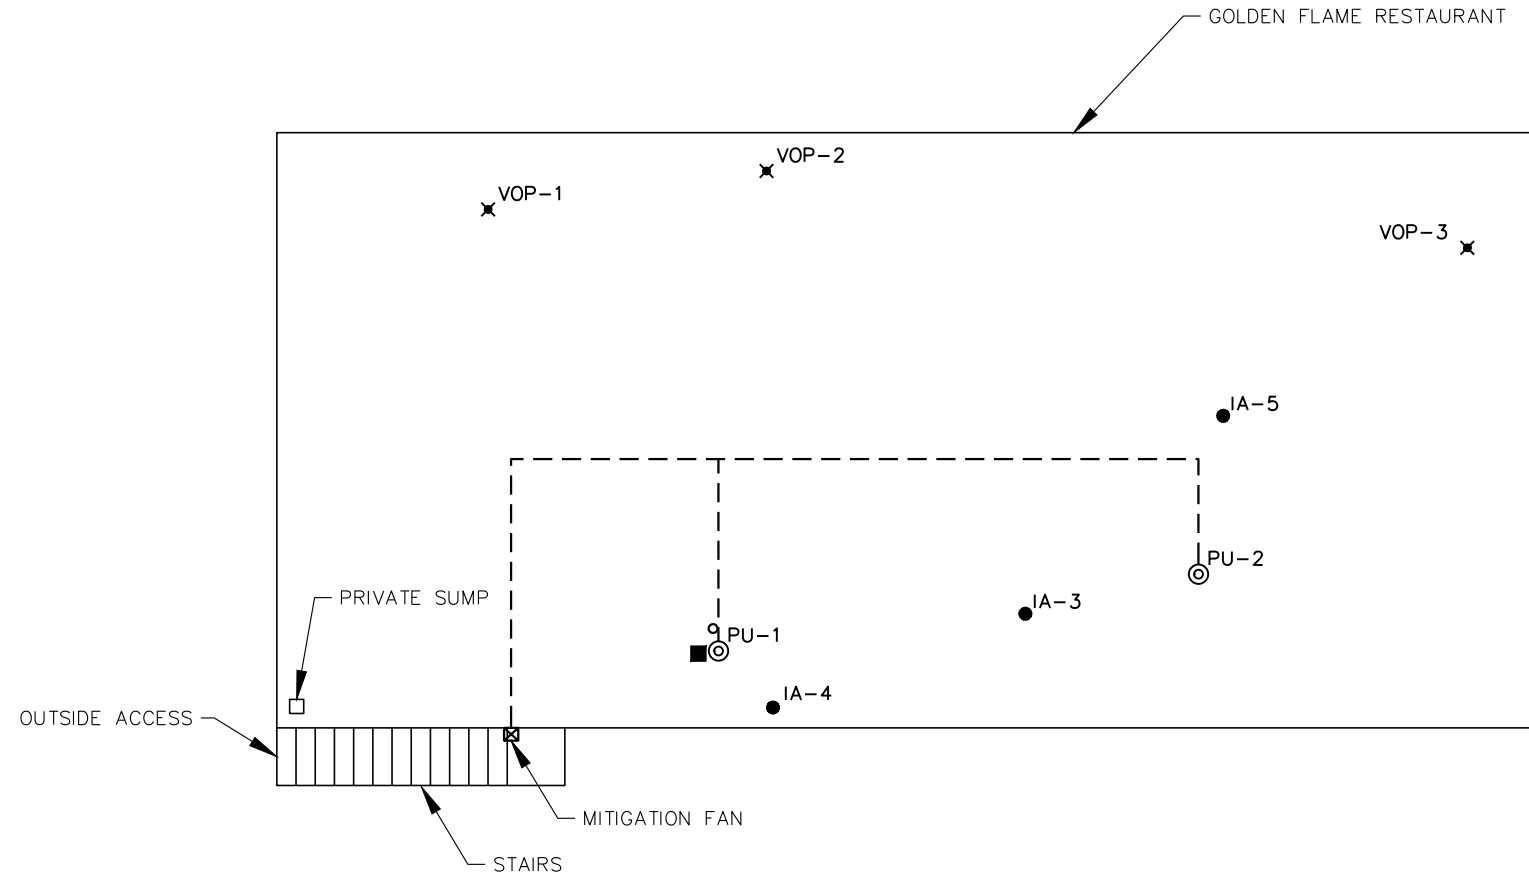
| REVISED: 12/07/2023 | APPROVED BY: REL | REL 12/07/2023 | FIGURE 1 | FIGURE 1 |

SCS Engineers (SCS) has prepared this report to summarize the inspection and vacuum verification performed for the vapor mitigation system (VMS) installed at the Golden Flame Restaurant in Manitowoc, Wisconsin (**Figure 1**). The VMS is maintained to prevent migration of chlorinated volatile organic compound (CVOC) vapors into the building. The continuing obligations to maintain the VMS are summarized in a Wisconsin Department of Natural Resources (WDNR) letter dated September 30, 2021. The VMS inspection work and preparation of this report were performed under the Vapor Intrusion Zone Contract (VIZC) at the request of WDNR.

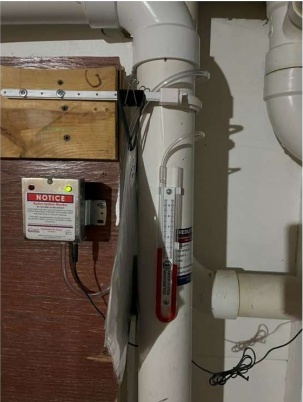
| SYSTEM COMPONENT | | | | Date of Inspection: |
|--|--|---|--|---|
| <p>PHOTO</p> | | | <p>NOTES: (Record the reading on the gauge. Identify specific building and location description:)</p> <p><input type="checkbox"/> Not Applicable</p> <p>Pickup Point No. 1 with liquid manometer and alarm. Manometer reads 0.8 inch water vacuum. Tested the alarm by temporarily removing the alarm vacuum tubing from the pickup point. Both the alarm light and the audible alert are working properly.</p> | |

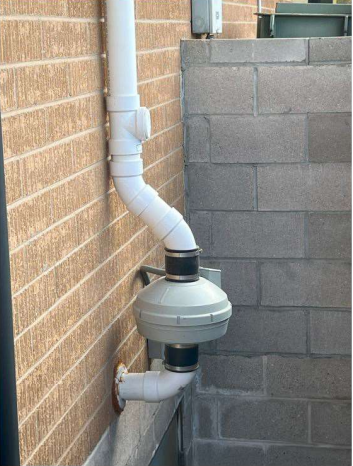
| <p>PHOTO</p> | <p>NOTES: (Identify specific building and location description:)</p> <p><input type="checkbox"/> Not Applicable</p> <p>Fan is operating as intended. No damage or excessive motor noise observed.</p> |

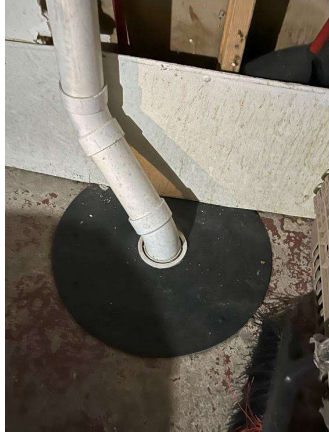
| SYSTEM COMPONENT | | | | Date of Inspection: | 10/09/2023 |
|---|---|---|---|--|---|
| | | | <p>Pickup Point No. 1. Vent piping appeared secure and connected to the fan. No damage to piping observed. Used smoke pen to test pickup point floor seal and found no leakage.</p> | | |

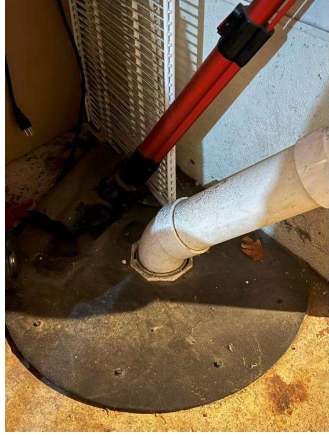
| SYSTEM COMPONENT | | | | Date of Inspection: | 10/09/2023 |
|---|---|---|--|---|---|
| | | | Pickup Point No. 2. Vent piping appeared secure and connected to the fan. No damage to piping observed. Used smoke pen to test pickup point floor seal and found no leakage. | | |

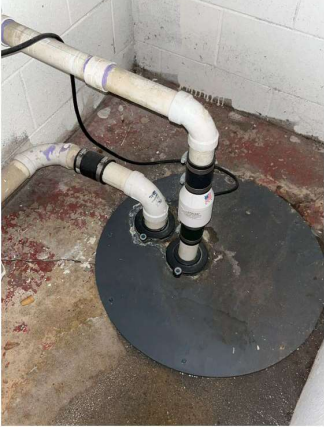
| SYSTEM COMPONENT | | Date of Inspection: 10/09/2023 | | |
|--|---|---|---|---|
| <p>PHOTO</p> | | | <p>NOTES: (Identify specific building and location description:)</p> <p><input type="checkbox"/> Not Applicable</p> <p>Used smoke pen to test sump lid fittings and floor seal and found no leakage. No damage to piping or lid observed. Sump pump did not appear to cycle while present.</p> | |

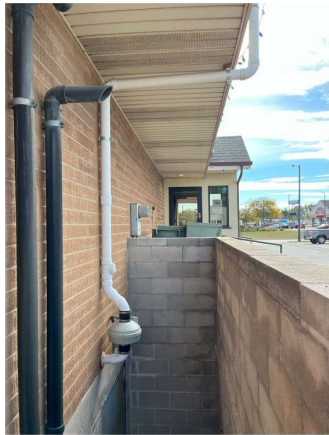
| SYSTEM COMPONENT | | | | Date of Inspection: | 10/09/2023 |
|---|---|---|---|--|---|
| PHOTO | | | NOTES: (Identify specific building and location description:) <input type="checkbox"/> Not Applicable Vent pipe appears solid and connected to fan, no damage observed. Checked exhaust end for obstructions. No obstructions observed. The exhaust appears to be more than 15 feet from windows or air intakes. | | |

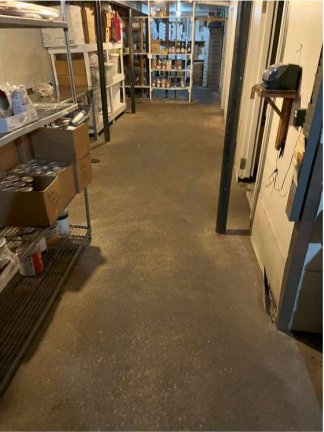
| SYSTEM COMPONENT | | Date of Inspection: 10/09/2023 | | |
|---|---|---|--|---|
| PHOTO | | | NOTES: (Identify specific building and location description:) <input type="checkbox"/> Not Applicable Some minor cracks observed in floor in south end of basement. The cracks are less than approximately 1/8-inch diameter and trend for several feet. These appear to be old and were likely present when the vapor mitigation system was installed. There do not appear to be any alterations to the building that would influence the vapor mitigation system. | |

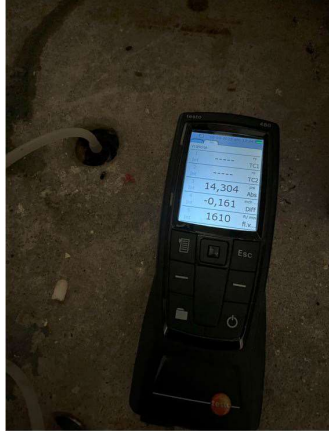
| SYSTEM COMPONENT | | | | Date of Inspection: | 10/09/2023 |
|---|--|---|--|---|---|
| | | | <p>Sub-slab Vacuum Observation Point 1. Measured vacuum using digital manometer at 0.161 inches water. No missing components or damage to point observed.</p> | | |

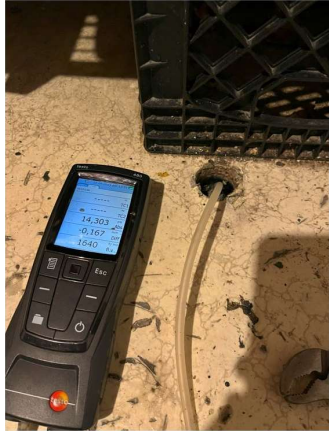
| SYSTEM COMPONENT | | | | Date of Inspection: | 10/09/2023 |
|---|--|---|--|---|---|
| | | | <p>Sub-slab Vacuum Observation Point 2. Measured vacuum using digital manometer at 0.167 inches water. No missing components or damage to point observed.</p> | | |

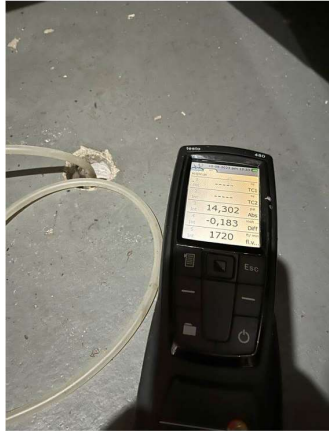
| SYSTEM COMPONENT | | | | Date of Inspection: | 10/09/2023 |
|---|--|---|--|---|---|
| | | | <p>Sub-slab Vacuum Observation Point 3. Measured vacuum using digital manometer at 0.183 inches water. No missing components or damage to point observed.</p> | | |
