From: [Gross, Stu](#)
To: [Graham, Joseph R - DNR](#)
Cc: [Lennie, Brian](#); [Morberg, Kyle](#); [Cull, Whitney](#); [Christian Zuidmulder](#)
Subject: Status Update - C. Reiss Coal Dock, Superior (BRRTS #02-16-589248)
Date: Tuesday, November 21, 2023 8:43:15 AM
Attachments: [image001.png](#)

Excavation of the stormwater pond on the C. Reiss site in Superior, Wisconsin is underway and we wanted to provide an update on the recent field conditions encountered during installation.

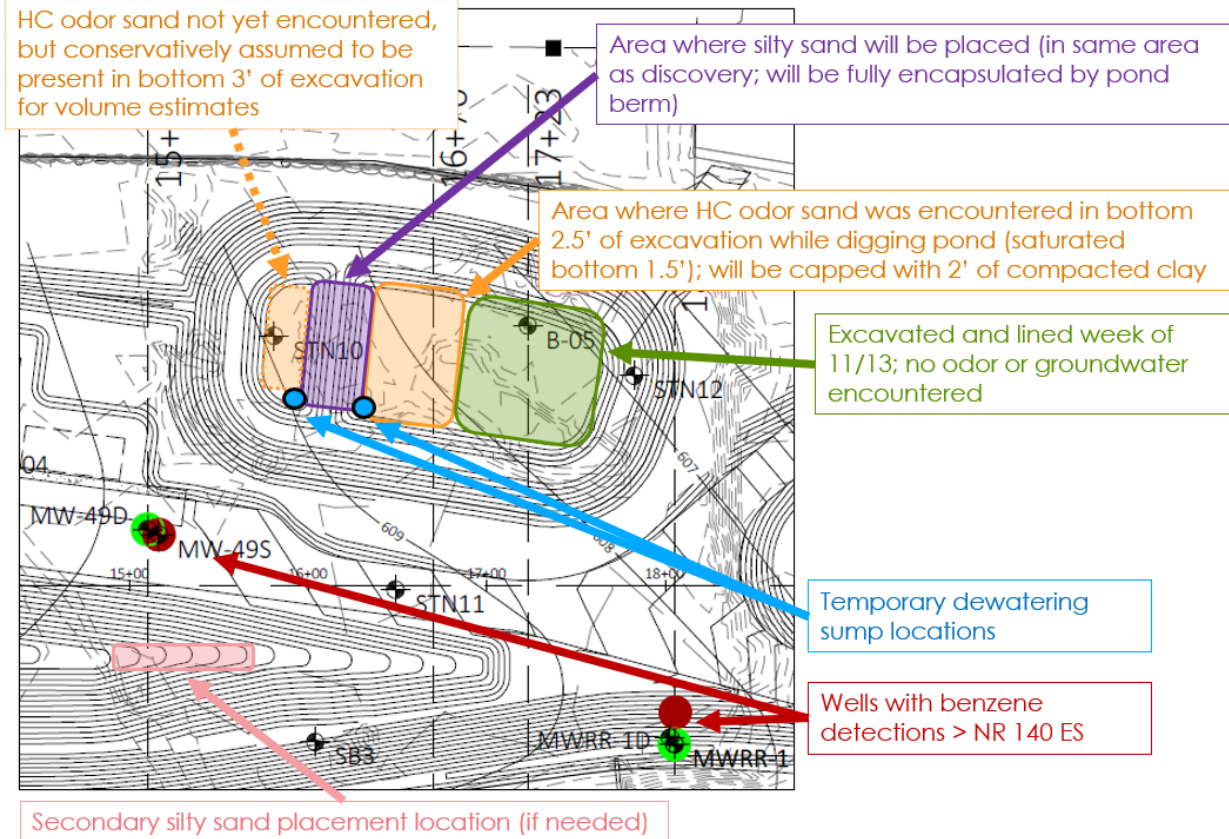
Stormwater Pond Exhibit

Northern half. Excavation and subsequent installation of the 2-foot clay liner was performed in the approximate northern half of the stormwater pond as planned the week of 11/13 (**green** in the exhibit below); note that the “total depth” of pond excavation is inclusive of over-excavating the bottom two feet of the pond in order to appropriately install the 2-foot, compacted clay liner. As indicated by a geotechnical boring performed in this area (B-05; refer to the exhibit below), native clay was encountered as expected at the maximum depth of excavation. No groundwater was observed at total depth in the northern half of the pond excavation.

Southern half. Excavation is in progress on the southern half of the stormwater pond (**orange** in the exhibit below). Unlike the northern half, silty sand was observed in this area approximately 2.5 feet above the target depth and was found to be saturated and exhibiting a hydrocarbon (HC) odor approximately 1.5 feet above the target depth. Upon this discovery and per the requirements of the Remedial Action Plan/Materials Management Plan (RAP/MMP), the Site representative paused onsite work and notified Stantec for confirmation of next steps.

- **Contaminated groundwater:** While groundwater is not pooling in the excavation currently, it is expected that contaminated groundwater will accumulate as the excavation reaches total depth, and benzene is known to be present in groundwater at a concentration greater than the NR 140 ES in this area (**red** in the exhibit below). Stantec is presently coordinating with Northland (the Contractor) to profile and dispose of any accumulated groundwater via vacuum pumping for the remainder of the stormwater pond excavation. Temporary “sump” locations will be utilized for dewatering as illustrated in **blue** on the exhibit below.

- **Silty sand:** The silty sand (which has HC odor from the impacted groundwater) will be placed in the bottom of the dividing bench between the stormwater pond “lobes”, to be ultimately capped by compacted clay liner (outlined in **purple** on the exhibit below). This location was determined as it was:

- Though not anticipated, in the event that an additional location is needed for stockpiling this silty sand material, a secondary location has also been identified in the core/bottom of the east-adjointing sediment berm (illustrated in **pink** in the exhibit below) as this area also contains similar benzene-impacted groundwater. Material stockpiled in this location would be covered with plastic sheeting until more substantial filling of the berm would be performed in Spring 2024.

- **Approach:** The associated remaining excavation, groundwater pumping/disposal, and pond liner installation is proposed to be performed in concert to limit the amount of time that contaminated materials are exposed, during the week of 11/27. Dewatering will be performed concurrently with final excavation and will continue during the immediate and subsequent installation of the compacted 2-foot clay liner. The silty sand placement in the dividing bench within the pond will additionally allow for dewatering of the material prior to capping with a minimum of two feet of clay.

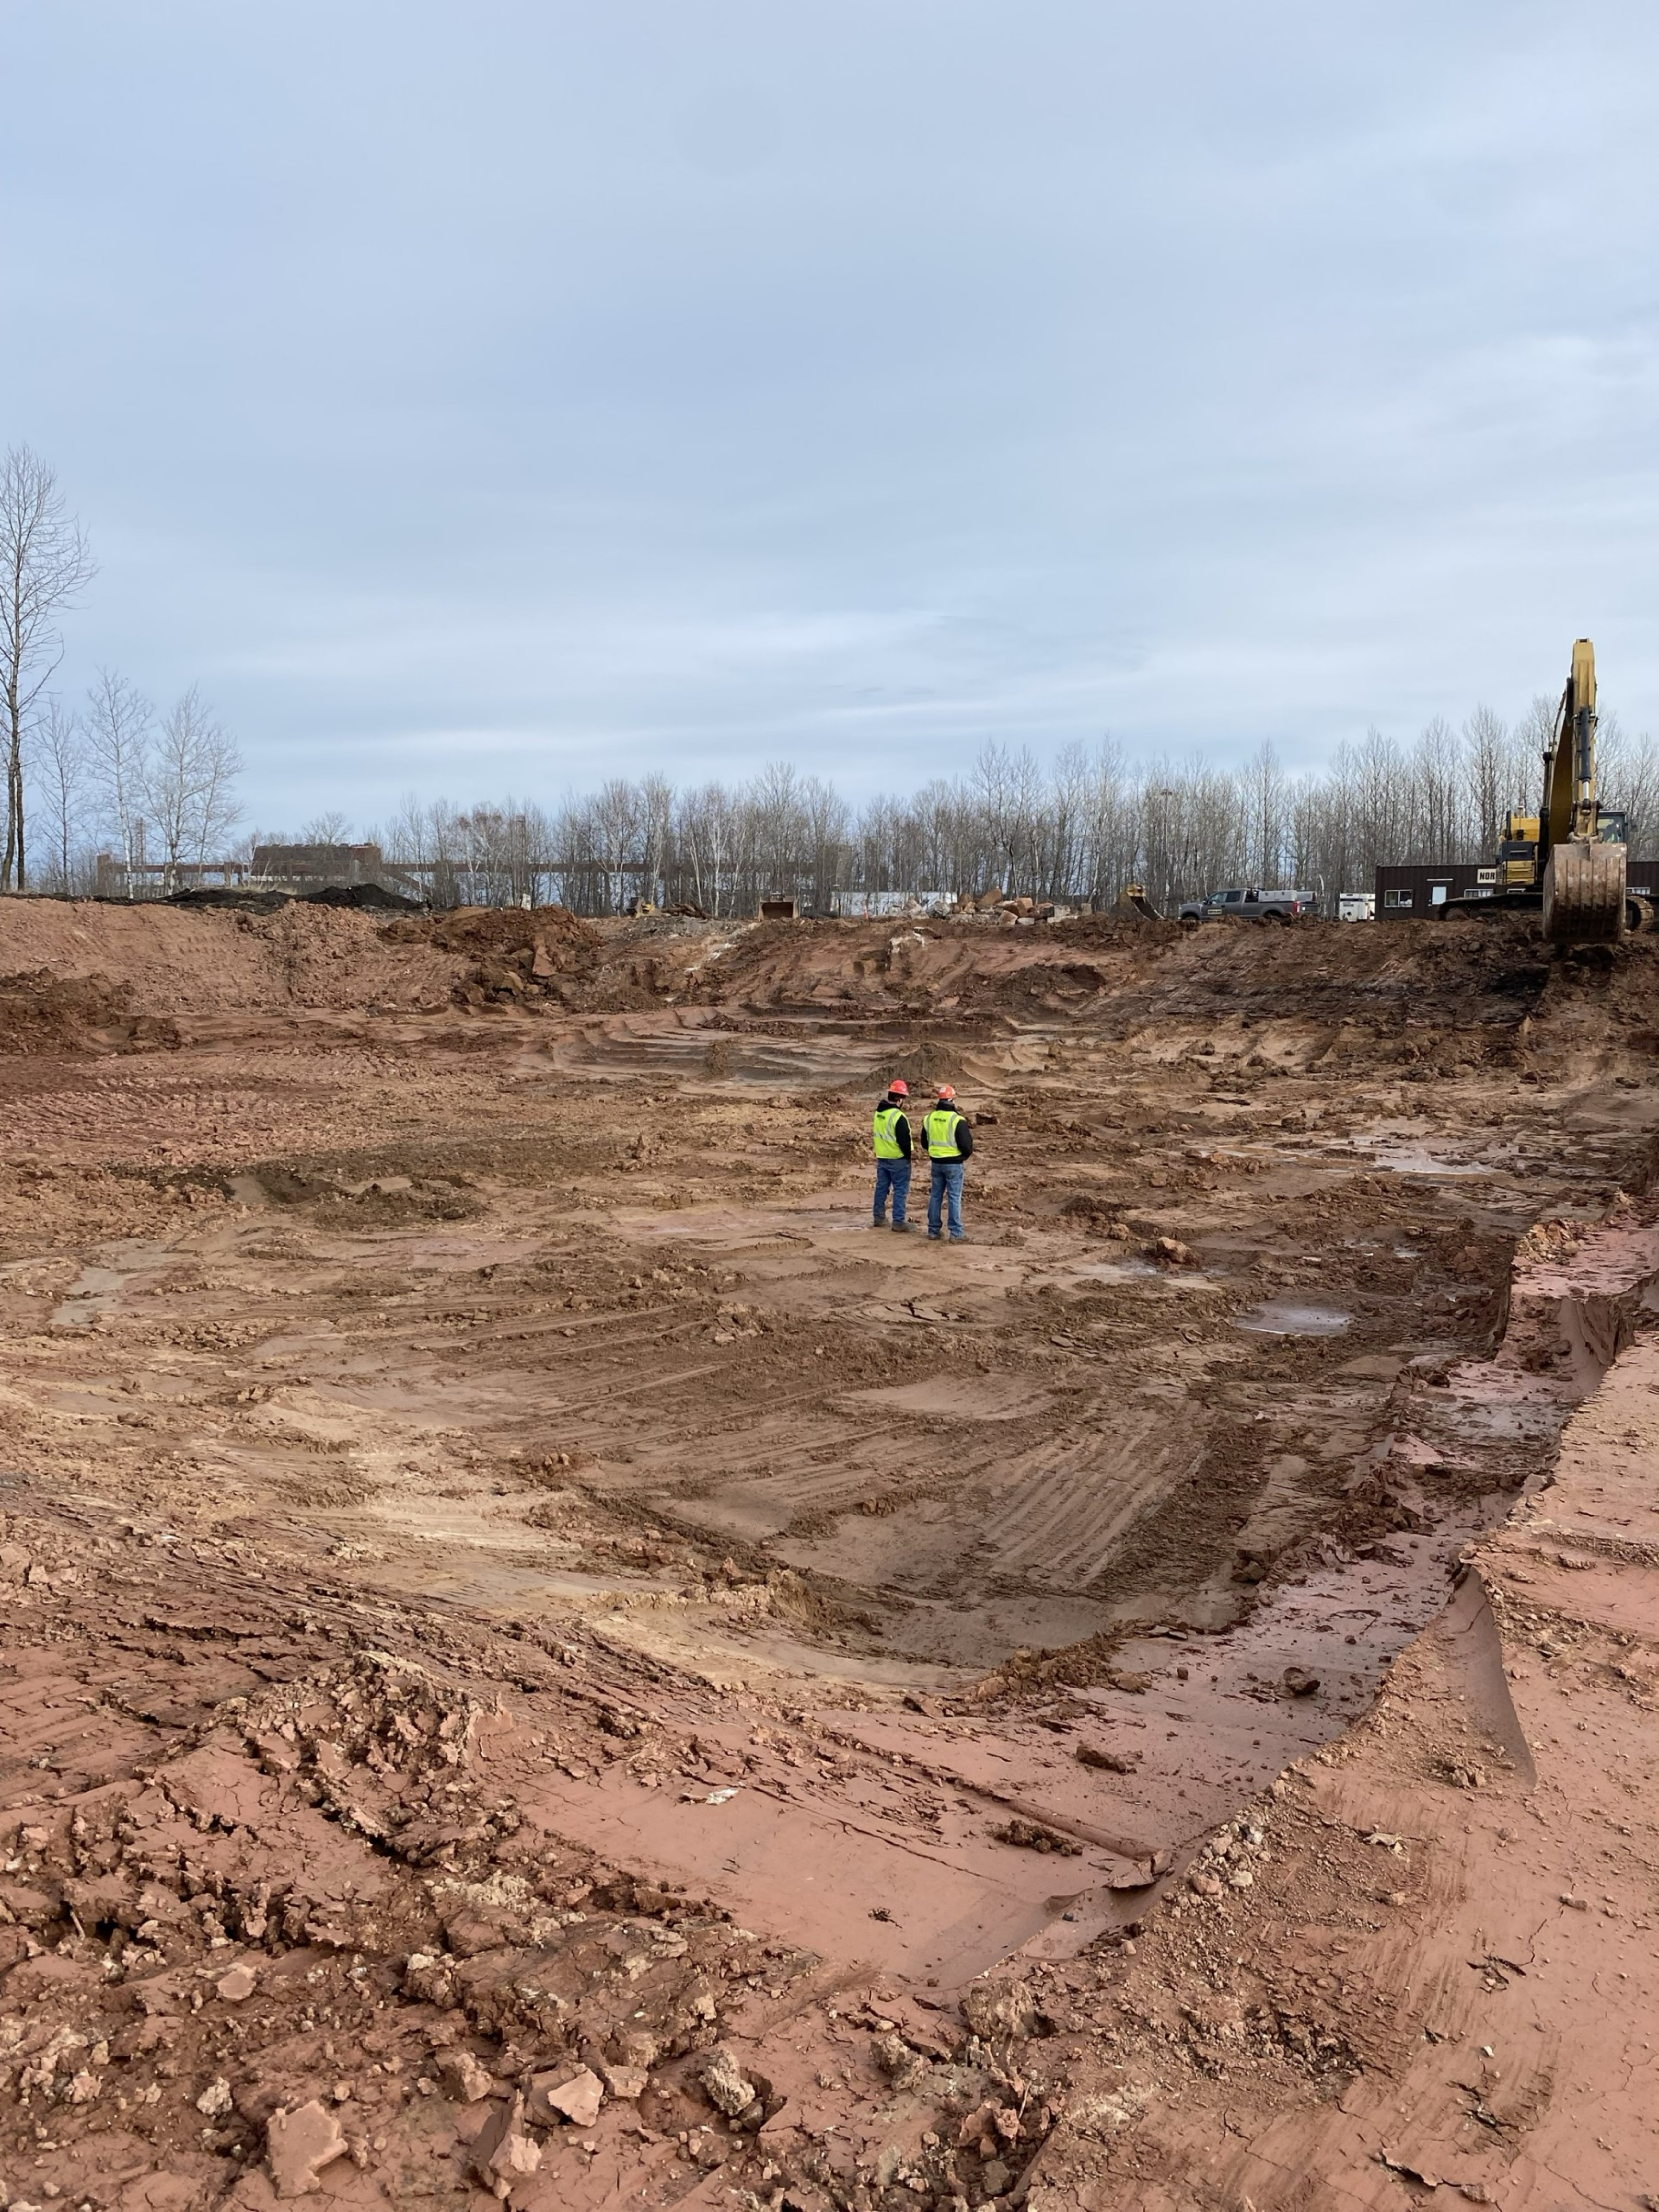
Current conditions: Deeper excavation in this area was temporarily suspended as soon as saturated conditions were observed in the silty sand. As depicted in **Photograph 1** attached, there is presently no water pooling or evidence of free product/LNAPL in the excavation. Stantec estimates that a total of approximately 100 cubic yards of saturated silty sand will be displaced by the pond excavation. The HC odor present within the silty sand appears to be associated with documented benzene-contamination to groundwater in this area originating from the east-adjointing property.

Proposed material management: Excavation is planned to continue (deepen by 1.5 feet) in this area the week of 11/27, Stantec intends to manage the excavated silty sand and future contaminated groundwater in the following manner:
