Spill Notification Information / Spill Reporting Form
Tyco Fire Products, LP

Facility Address <i>One Stanton Street, Marinette, WI 54143</i>	Facility Telephone Number: <i>(715)735-7411</i>
Date of Spill <i>9 / 14 /22</i>	Time of Spill: <i>11:55</i> AM / PM
Type of Material Discharged <i>Influent Municipal City Water</i>	
Estimated Total Quantity Discharged <i>Indeterminate, influent municipal city water release occurred over a 10-minute time period</i>	
Estimated Quantity of Material Discharged to a Water Body <i>Indeterminate, influent municipal water release occurred over a 10-minute time period</i>	
Source of the Discharge <i>Underground water line fracture</i>	
Medias Affected <input type="checkbox"/> Soil <input checked="" type="checkbox"/> Surface Water <input type="checkbox"/> Ground Water <input type="checkbox"/> Air <input type="checkbox"/> Other	
Cause of Discharge <i>An unknown undocumented offshoot of the facilities old underground city water line was struck during the installation of the new city water main causing upwelling of water.</i>

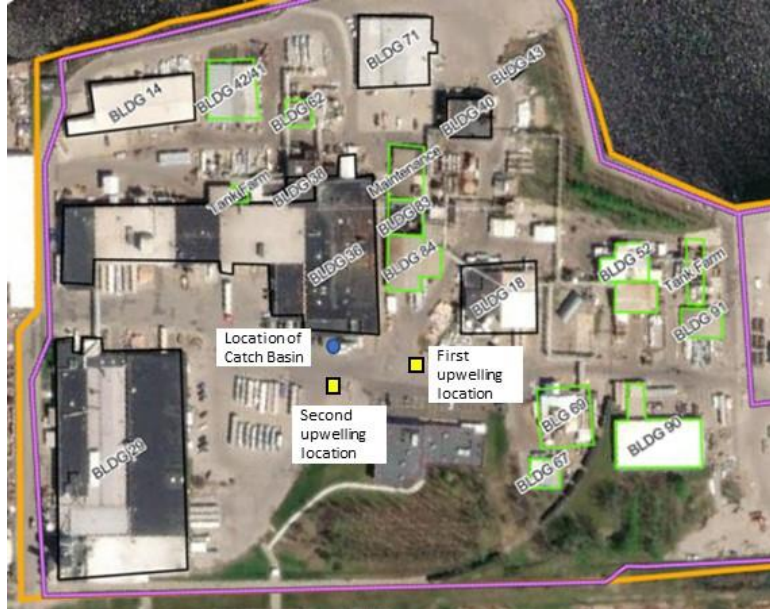
Location of incident:

Describe the Cause of the Discharge, including a failure analysis of the system in which the failure occurred: During installation of the new extension of municipal water line coming from the City of Marinette under Tyco's Stanton Street facility as part of the Site's overall infrastructure upgrades being conducted pursuant to our new WPDES Permit WI-0001040-08-0, Tyco's drilling contractor struck an unmarked water line extension and noticed municipal water upwelling from the drill area. The contractor notified site staff and worked with site maintenance to have the valves shut that feed the municipal water main. Utilities had been marked out in the area using traditional methods, ground penetrating radar and potholing. The line that was struck was found to be an undocumented unmarked 2" copper line that was struck over 3' from the actual 6" municipal water main location. The water from the initial break was influent municipal water and was contained without any off-site release. When the water main valves were closed to isolate the municipal water line break the upwelling in the area stopped, however within 5 minutes of the valves being closed a new upwelling condition was noticed approximately 50 yards southwest of the drilling location. Additional valves on the municipal water main were closed to stop this second noted upwelling of water, however, the location of the second upwelling of water was directly adjacent, and upland of a catch basin attached to the sites industrial sewer. A catch basin seal was applied to the catch basin within 10 minutes during which an indeterminate amount of municipal water went into the catch basin and was discharged from WPDES outfall 001. The remaining standing municipal water was captured via vac trucks and loaded into frac tanks for on-site storage. The contractor was able to excavate and repair the original break in the municipal water line. When the contractor attempted to begin slowly opening the municipal water supply, municipal water was noted to still be flowing which confirms the existence of a second break. It is believed at this time that the closing of the valves to isolate the original leak caused a pressure buildup which created a second break in the line. The municipal water to the line is currently turned off, repairs will be conducted within the next few days, and the line will be verified leak-free prior to returning to service.

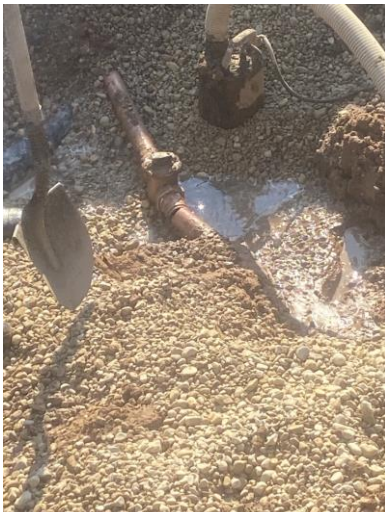
The root cause of the line breaks is the age of the existing municipal water main which in many places is over 70 years old. The area that was hit was undocumented which is not uncommon given the age of the site. The new municipal water main being installed will be much more durable and will have full as built drawing along with tracer wire so that it can be easily and fully located.

Location of initial break and upwelling. No municipal water from this area reached the catch basin.

Maximum Storage or Handling Capacity of Facility: <i>Indeterminate, city potable water supply</i>
Corrective actions and countermeasures taken (include a description of equipment repairs and replacements): <i>Spill control equipment deployed and used to capture and clean spill of municipal water within ten minutes. Municipal water from line break captured and collected for disposal.</i>

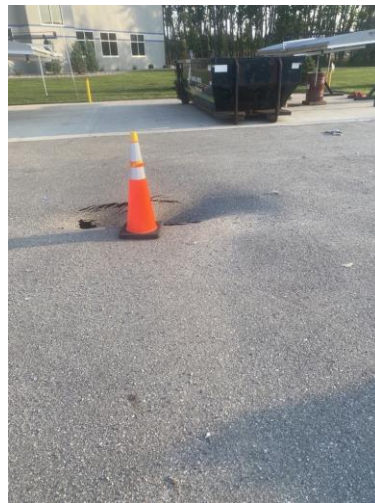
Second upwelling location. Municipal water from this area reached the catch basin.
