Spill Notification Information / Spill Reporting Form  
 Tyco Fire Products, LP

Part 1. Spill Notification Information (Part 1 must be completed prior to calling regulatory agencies.)

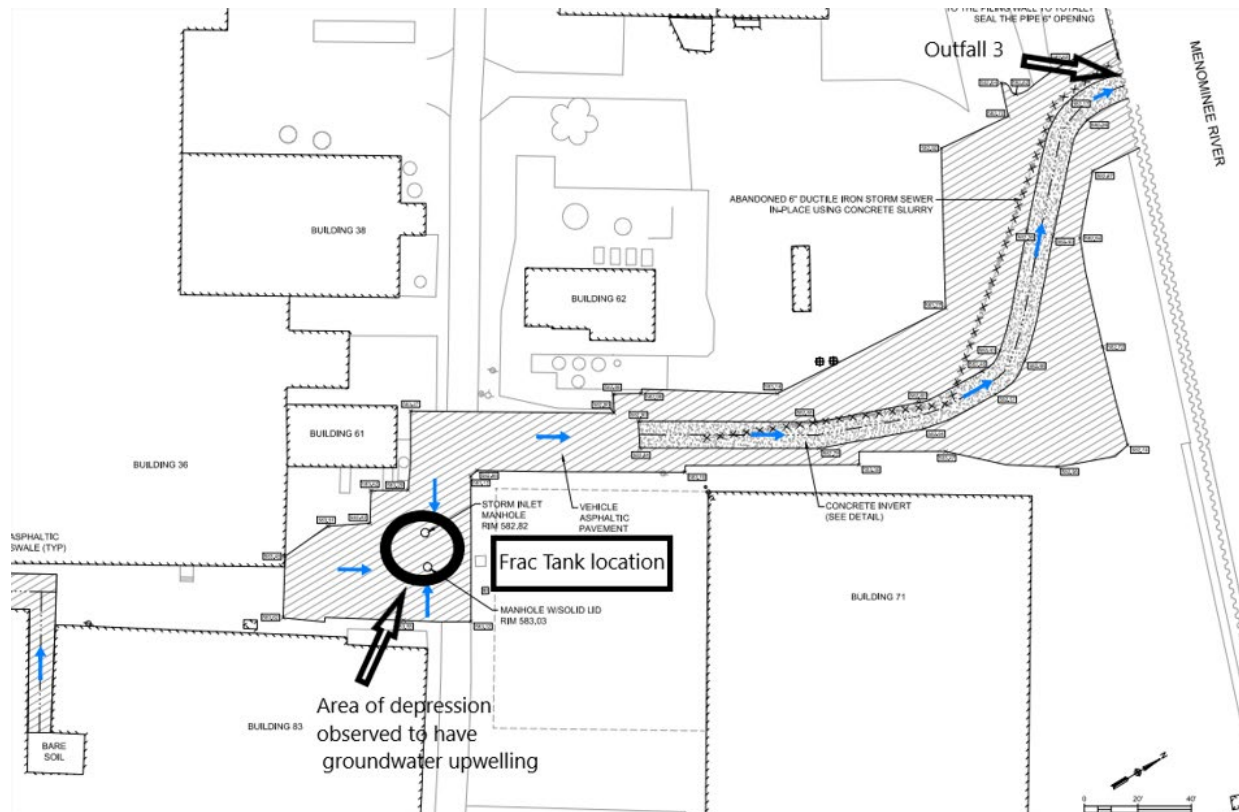
Maximum Storage or Handling Capacity of Facility: <i>N/A Groundwater</i>
Corrective actions and countermeasures taken (include a description of equipment repairs and replacements): <i>Dewatering pump deployed on a more continuous basis as needed to pump down standing water in the groundwater impacted area until the groundwater extraction system (currently under construction for an upgrade) is redeployed, anticipated to be at the end of April. When deployed, additional monitoring of the pump, and posted signage to ensure the pump continues to remain in place and operational will be implemented.</i>
Describe Facility (See Figure inset, below)

This is a courtesy report only. Groundwater may have upwelled; we do not have information that that happened. As the WDNR knows, the Stanton St facility is finalizing upgrades to both the Stormwater infrastructure and to the Groundwater Extraction and Treatment System. These upgrades will be completed by the end of Spring, 2023. As part of the interim measures until the final upgrades are completed, Tyco has been pumping any potential groundwater that may be surfacing in low areas into containment and disposing of the pumped water at an off-site permitted facility. One of these areas is near B71 (see figure below), where high groundwater levels at the site primarily caused by excessive snow melt coupled with the groundwater pumping system down during system upgrade construction activities has resulting in some upwelling of groundwater in an area south of B71 at the Stanton St. Facility. This upwelling was observed in a localized elevation depression and Tyco deployed a utility pump the week of February 27<sup>th</sup> with a float switch to dewater the area into a frac tank for disposal. At 5 PM on March 6, the pump was observed running and dewatering the area. At approximately 8:45 AM on March 7, the pump was found not running.

As a result, arsenic impacted groundwater may have been exposed to stormwater at stormwater Outfall #3 at the Stanton St. facility, but we have no information that that occurred. When it was noted that the pump was not running it was also observed the depression had been flooded from the snowmelt caused

by a storm the night before. The snowmelt volume of water was potentially enough to cause a connection between the standing water in a low depression area and the stormwater swale connected to Outfall 3 which discharges storm water to the Menominee River.

As the depression area had been in active dewatering for several days, it is unlikely there was any active flow of groundwater into the swale, rather the flooding of stormwater from snowmelt caused a potential connection to the stormwater outfall. Any spread of impacts to the stormwater outfall would have been diffusive in nature and not due to active flow. We have no information that that occurred.

Snow piles onsite are being relocated to impervious areas of the site to prevent additional potential groundwater loading. The new groundwater treatment system installation is being expedited as much as possible to resume dewatering operations at the site. All final, long-term solutions are expected to be completed by the end Spring of 2023.
