*Spill Notification Information / Spill Reporting Form*  
*Tyco Fire Products, LP*

Part 1. Spill Notification Information (Part 1 must be completed prior to calling regulatory agencies.)

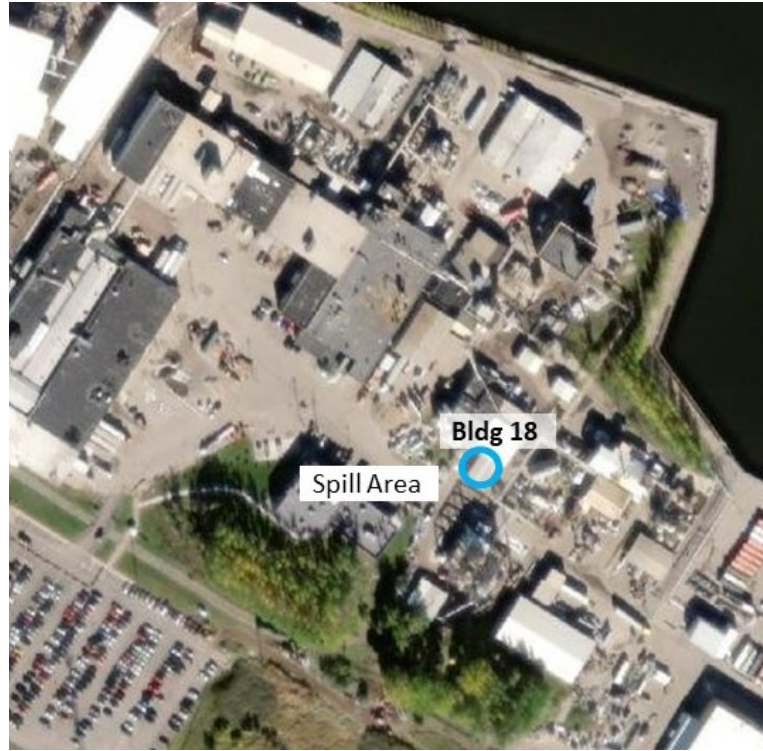
Location of incident:

Describe the Cause of the Discharge, including a failure analysis of the system in which the failure occurred: Drum awaiting transfer into the building was located in an area accessible to traffic when it was ruptured. On site protocols mandate drums, even temporarily staged, be appropriately cordoned off, away from traffic areas. Staff will be re-trained on this procedure to prevent staging of material in traffic accessible areas in the future.

Maximum Storage or Handling Capacity of Facility: <i>Indeterminate, city potable water supply</i>
Corrective actions and countermeasures taken (include a description of equipment repairs and replacements): <i>Spill was noticed immediately by on-site staff. Drum was immediately moved into secondary containment. Pooled propylene glycol was transferred into an empty 265-gallon tote.</i>
<i>Stained soil impacted by release was removed and placed into three 55-gallon drums. Soil will be profiled and disposed of off-site by Waste Management to the Arlington, OR landfill.</i>
