**Remediation & Redevelopment
Continuing Obligation Review**

BRRTS ID No. 02-16-592853 _____

Review Date: 08/29/2023

Site Name: Amoco Oil Terminal - FedEx Facility

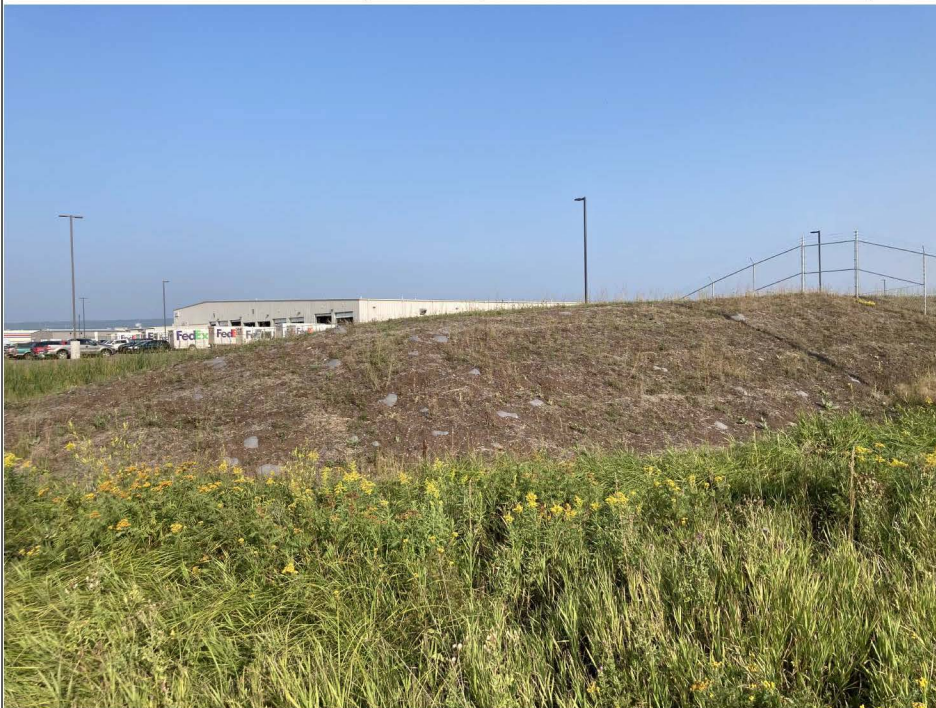
- Yes
- No – Describe what's not in compliance and the reasons for noncompliance:
Topsoil cover over bermed area is not in compliance with the materials management plan (MMP) approved by DNR in an Aug. 31, 2021 letter. Topsoil was specified in the MMP to be 8 inches in depth and vegetated. The inspection found thin poor quality topsoil with numerous exposures of cap liner material and little to no vegetation on the cap.

Title: South end of berm, viewing northwest, note little to no vegetation and numerous exposures of cap liner material.

- No
- Yes – Summarize the actions needed to return the site to compliance and identify who is responsible:
Add higher quality topsoil to the berm and establish vegetation as required in the MMP approval. The approved MMP specified 8 inches of topsoil covering the berm cap liner.

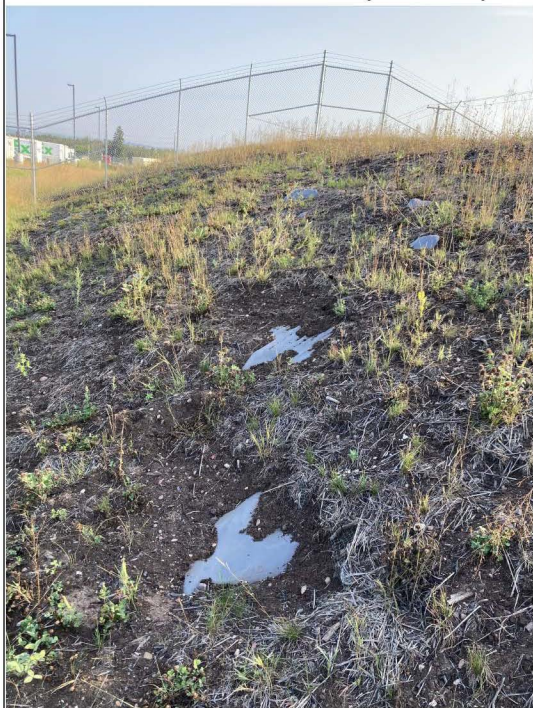
Title: Exposures of cap/liner material at southwest end of berm, viewing north.

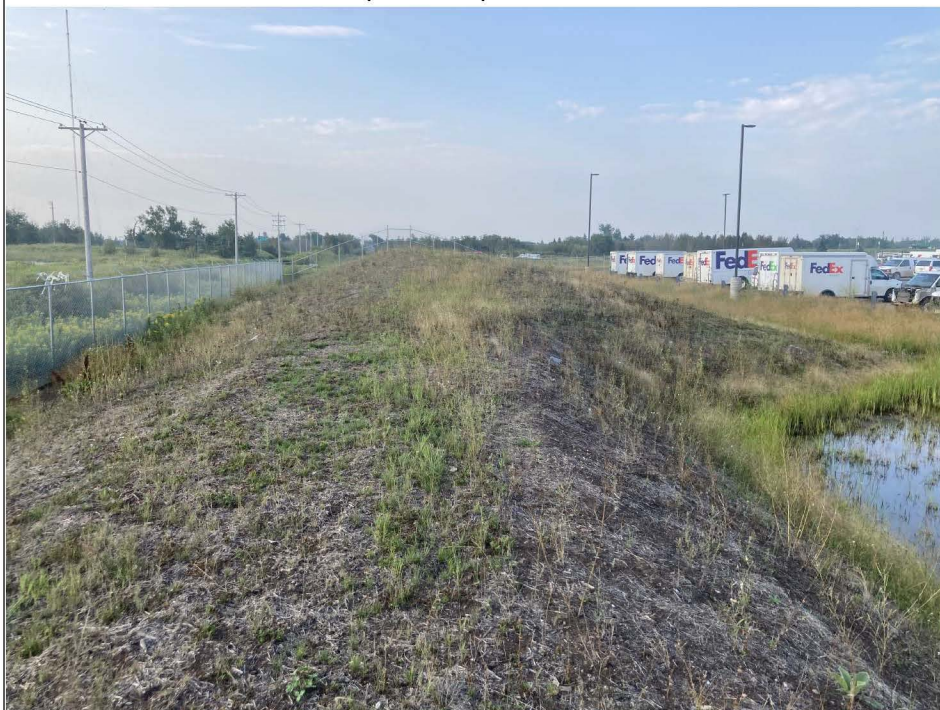
Title: Berm viewing south, storm water detention pond on right. Note scarce vegetation.

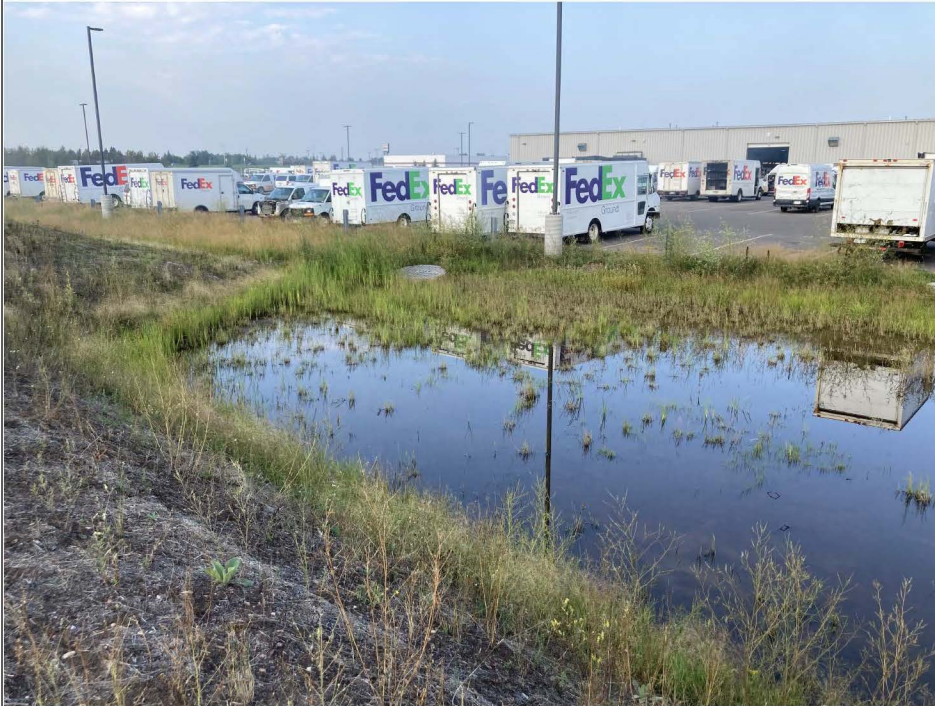
Title: South half of storm water pond viewing southwest. Note outflow structure in center at end of pond.

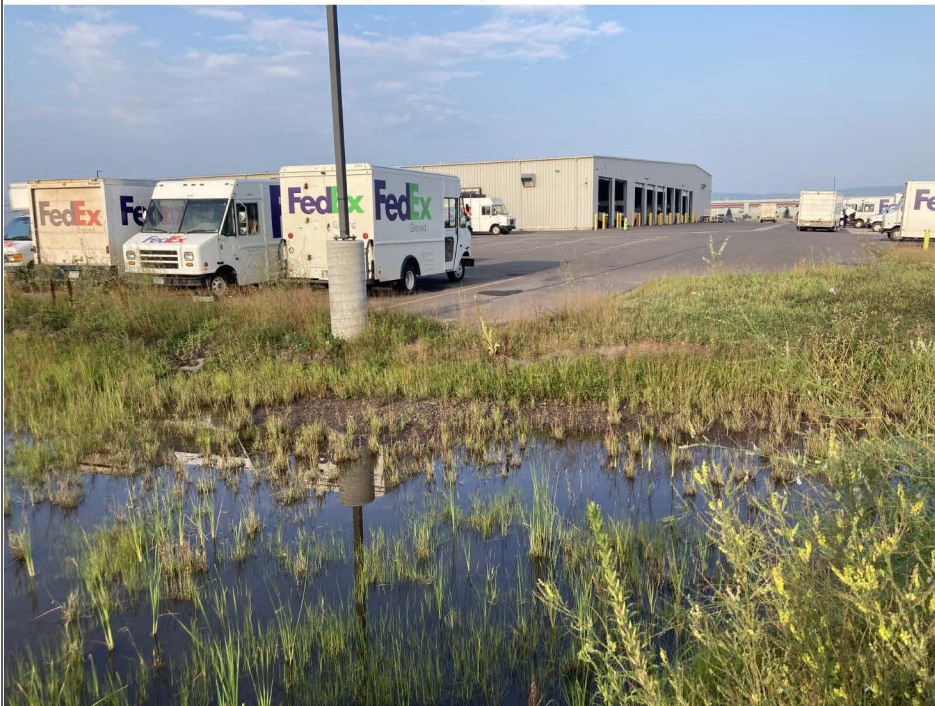
Title: North end of storm water pond viewing west. Note asphalt parking lot in background which also serves as cap/cover.
