Re: **Construction Documentation Report**  
**Portions of Parcels 06-806-00739-05 and 06-806-00739-00**  
**2929 Halvor Lane**  
**Superior, Wisconsin**  
**BRRTS#: 07-16-583046**  
**BBJ Group Project No. R2413652**

# CONSTRUCTION DOCUMENTATION REPORT

**FedEx Facility  
2929 Halvor Lane  
Superior, Wisconsin  
BRRTS#: 07-16-583046**

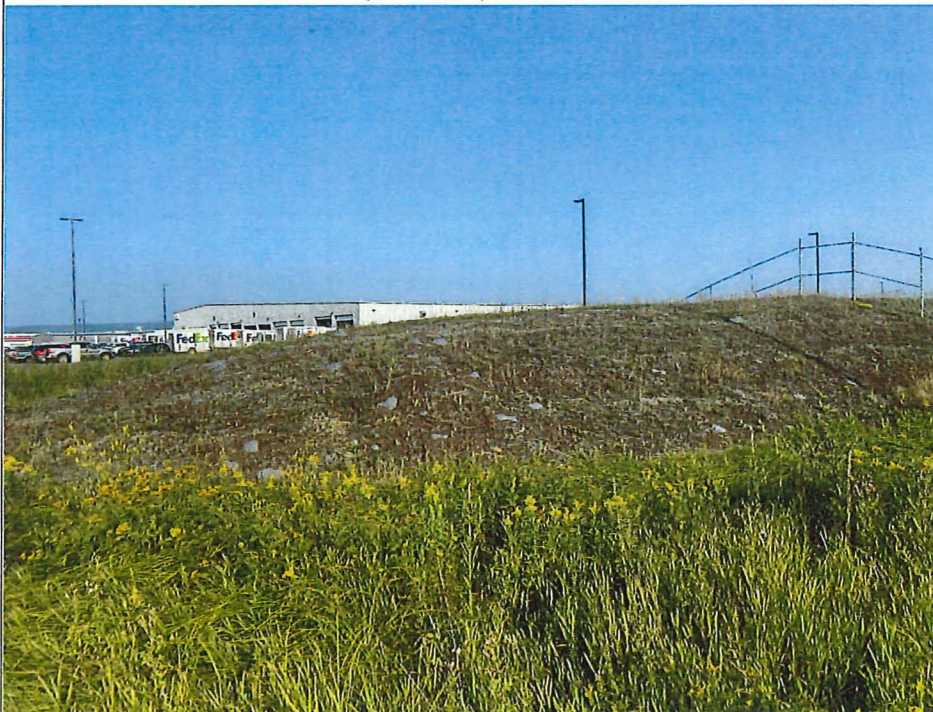
Topsoil cover over bermed area is not in compliance with the materials management plan (MMP) approved by DNR in an Aug. 31, 2021 letter. Topsoil was specified in the MMP to be 8 inches in depth and vegetated. The inspection found thin poor quality topsoil with numerous exposures of cap liner material and little to no vegetation on the cap.

Title: South end of berm, viewing northwest, note little to no vegetation and numerous exposures of cap liner material.

- Placement of 8-inches of topsoil on the berm to meet the requirement of the approved MMP. An attempt will be made to compact the topsoil so that it is stable. Soil compaction will be performed in 6-inch lifts when able. This response action is to be completed as soon as possible so that the liner will be covered prior to the first frost.

northern Wisconsin. As such, establishing a vegetation cover was unlikely before the end of 2023. As such, placement of seed mats over the exposed soils prior to the first frost would be performed. Seed mats will be secured to the topsoil and will not penetrate the cover. The seeds in the seed mats will remain dormant until spring, and vegetation cover will begin at that time.

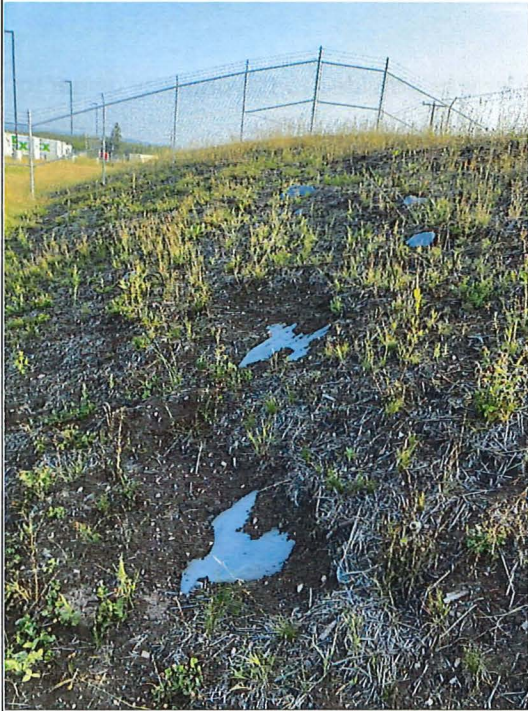
Title: Exposures of cap/liner material at southwest end of berm, viewing north.

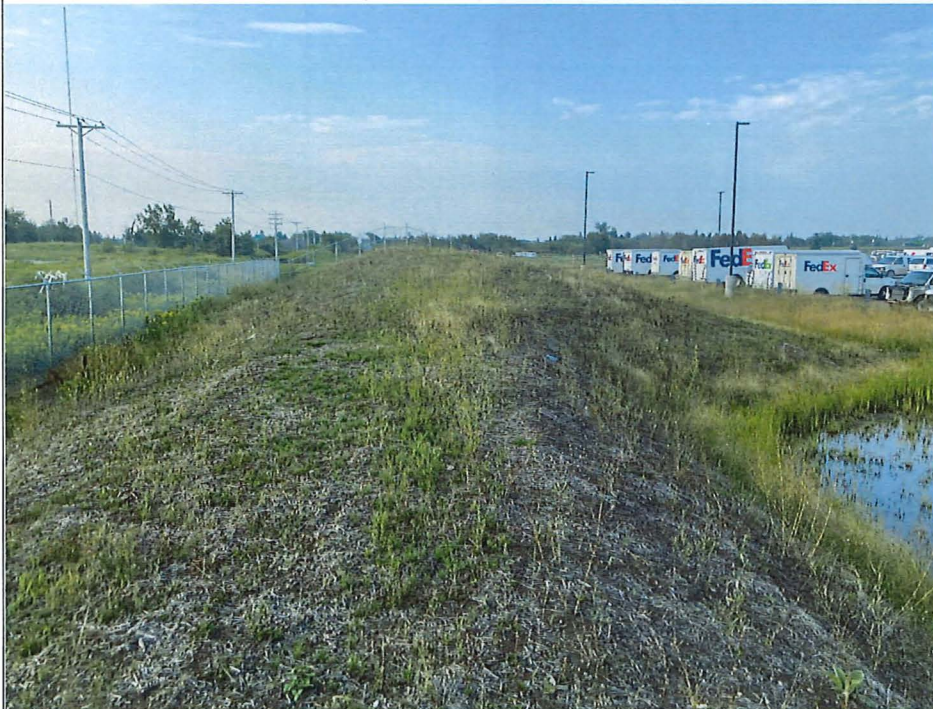
Title: Berm viewing south, storm water detention pond on right. Note scarce vegetation.

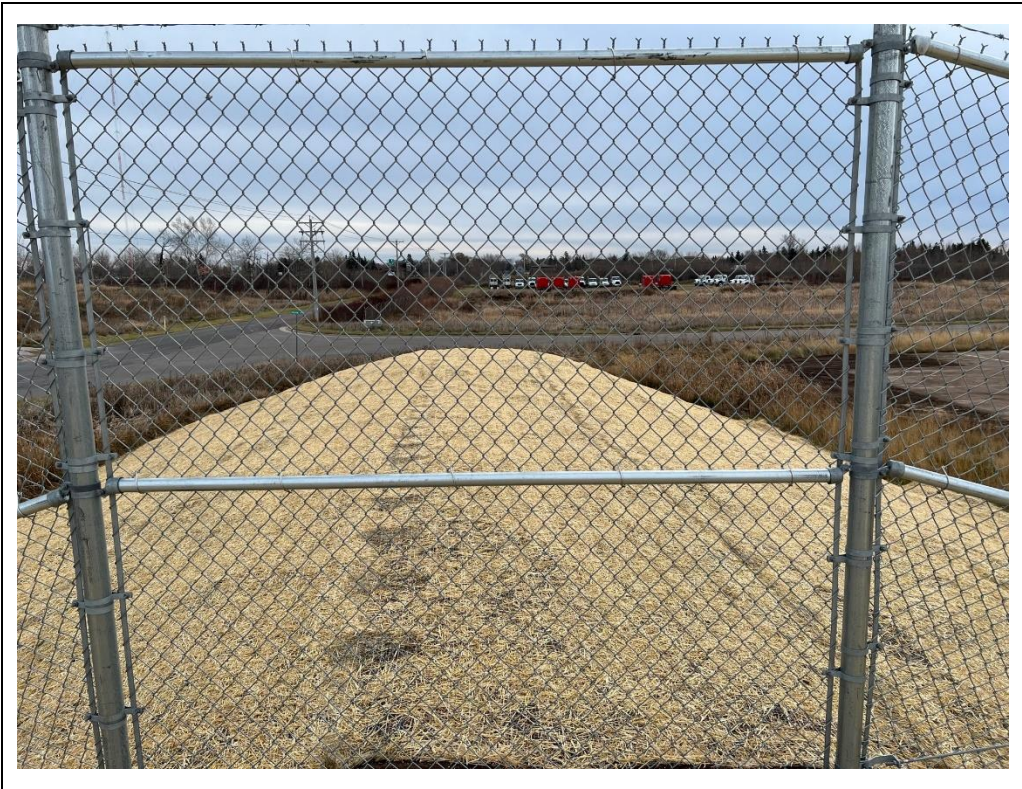
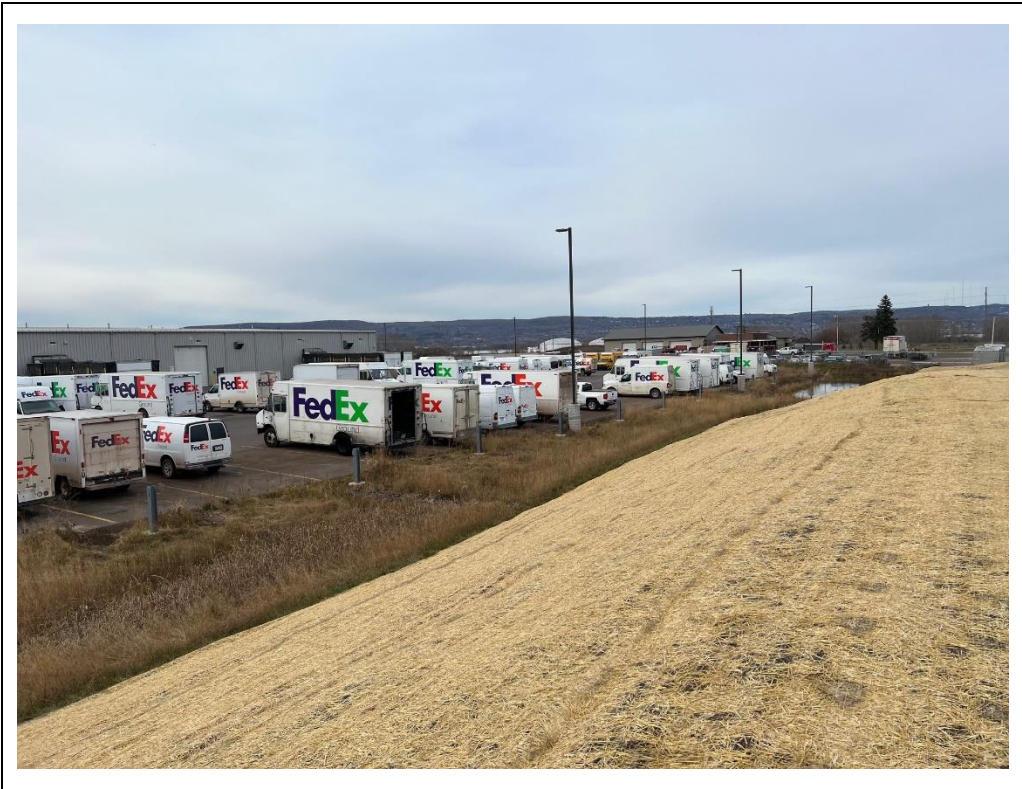
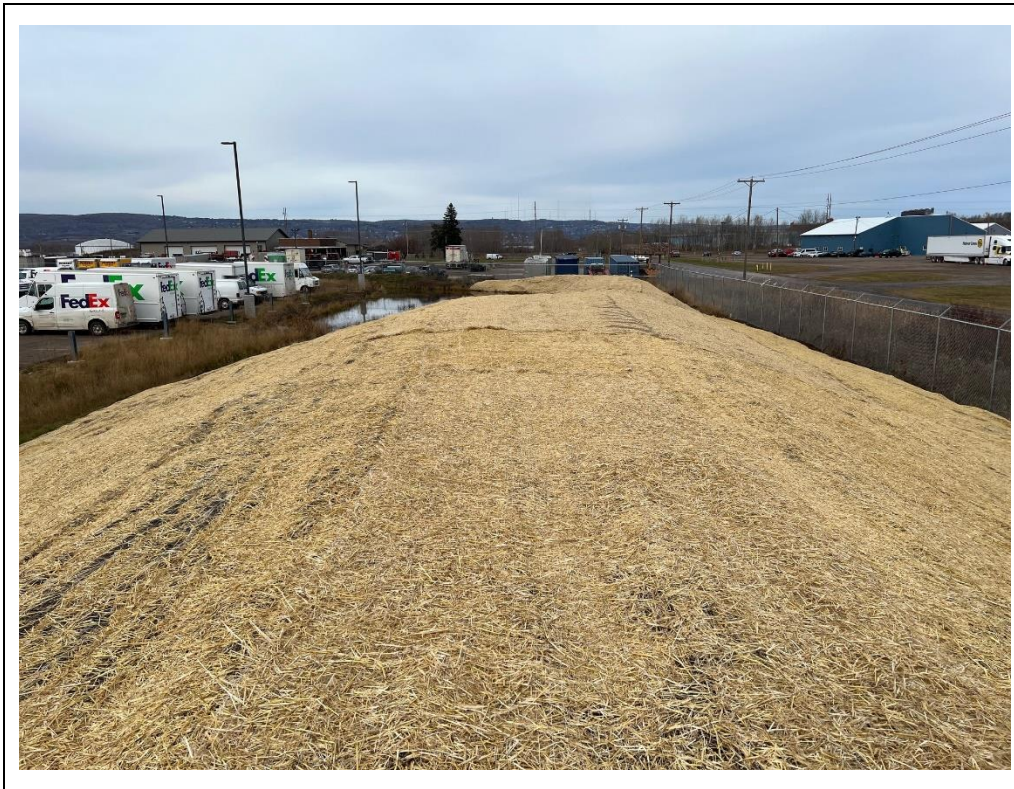
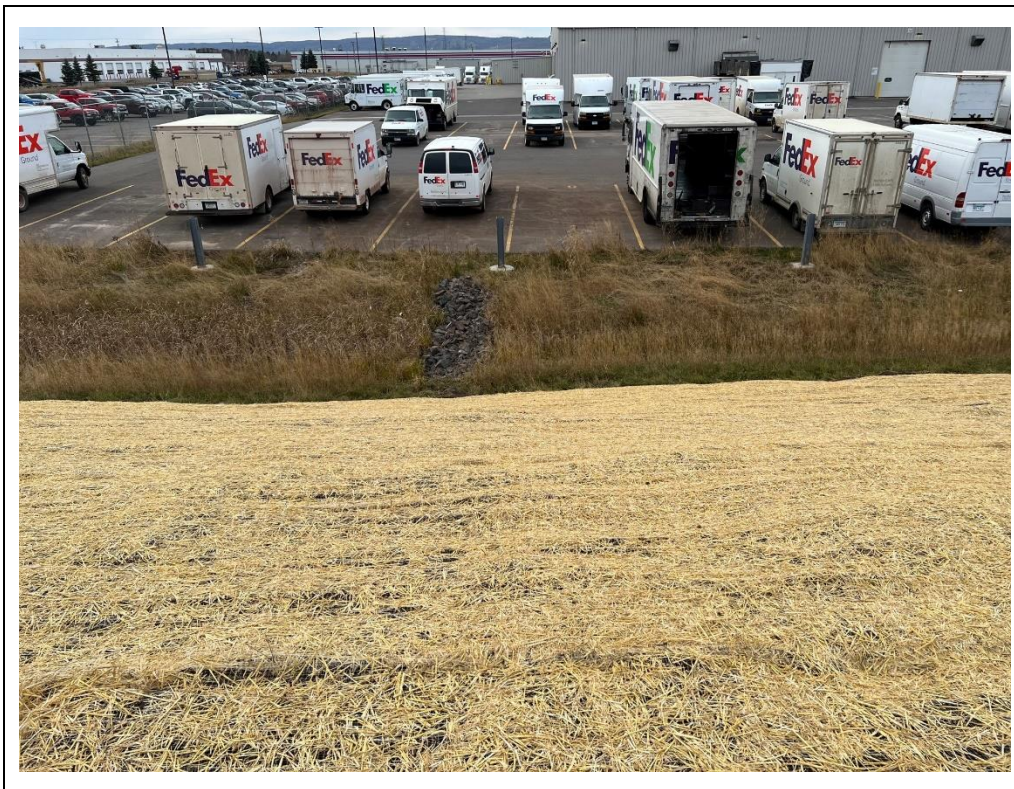
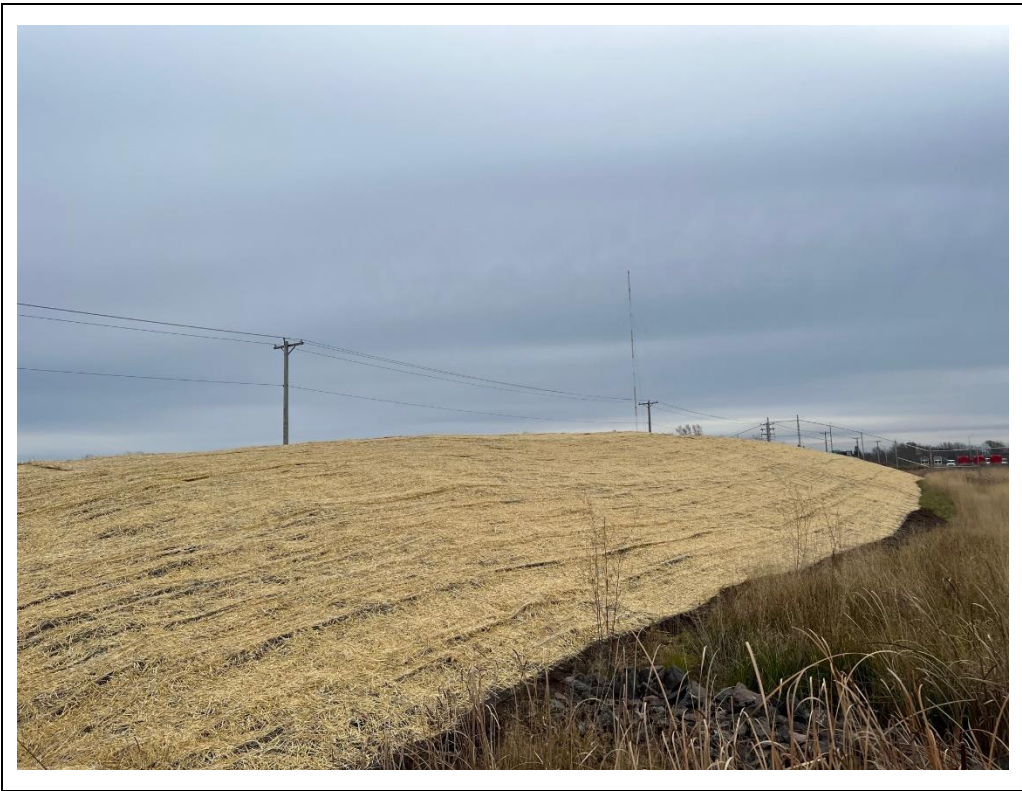
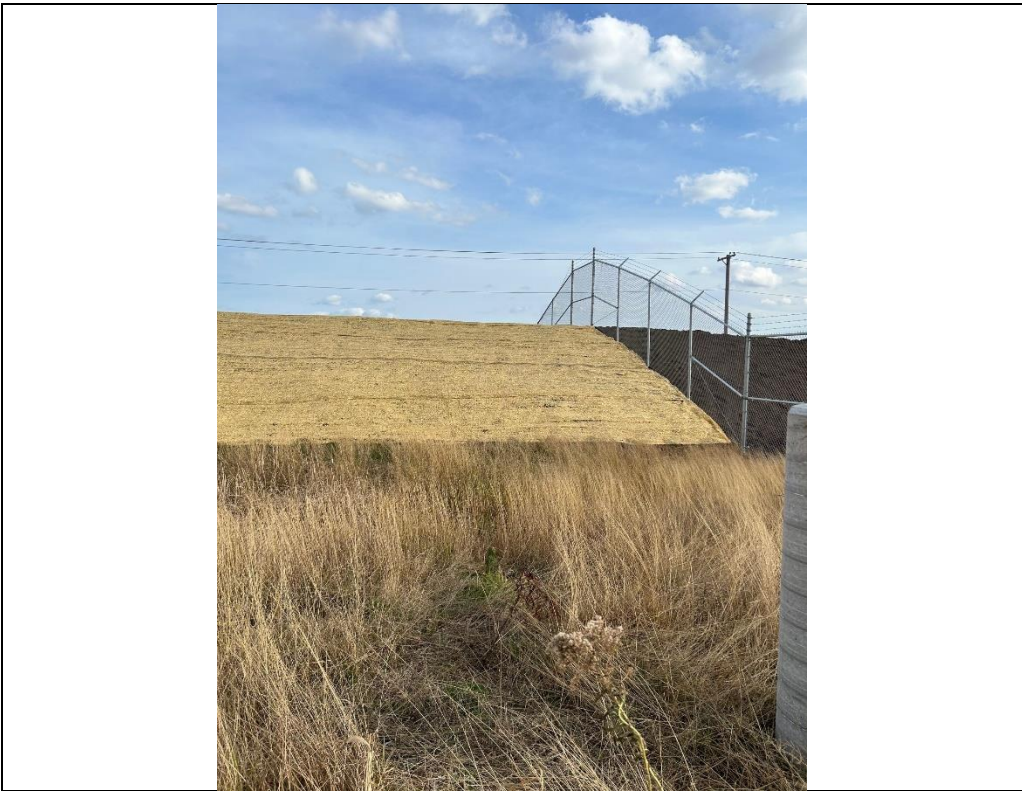
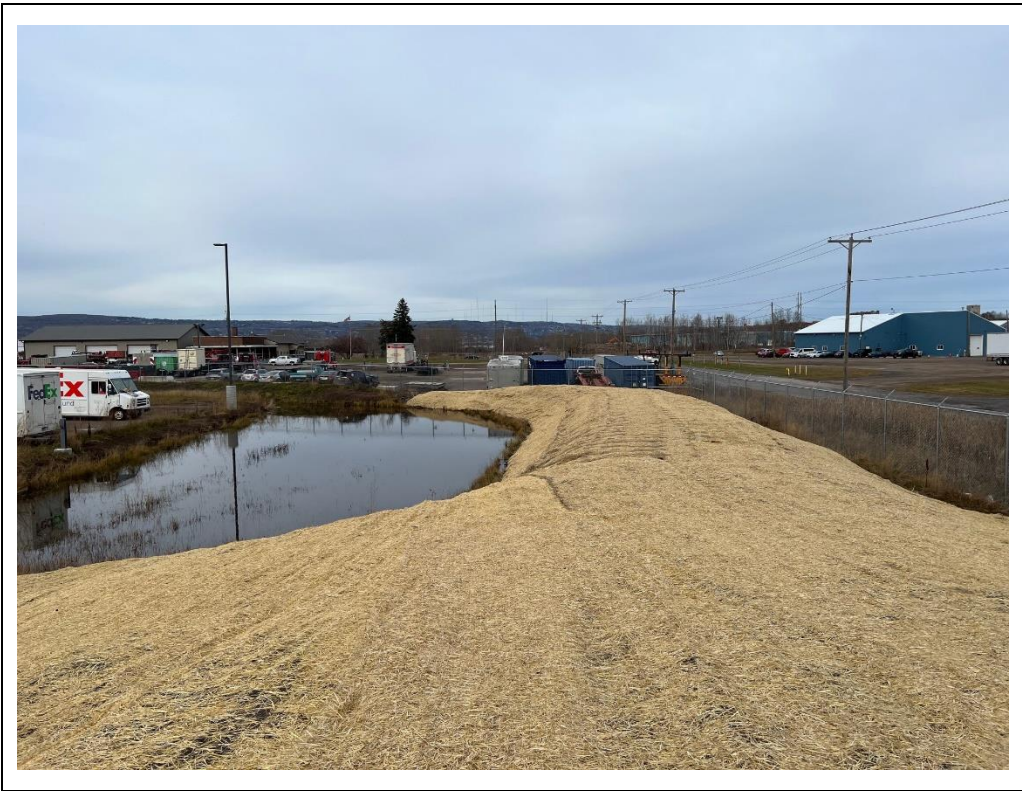
Photograph 1 - Soil Berm with seed mats

FedEx retained the services of Jensen Construction based out of Superior, Wisconsin, to perform maintenance activities for the berm. Jensen Construction and BBJ Group discussed the planned repair activities prior to initiation of work. The repairs were conducted from November 10 through November 17, 2023. During this time, Jensen imported soil, placed soil in locations that had inadequate coverage, hand raked the soil and confirmed proper coverage in conformance with the MMP, placed seed and fertilizer, and secured erosion control mats to prevent loss of soils.

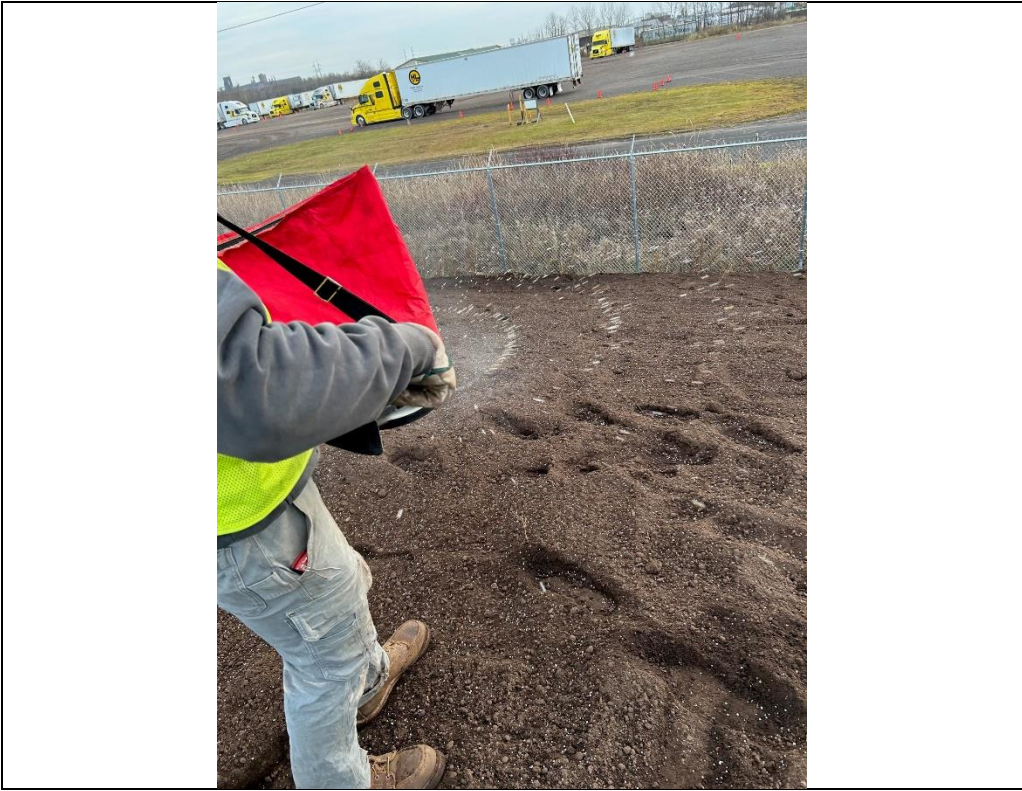
Photograph 8 - Dispersion of seed for grass coverage on berm.

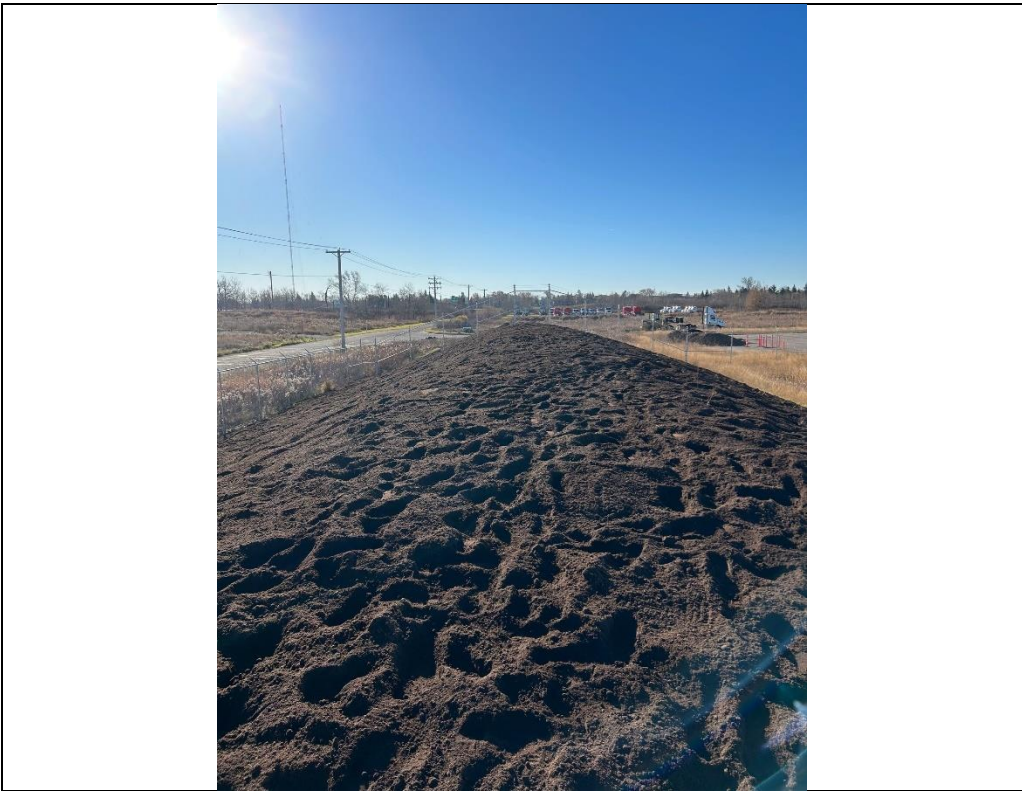
Photograph 9 - Soil cover on the berm

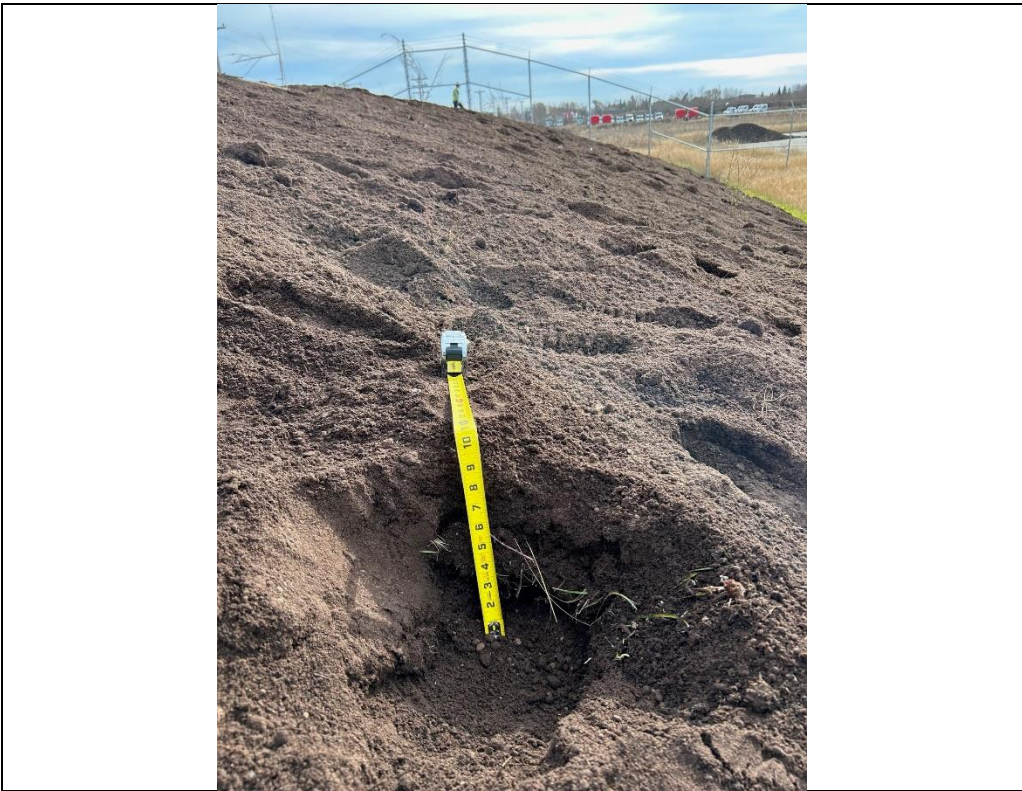
Photograph 10 - Showing Depth of Soil Coverage.
