September 15, 2020

Re: Landfill maintenance and upgrades request  
Junker's Landfill, Hudson, WI  
BRRTS# 023-0000

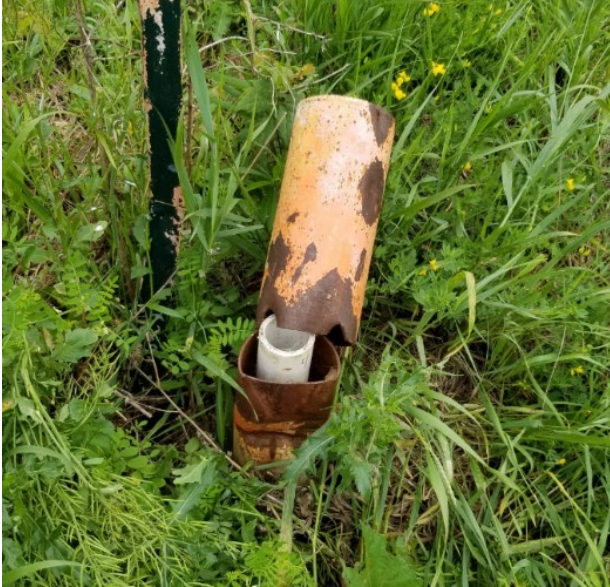
1. Monitoring Wells- estimate costs \$21,500
  - a. Steel outer casings need replacement and new locks on LHW, MW-6, GMW-18.
  - b. Several other wells need to be painted (prior to snowfall)

Broken steel casings on wells

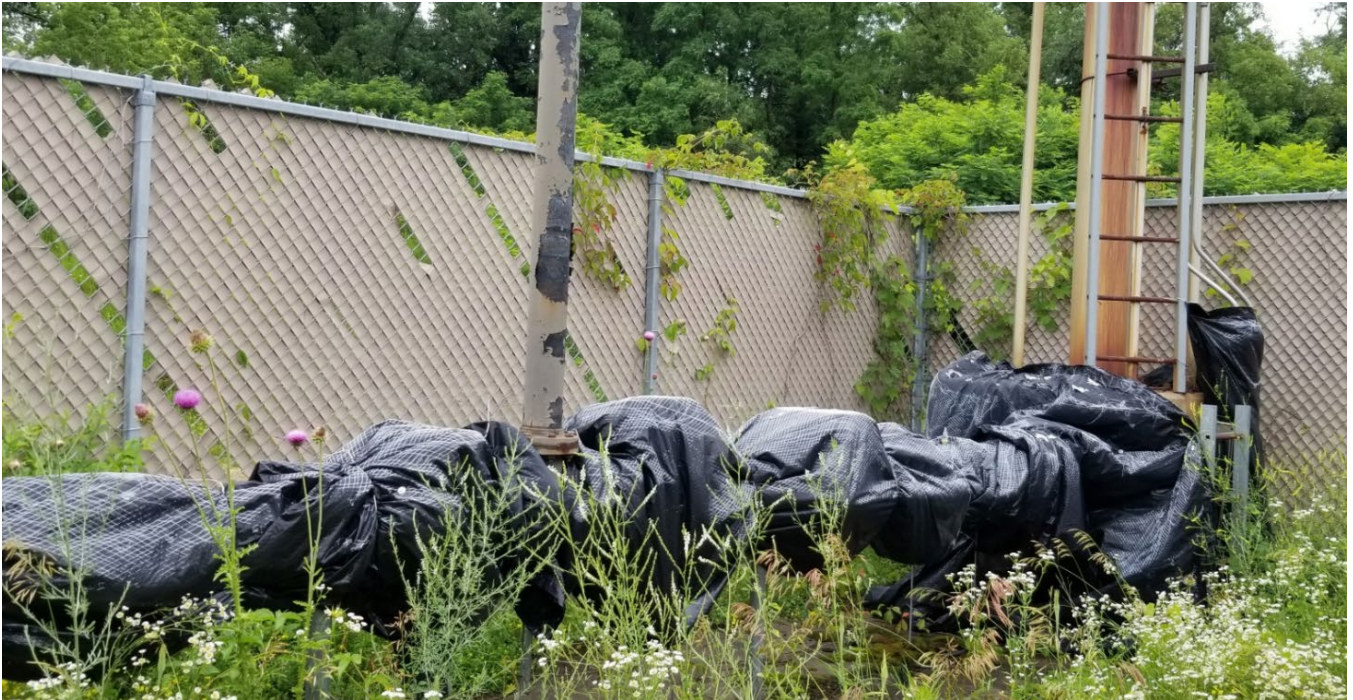
- c. Electrical upgrades
4. Replacement of Flare Insulation and removal of wood panels that have deteriorated and are no longer needed. The current insulation system has been piecemealed for many years.

1. Flare system; no longer in use and deteriorating. The old flare stack is currently being used to vent methane. This should be removed and re-piped with a new stack system. A smaller more efficient venting/discharge system could be installed as flaring is no longer needed at the site. Estimate cost \$25,000

Old stack system with degrading and insufficient insulation.

- a. Insulation Replacement on discharge piping- estimate costs \$1,995

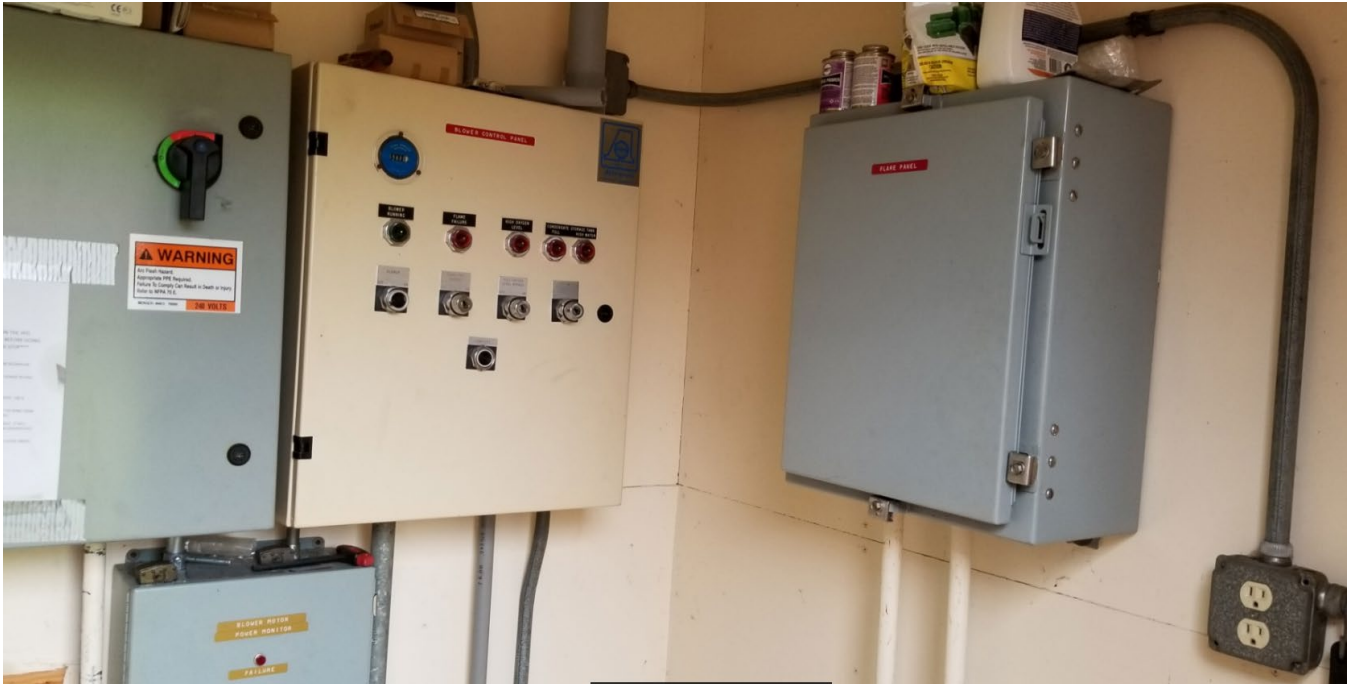
- b. Removal of Flare Panel and the unnecessary cross connections from unused components which are hard to troubleshoot and have been the source of system shutdowns

outdated control panels that are cumbersome and outdated. The DNR has concerns about efficiencies during emergency situations. Also, as no telemetry exists the only way to identify problems is upon physical inspections. This is worrisome as leachate could overflow during heavy storm events.

3. Installation of simple telemetry system and upgrading and simplifying the control panels- estimate costs \$6,660
  - a. Omni Beacon – with one year of cell service and required control panel components
