MEMORANDUM

FROM : Pratap Singh, Ph.D., PE / KSingh

SUBJECT : Weekly Progress Report for Week Ending 06/03/2023
Community Within the Corridor - East Block

COPY TO : Que El-Amin / Scott Crawford, Inc., Robert Reineke, PE, Robert Fedorchak, PE
Project #40441B

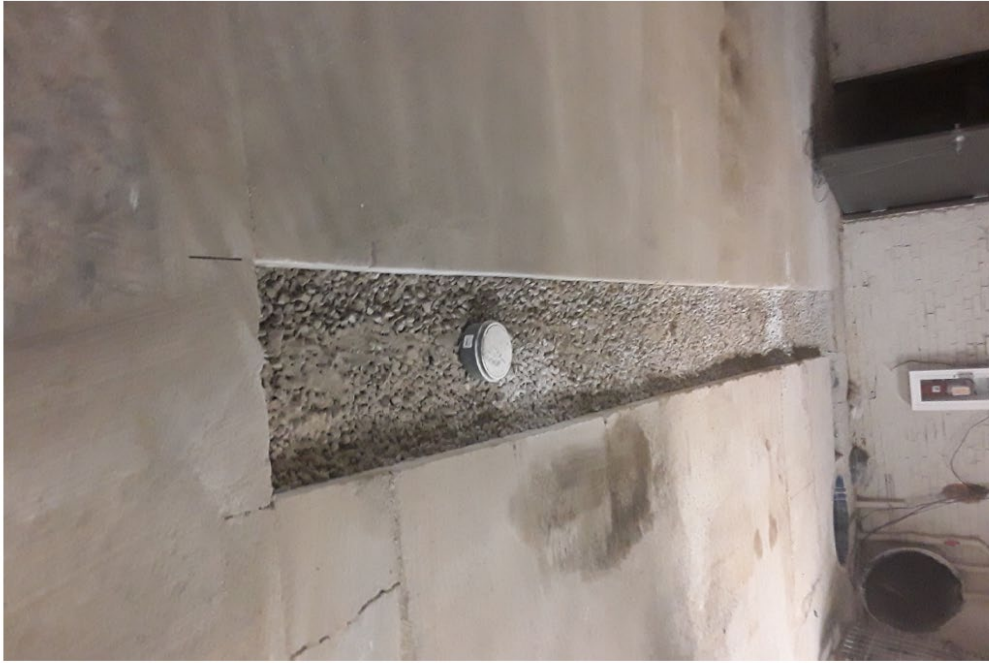
May 30, 2023 - Drain Tile and Inspection Port Ready for Vapor Barrier and Concrete at Building 1B-NE Elevator Pit Sump

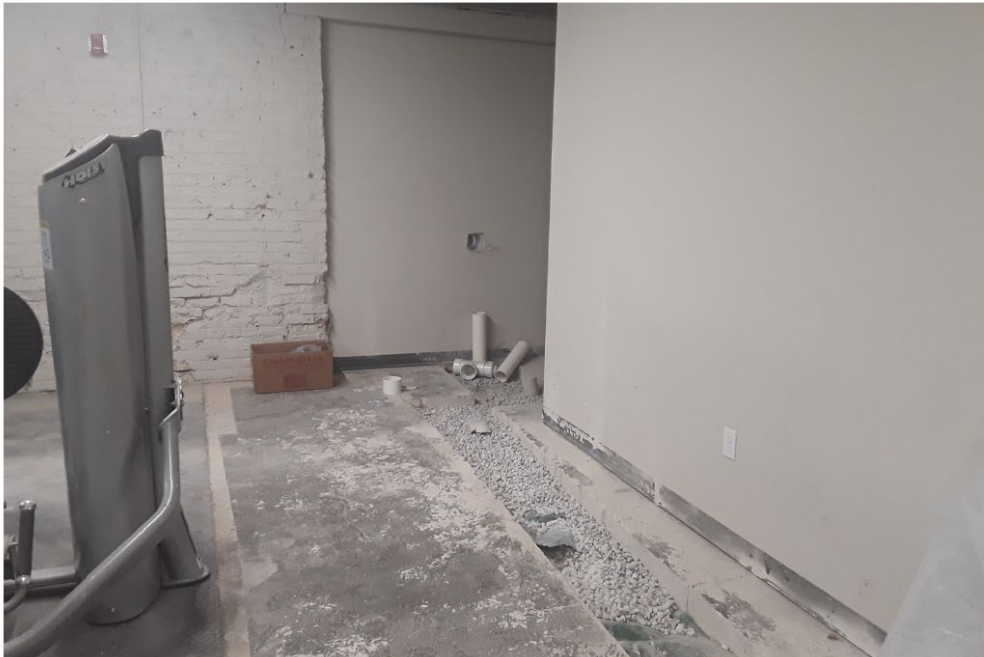
May 30, 2023 - Hole Cored for Piping in Fitness Room

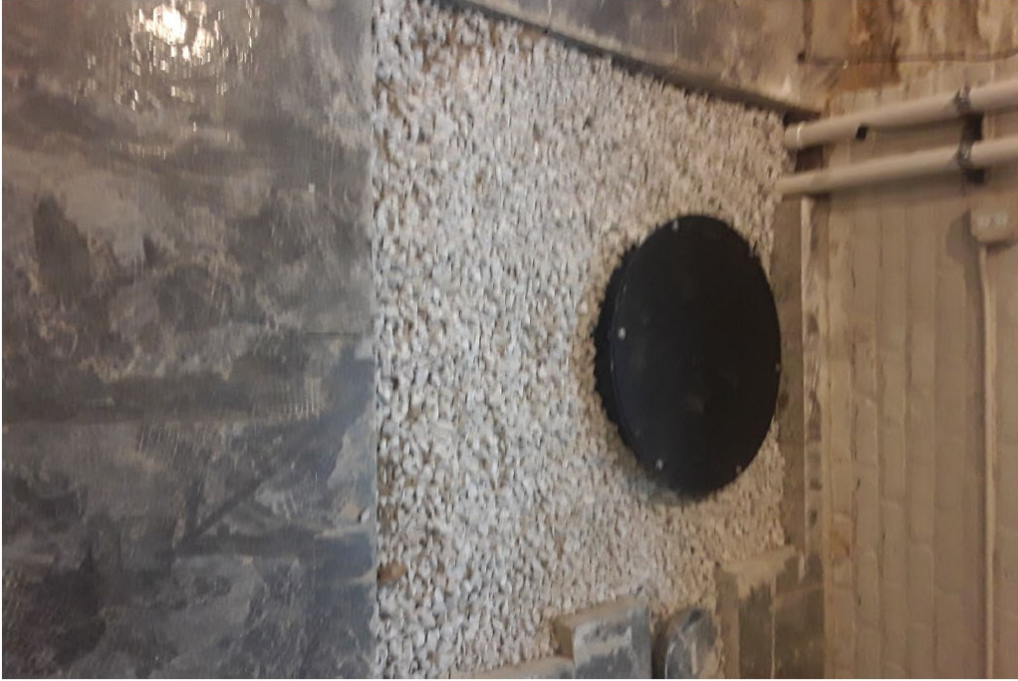
May 30, 2023 - Sump in Unit 1042

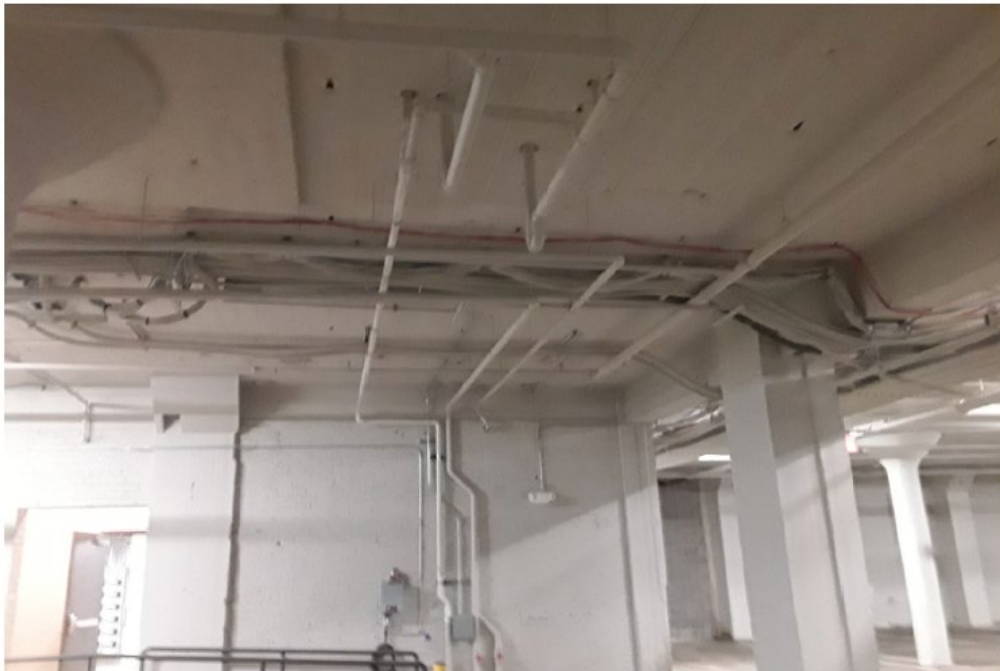
May 31, 2023 - Installed Discharge Plumbing to Overhead Storm Piping - Elevator Sump - Bldg 2A

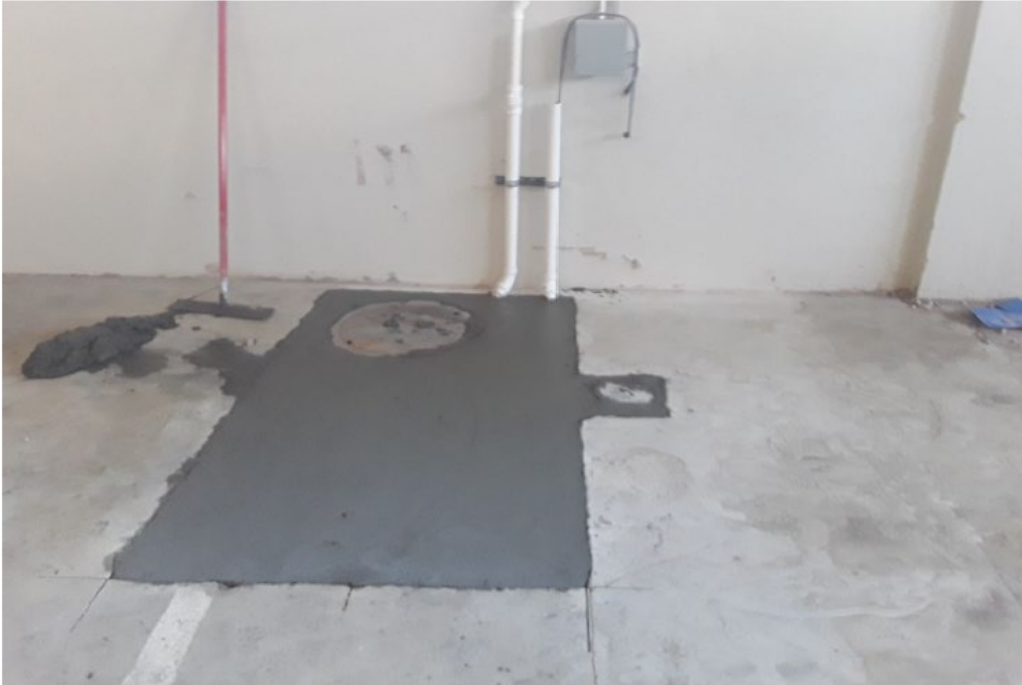
May 31, 2023 - Concrete Sealed Sump in Building 2A

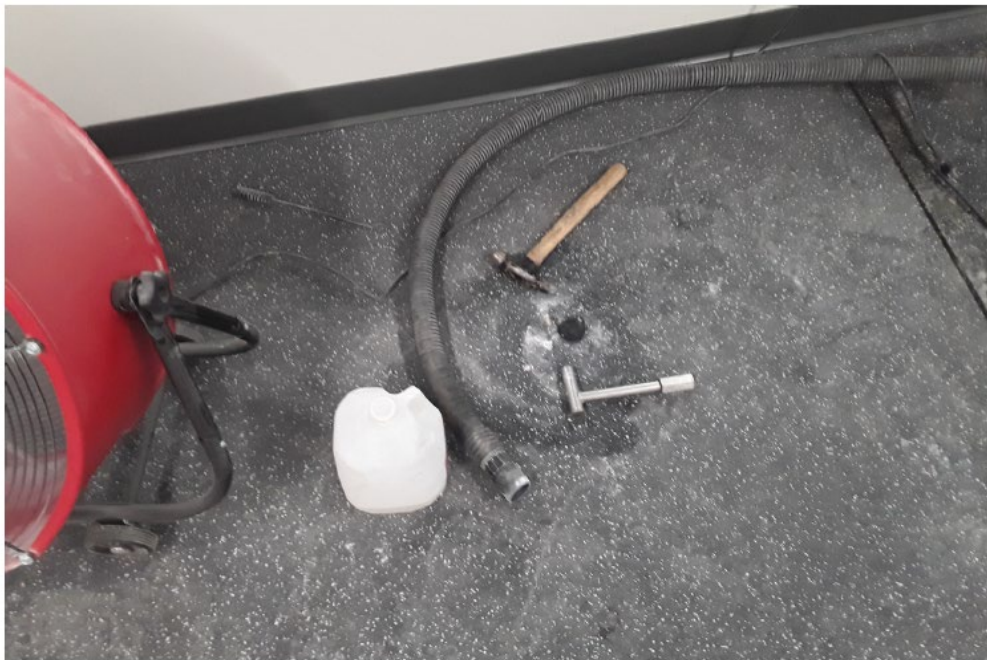
May 31, 2023 - Installed Vapor Pin in Fitness Room

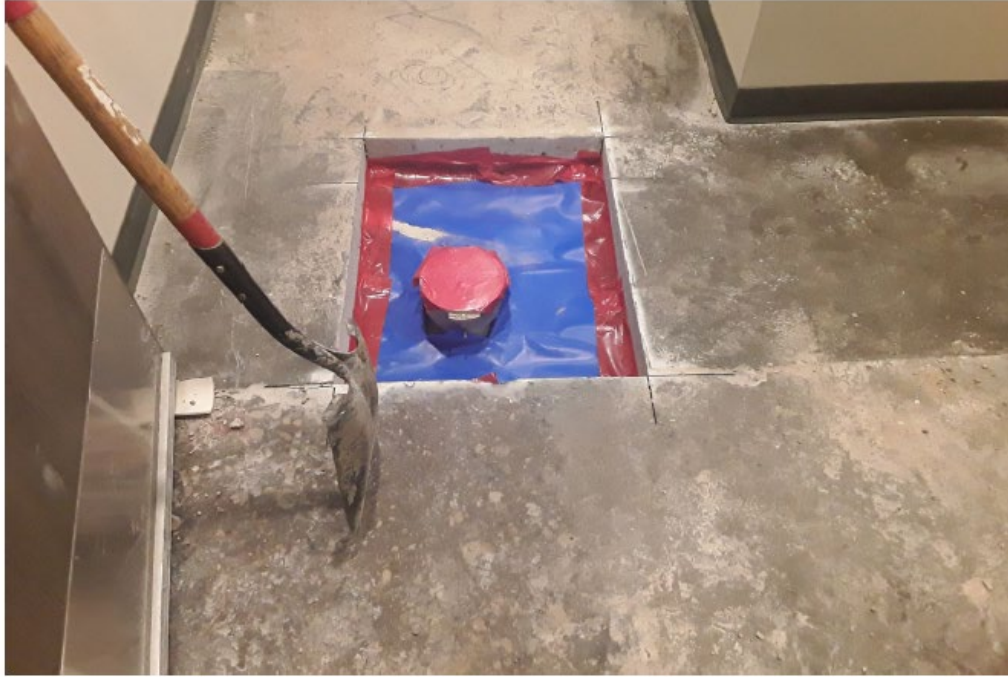
June 1, 2023 - Vapor Barrier Around Inspection Port in Unit 1025

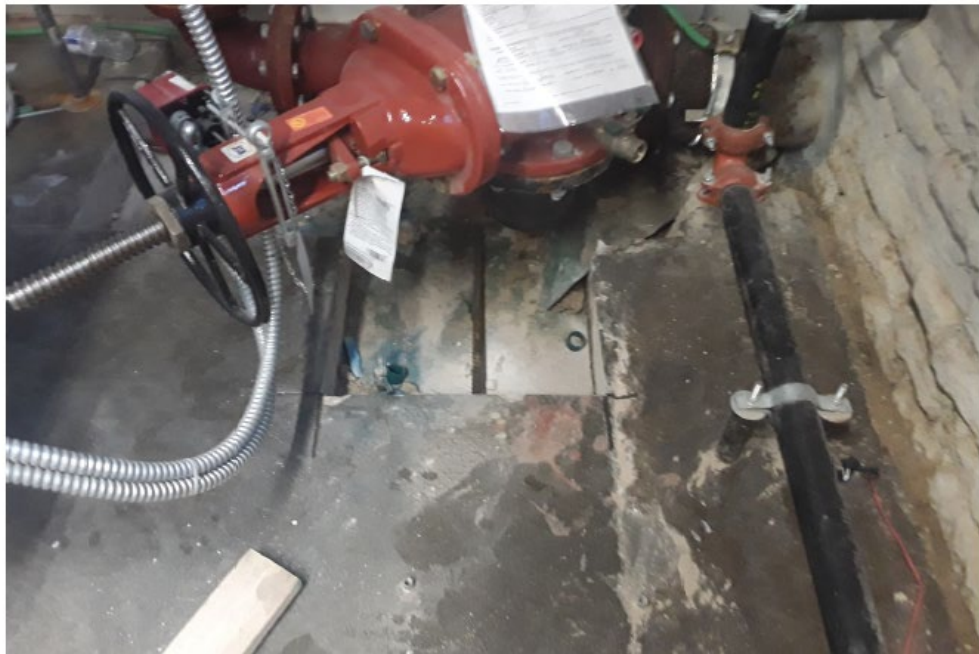
June 1, 2023 - Rebar Installed Under Mechanical Room Cut

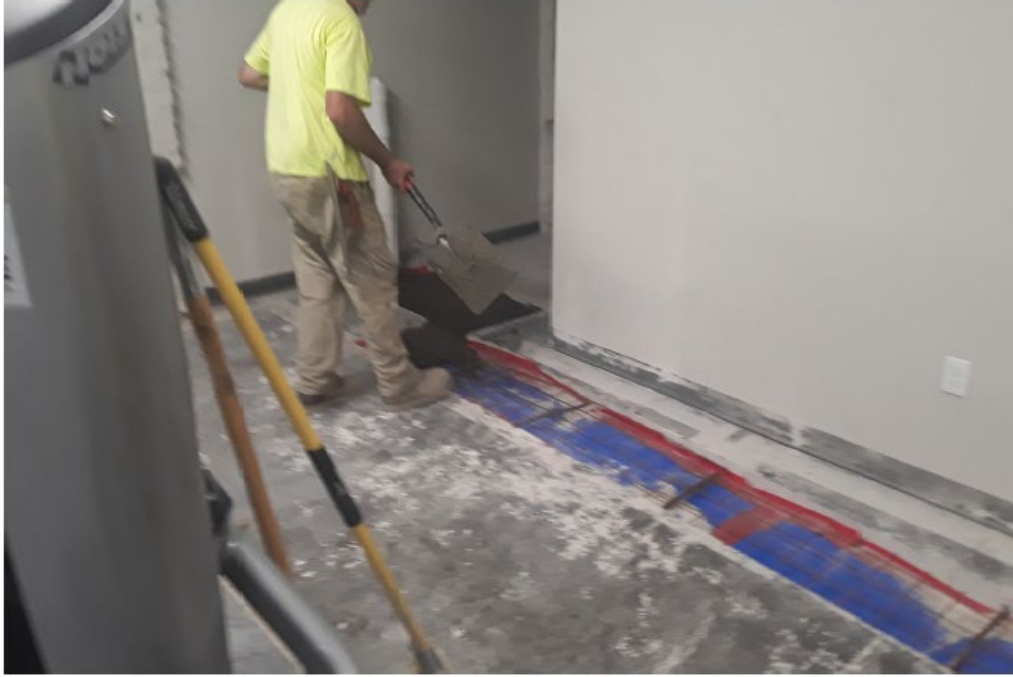
June 1, 2023 - Concrete Sealing in Fitness Room

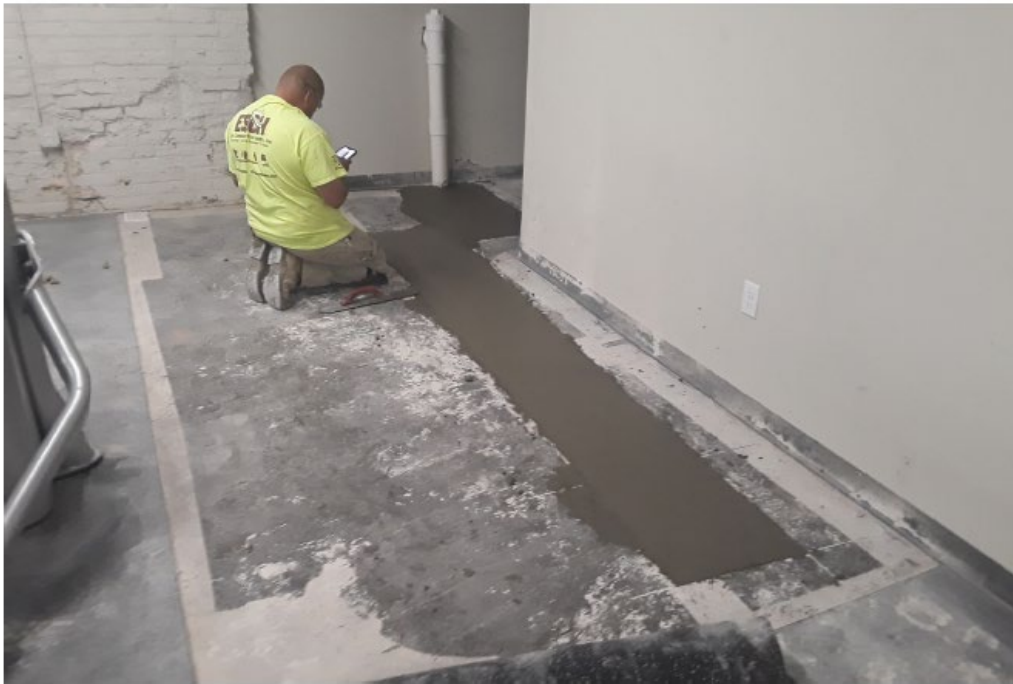
June 1, 2023 - Concrete Sealing of Floor in Fitness Room

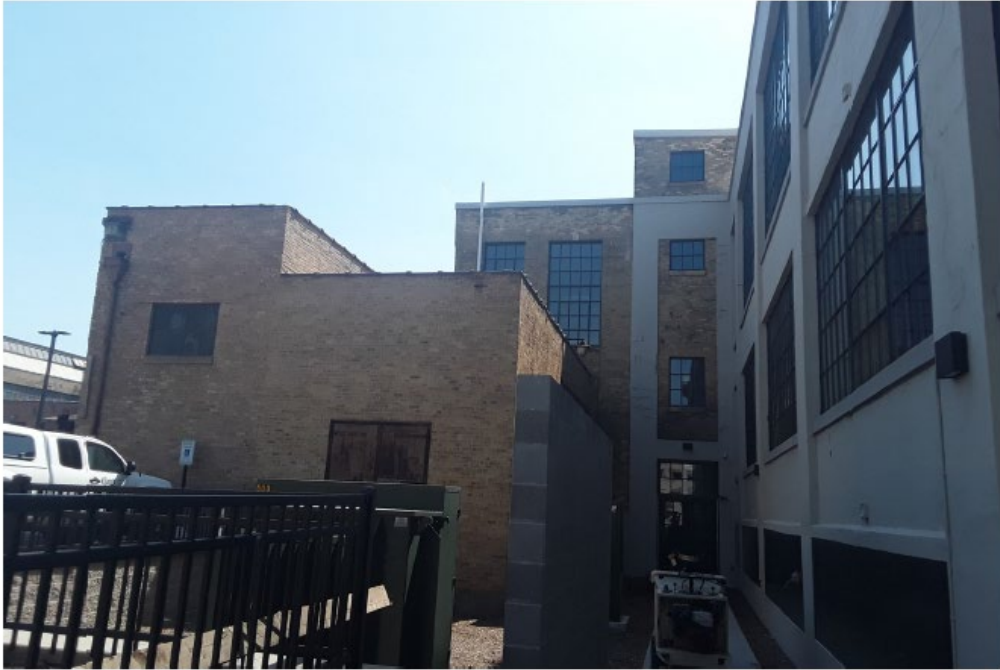
June 1, 2023 - Power House / Mechanical Room Vent Line Above Roof Line

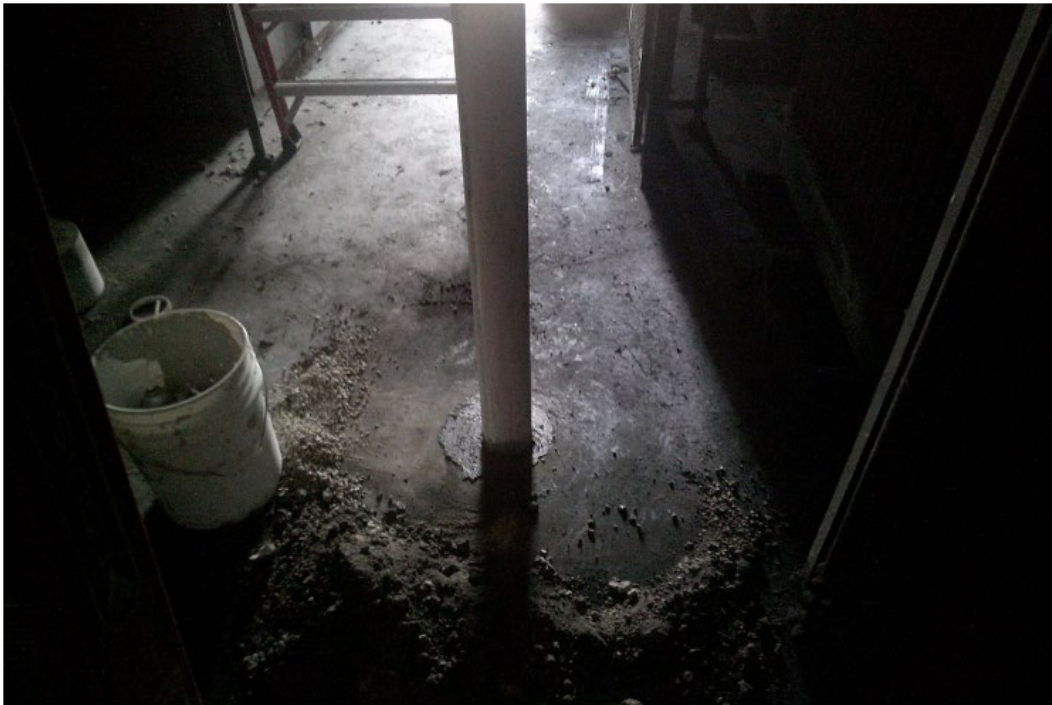
June 2, 2023 - Power House Sealed Vapor Extraction Point

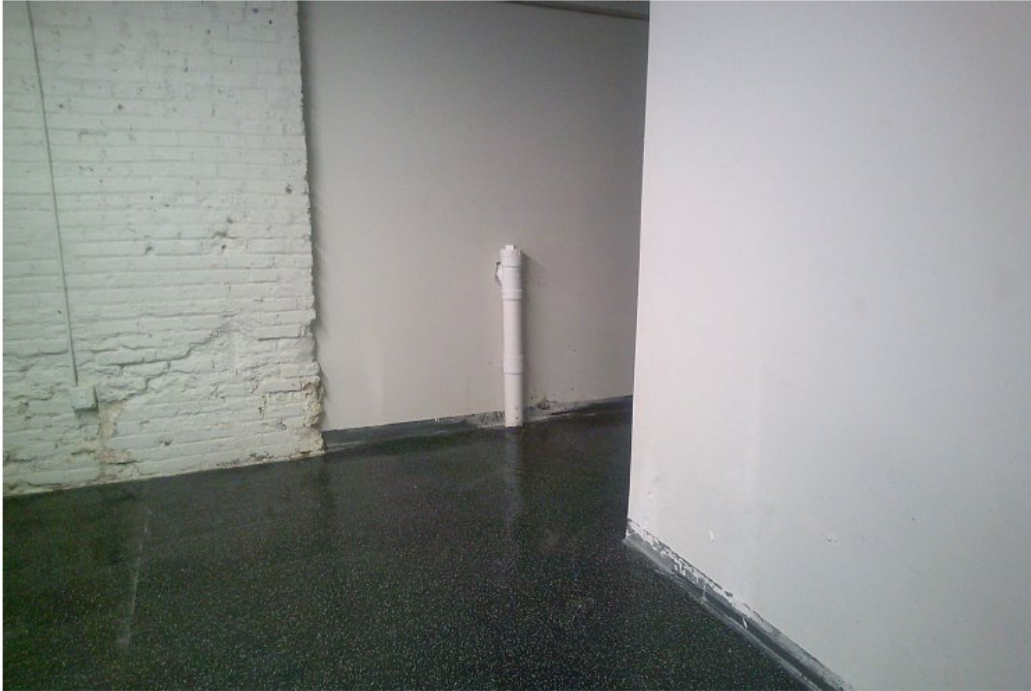
June 2, 2023 - Fitness Room Restored

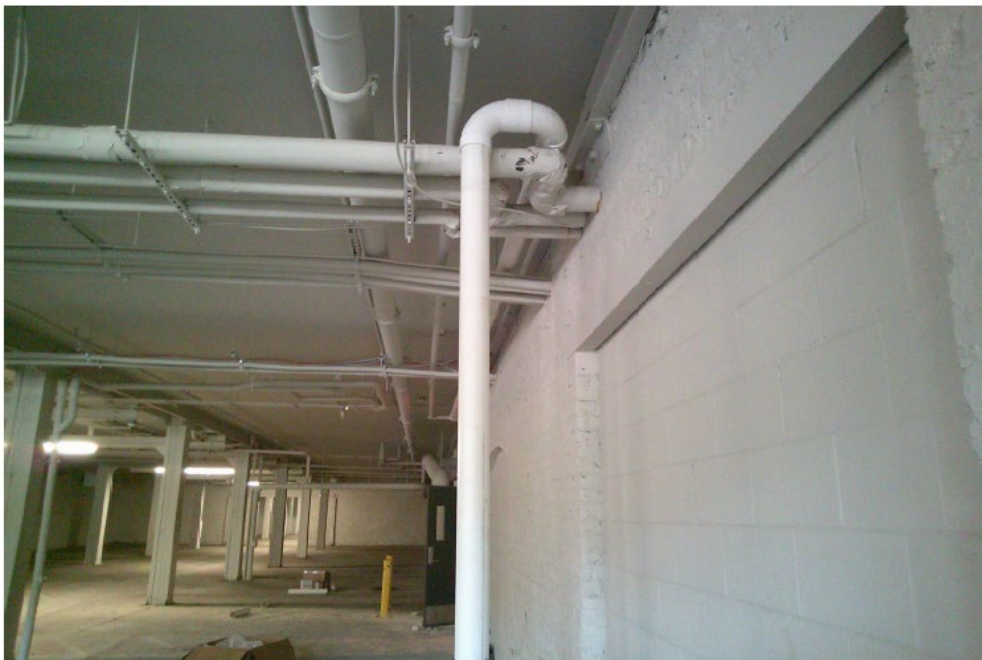
June 2, 2023 - Completed Piping Hookup to Outlet Pipe

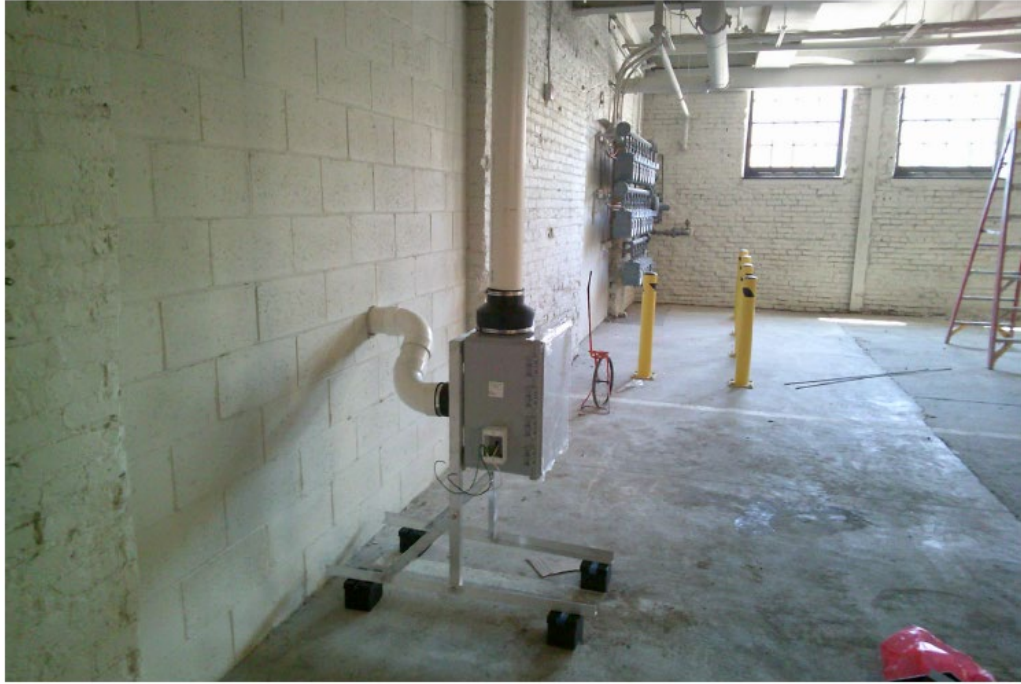
5. Task #5 – Preparation for and Installation of Additional Blower
An OBAR Fan was delivered on site and installation was completed by Horner Plumbing on 6/2/2023. Arrangements are being made to bring electrical power to start pressure measurement testing.

June 2, 2023 - OBAR Fan Hooked Up to Outlet Piping

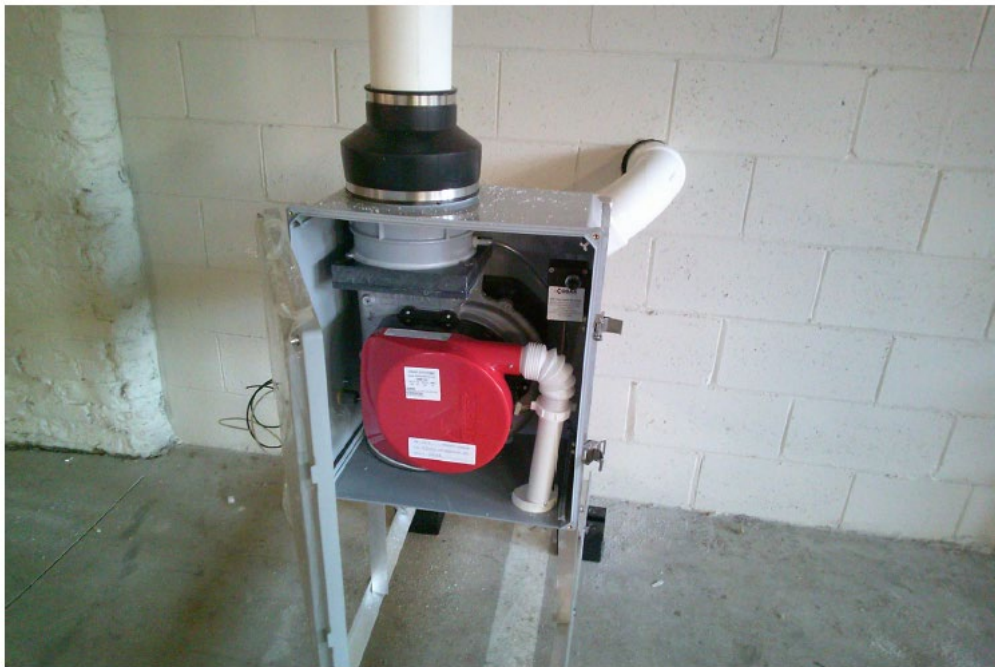
June 2, 2023 - OBAR Fan

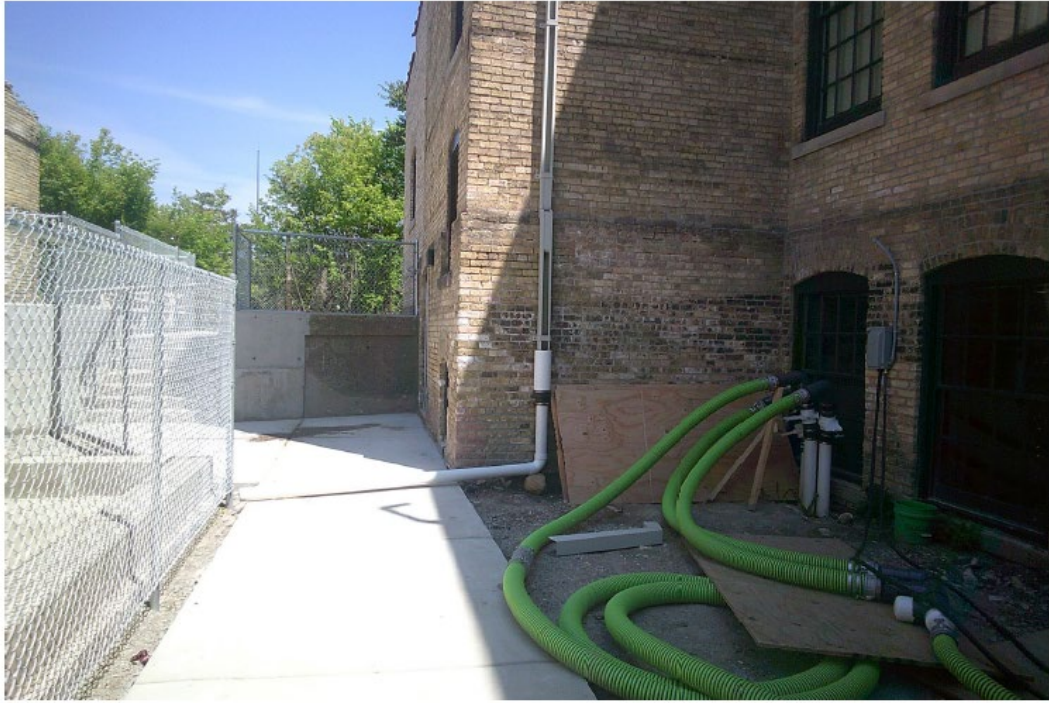
June 2, 2023 - Temporary Redirection of Downspout Discharge
